UNITED STATES
NUCLEAR REGULATORY COMMISSION
OFFICE OF NUCLEAR REACTOR REGULATION
WASHINGTON, D.C. 20555

NRC INFORMATION NOTICE 2003-11, SUPPLEMENT 1: LEAKAGE FOUND ON
BOTTOM-MOUNTED
INSTRUMENTATION NOZZLES

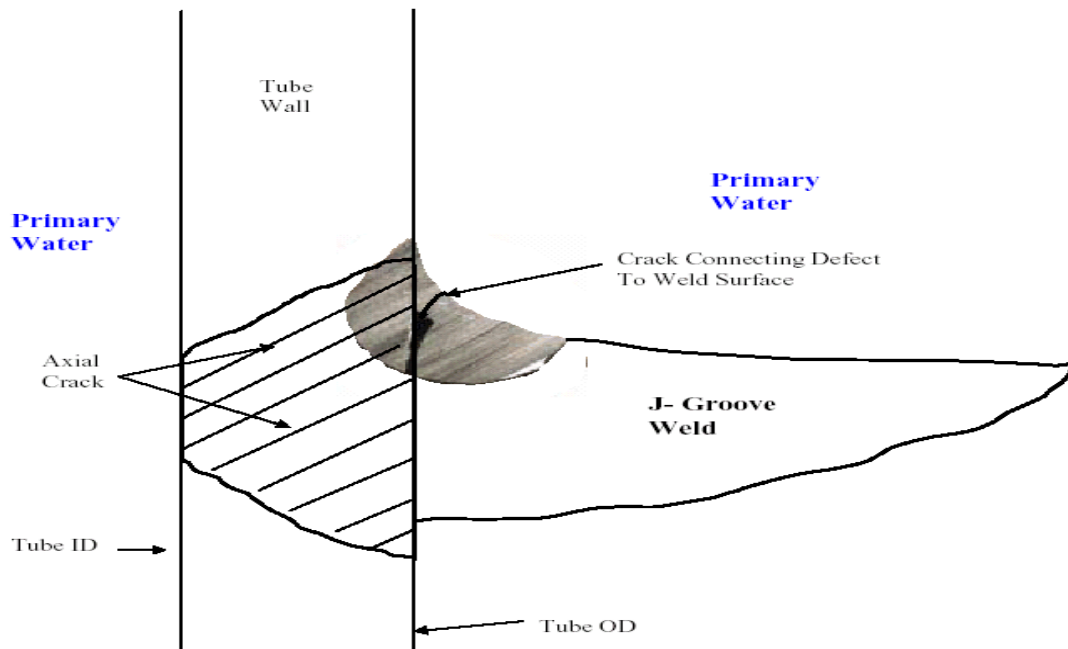
Figure 1 Overlay of cross section of boat sample from STP Unit 1 penetration 1 with drawing of penetration 1 tube and weld geometry.

- (2) The UT discontinuity at the tube-to-weld interface which was captured in the boat sample (the dark area in the boat sample in Figure 1) was confirmed to be a weld lack-of-fusion zone from initial fabrication. A weld material ligament of approximately 80 mils (0.080 inch) separated the weld lack-of-fusion zone from the surface of the J-groove weld. The length of the lack-of-fusion zone in the circumferential direction was about 0.2 inch. The axial PWSCC crack in the tube wall was located at one end of the lack-of-fusion zone.

- (3) A second cracklike defect was observed in the weld material (the dark line in Figure 1), running in the circumferential direction. The length of this defect was about 0.2 inch, consistent with the length of the lack-of-fusion zone. This defect was completely through the 80 mil weld ligament and would have permitted primary water to leak into the lack-of-fusion zone. The precise mechanism for the initiation and propagation of this defect through the weld material could not be determined from the boat sample. However, its location and size relative to the associated lack-of-fusion zone suggest that the formation of this defect was also related to initial fabrication processes.
