NTSB National Transportation Safety Board

Corporate Aviation Safety Seminar

Deborah Hersman
Board Member, NTSB

April 30, 2008
Palm Harbor, Florida

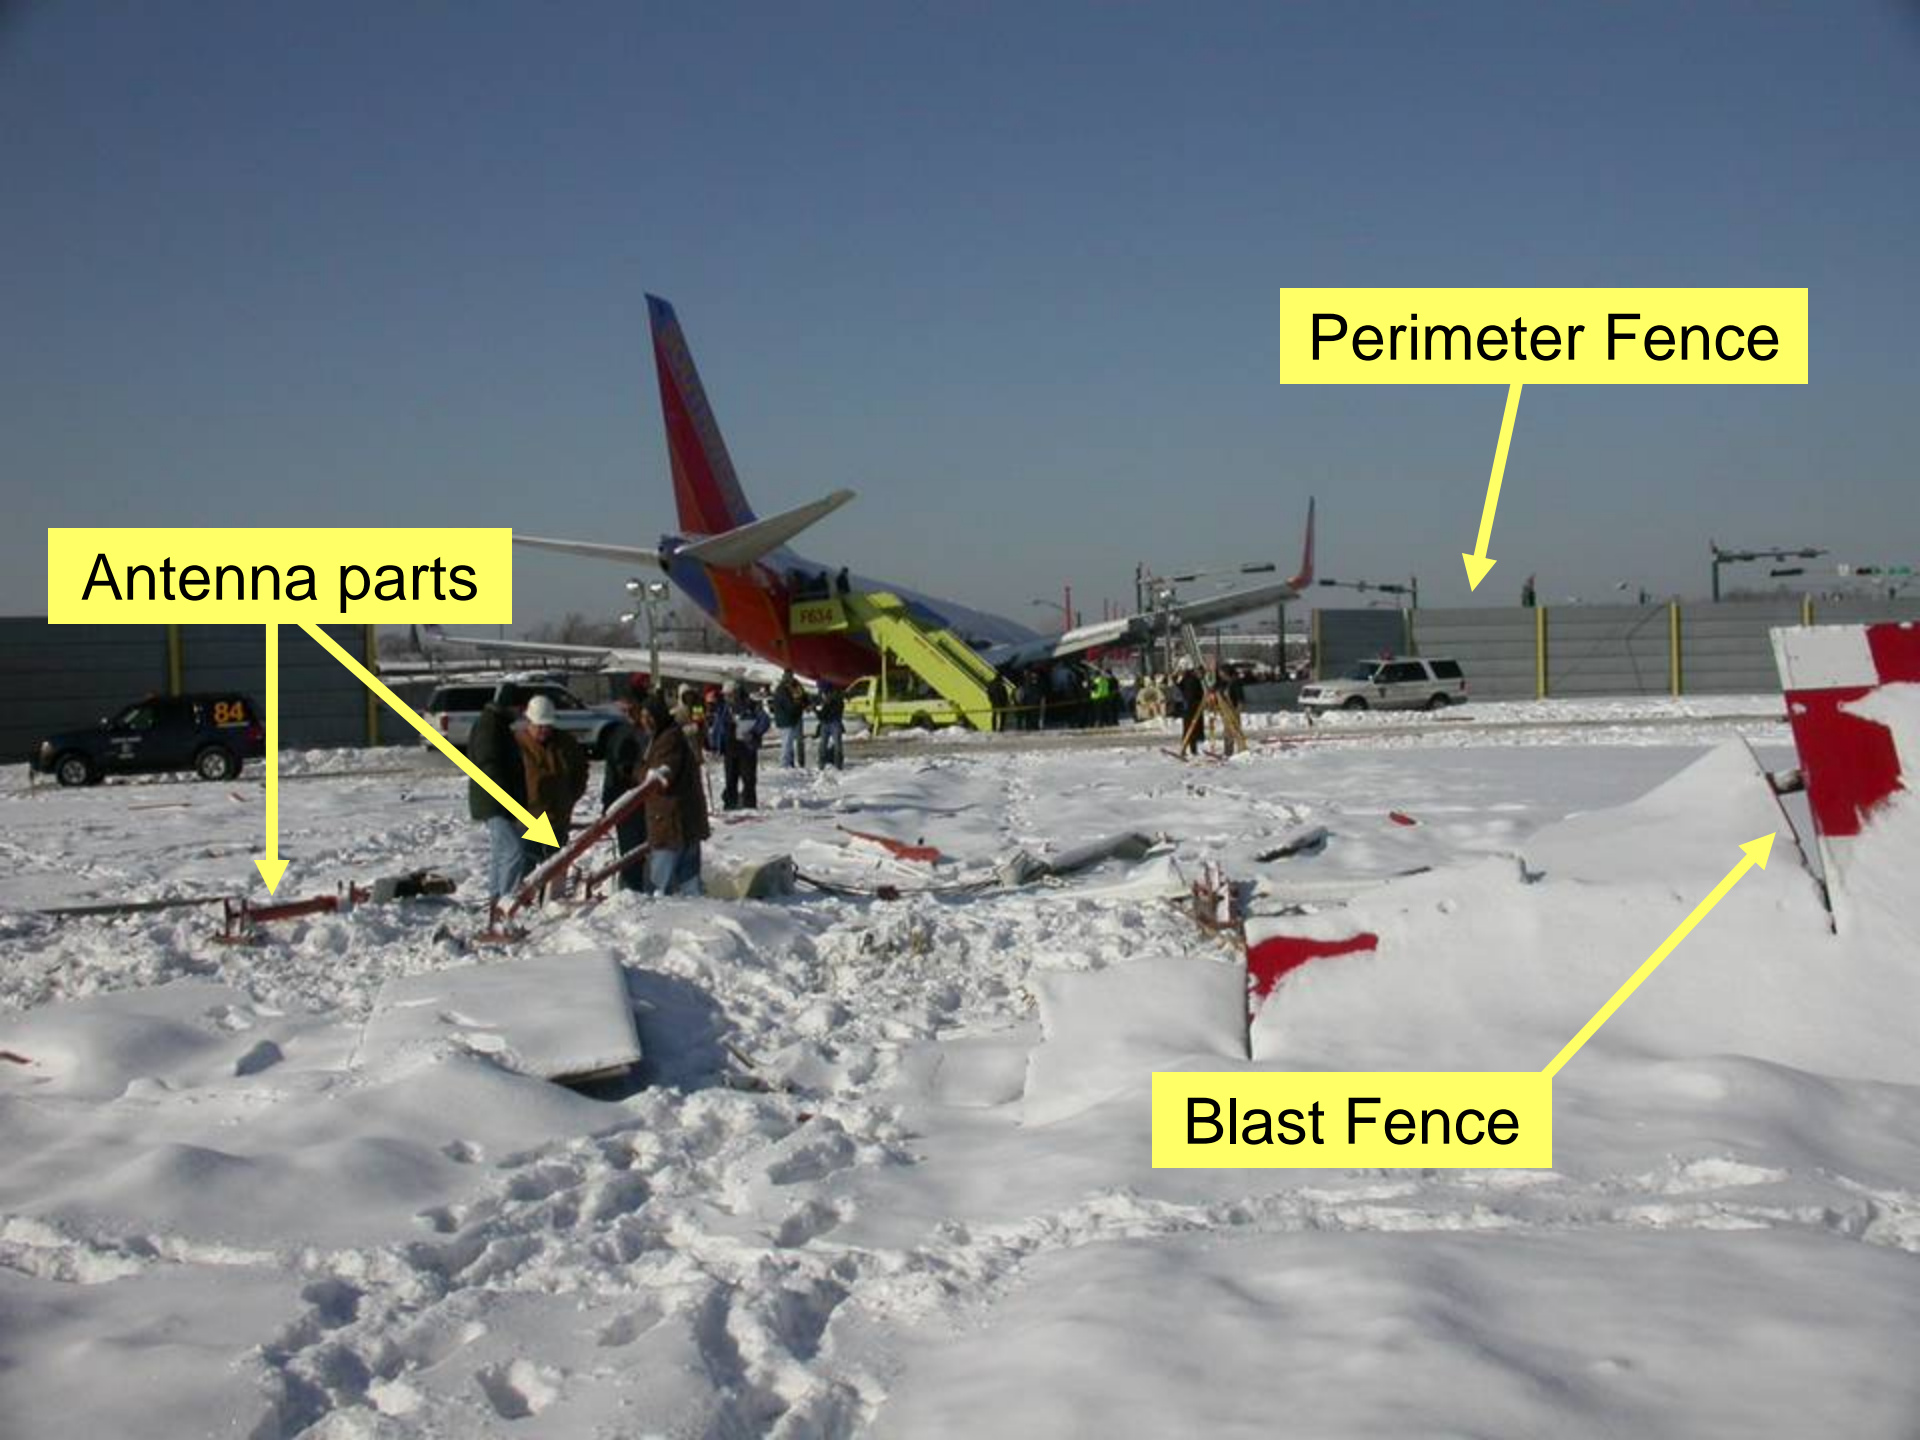
Antenna parts

Perimeter Fence

Blast Fence

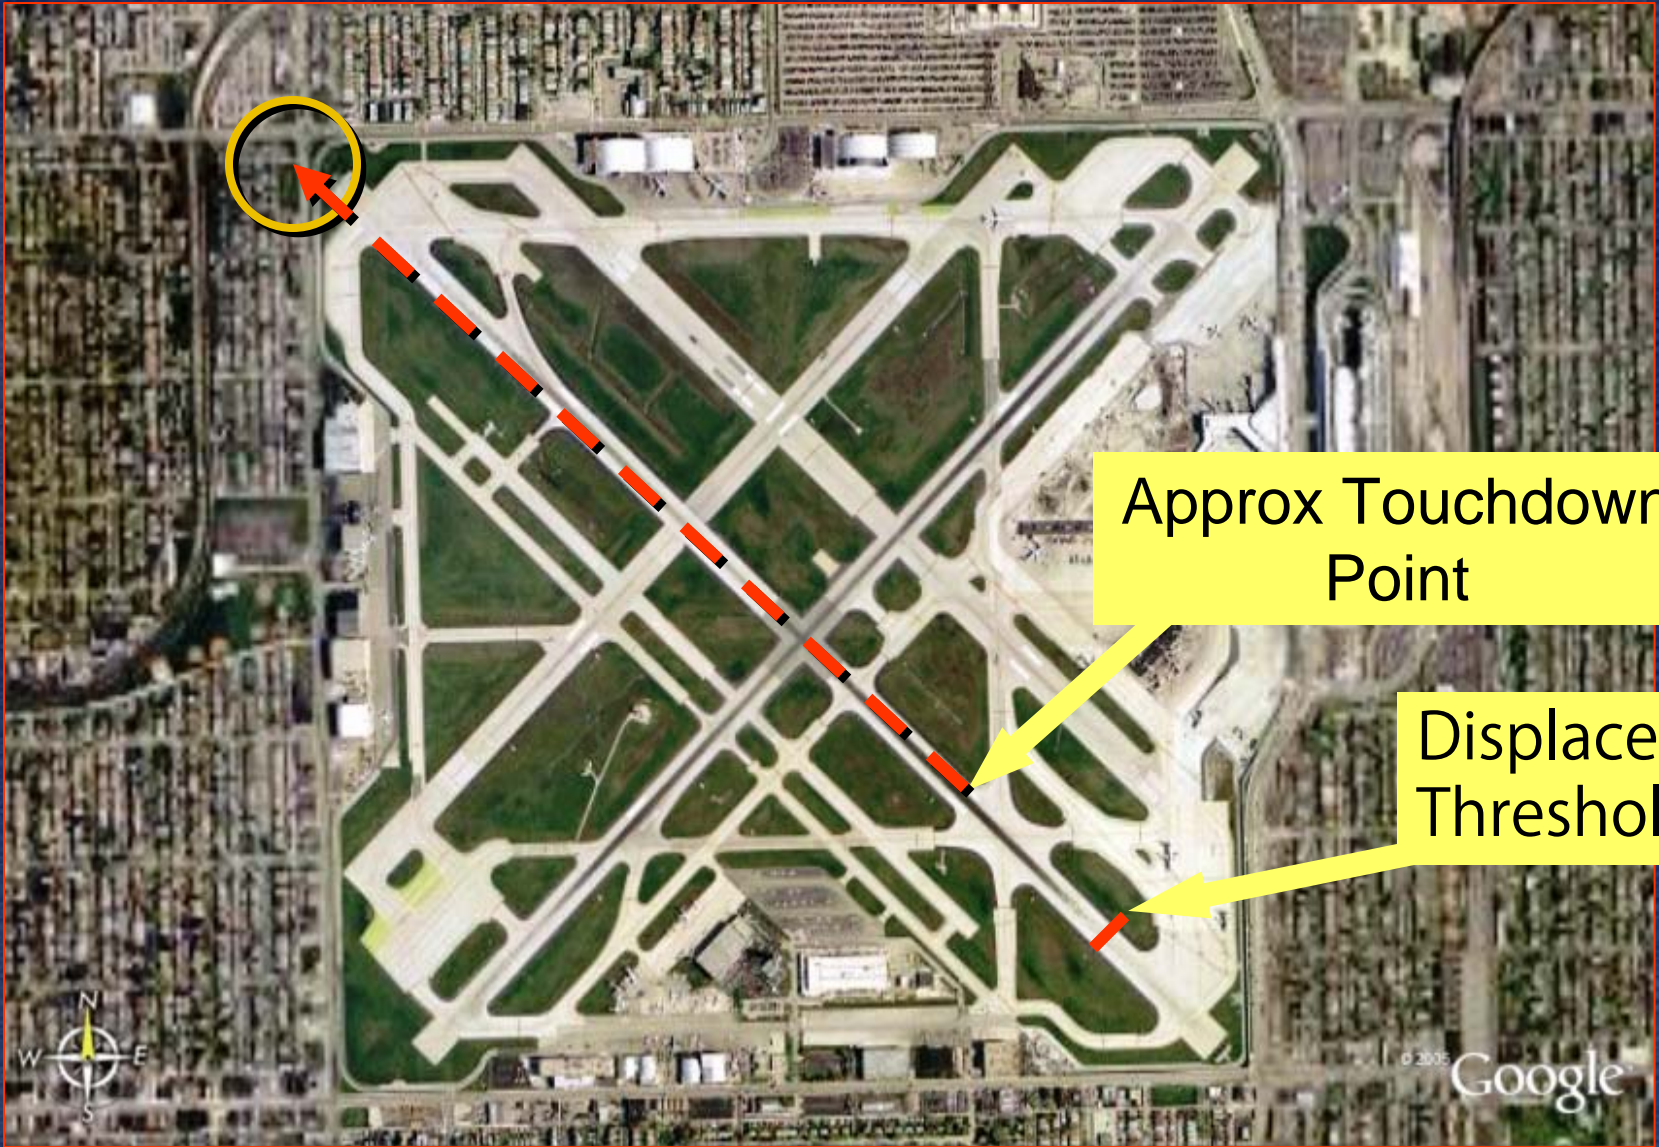
Approx Touchdown Point

Displaced Threshold

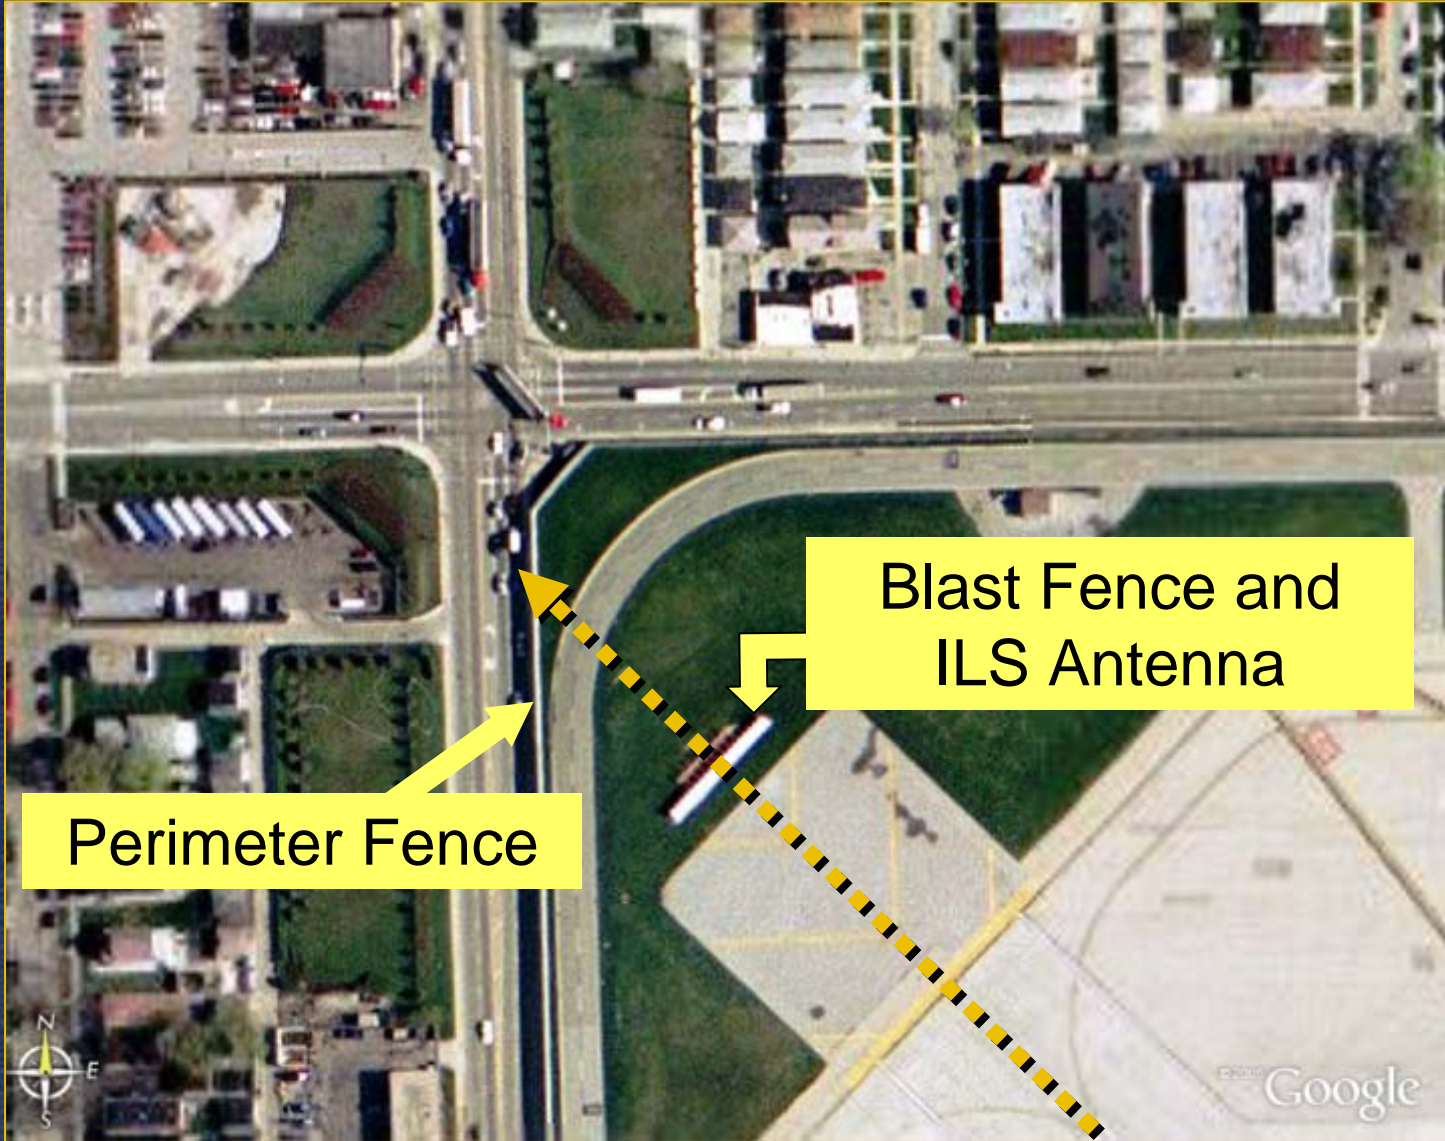
Perimeter Fence

Blast Fence and ILS Antenna

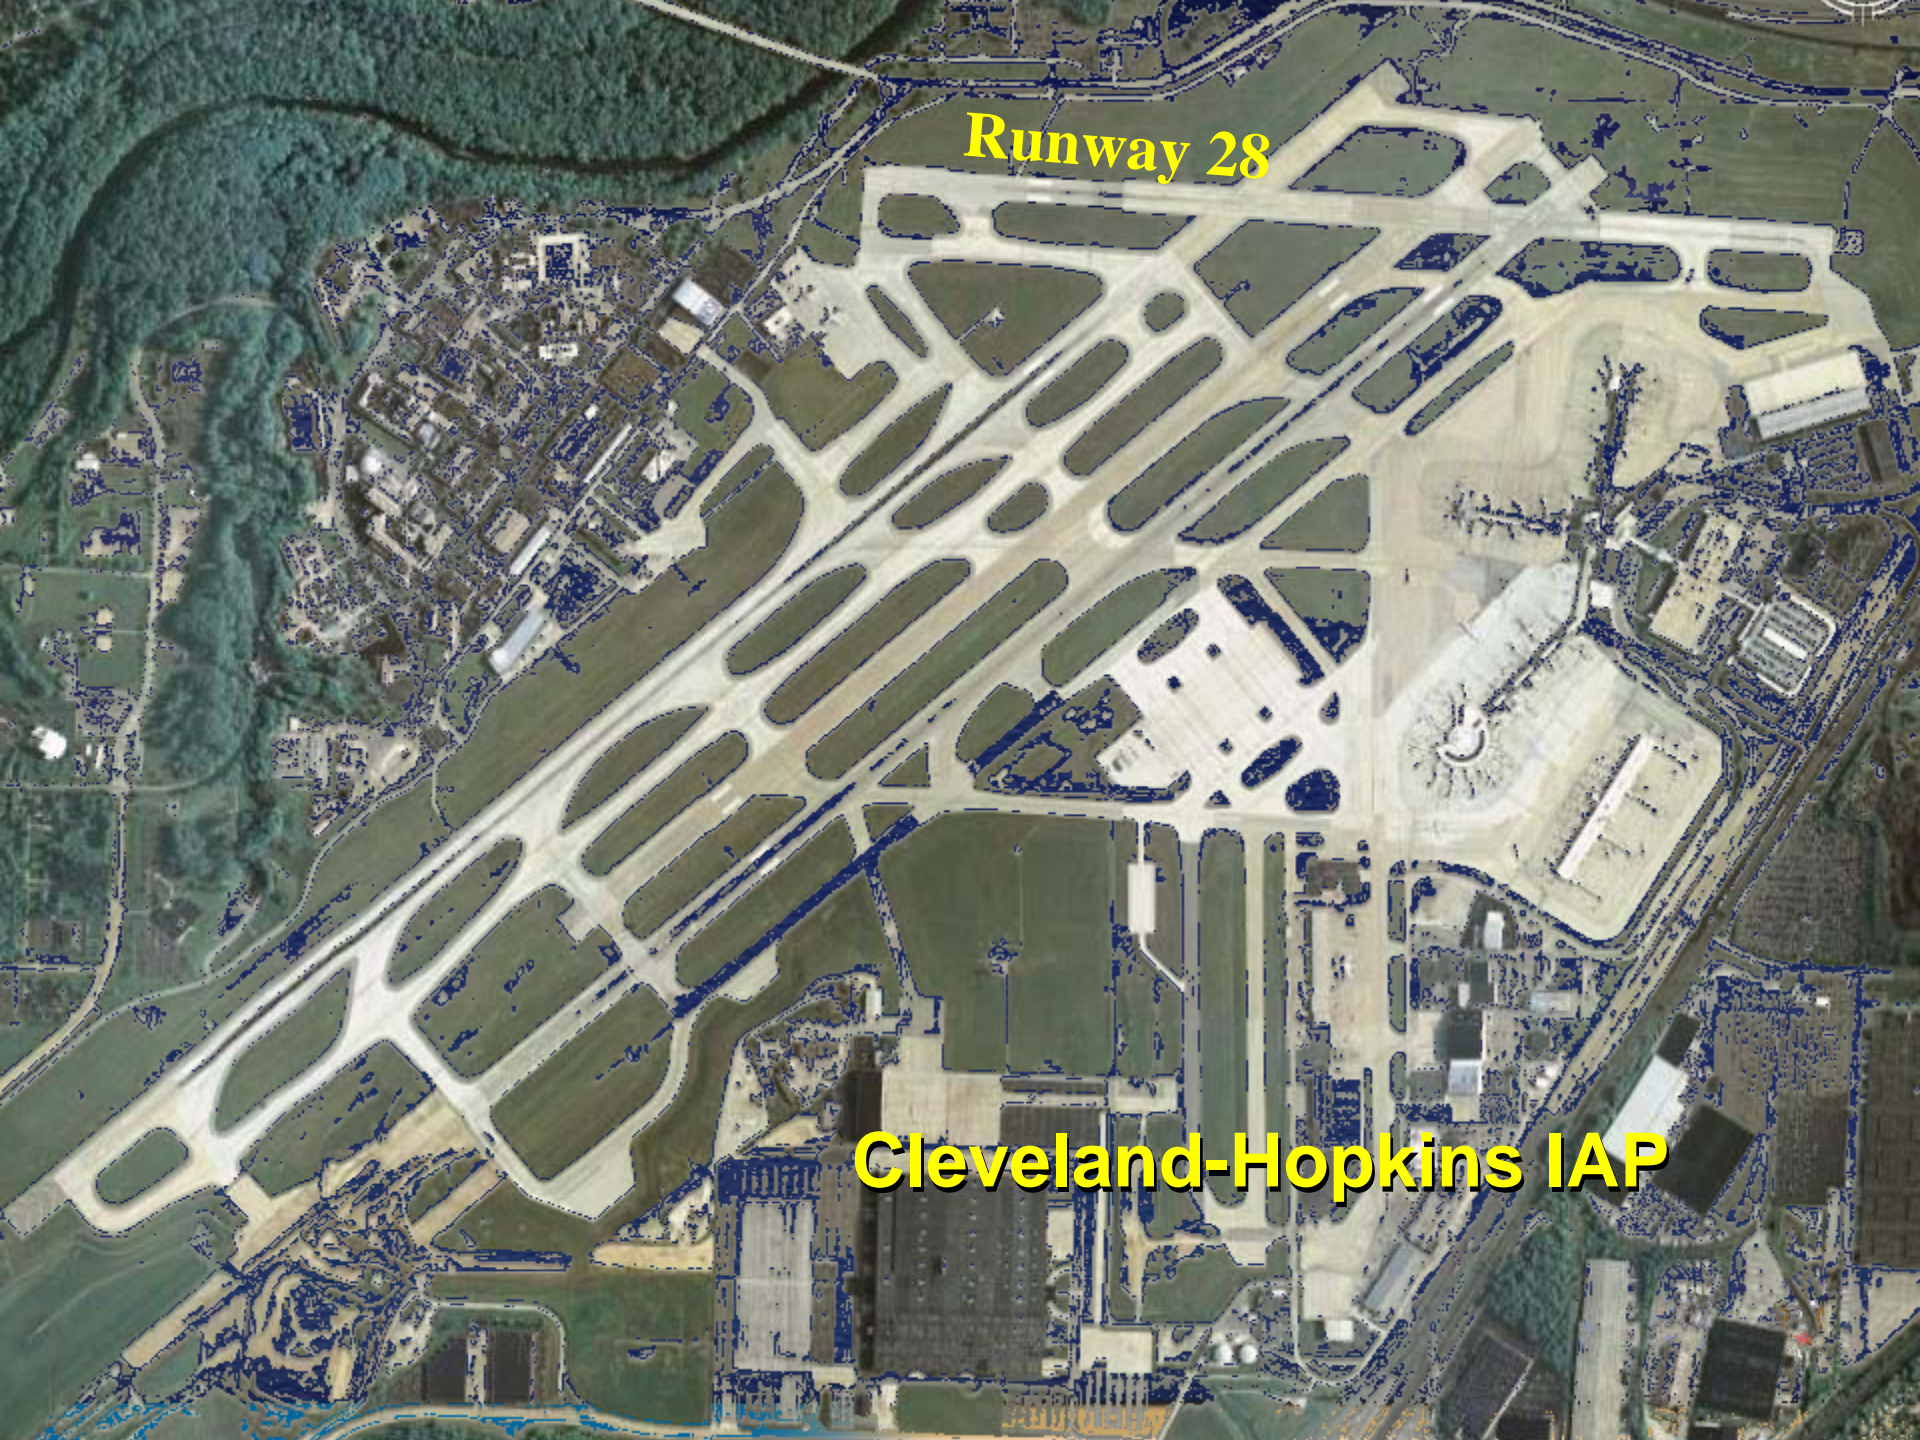
Aircraft Stopped

Landing Area

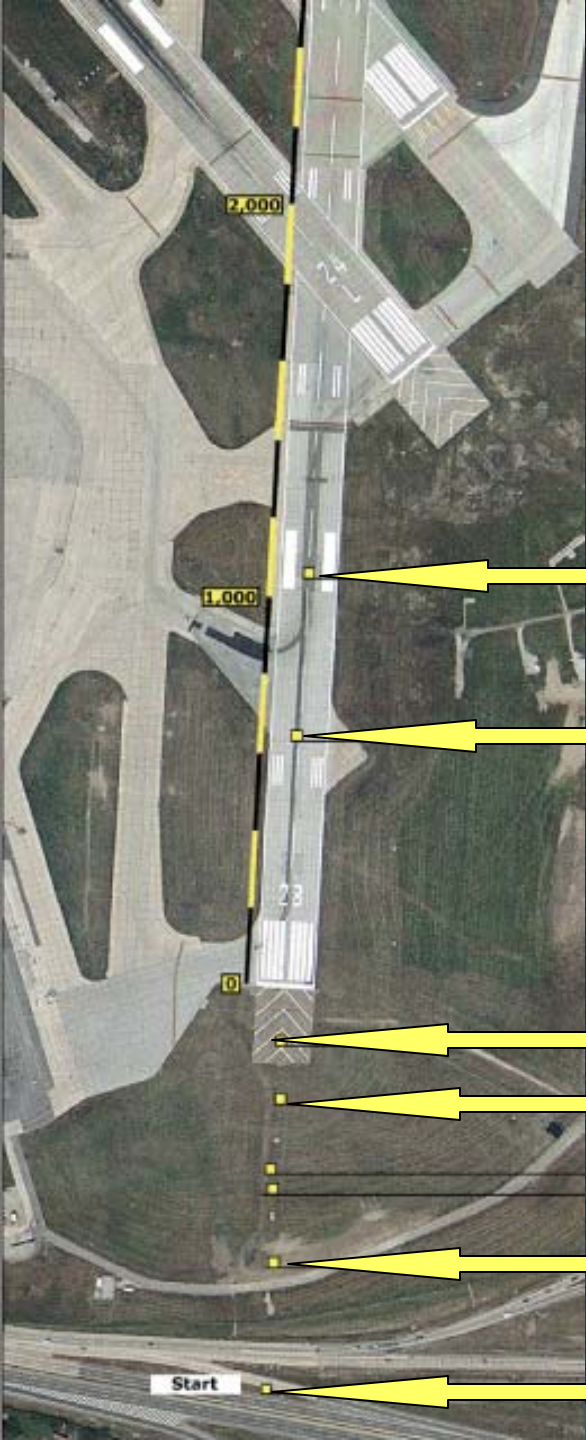
10 Feet

30 Feet

40 Feet

Captain Sees Runway

F/O Sees Runway

80 Feet

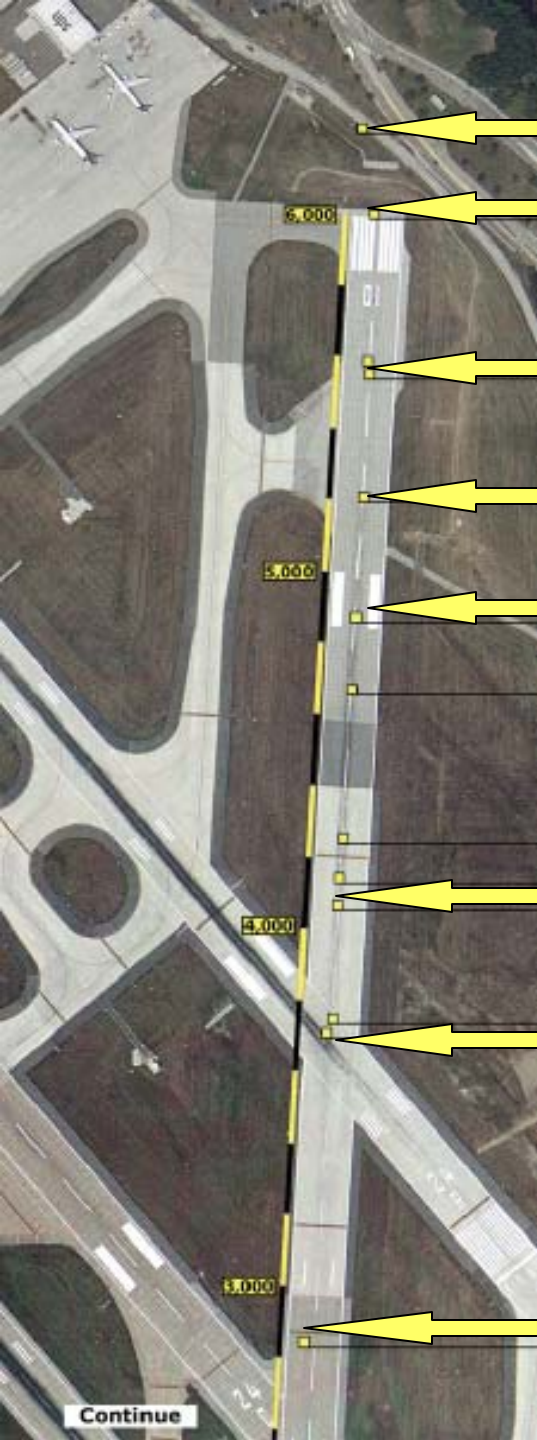
Aircraft Stopped

25% N1

Capt 90% Braking

F/O 75% Braking

63% N1

TRs Deployed

Nose Gear Touchdown

Main Gear Touchdown
