U.S. Department  
of Transportation  
**Federal Aviation  
Administration**

## ADVISORY CIRCULAR

# AVIATION MAINTENANCE ALERTS

**ALERT  
NUMBER  
355**

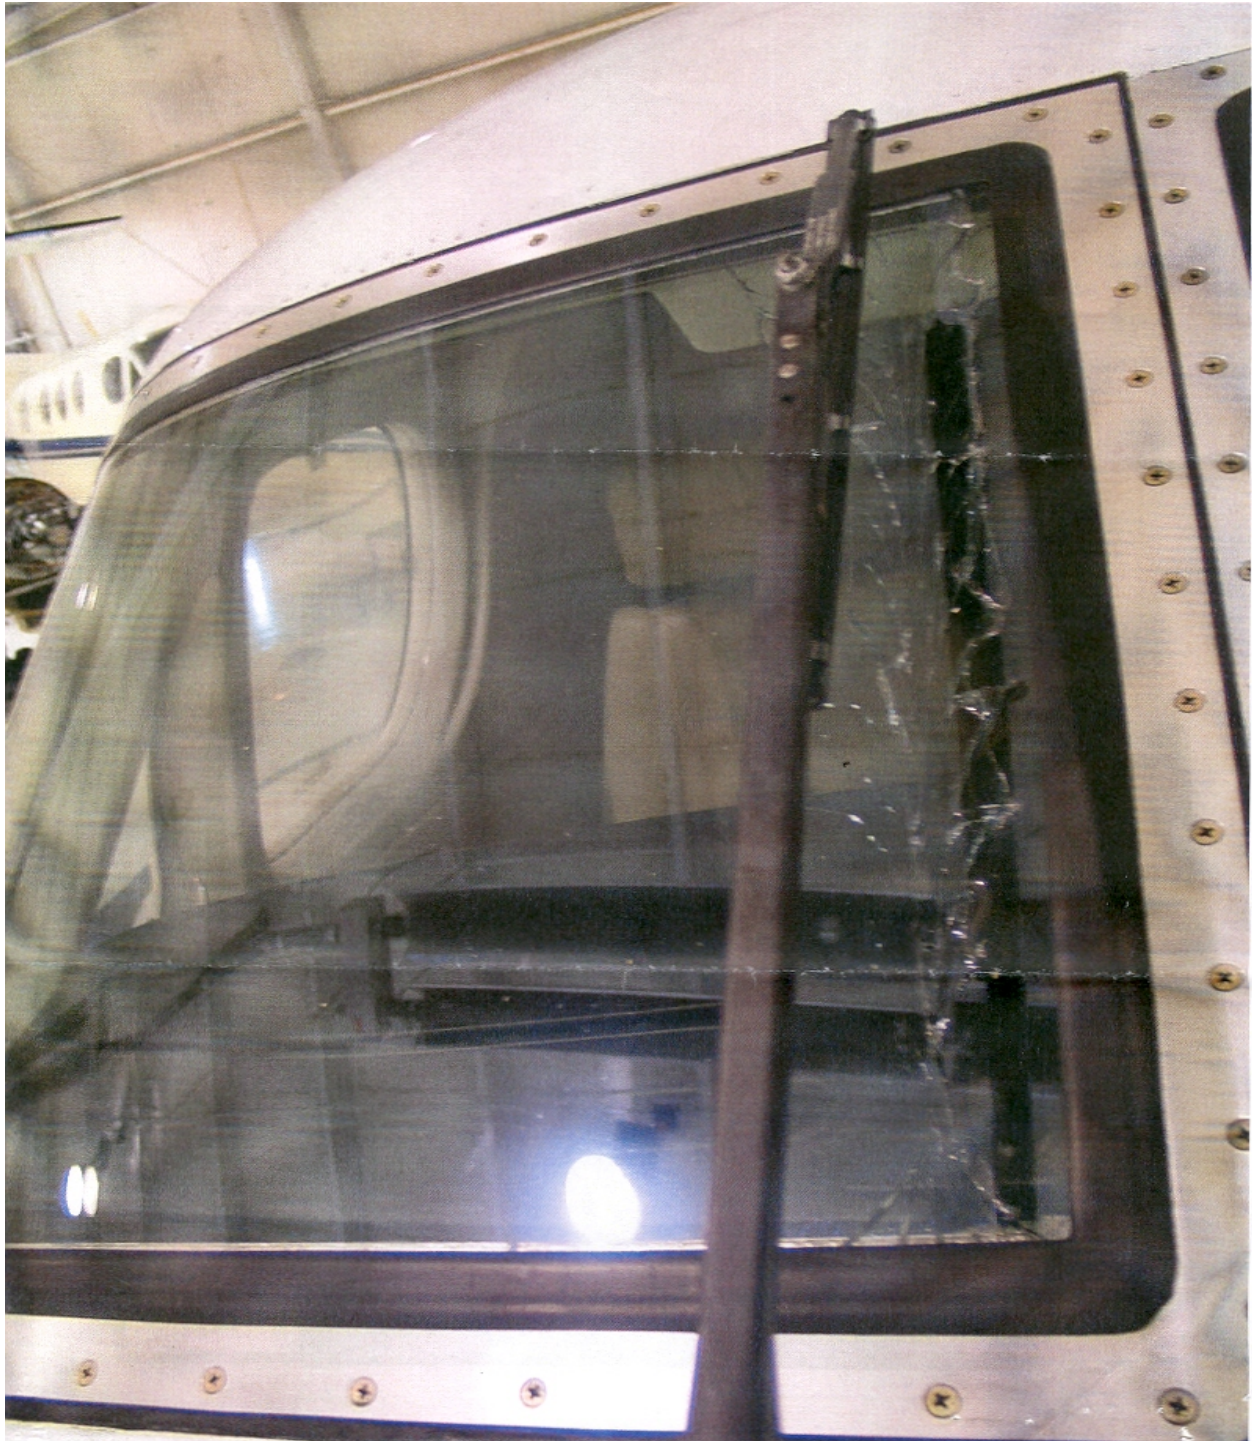
**Beechcraft: B300; Cracked Windscreen; ATA 5610**

A repair station submission reads, "At an altitude of 17,000 feet (*and an outside temperature of minus 6 degrees Celsius*) the right windshield cracked (*about 2 inches outboard of the center post*), from the top to the bottom in the outer pane. The aircraft returned to the departing airport without any problems (*and*) the windshield (*P/N 101-384025-24*) was replaced. There was no known cause for this part to have cracked."

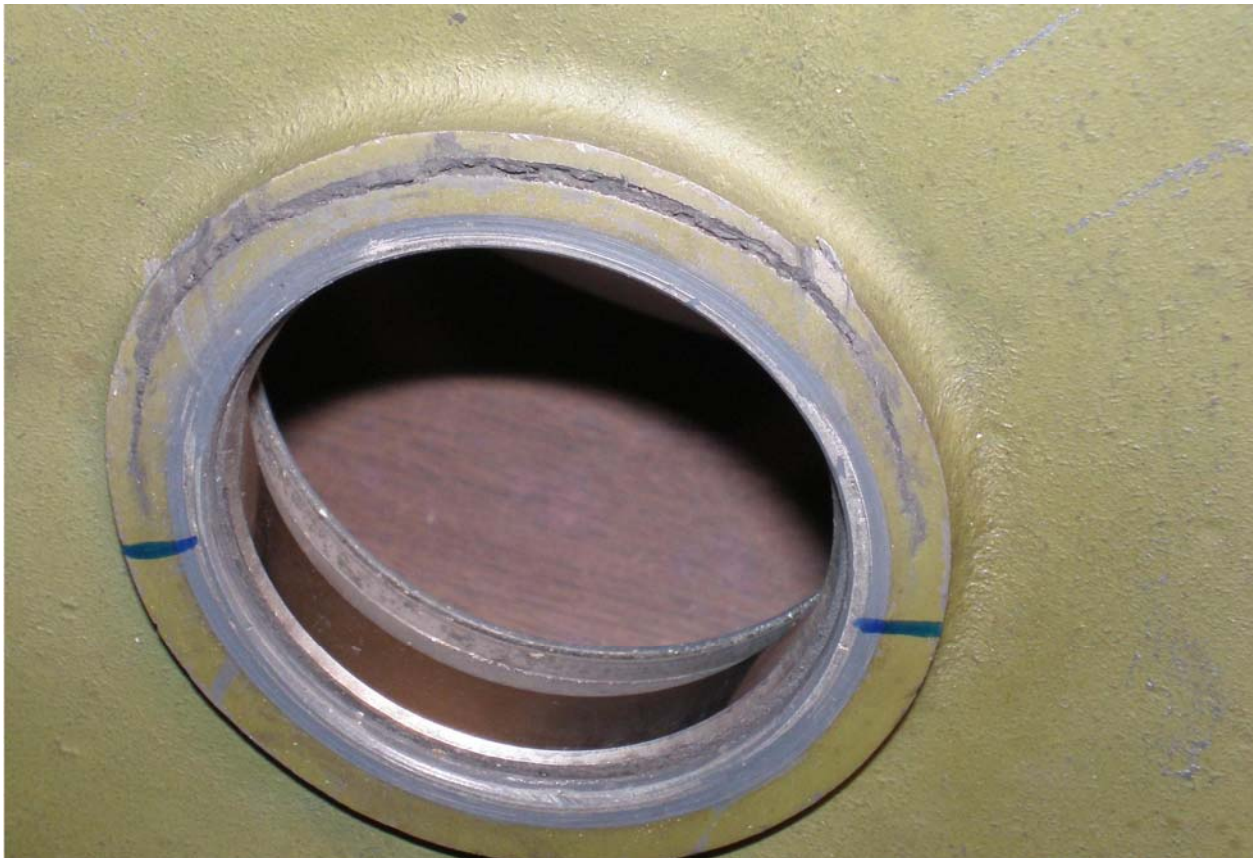
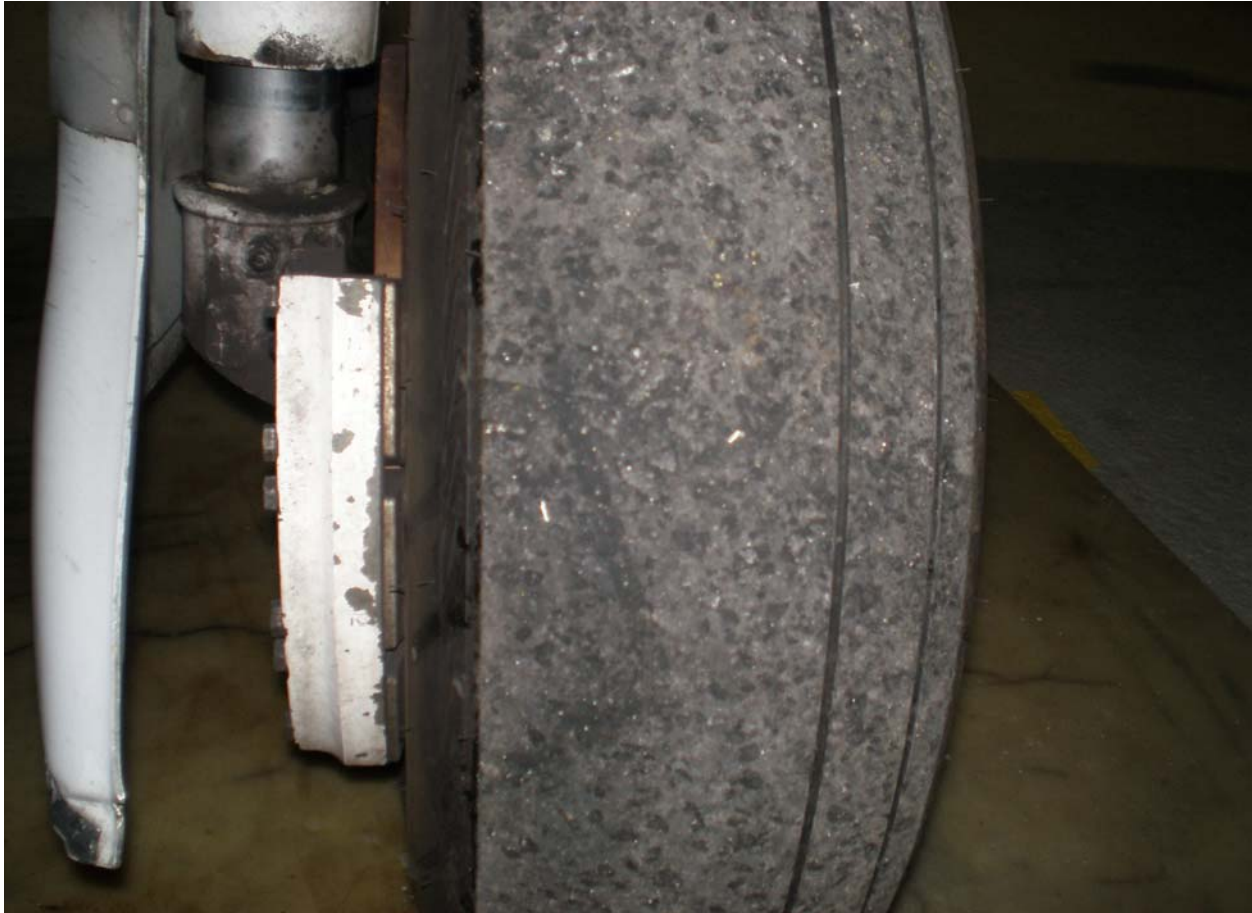
### Cessna: 310L; Cracked Wheel; ATA 3246

A mechanic writes, “Upon changing a tire on a Cleveland wheel assembly on this aircraft, it was discovered the wheel half holding the bearing race was cracking. It had cracked over 180 degrees around the opening, which eventually could have *(led)* to a serious accident.”

Contact with the aircraft owner provided additional discussion and two excellent photos. Don Higgins writes, “Some tips for owners and mechanics: we noticed the first indication of this problem as uneven tire wear. When we had *(our mechanics)* turn the tire 180 degrees to even out the wear, they found the loose race—*(prompting)* them to look further. The wheel crack was *(then)* found, *(having progressed)* more than 180 degrees around the axle hole. My suggestion is anytime a wheel is off the axle, not only do the bearings need to be checked, but also the races. If the race is loose the tire needs to be pulled apart and checked to see if there is a crack causing the race to loosen up.”

“Cessna 310’s touch down in the 90 knot range. To have a wheel assembly fail (as this one was working up to) would render the aircraft uncontrollable and easily cause injury or death to the pilot/passengers.” *(Provided wheel P/N’s are 199-64 and/or 40-40A.)*

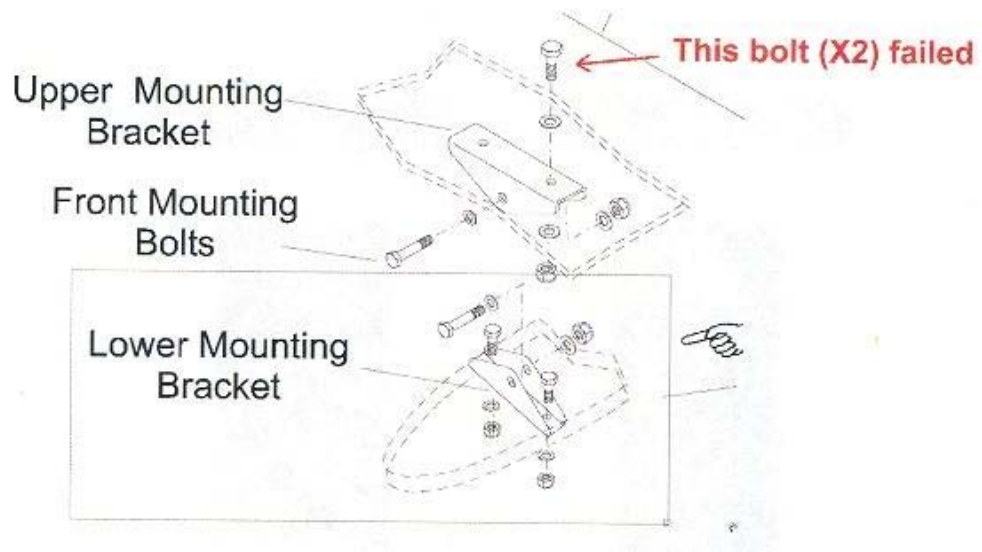
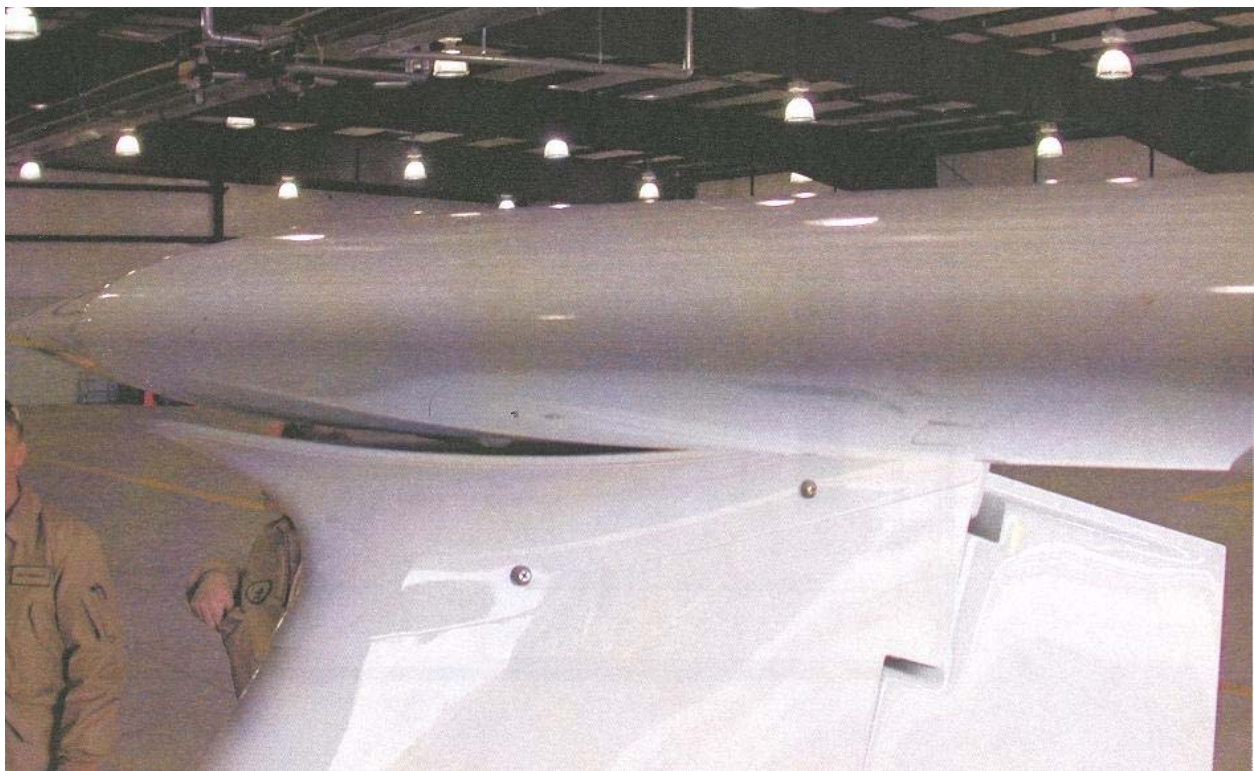
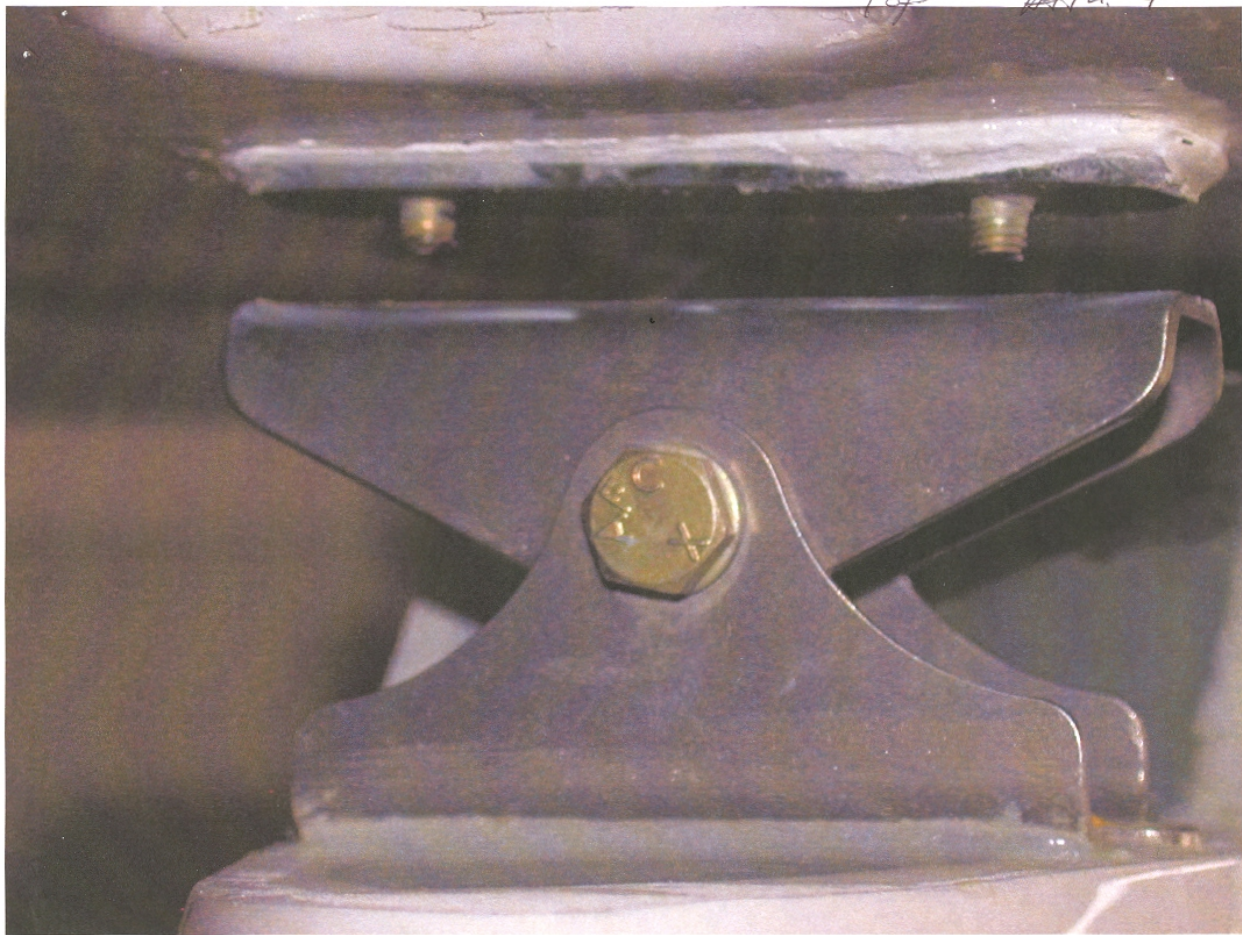
### **Diamond: DA-20; Broken Horizontal Stabilizer Bolts; ATA 5551**

A technician for a flight training school writes, “*(This aircraft)* returned from flight with both horizontal stabilizer mount bolts broken (*P/N AN3-11A*).” “We removed the rudder and horizontal stabilizer to inspect the entire area. The aft mount plate and forward mount bracket were replaced, along with all new bolts, washers, and nuts. We also inspected our other (*DA-20*) aircraft and replaced all of their (*horizontal stabilizer mounting*) bolts. No other issues were found on our aircraft. Diamond Aircraft has been briefed and they are working with the NTSB (*National Transportation Safety Board*).”

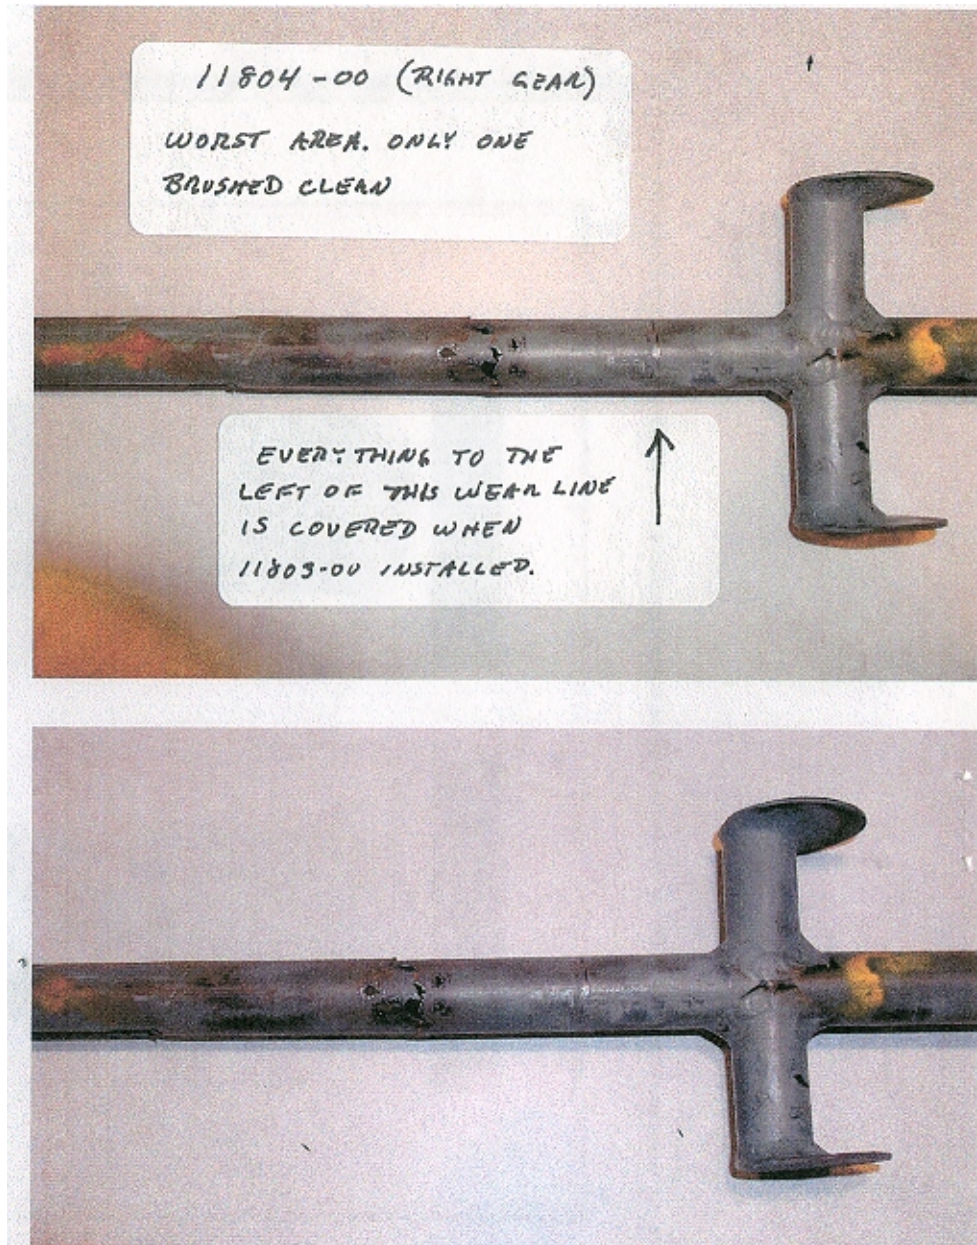
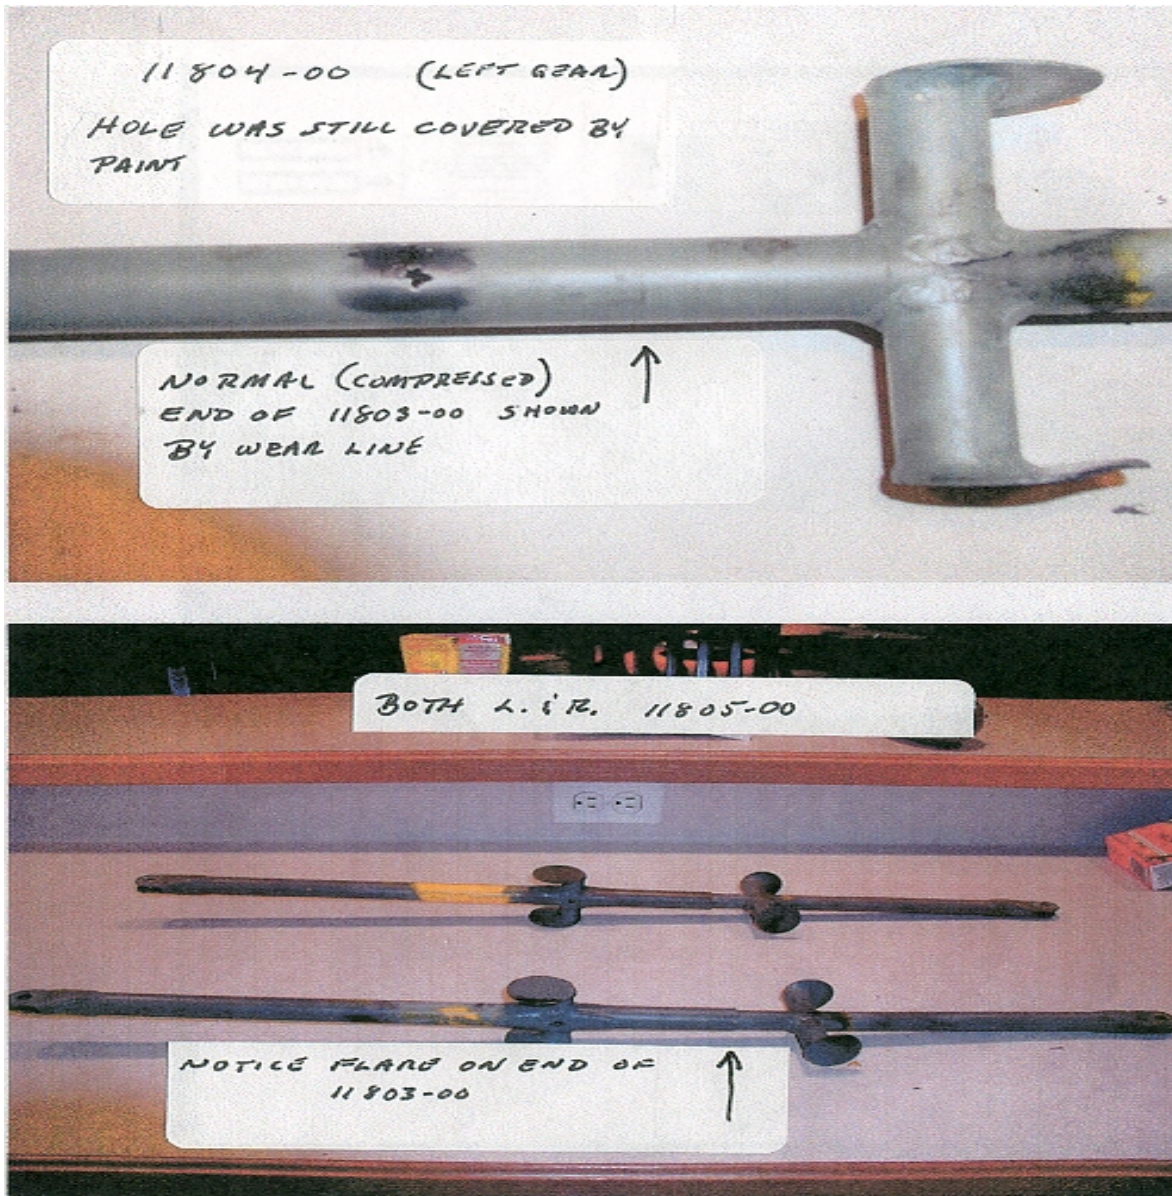
**PIPER****Piper: PA17; Corroded Strut Tubes; ATA 3230**

A mechanic holding an IA (*inspection authorization*) says, “When changing shock cords on this aircraft, I noticed a discoloration of the inner strut tube (the longer tube—P/N 11804-00). I removed it from the outer tube (the shorter tube—P/N 11803-00). One of these inner strut tubes was corroded approximately 50 per cent (*around*) its circumference. The other inner strut had multiple corrosion holes through out (*the part*). Both outer short tubes showed oval elongation at the ends, indicating flexing/bending of this assembly during landings and takeoffs. I believe only the relatively new bungees kept this gear from final failure and (*the predictable*) ground loop.

“Installed bungee cords cover this (*corrosion*) area and they also (usually) have a cloth or aluminum fairing over them. Detection of this (*defect*) requires removal of the fairings at a minimum, and (*preferably*) removal of the bungees to clearly see the outer tube’s circumference. To inspect the area that failed, it is necessary to disassemble the unit (P/N 11803-00) and view the inner and outer pieces separately. I would recommend whenever bungees are changed, the pieces should be removed from the aircraft, disassembled, and inspected for corrosion.”

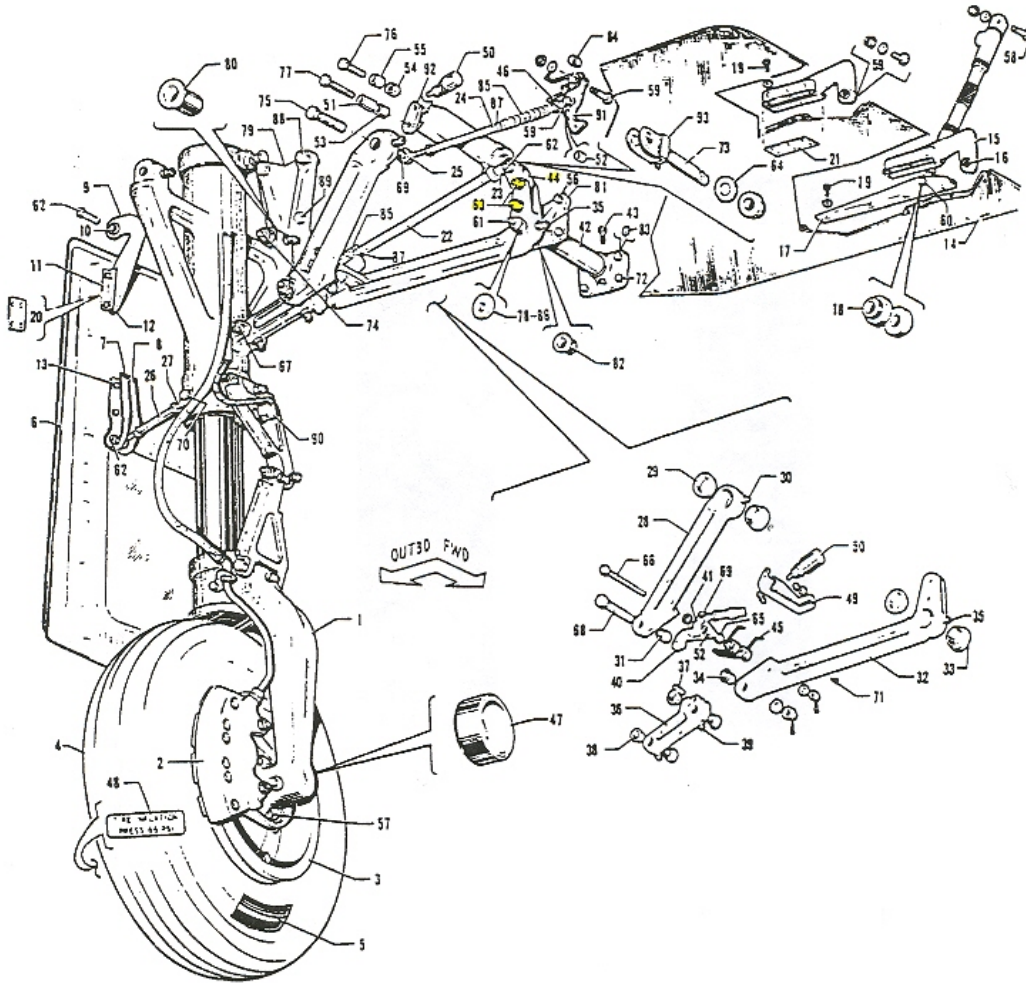
Figure 39. Main Landing Gear Installation

### Piper: PA31-350; Failed Main Gear Bolt; ATA 3230

A mechanic writes, "Our aircraft had a 'gear unsafe light' and no 'left down and locked' indication light. The gear handle (*also*) would not return to neutral position. The aircraft landed with out incident. We believe the upper bolt retaining the main gear retraction arm broke due to fatigue. This allowed the main gear actuator to bind on the upper section of the drag leg, breaking the main gear actuator ball end out of the main shaft of the actuator.

“There is no requirement for the bolts (P/N AN6-17) that retain the main gear retraction arms to be inspected or replaced. These bolts are (*given a cursory*) inspection during retraction arm removal by a visual check for wear and corrosion. We believe these bolts need to also have a life limit or be magnaflux inspected. These bolts showed little wear. The bolt that failed appears it may have been cracked for sometime before it failed completely, but it was not detected during the last compliance with SL-1092.” *The FAA Service Difficulty Reporting System (SDRS) data base returns 14 similar entries for the base part number 42042 with ATA 3230.*)

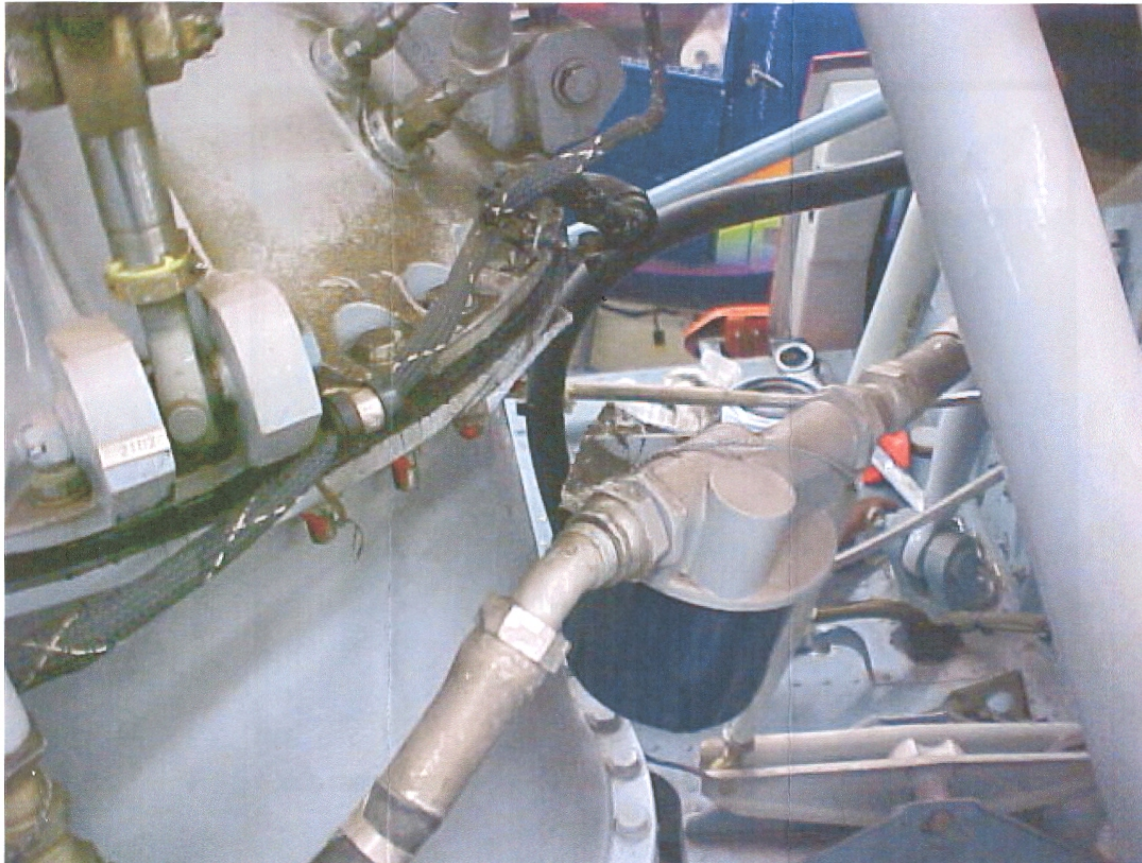
### Aerospatiale: AS350B3; Broken Oil Filter Mount Bracket; ATA 7261

A repair station technician states, “During a 100 hour inspection, the mechanic reached to unscrew the oil filter and the bracket broke off in his hand (*P/N N325400A*). This part was replaced. The entire break looked fresh—even with 10 power magnification. It (*appears to be*) a pot-metal bracket.”

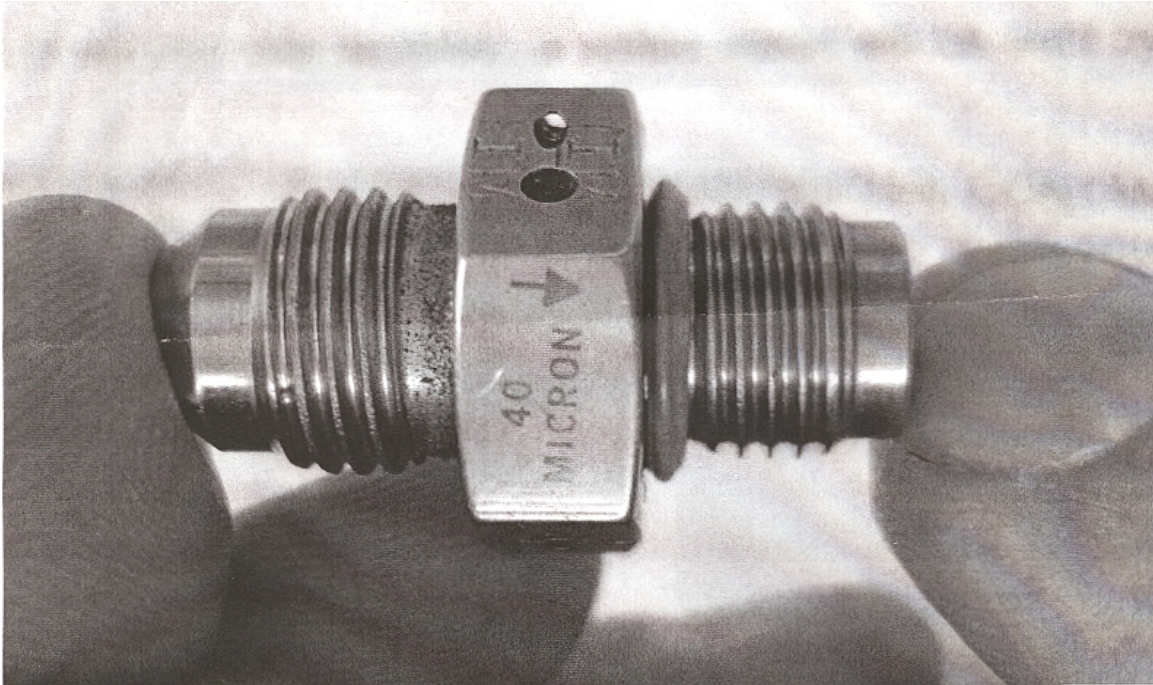
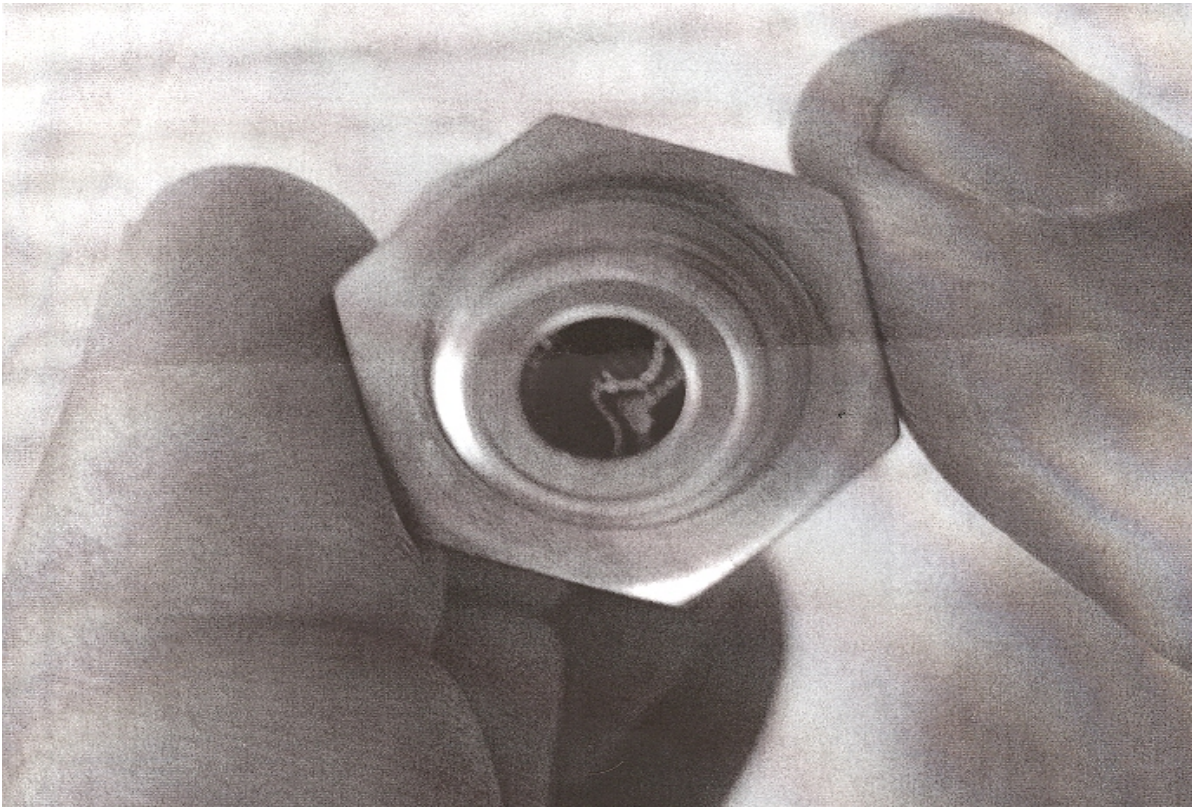
A lead quality control inspector for this repair station writes, “During this aircraft’s 200 hour progressive inspection of the L/H engine fuel manifold (P/N 3105455-1), the in-line 40 micro fuel filter (P/N 337-541-9106) was removed to inspect for fuel limitation issues. The filter screen was found to be clogged and collapsed. This filter is not referenced in the Honeywell Illustrated Parts Catalog (73-20-40 page 0) and it is not required to be inspected and/or cleaned during routine or special inspections. This filter needs to be removed, inspected, and cleaned every 200 flight hours until a suitable solution to this issue is found by the engine manufacturer. A collapsed filter could lead to fuel limitation and performance issues—and improper troubleshooting by maintenance technicians.

“Honeywell technical representatives have been contacted and (*they*) are aware of this (*problem*). Since then several filters have been found clogged and collapsed on other, same type aircraft and engines. Other, similar engine installations could (*also*) have this manifold/filter installed.”

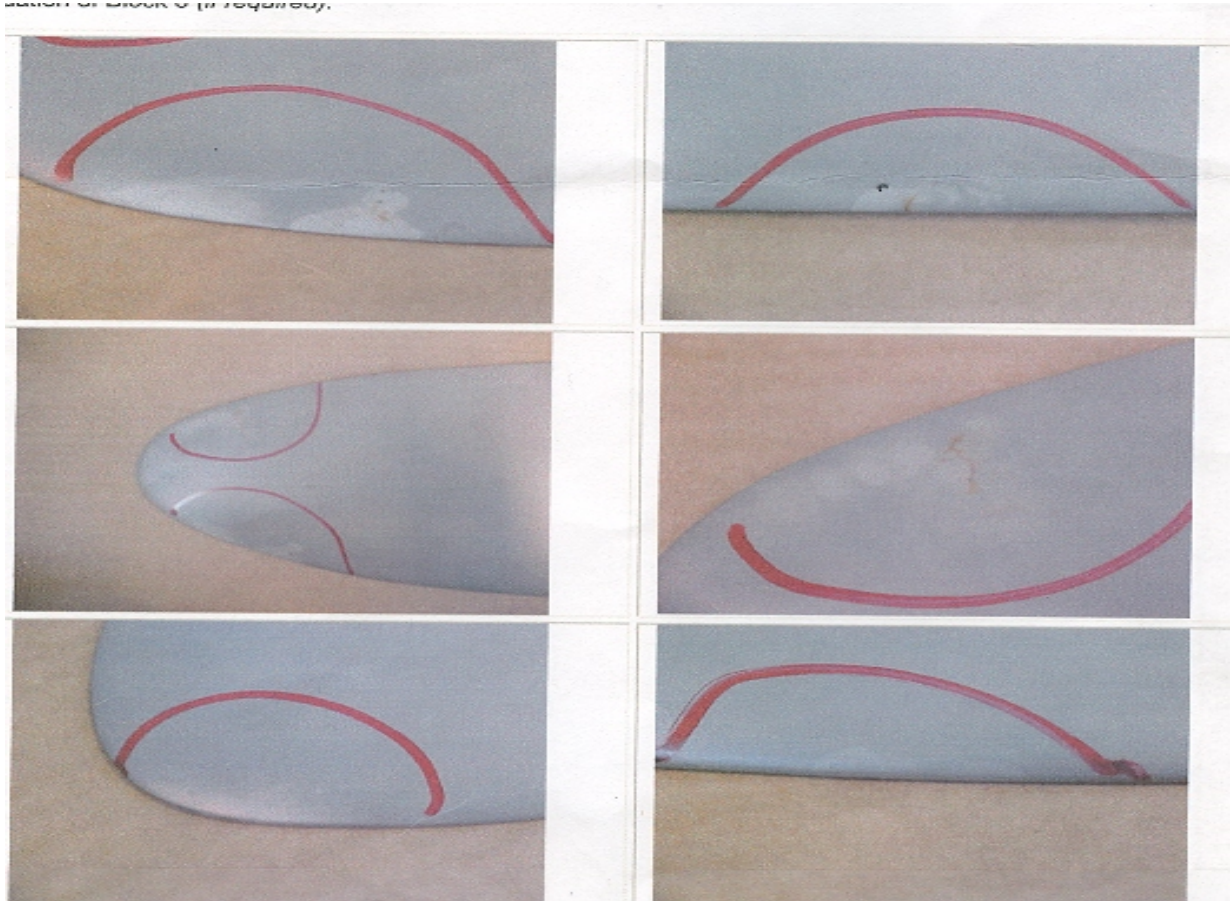
**Hartzell Propeller: HC-C3YR-1RF; Unapproved Repair; ATA 6111**

A repair station manager submits this defect report. He states, “Two of three propeller blades (*on this unit*) were previously repaired using an unapproved weld method in several locations on the blade airfoil. The blades have been scrapped—pending disposition instructions from Hartzell Propellers, Inc. The customer has been contacted for historical records.” (*P/N's for the propeller blades are F8483.*)
