ADVISORY CIRCULAR

43-16A

AVIATION MAINTENANCE ALERTS

**ALERT
NUMBER
358**

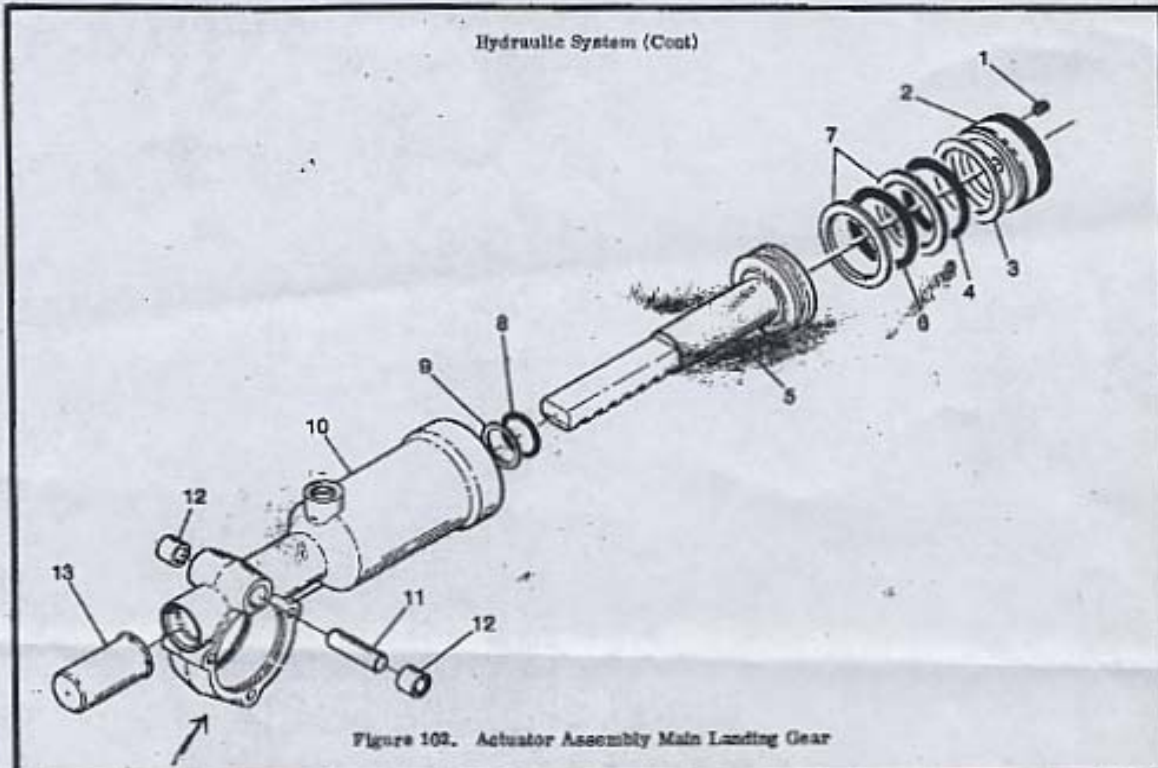
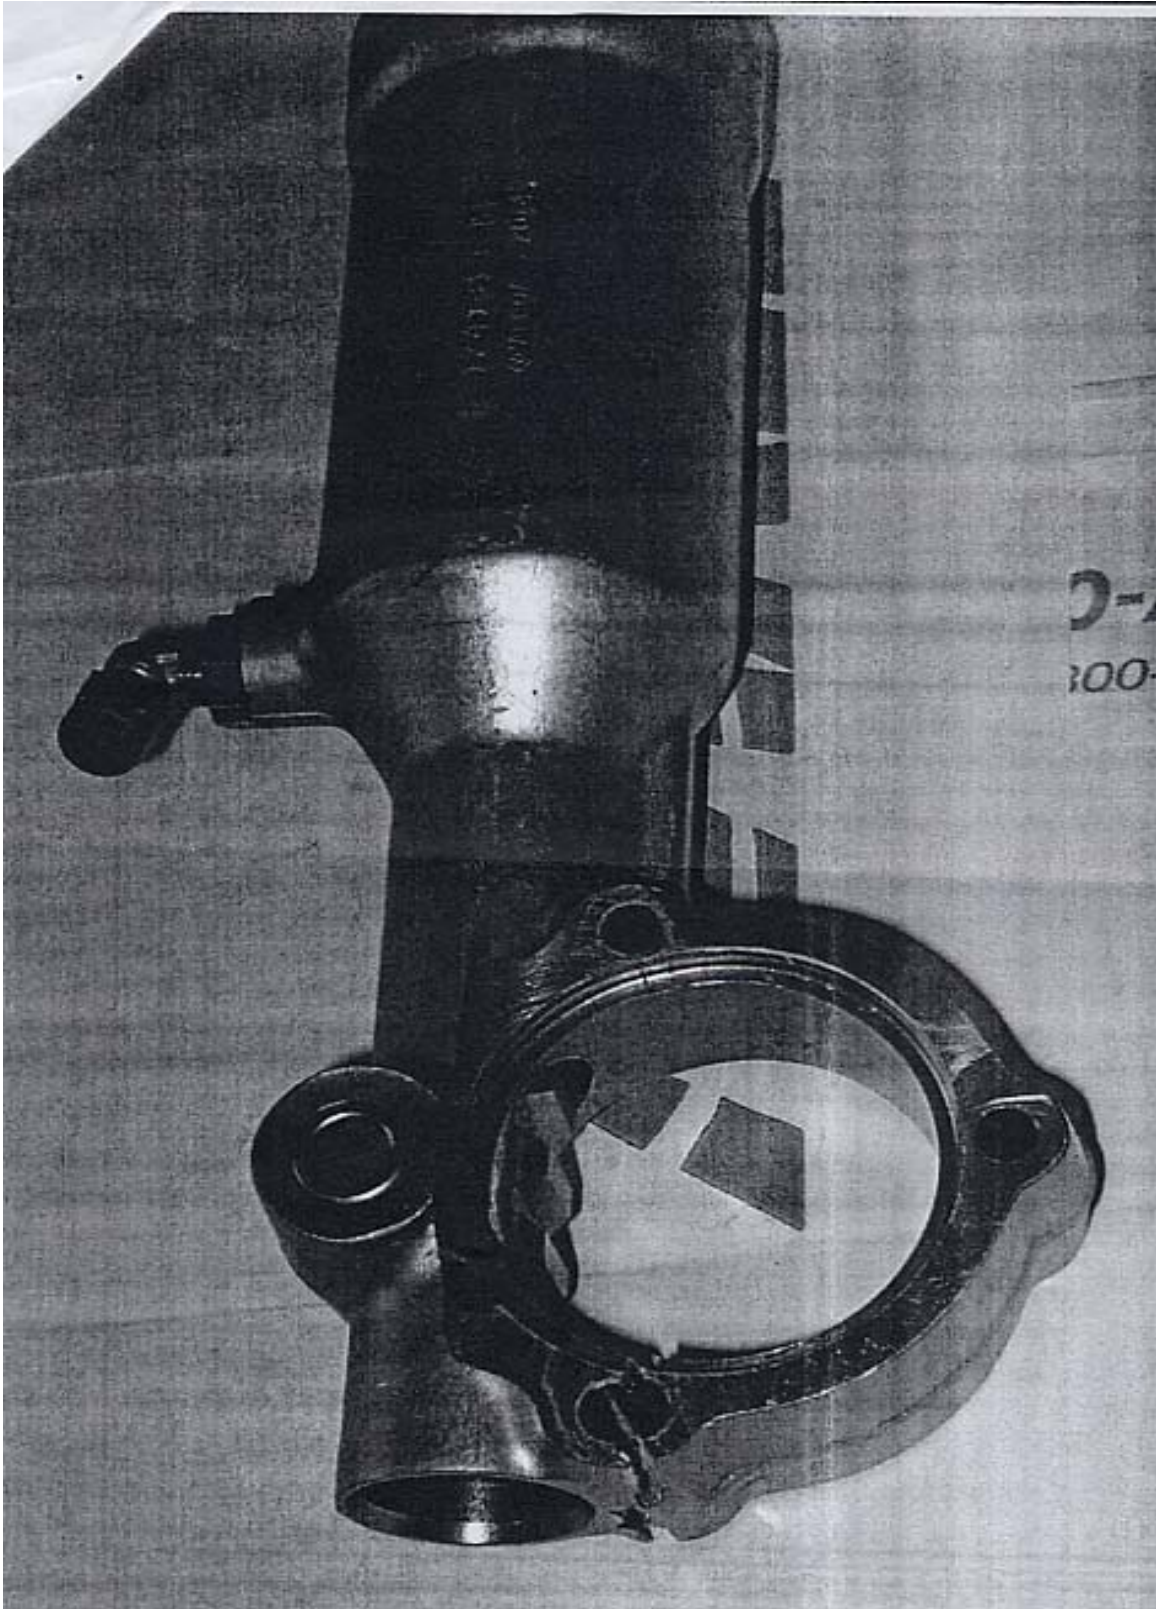
Figure 102. Actuator Assembly Main Landing Gear

Cessna: 172RG; Cracked Main Gear Actuator; ATA 3233

A licensed aircraft mechanic states, "On a dual training flight a student and instructor heard a noise when the (*aircraft's*) landing gear was retracted. The left landing gear remained in a partially retracted position, unable to actuate up or down. A successful gear up landing was made.

"The L/H landing gear actuator body (*P/N 128101-3*) had failed (cracked) at the forward mounting bolt hole, allowing the actuator bore to open—enough that the piston would not engage the pivot sector gear sufficiently to move the landing gear."

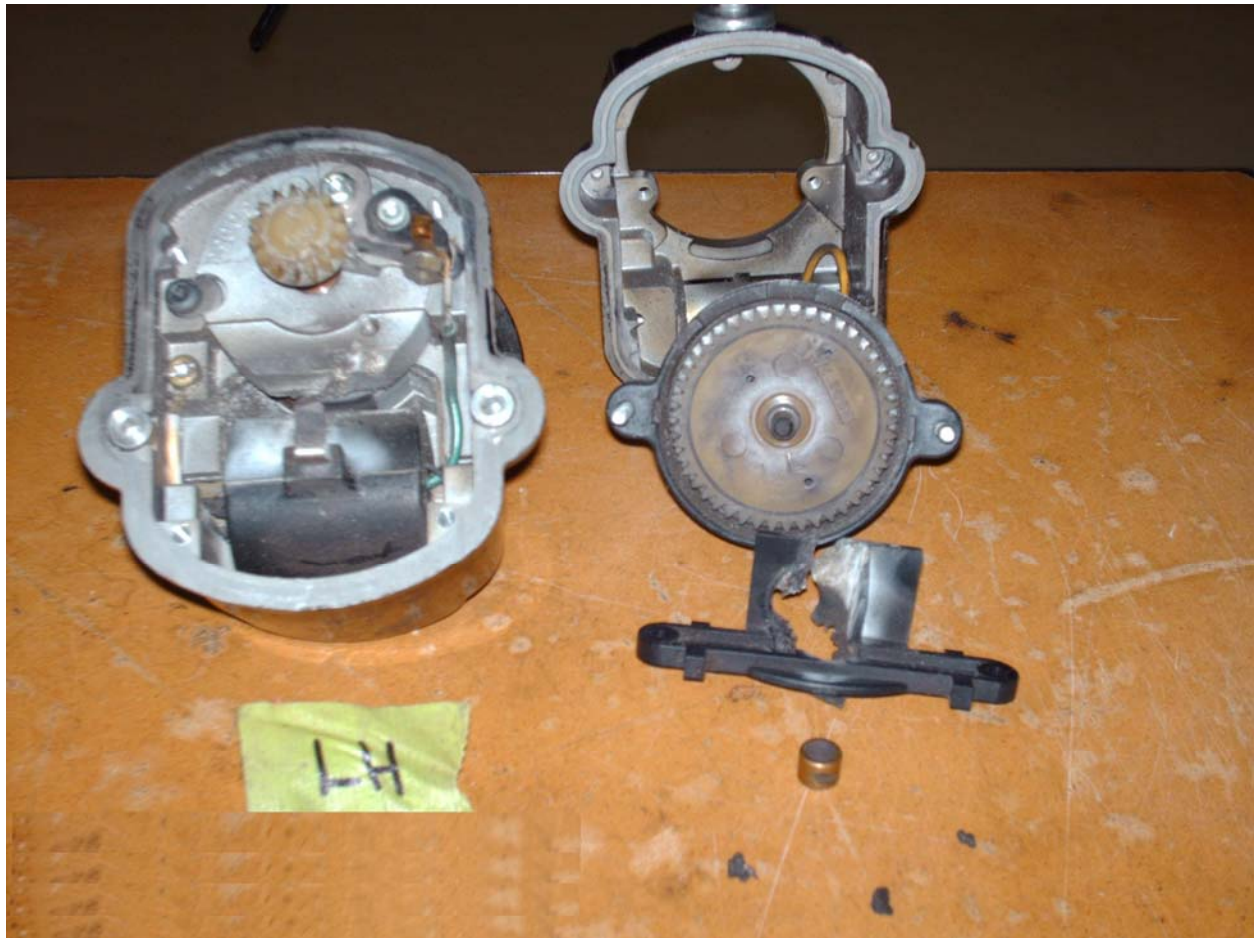
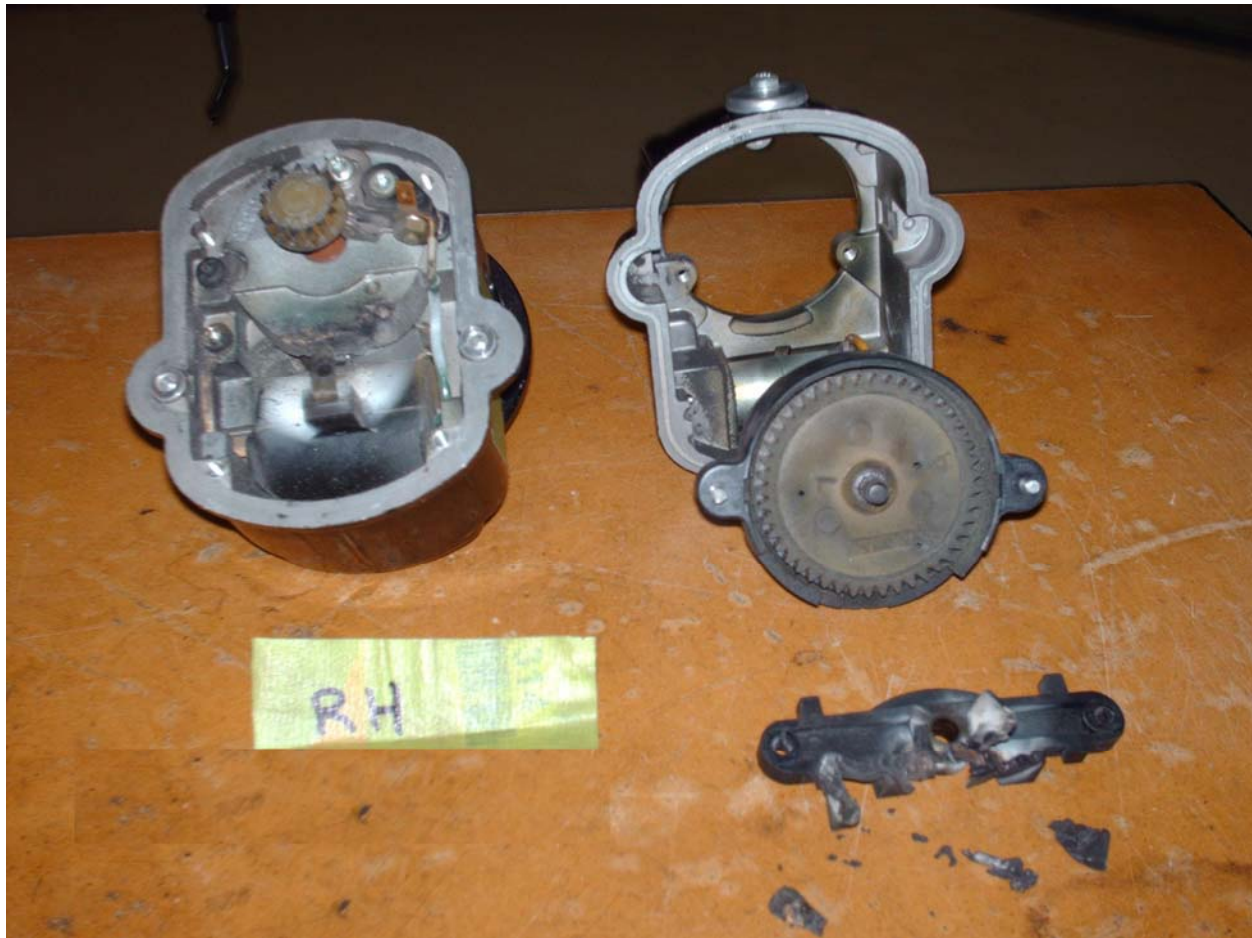
Unison Magneto: 6314; Internal Arcing Damage; ATA 7414

“During (*this aircraft’s*) first annual inspection (*a required*) 500 hour magneto inspection was complied with early due to the number of hours previously flown. Both magnetos showed the same internal arcing—so severe the brush holder (*P/N K3823*) was melted and/or burned up. We contacted Unison/Slick technical support—(*apparently*) our magnetos were matched (*to a production series about which Slick is aware*). The carbon (*composite*) used in the manufacture of these brushes was too soft, (*resulting in excessive*) dust which caused the arcing. It is a wonder this customer’s engine continued to run. I believe he was on the verge of finding out what a parachute is all about!”

(A search of the FAA Service Difficulty Reporting System data base revealed the K3823 P/N is specified at least 19 times. Thanks for the new photos, Otis—Ed.)

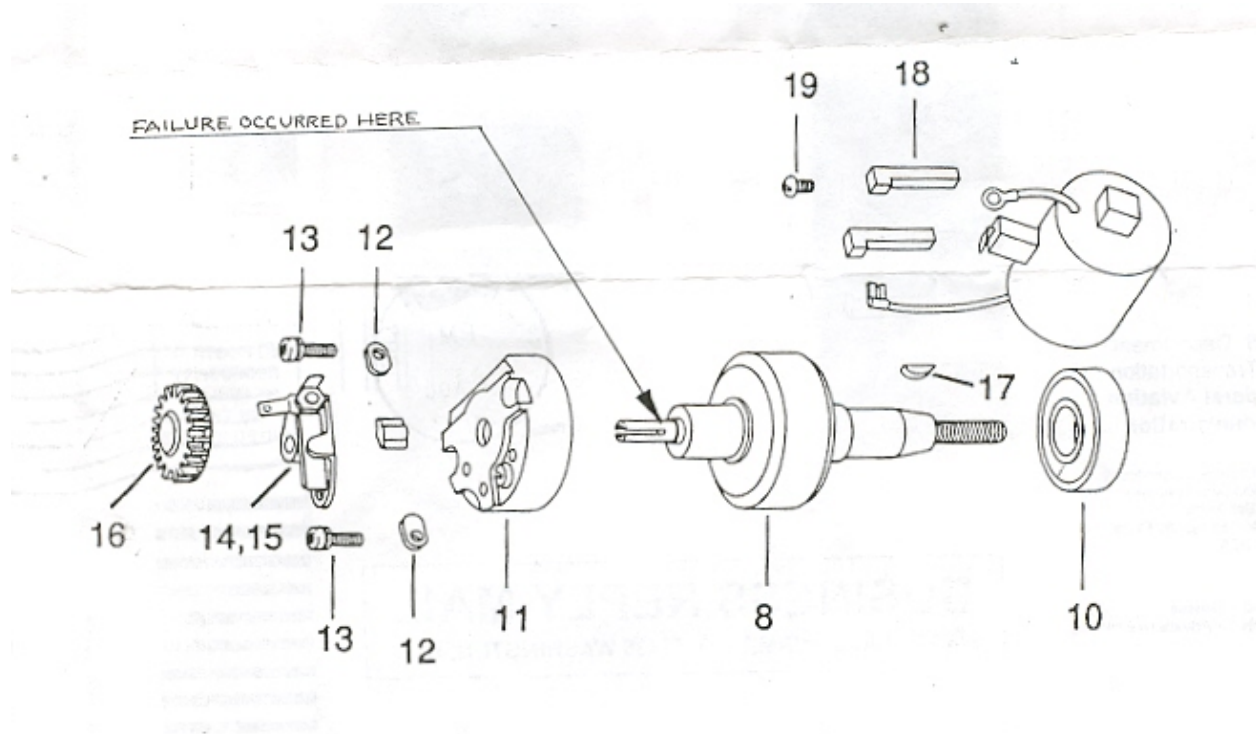
Unison Magneto: 4370; Broken Rotor Shaft; ATA 7414

“A pilot departed on a VFR day flight,” says the submitting mechanic. “During the climb from departure, the pilot noticed a slight engine roughness that lasted only a second. The engine smoothed out until the aircraft was leveled out at cruise altitude—approximately 2500 feet AGL (*above ground level*). Shortly after reaching cruise altitude and cruise power settings the engine began to run rough. The pilot performed a magneto check in flight, finding the right magneto inoperative. The pilot switched to ‘left magneto’ and returned to land at the departure airport without incident.

“Upon opening the magneto, the rotor gear (P/N M3827) and a portion of the rotor shaft were found laying inside the magneto housing. The rotor gear was pressed on the shaft as per manufacturer’s drawing—(*this part*) and the gear in the distributor block assembly (P/N K3822) were not damaged and were free of obstructions. They moved without binding. The shaft broke just below the slot in the shaft that holds the cam which, (*in turn*) opens the contacts. There did not appear to be any other mechanical defect with the magneto.”

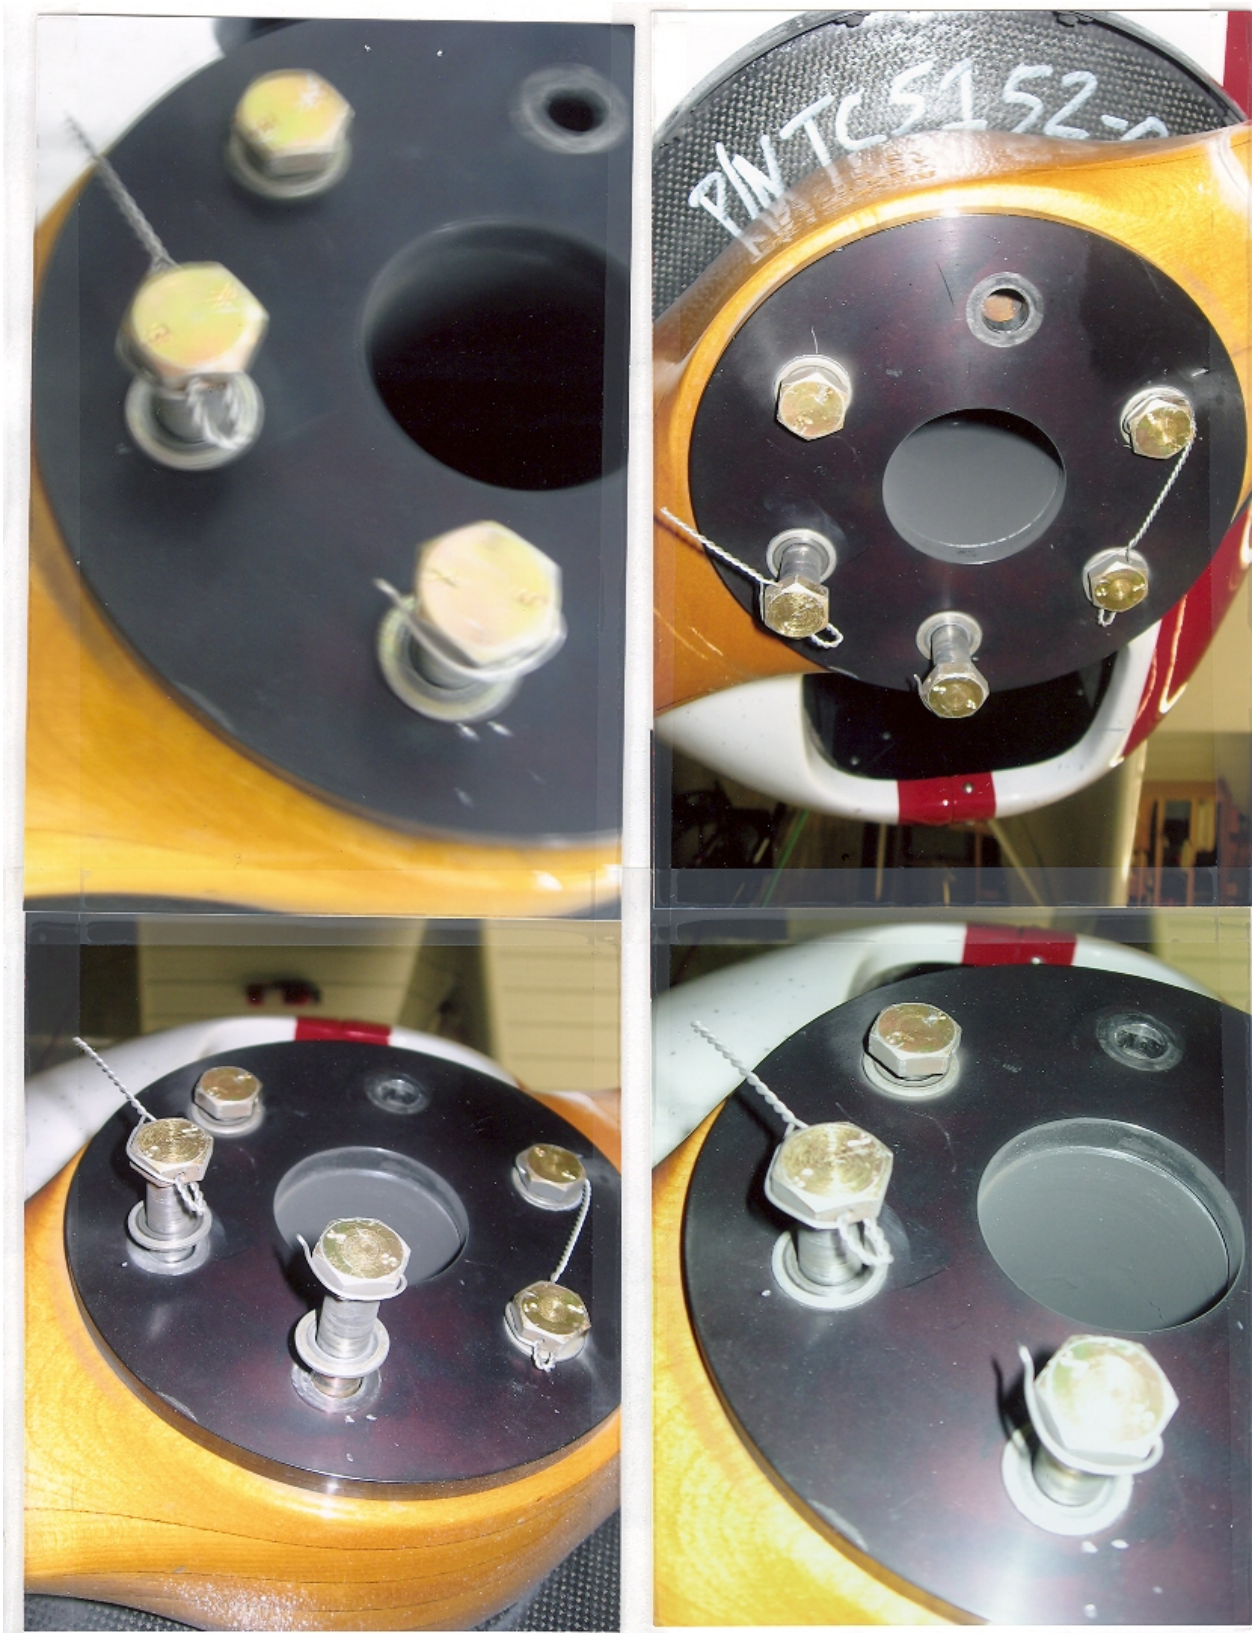
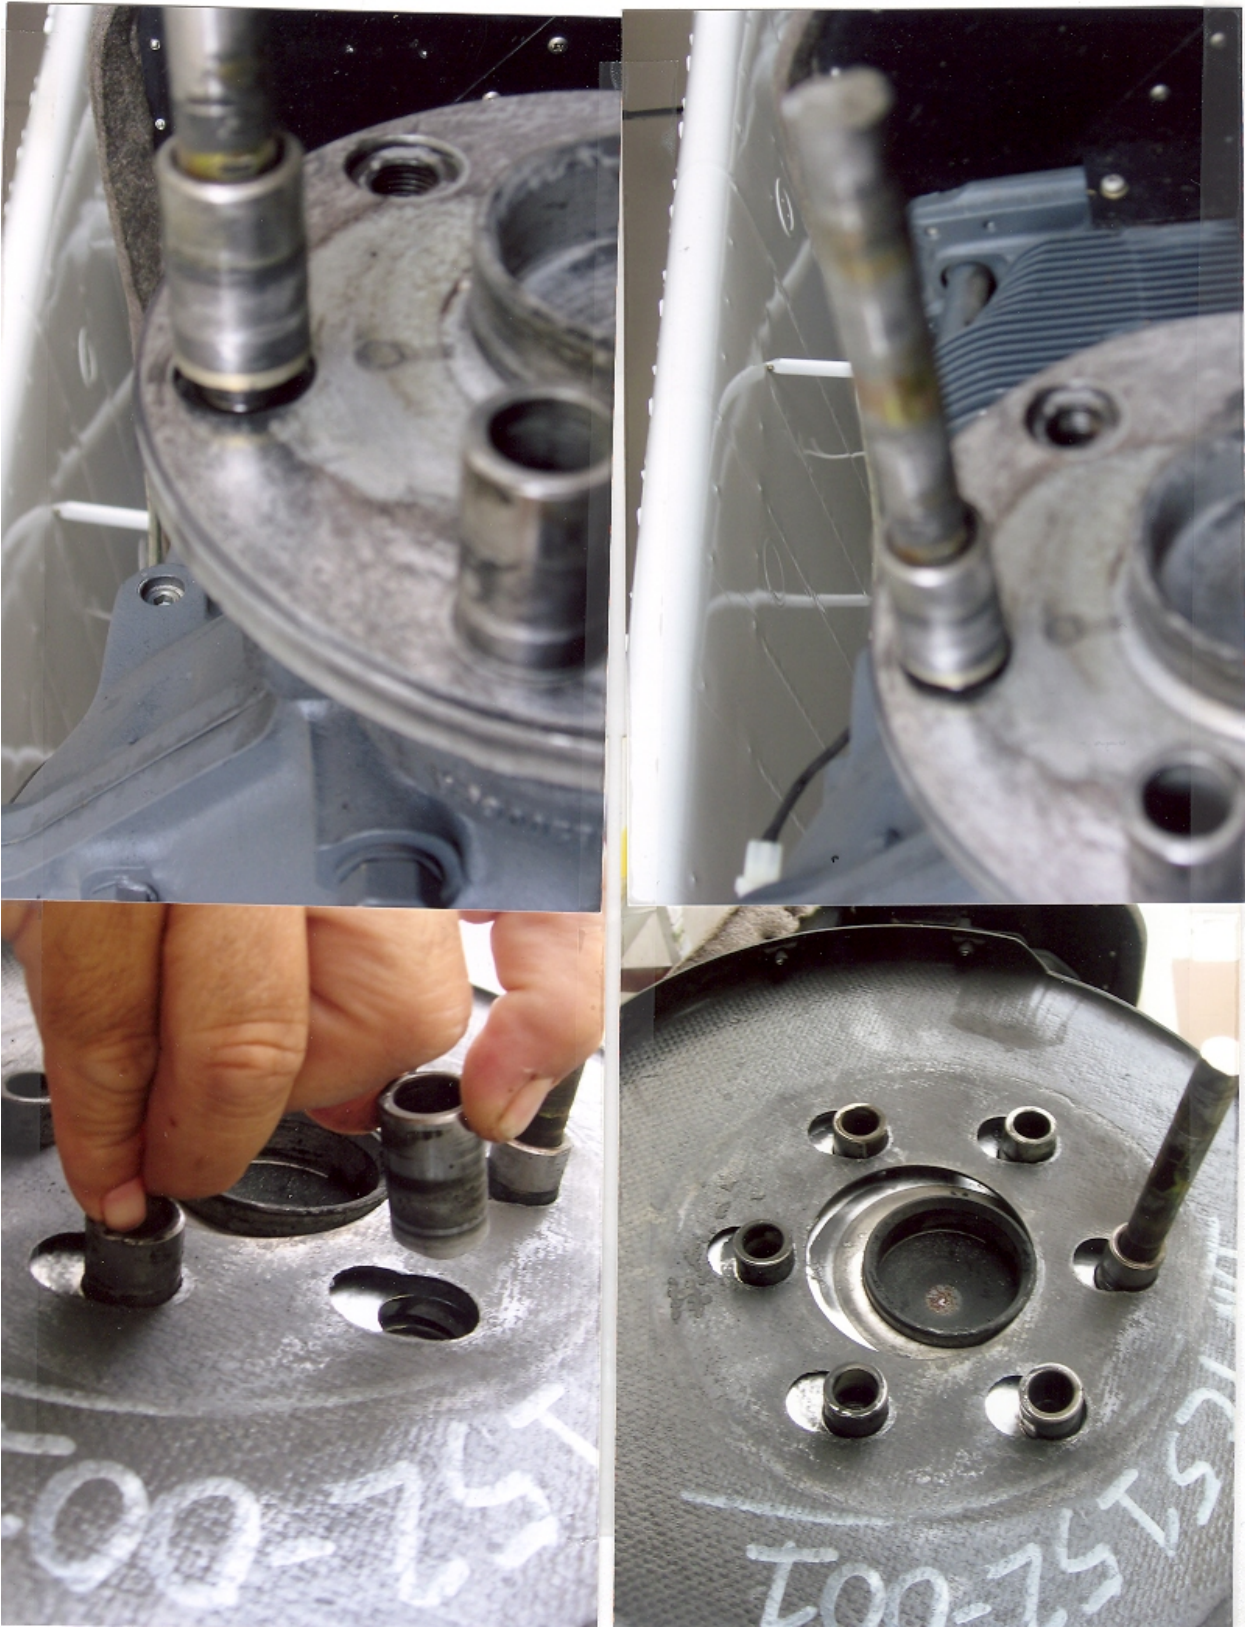
Sensenich: W80CM845; Loose Propeller; ATA 6110

“The pilot reported slight vibration during a flight of approximately one hour. When power was reduced for landing the vibration became more evident. Our initial inspection found one prop bolt (*missing; bolt #1*) had come out forward and through the spinner, and the propeller (*itself*) was loose. After removal of the spinner we found (...*bolt 2 had also backed out about approximately 1/8 inch*). Bolts (*3 and 4*) remained safety-wired but not tight. On the remaining pair of bolts (*5 and 6*) the safety wire was broken...and these bolts were backed out approximately one inch. Complete removal of the prop required cutting the head off one bolt. (*Its*) attachment bushing (*was found*) broken off flush with the crankshaft flange. A second attachment bushing was also found broken off...”

“The original metal propeller (model 76EM8-0-56) was removed from the aircraft on July 20, 2006 and this wood propeller installed (STC SA 192NW and Sensenich ‘Wood Propellers Installation and Maintenance’) and torqued in accordance with (*Sensenich*) Table 1. Propeller maintenance bolt torque (*had also been...*) complied with since installation. Please refer to the attached log book entries.”

(This submission provided no speculation as to cause. To summarize the log entries: the wood prop was installed and run for 1 hour, then the bolts re-torqued. Six months and 15 flight hours pass and apparently all is well. The aircraft receives an annual inspection—with prop torque. Another 6 months pass with another 15 hours flight time, but now the bolts are falling out—and there is no mention of thread failure in this report. An obvious question: what would this same equipment look like if the bolts had been run down to the flange in preparation for a final but forgotten torque, then saftied and flown for 15 hours? One would have to look hard at the last inspection. "Thank-you" to the submitter for the scary photographs—Ed.)
