U.S. Department  
of Transportation  
**Federal Aviation  
Administration**

## ADVISORY CIRCULAR

# AVIATION MAINTENANCE ALERTS

**ALERT  
NUMBER  
361**

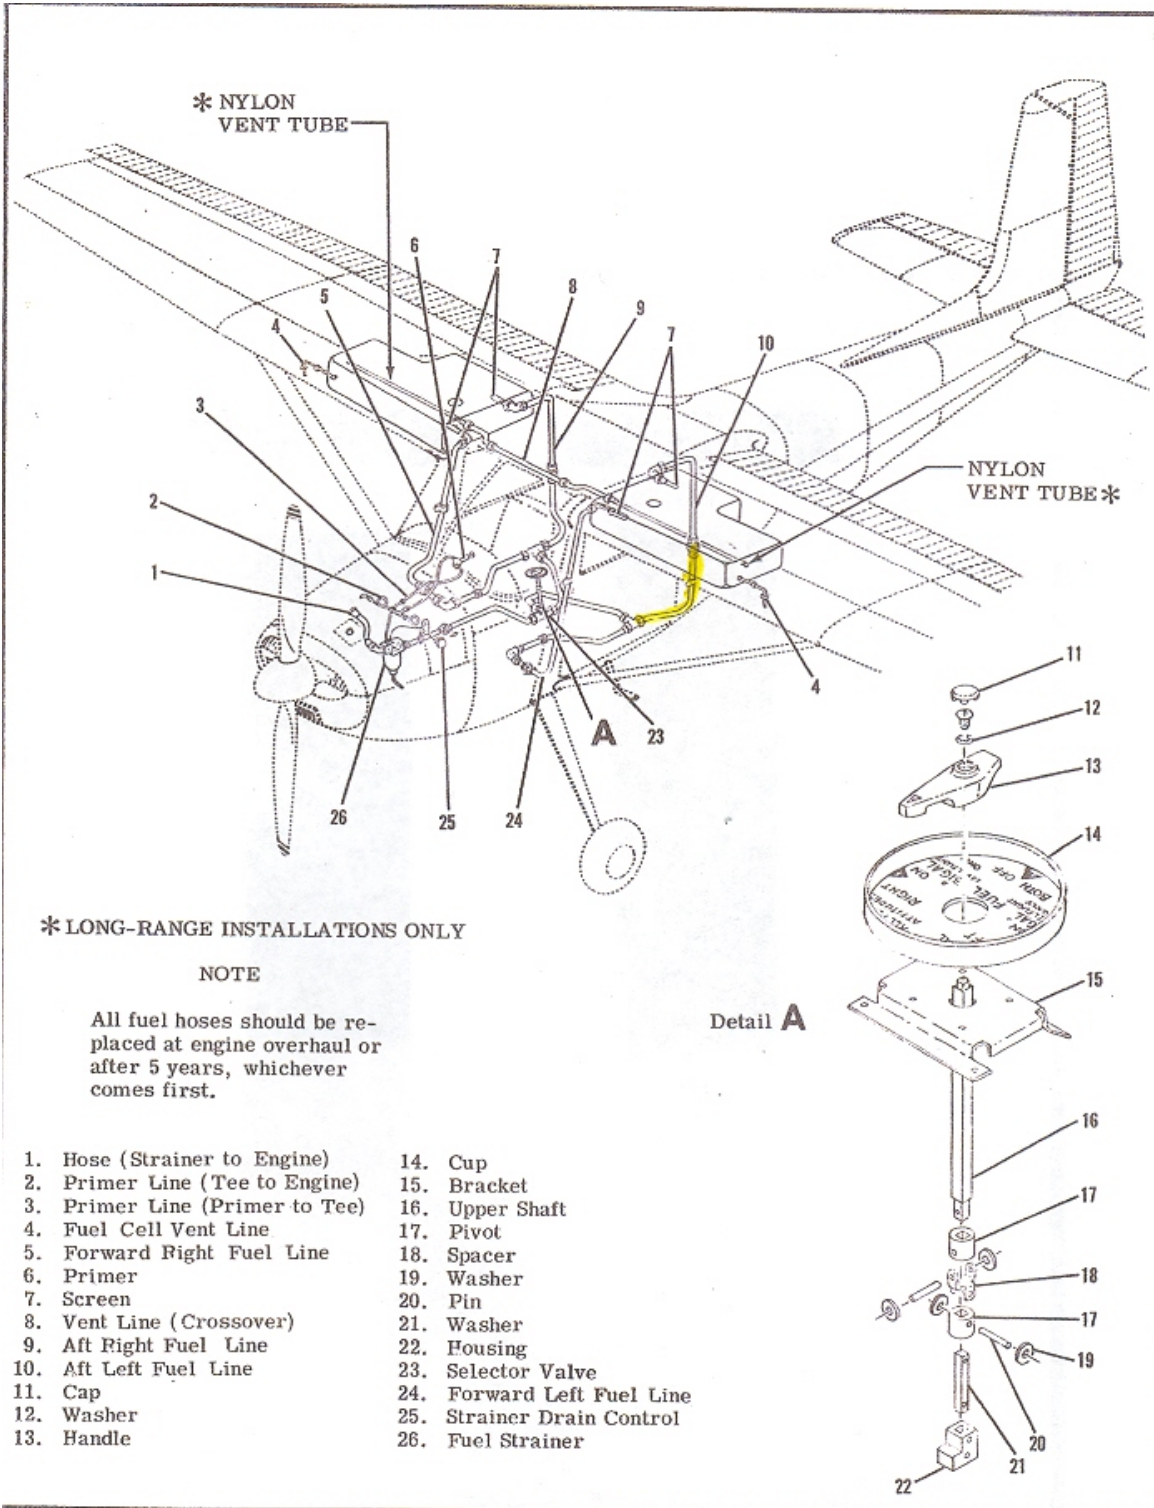
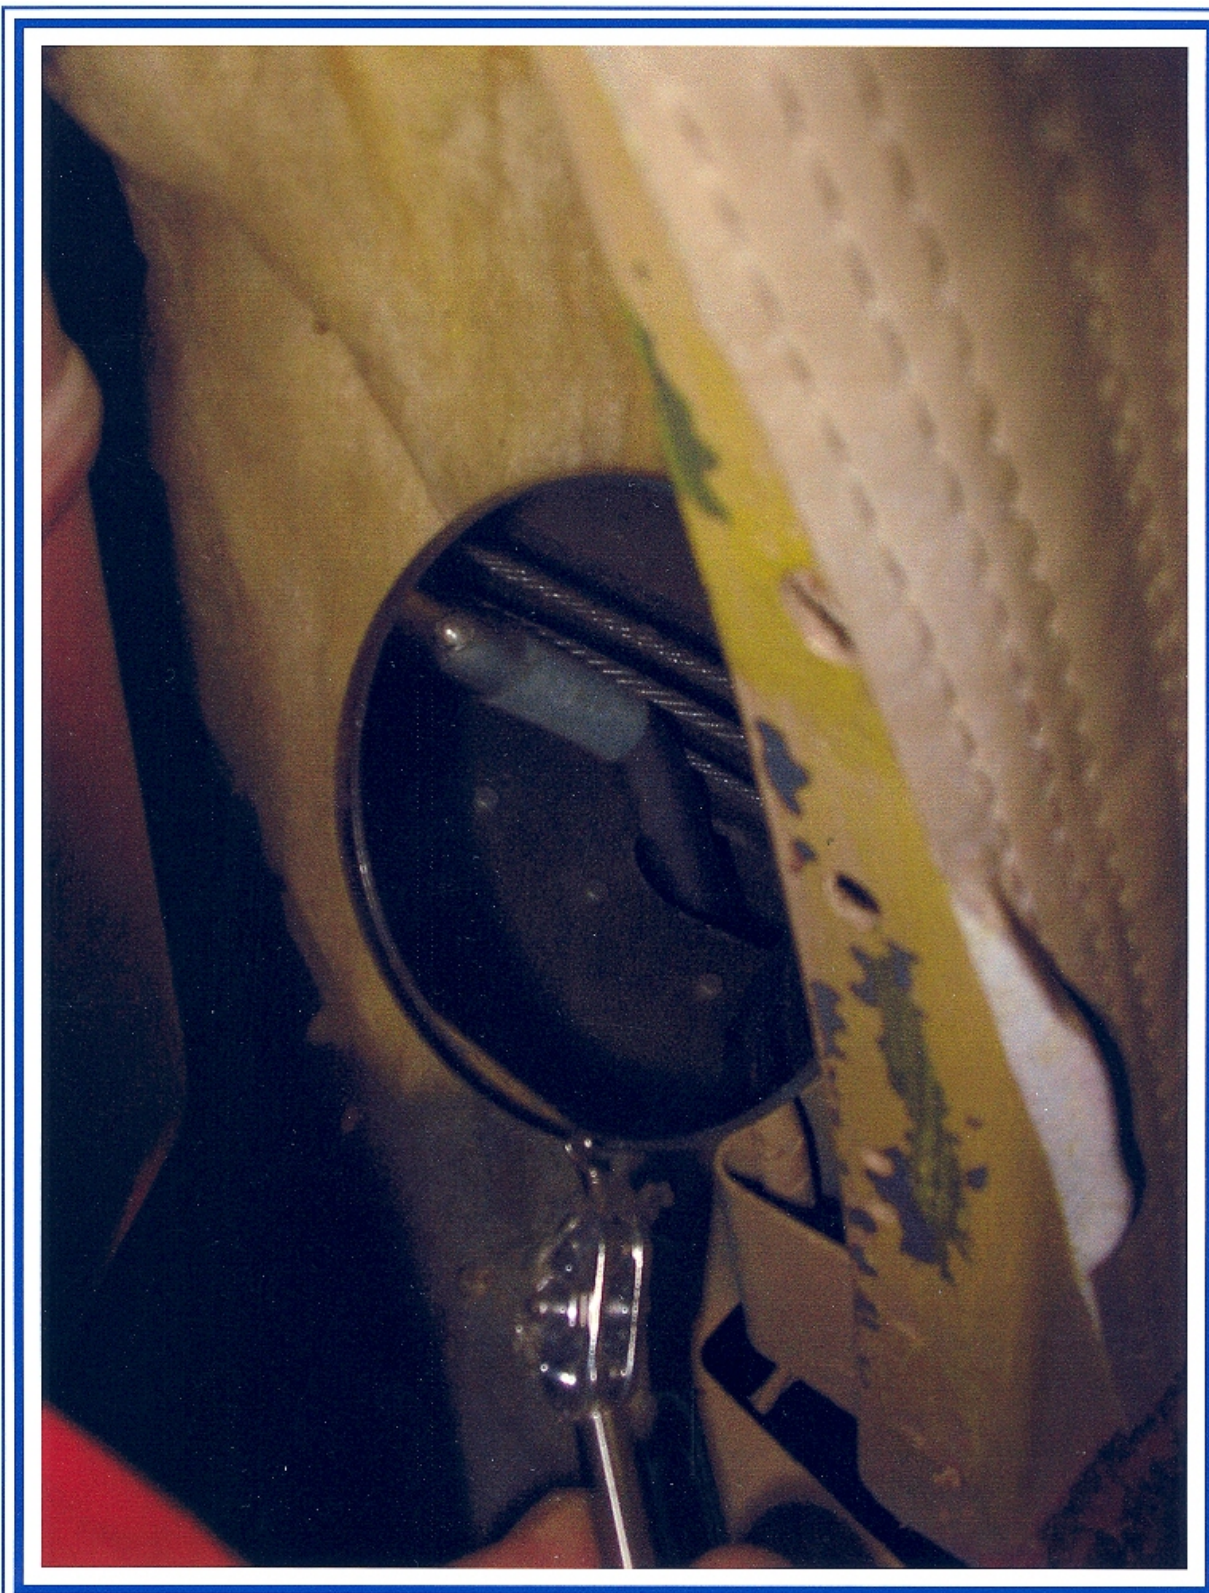
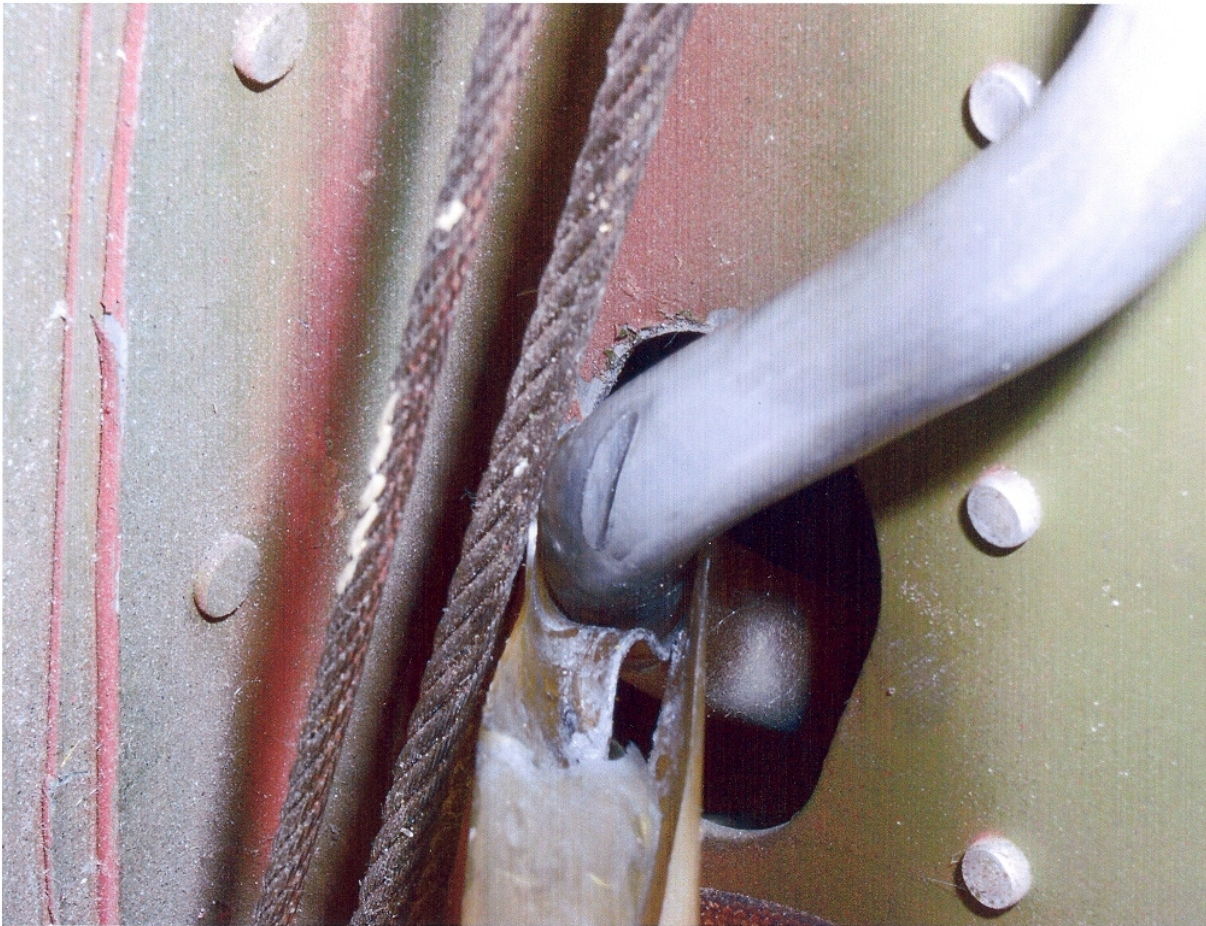
A mechanic writes, "Two aileron cables, one flap cable, and the fuel line are all routed through the L/H lower aft door post area. This fuel line is protected by a plastic sleeve, but an (*aileron*) cable wore through the sleeve (*and began cutting*) into the fuel line. This line (*P/N 0500106-326*) is approximately 20 inches long with four bends. I suggest a one time inspection in case other aircraft might have this problem."

*(A search of the FAA Service Difficulty Reporting System data base revealed five additional reports for this part number, all from similar chafing cables. See following pictures.)*

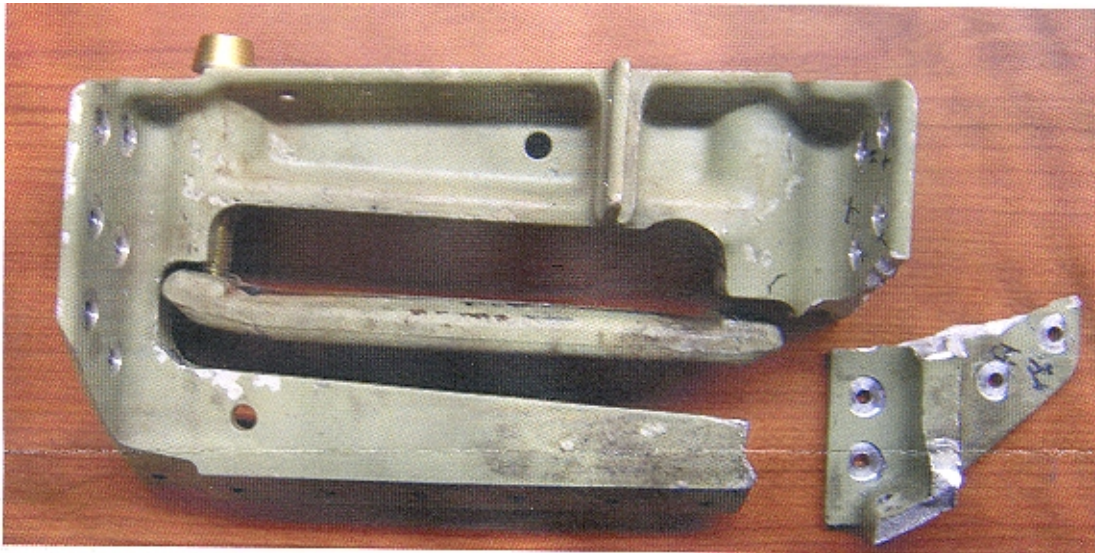
### **Cessna: T206H; Failed Main Gear Castings; ATA 5343**

A technician states, "This aircraft is operated on mostly unimproved airstrips in Lesotho, South Africa. The part is the same *(as found on)* 206 F and G models, and was installed at the time of aircraft manufacture *(P/N 1211601-3)*. This casting cracked and failed upon landing. The aft bolt was also cracked and sheared. *(This aircraft)* had a normal approach and landing *(which resulted in)* the L/H gear leg breaking loose from the outboard casting and pushing backwards, pinching the brake line and locking up the left brake." *(Part time: 1,776.6 hours.)*

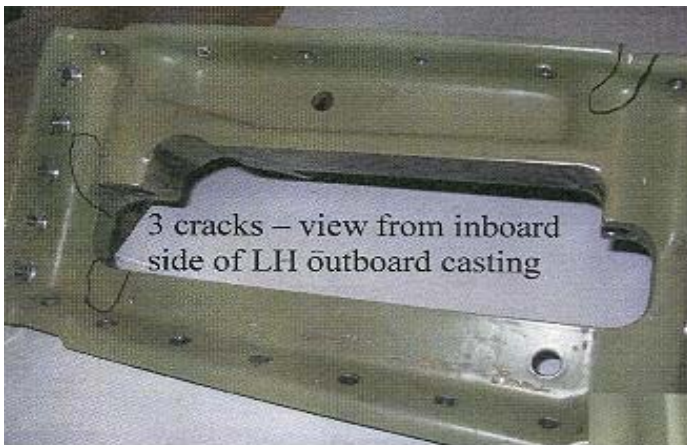
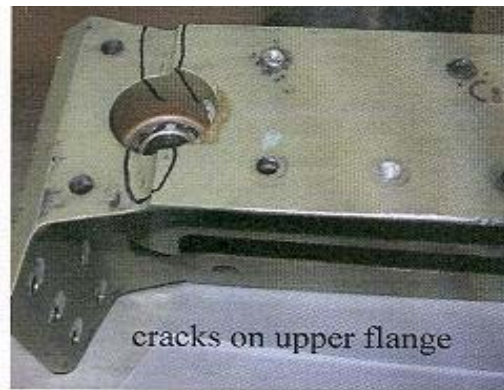
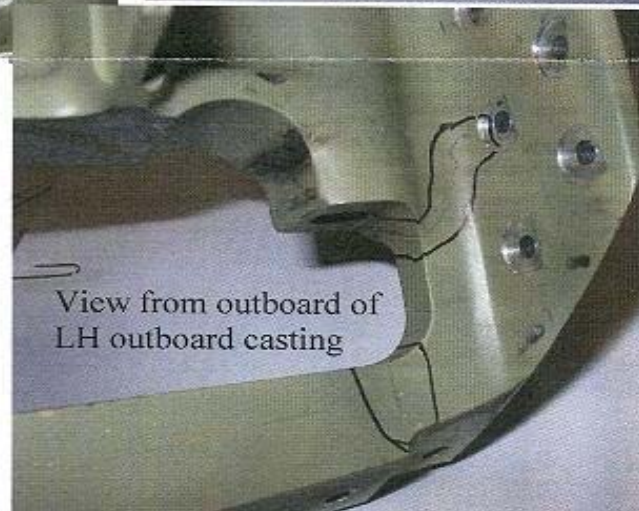
About the second aircraft Rocky says, “This casting is cracked in three different locations. We operate (*many*) of these aircraft and have a long history with the (*model*) 206. We have seen cracks of this nature before, but rarely with so little time in service.” (*Part Total Time: 1,250.0 hours.*)

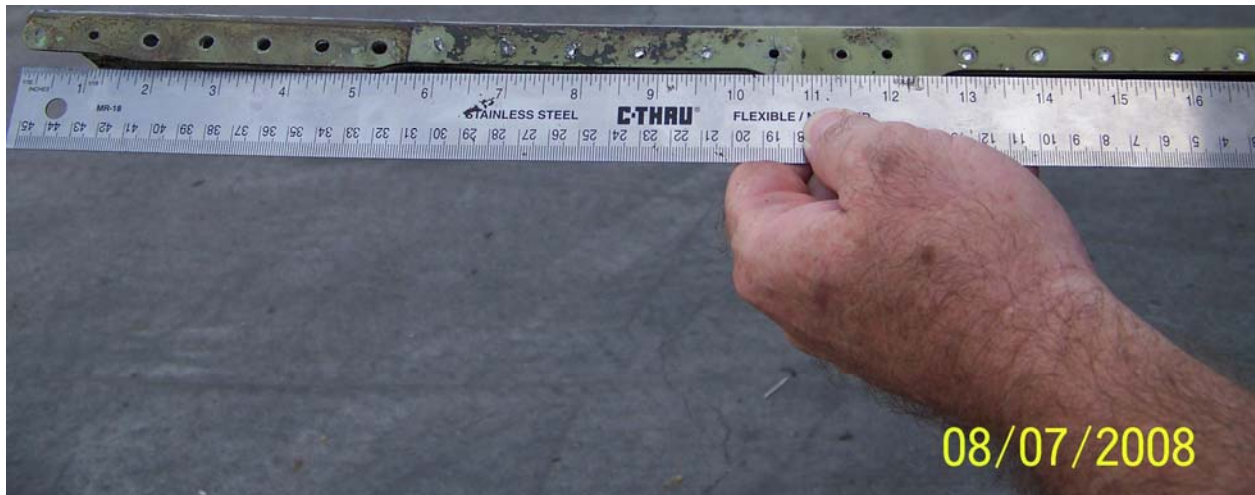
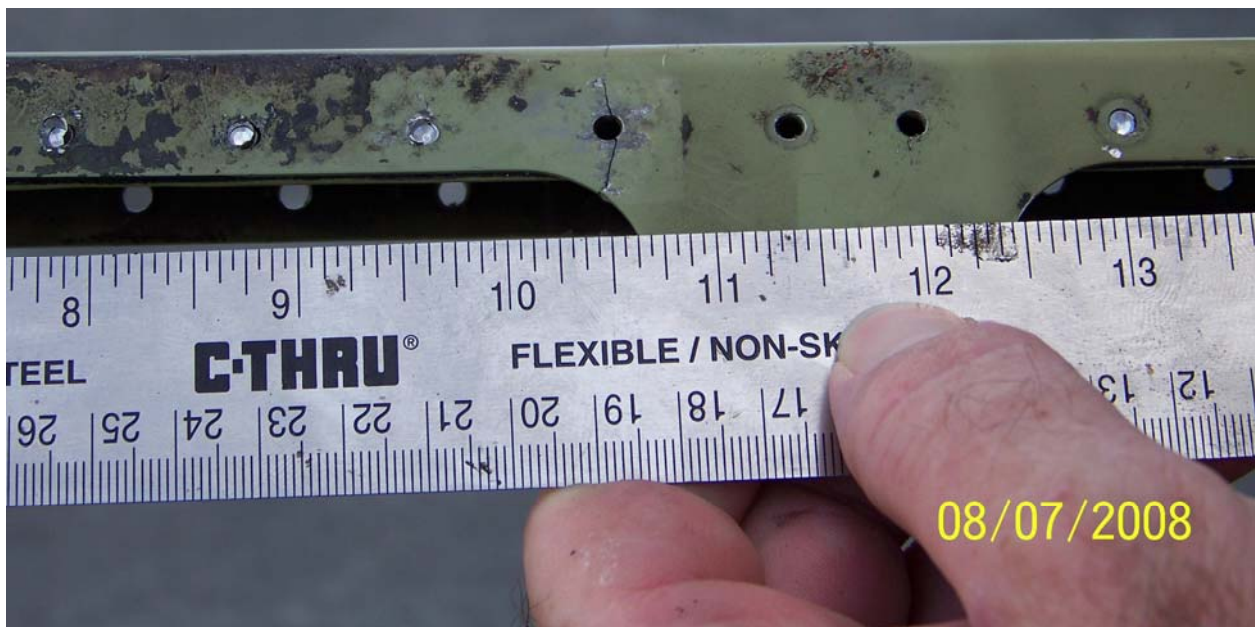
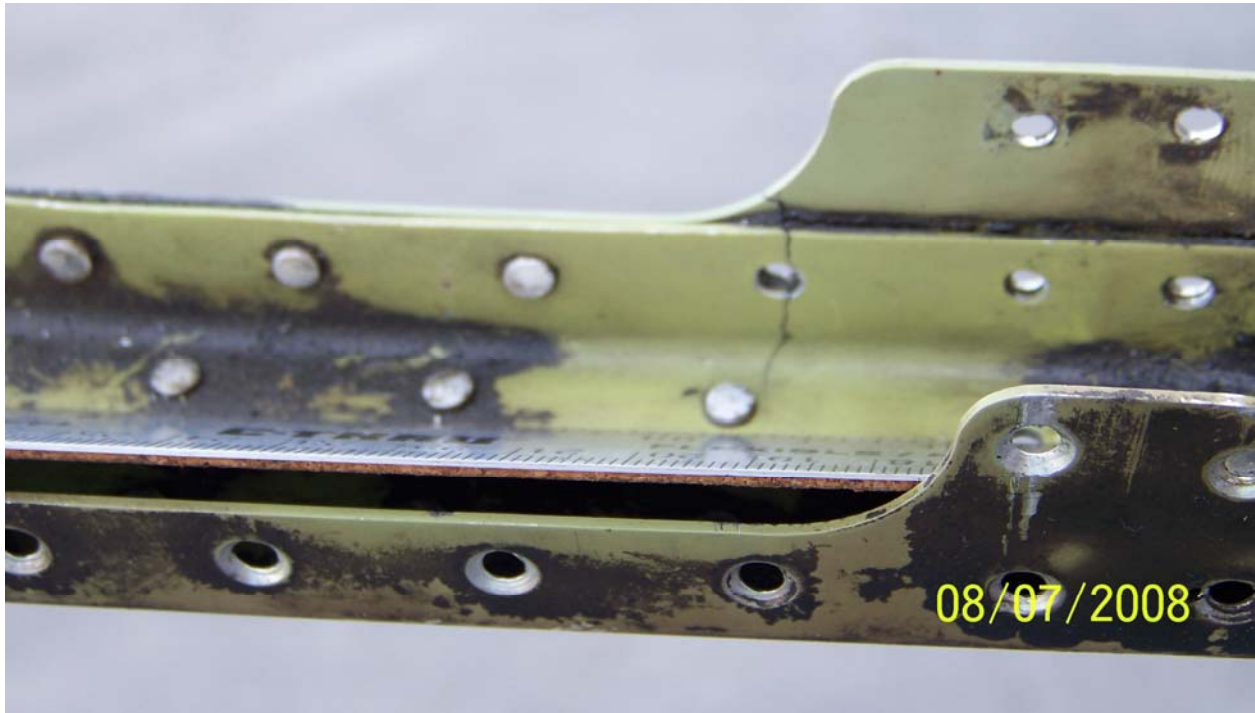
#### De Havilland: DH6-300; Cracked Nacelle Longeron; ATA 5413

A submitting mechanic says, "The R/H nacelle inboard longeron cracked 10.5 inches aft of the forward end (P/N C6W1512141). I removed and replaced the R/H inboard longeron...and verified modification 6/1655 is installed per AD 80-13-12 R1."

(Phone conversation with the mechanic notes four additional, similarly cracked longerons on separate de Havillands. Thanks for the pictures, John.)

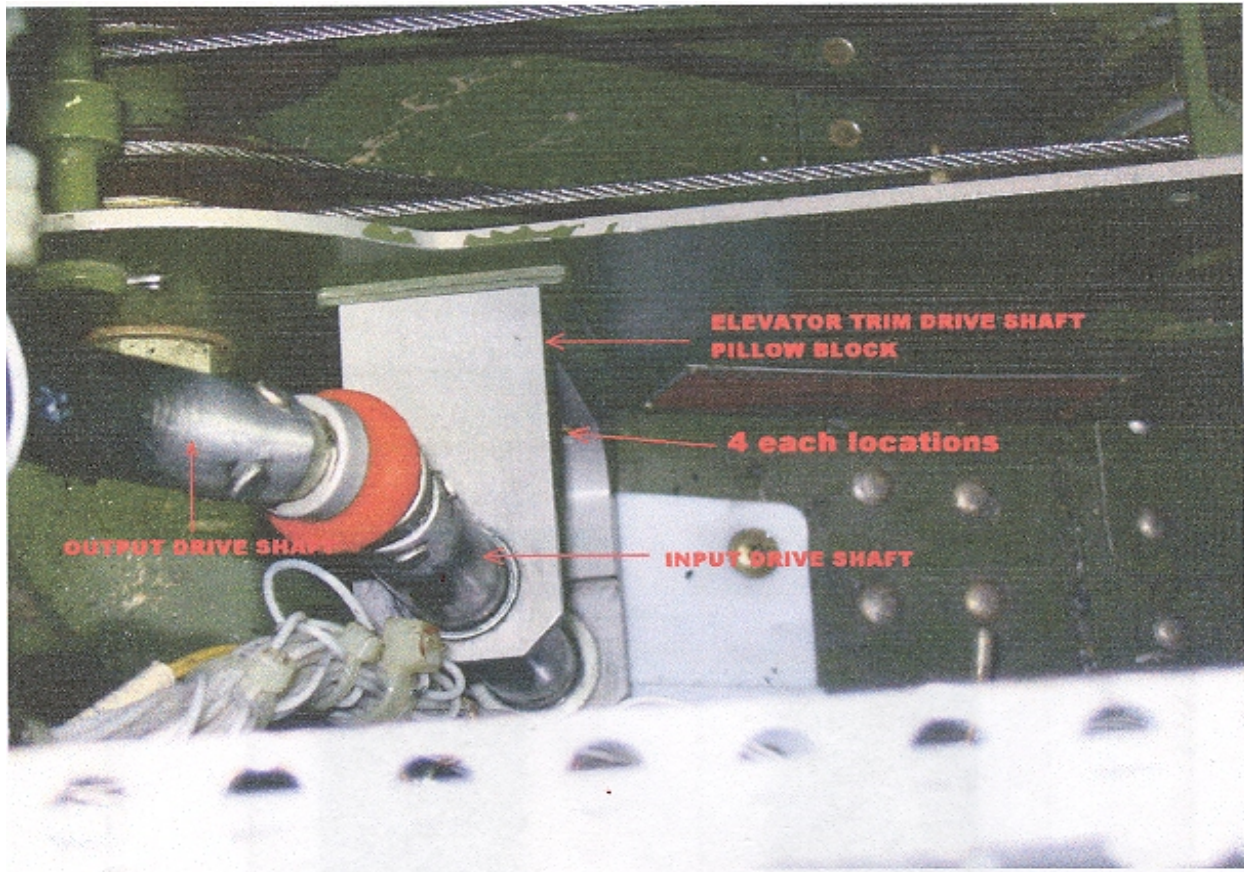
### **Gulfstream: GIV; Loose Pillow-block on Elevator Trim; ATA 2742**

About this aircraft the Director of Maintenance for an air carrier writes, “...upon descent from 41,000 feet (*the flightcrew*) got an ‘FGC1 fail message’ along with a ‘forward trim limit’ message. They were unable to trim the aircraft elevators. They complied with the checklist to reset both messages with no success. The autopilot was disconnected and an emergency declared with Air Traffic Control..., manually landing the aircraft without incident.” “Technicians found the hardware attaching the elevator trim, driveshaft pillow block had loosened, causing the driveshaft to separate from the output shaft. They secured the hardware and attached the output shaft

to the drive input shaft. Then the elevator trim system was rigged IAW GIV, AMM 27-04-00 (*maintenance manual*). No other discrepancies were noted. After further investigation it has been found that Gulfstream issued an ASC (Aircraft Service Change) number 70 which (1) installs cotter pins on the output to the input drive rods, and (2) changes the attachment hardware for the pillow drive block (*to accept*) cotter pins. I strongly recommend this ASC to prevent an occurrence like this in the future. It surprises me that Gulfstream only has this as a 'recommended ASC' (*instead of a*) 'mandatory'." (*The "pillow-block" part number was not provided.*)

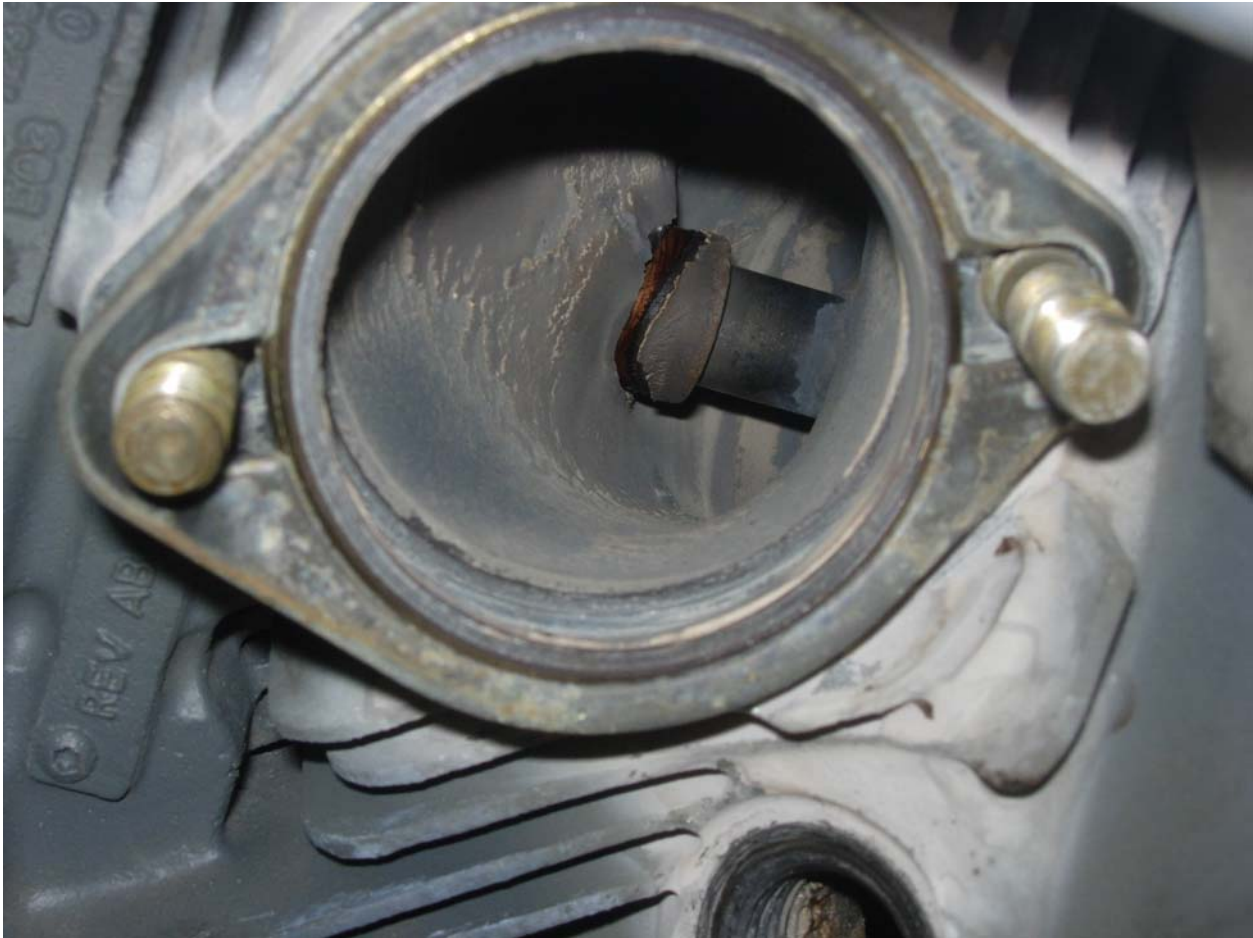
#### **Lycoming: IO360-L2A; Seized Exhaust Valve; ATA 8530**

An inspector for a repair station provides the following discrepancy report concerning a Cessna 172. “During flight the engine started running rough and lost power. An emergency landing was completed without damage or injury. Maintenance found the number three exhaust valve seized in the valve guide. Further investigation found the guide (P/N 74230) broken in the cylinder head. This operator has seventeen Model 172S aircraft with the new roller tappet engines. We have been performing an SB388C (*service bulletin*) inspection on the rest of the fleet and have found the majority of the exhaust valves for all cylinders to be tight in the guides. Lycoming SI1485 (*service instruction*) recommends a 1000 hour interval for these engines for the SB388C inspection. Our current fleet has between 650 and 900 hours total time per aircraft. We will be initiating a 600 hour interval for the SB388C for our fleet. We have also revised our (*fuel*) leaning procedures.”

*A search of the FAA Service Difficulty Reporting System data base revealed 11 reports on this part number. Nice picture, Pat. Thanks!)*
