U.S. GEOLOGICAL SURVEY DEPARTMENT OF THE INTERIOR

Map showing Features and Displacements of the Scenic Drive Landslide, La Honda, California, During the Period March 31-May 7, 2005

Ray E. Wells, Michael J. Rymer, Carol S. Prentice and Karen L. Wheeler

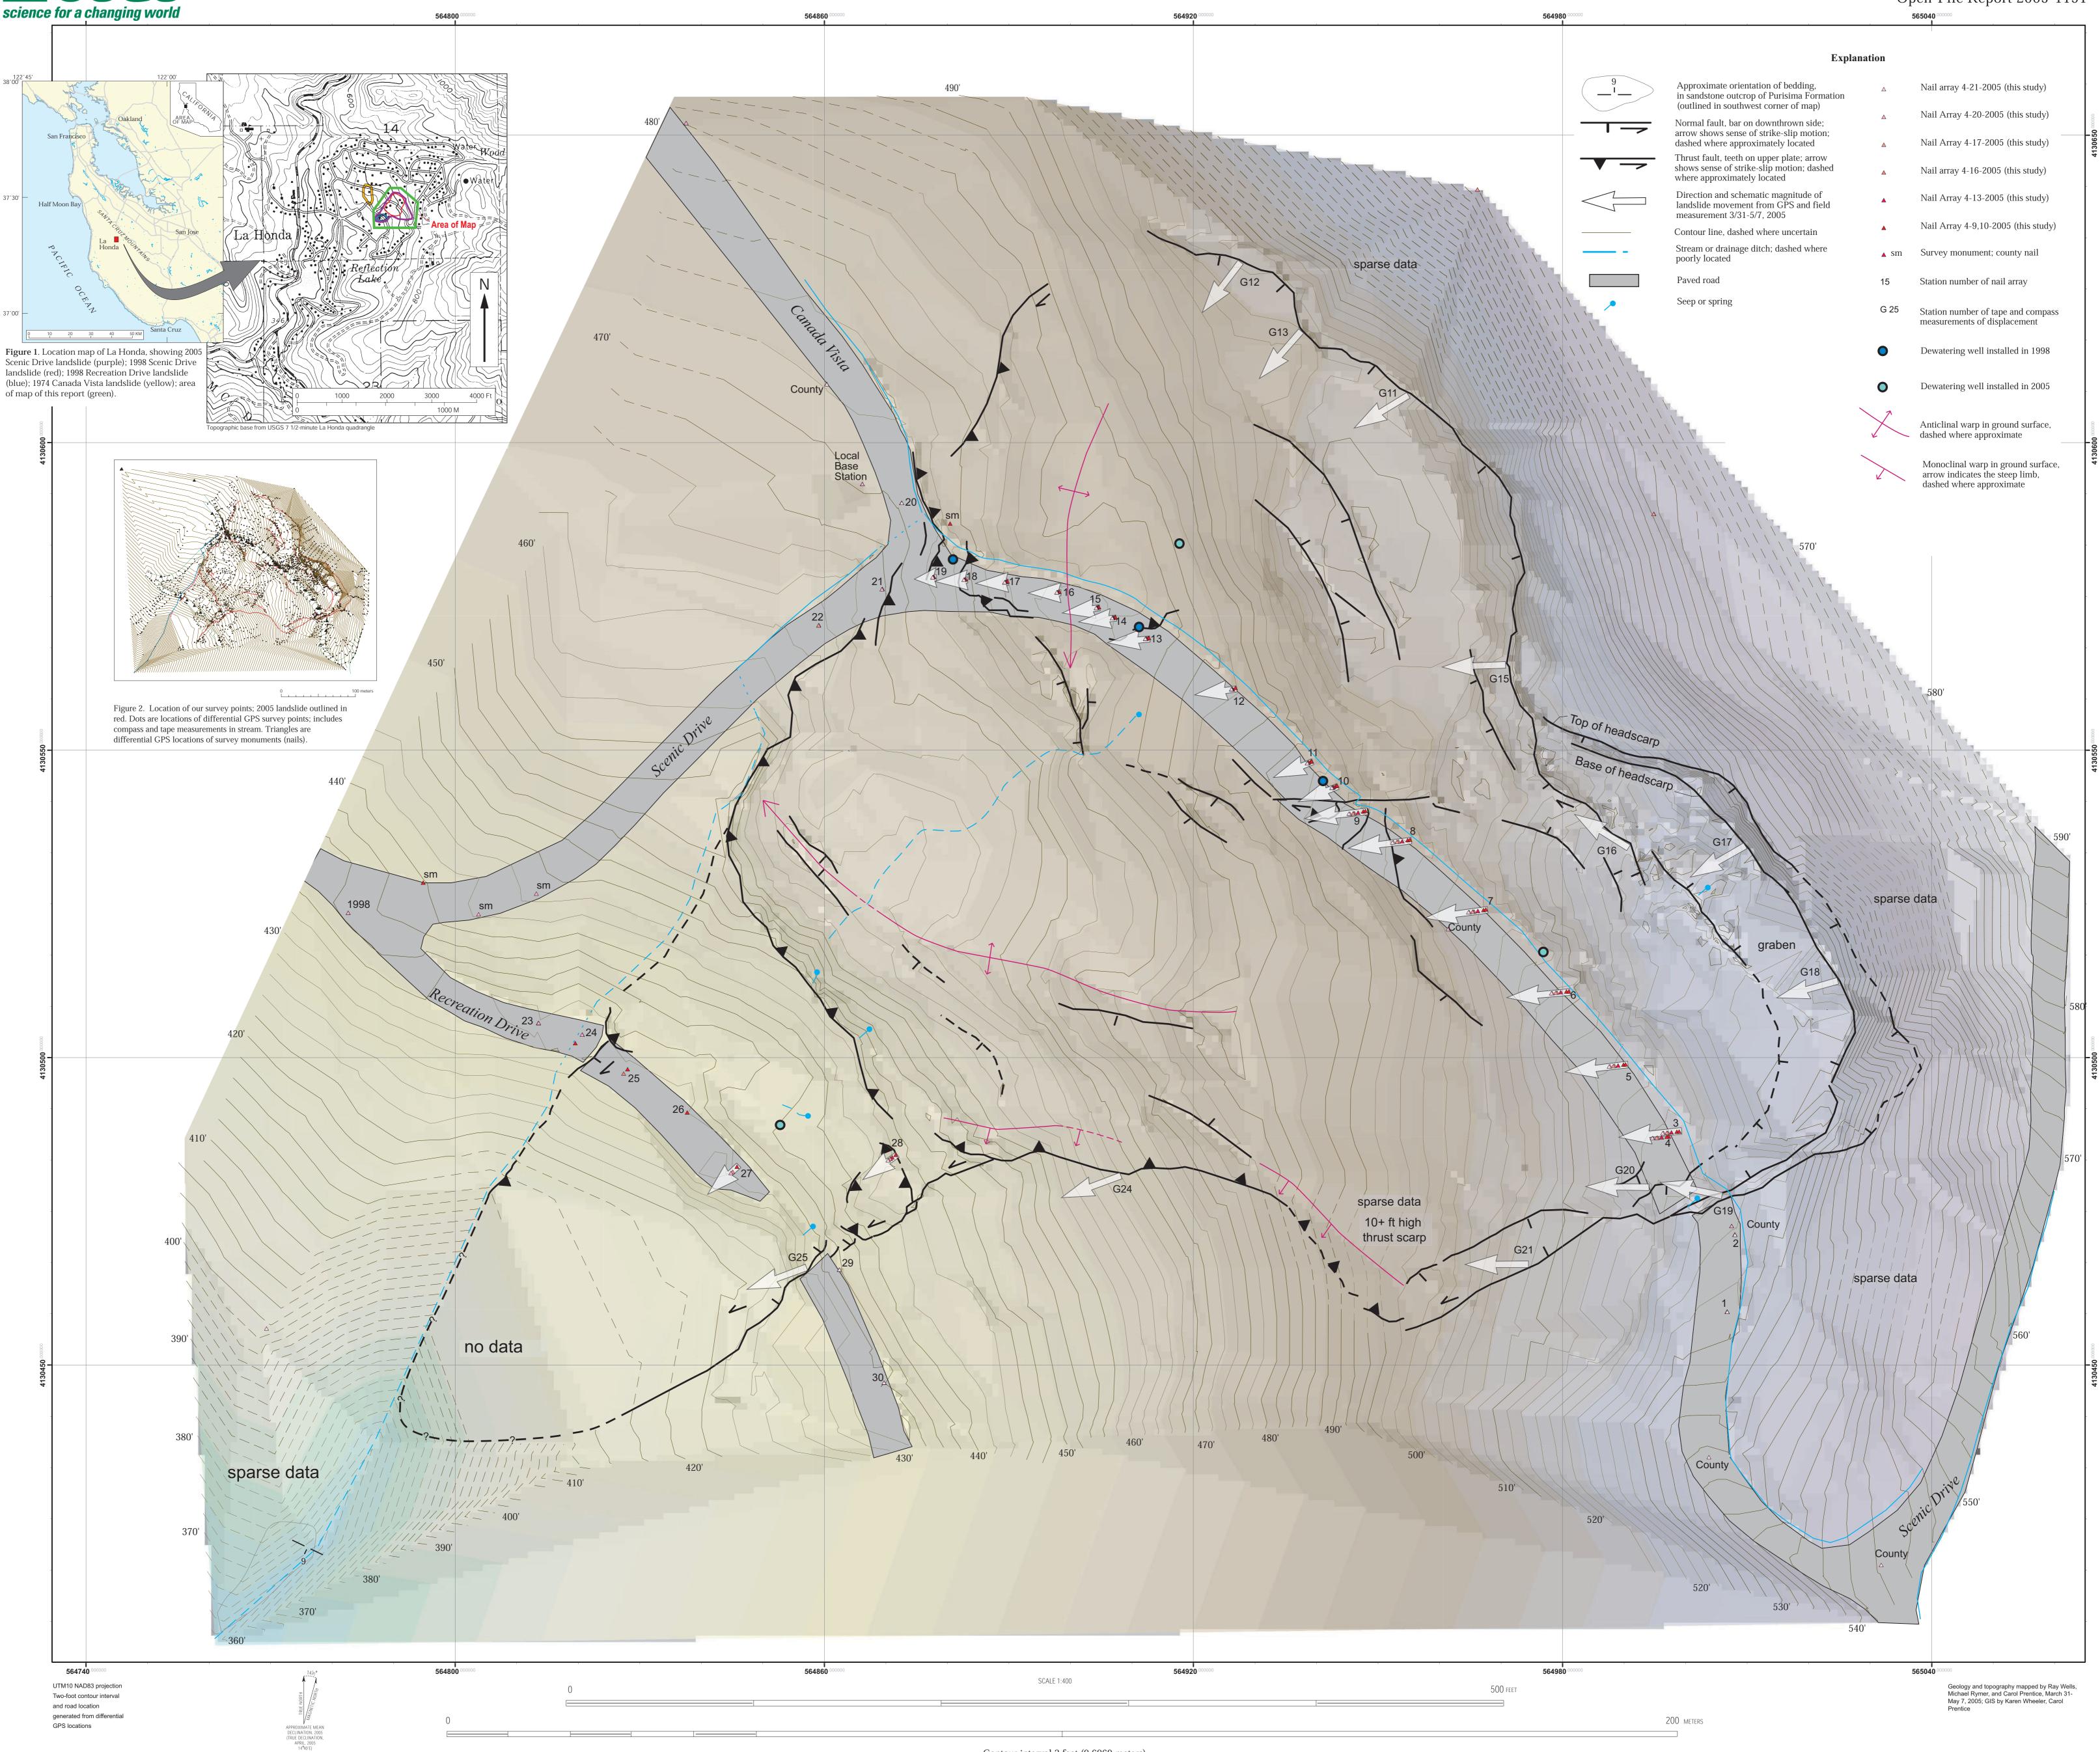
The Scenic Drive landslide can be divided into three lobes based on its geometry and kinematics (Figure 4). Major deformation of the north Scenic lobe occurred in late February and the first week of March, offsetting Scenic Drive approximately along the locus of major movement in 1998 (Figure 4). A nail array installed to measure motion recorded 18 cm of displacement between February 27 and March 10 but was paved over in mid-March.

In the last week of March, a new landslide head scarp developed more than 75 m (240 feet) uphill along Scenic Drive. The area between the old and new head scarps (south Scenic lobe) began moving westward in excess of 29 cm per day (Table 1, Figure 4). Cumulative slip in this southern lobe of the landslide exceeds 8 m (25+ feet) through May 7 (Figure 5).

Since mid-April, the southern lobe of the landslide has been moving much faster than the northern lobe (Figure 4; Tables 1 and 2). A major right-lateral boundary between the two landslide segments has developed just south of the southernmost of three dewatering wells in the 1998 landslide mass, between nails 8 and 10. Slip has since slowed to about 12-18 cm per day in the southern lobe (Tables 1 and 2), and motion of the northern lobe has nearly stopped (within the measurement error).

In the western lobe, thrusting along the toe of the 1998 landslide has increased its height up to 2 m (>6 ft) and has offset a fence crossing the toe by about 6 m (>18 ft) near station G24. Closely spaced thrust ridges have developed southwest of the 1998 toe as far as Recreation Drive. A continuous left-lateral boundary has developed between the Scenic Drive landslide toe and the southeast flank of the 1998 Recreation drive landslide. Station 28 in the toe region has been moving 8-10 cm per day through May 7. The lateral boundary fault has offset the wooden barrier around the 1998 head scarp on Recreation Drive about 6.5 m (21 ft), which is similar to the offsets seen on upper Scenic Drive.

The Scenic drive landslide is roughly triangular in shape and about 200 m on a side. It has most of the characteristics of a deep-seated landslide (Figure 3). Its eastern, upslope edge is the head scarp--the steep, exposed part of the surface along which the landslide mass moved downhill. The head scarp is slickensided and grooved and is more than 7 meters high (21+ feet) at its southern end. Displacements along the head scarp diminish to near zero at its northern end. Internally, the landslide is locally folded and cut by numerous extensional cracks and normal-displacement scarps up to 2 m high.

The western lobe of the landslide is the toe area, a zone of compressional deformation defined by transverse ridges and closely spaced thrust faults. The 1998 toe, a prominent ridge just upslope from Recreation Drive, has deformed substantially in 2005. Significant motion has extended down slope from this toe, as evidenced by the offset in Recreation Drive. By April 2nd, thrusting was affecting Recreation Drive. Subsequently, the rising toe area of the 1998 landslide began to collapse with closely spaced, down-to-the-southwest normal faults.
