ACCIDENTAL RELEASES OF SLURRY AND WATER FROM COAL IMPOUNDMENTS THROUGH ABANDONED UNDERGROUND COAL MINES

*Stanley J. Michalek, P.E., George H. Gardner, P.E., Kelvin K. Wu, Ph.D., P.E.
Mine Safety and Health Administration, Pittsburgh Safety and Health Technology Center*

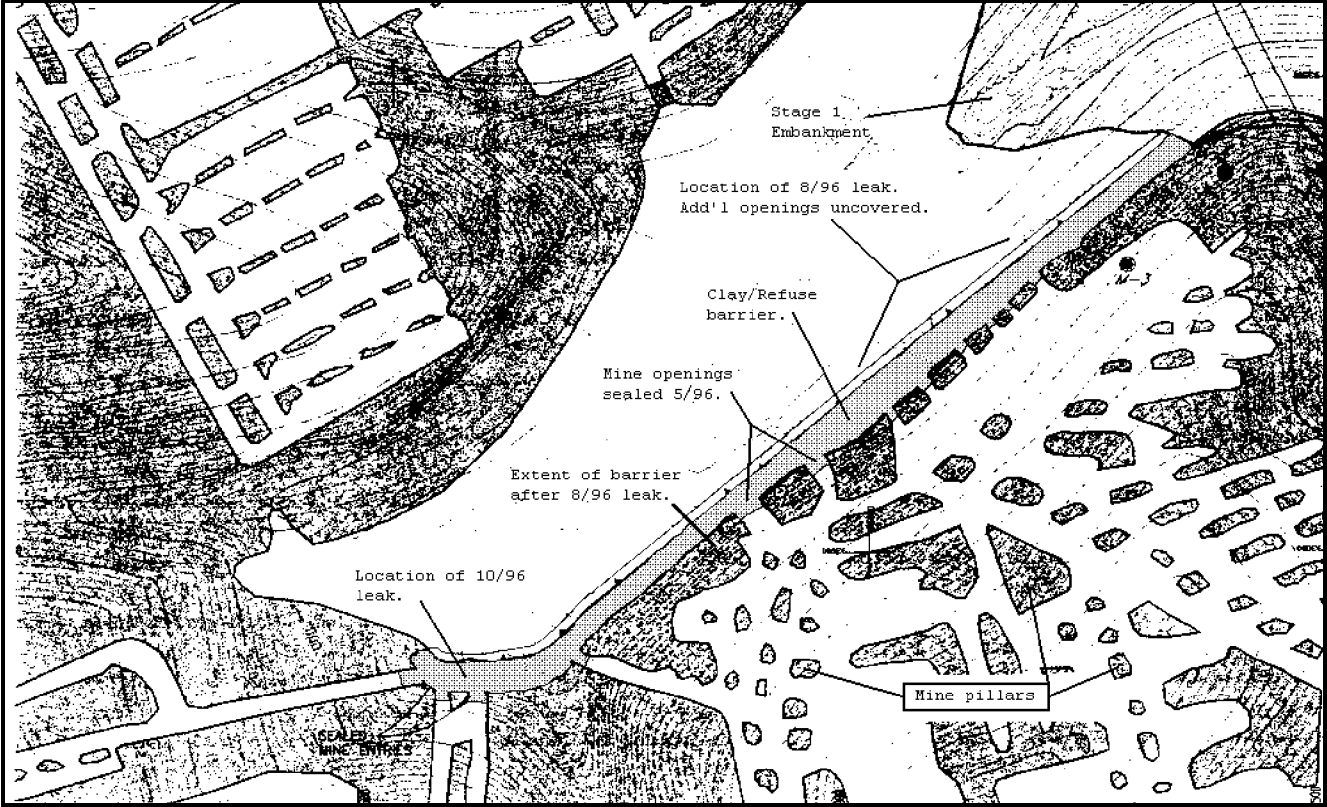
elevation of the coal seam, it was found that the seals constructed in known mine openings were intact. Further exploration revealed that the leak had occurred in an area that was originally thought to have a thick, solid barrier of coal. Available mine maps indicated that at least 25 feet of solid coal were present between the outcrop and underground mine workings in this area. The barrier was found to be less than two feet thick. It is believed hydrostatic pressure from the slurry had opened cracks in the coal seam and a piping type failure had begun. The thin coal barrier was progressively eroded, allowing water/slurry to flow uncontrolled into the mine. Figure 3 shows a portion of the mine map and the locations of mine openings.

Plan view of Miller Cove Impoundment showing extent of mining in upstream abutments and locations of mine openings.

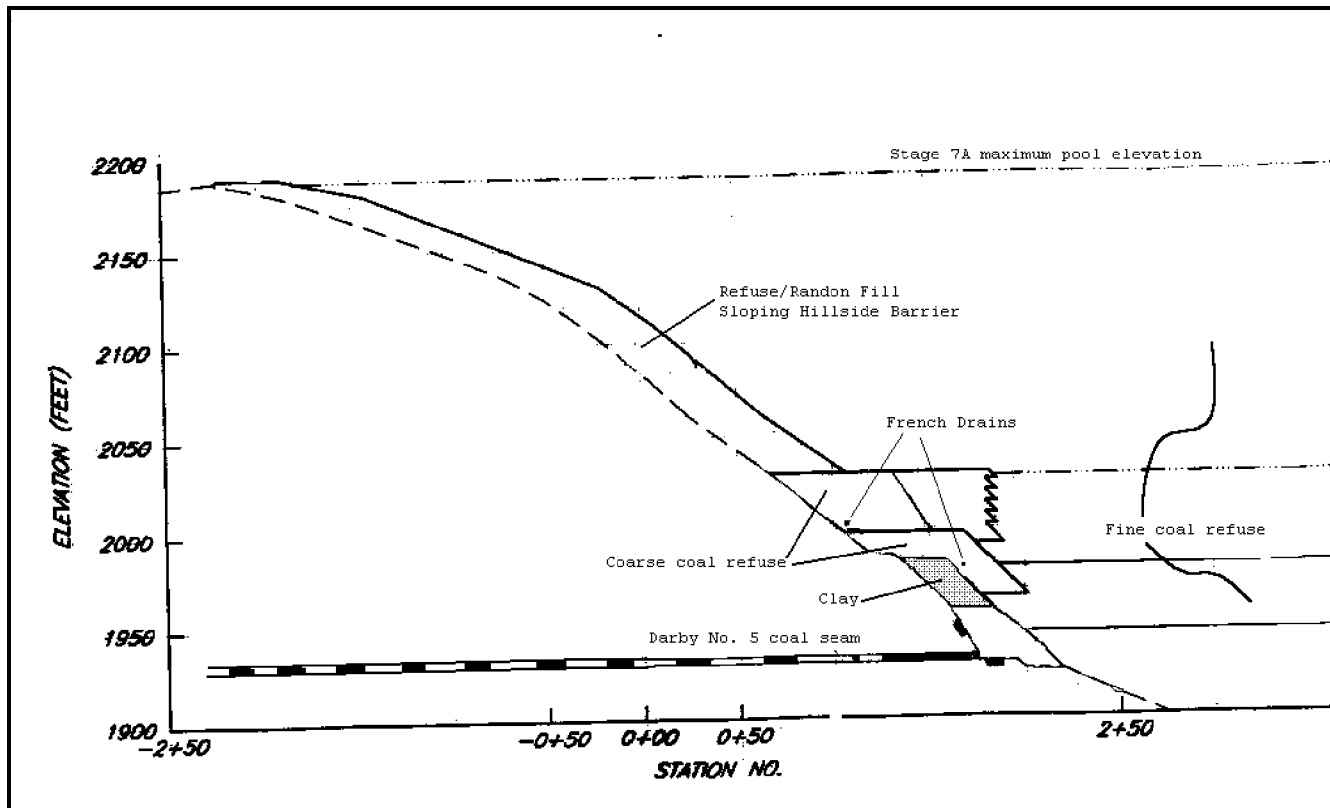
Figure 4
 Cross-section showing earthen liner to be constructed around impoundment.

To repair the situation, several hundred feet of the outcrop along the west abutment were cleared and thoroughly inspected. Weak areas and newly discovered openings were excavated and closed with designed seals. Then, a 20-foot-wide layer of low permeability earthfill was placed against the original hillside to impede the flow of water to the seals and to separate the fine refuse from the hillside. This liner was to be placed in compacted lifts and carried up the hillside until a vertical thickness of 100 feet was reached between the top of the liner and the coal seam. Figure 4 shows a cross-section view of the liner details.

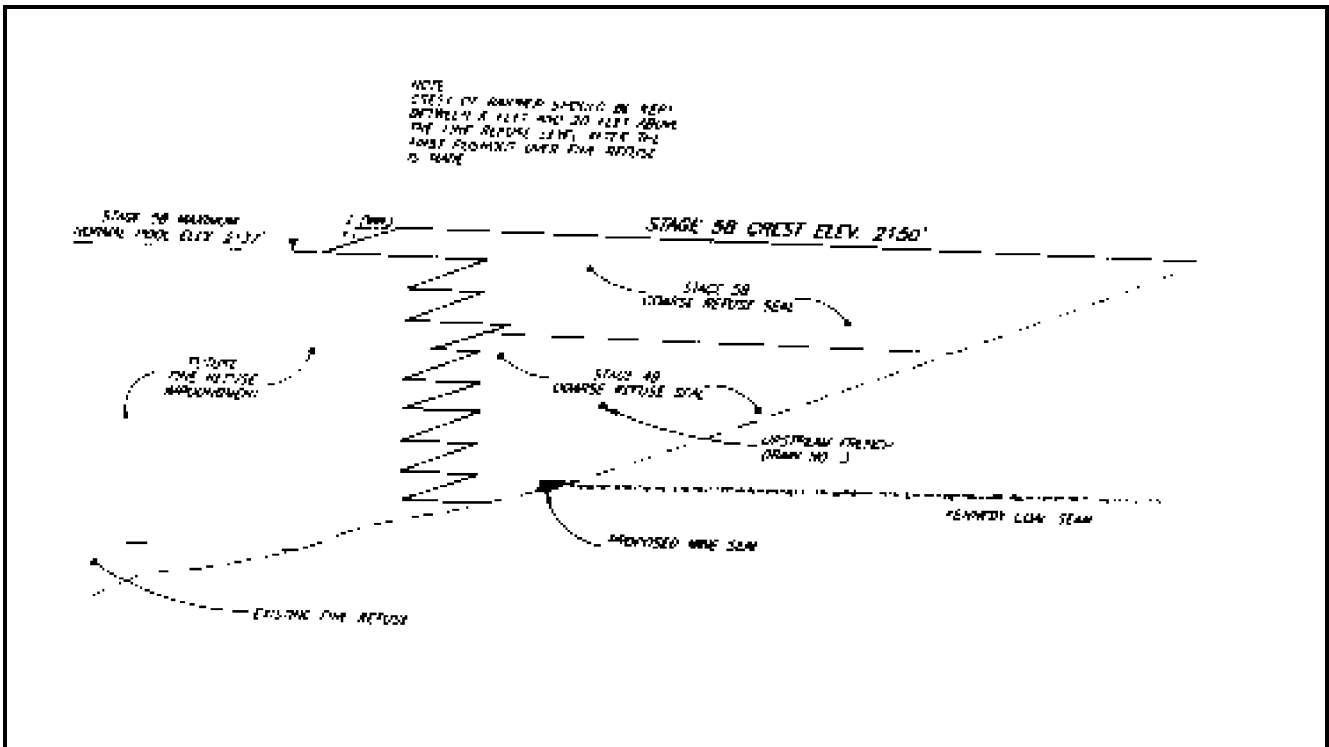
Figure 6
Proposed long-term mine seal.

The long-term remediation plan requires the mine seal barrier to eventually be constructed entirely around the reservoir. It is to be constructed such that free water is maintained as far as practicable from the mine openings. An extensive network of French drains will be installed to minimize the head and subsequently the flow into the mine openings. These drains have been designed to handle the anticipated seepage determined using finite-element methods. Piezometers were also installed at various locations around the barrier to confirm that excess hydrostatic pressures do not develop. Further, provisions were included in the specifications to inspect the hillsides for any evidence of subsidence. Figure 6 shows a cross-section of the proposed mine seal.
