4.1 INTRODUCTION

4.2 HEALTH CARE FACILITIES

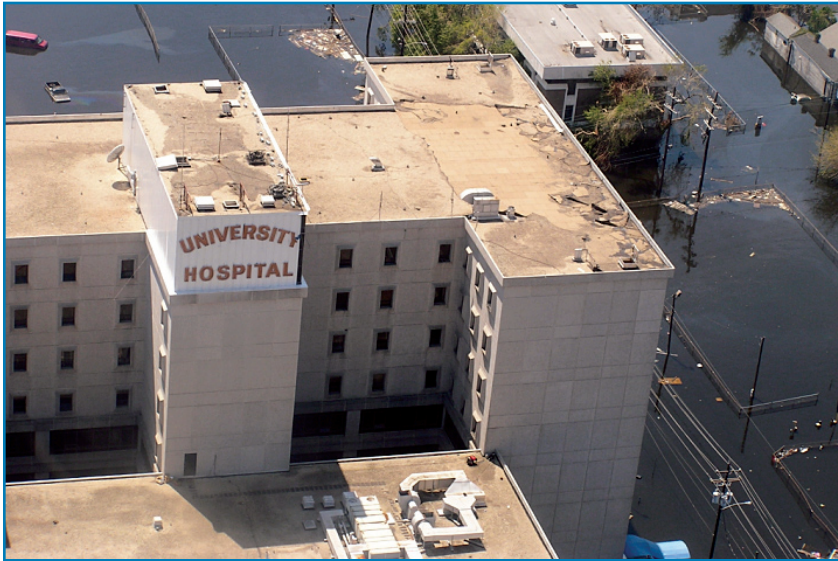
Figure 4-1:
University Hospital
surrounded by 4 feet of
water

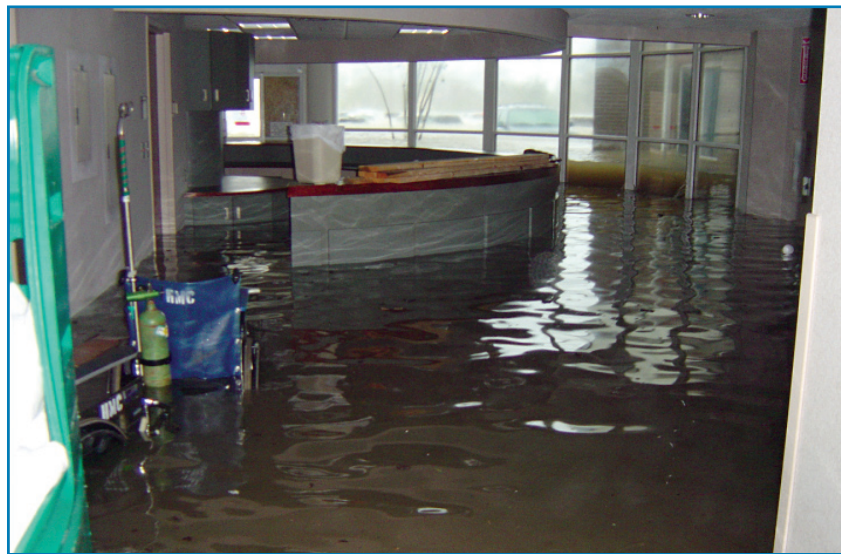
Hancock Medical Center in Bay St. Louis, Mississippi, although located outside of the 500-year floodplain, experienced 3-foot deep flooding as a result of the storm surge (see Figure 4-3). Access to the hospital was disrupted long before Katrina made landfall because, prior to the storm arrival, there was a 33-mile traffic back-up on the road leading out of town. Access was important because all the functioning hospitals needed relief supplies, medical gases, water, and fuel for their emergency generators. In many cases, the only way to resupply the facilities was by air, using large Chinook helicopters. These helicopters are too heavy for most roof structures, and to use them for emergencies in the future, a second helipad may be necessary on the site, requiring sufficient glide angles for landing and takeoff of the largest aircraft.

Figure 4-3:
The lobby of Hancock
Medical Center was under
3 feet of water.

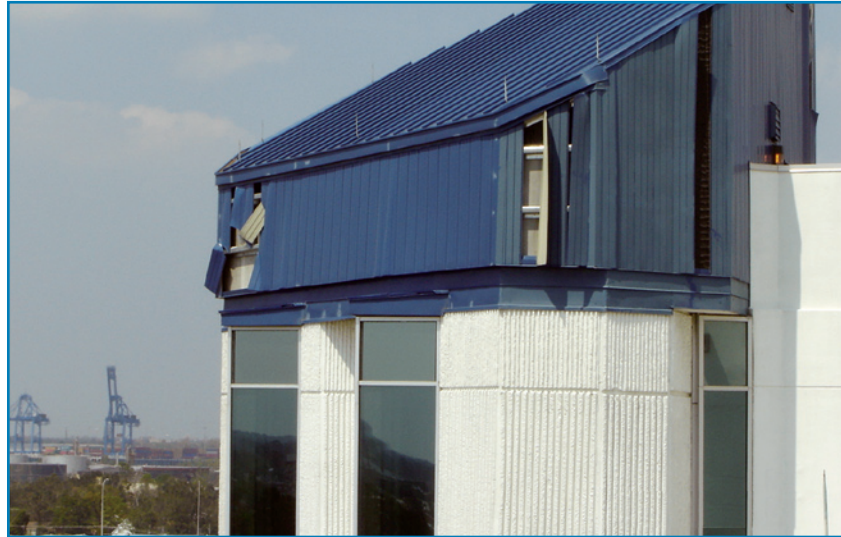
Building configuration and general shape frequently contribute to high-wind damage. Protrusions and projections in walls and roofs cause additional wind turbulence that increases uplift pressures. The penthouse at West Jefferson Medical Center illustrates the vulnerability of projections and corners to high winds (see Figure 4-4). Large portions of metal cladding came loose because they were not designed or constructed to resist these loads.

Figure 4-4:
Penthouse at the West
Jefferson Medical Center

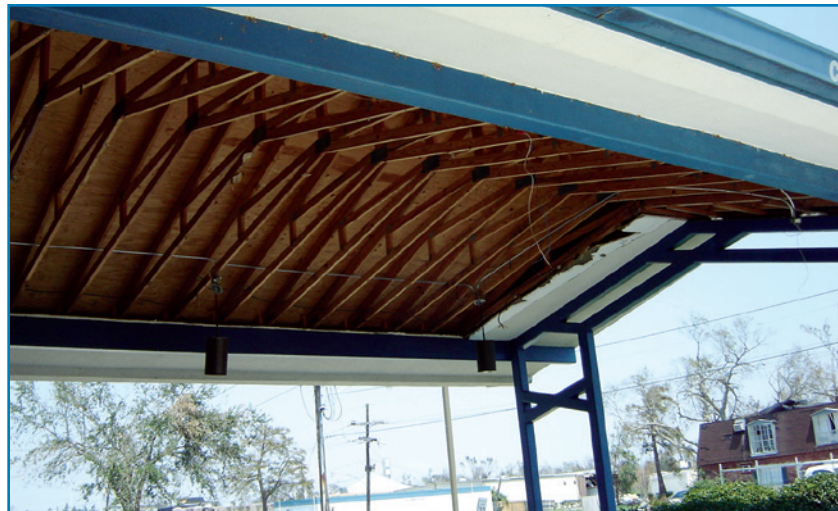
Canopies, which most hospitals have over drop-off areas, are particularly susceptible to uplift and other damage, if not designed to resist the loads (see Figure 4-5). Glass-enclosed lobbies and atria, common to many hospitals, also proved to be a hazard, because of the large areas of usually unprotected glazing that could easily shatter under the impact of wind-borne debris. In many cases, these areas were closed during the storm, thereby cutting off a major point of access to the hospitals.

Figure 4-5:
Canopy soffit damage at
West Jefferson Medical
Center

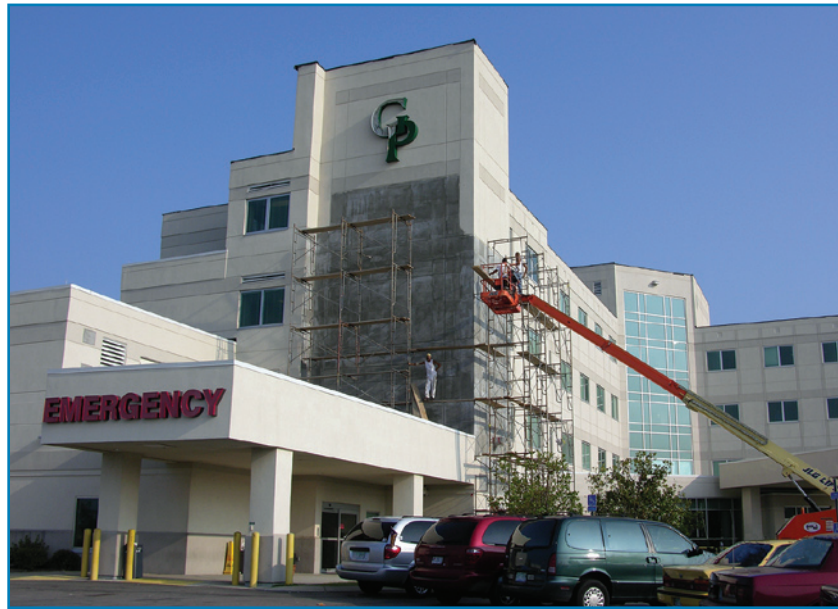
The building envelope on the Garden Park Medical Center in Gulfport, a relatively new building opened in 2000, sustained considerable damage from 130-mph winds during Hurricane Katrina. The estimated wind speed may appear to have been close to the current design wind speed of 135 mph for this facility, but the actual pressures were below the current design pressures as a result of the 1.15 importance factor required for hospitals. Wall cladding consisting of EIFS was blown off in several areas, allowing water to penetrate wall cavities (see Figure 4-6). Extensive use of EIFS, despite a long track record of failure during hurricanes, contributed to significant damage from water penetration. EIFS is a popular wall cladding system, but not strong enough to prevent damage from wind-borne debris in cases where EIFS is applied over studs. In addition, EIFS design or construction deficiencies frequently make it insufficiently resistant to suction pressures caused by high winds. This is especially significant for hospitals, where such damage can allow water penetration and trigger serious disruptions in the mechanical and electrical systems and damage the building interior. Hospitals in hurricane-prone regions that have EIFS should have field testing performed to evaluate its attachment.

Figure 4-6:
Repair of EIFS wall
covering on Garden Park
Medical Center

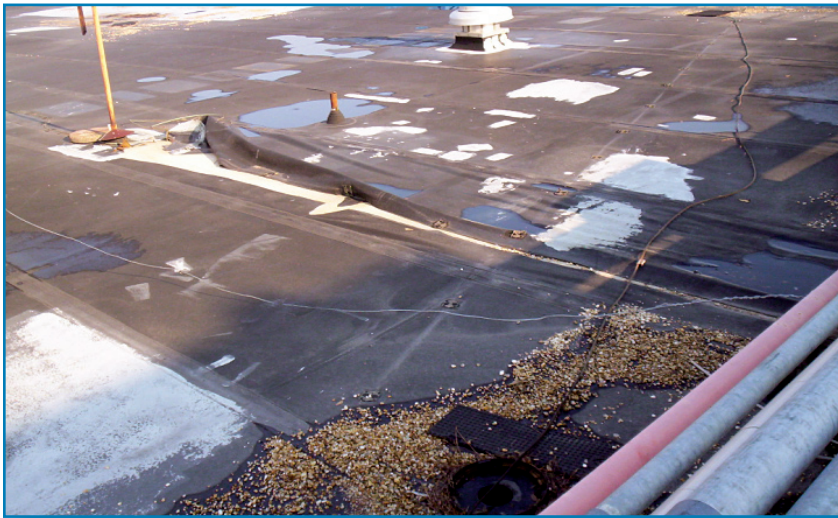
Many hospitals have low-slope roofs. There have been many instances of failure of this type of roof, frequently beginning at the edge flashing and progressively spreading to other parts of the roof. Roofs are also susceptible to puncture, as happened at the Hancock Medical Center and Garden Park Medical Center (see Figure 4-7). Rubber walkway pads were blown away and the roof membrane was punctured in several places by displaced equipment and other flying debris. As a result, a substantial amount of water leaked through the roof openings into the top floor, causing considerable damage to the interior. In addition, the aggregate surfacing blew off, damaging glazing on surrounding buildings.

Figure 4-7:
Roof membrane starting
to peel off at Hancock
Medical Center.

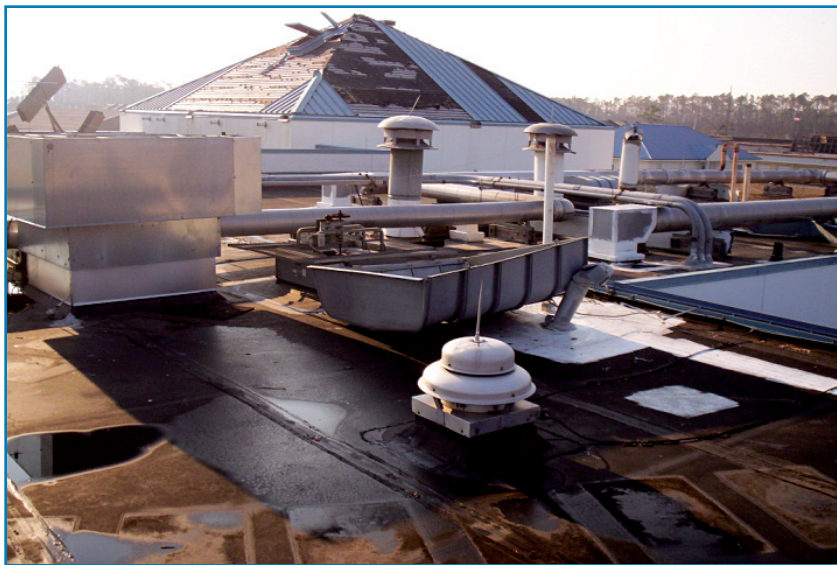
Hancock Medical Center lost substantial portions of its metal roofing. Patients had to be relocated from the top floor to lower floors because of roof leakage (see Figure 4-8). West Jefferson Medical Center lost portions of roofing on the Psychiatry building, when the metal roof covering partially peeled off. The leading edge began to peel back, but did not go any further than the edge flashing, so a minimal amount of water penetrated through the roof. The psychiatry building was not occupied at the time because the hospital evacuated the building before the hurricane landfall.

Figure 4-8:
Roof damage on Hancock
Medical Center

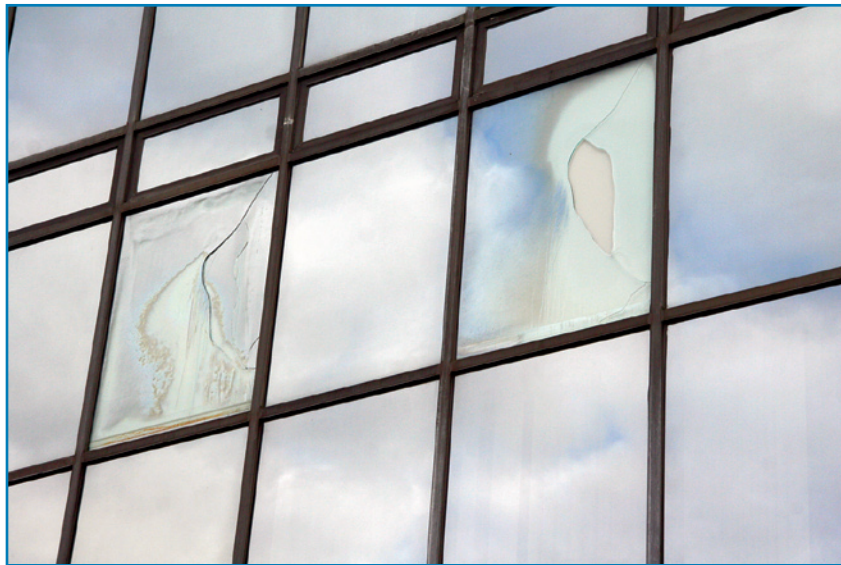
The primary cause of window breakage was wind-borne debris. (see Figure 4-9). West Jefferson Medical Center had 76 windows broken, mainly by flying aggregate. Intensive care patients had to be moved to the recovery room in the interior of the building and away from windows. The Psychiatry building had rainwater penetration through windows, even though they were not broken.

Figure 4-9:
Broken windows at Touro
Infirmary

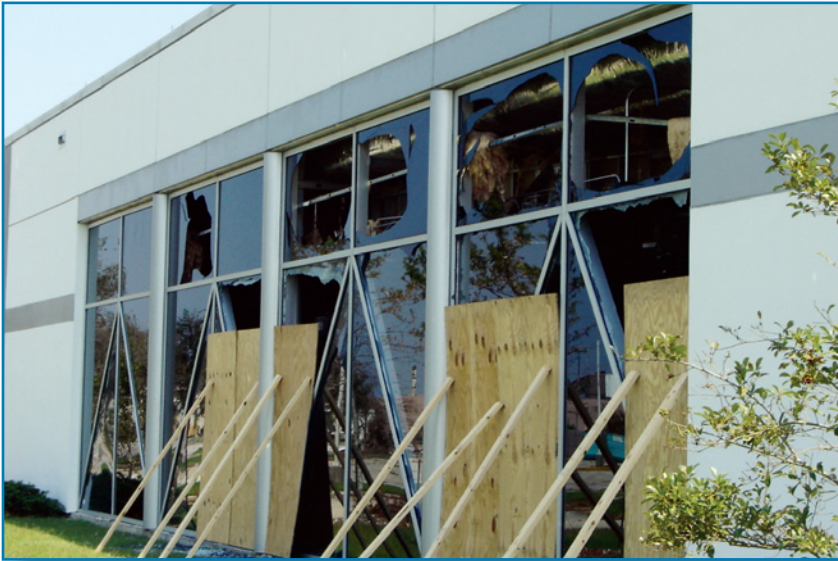
Although many important hospital functions are located away from the exterior windows, wind-blown rain can damage expensive equipment even when it is located some distance from the broken window (see Figure 4-10). At West Jefferson Medical Center, the fitness center building sustained \$250,000 worth of damage that resulted from water driven through the broken windows and from 30 days of high humidity, before the air-conditioning was restored.

Figure 4-10:
Broken windows at West
Jefferson Medical Center

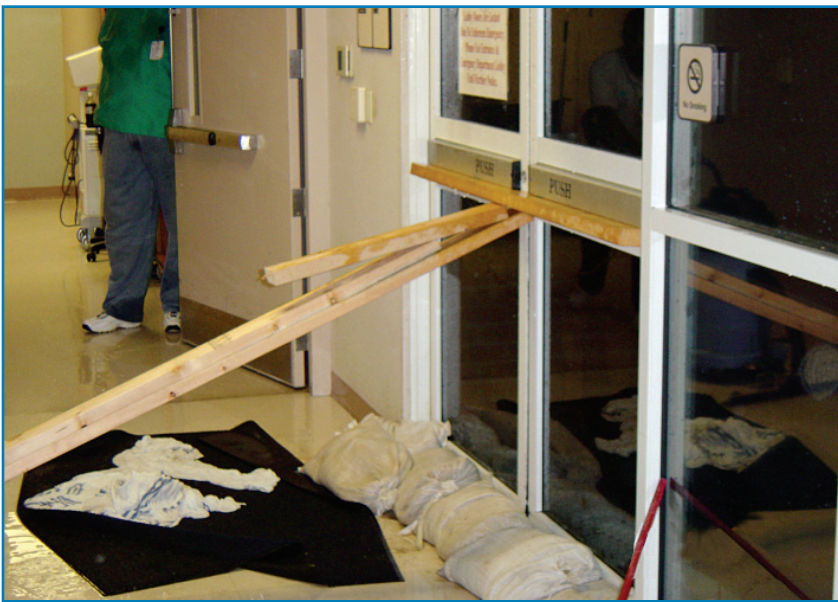
Exterior doors were often pushed in by floodwaters and blown open and damaged by wind pressure. Breakaway doors are particularly vulnerable to opening in high-wind conditions, as wind pressure can build up through the unsecured doors. Ground floor entrance doors at Hancock Medical Center had to be blocked by sandbags and two-by-fours, both on the inside and the outside, to stay closed (see Figure 4-11). The penthouse door at Garden Park Medical Center in Gulfport was blown off its hinges by strong winds.

Figure 4-11:
Blocked doors at Hancock
Medical Center

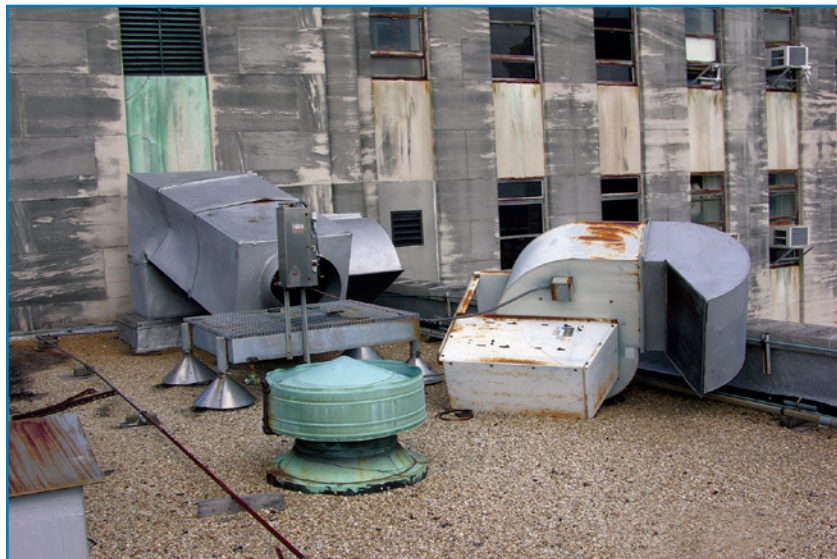
Hurricane Katrina struck at a time when the temperatures during the daytime reached 95°F. Air-conditioning systems in hospitals were generally not connected to the emergency power supply, nor was there any flexibility to switch emergency power from one system to another to provide some relief. The heat build-up was a significant factor in creating difficult conditions for patients and staff (see Figure 4-12).

Figure 4-12:
Topped HVAC equipment
at Charity Hospital, New
Orleans

- Install emergency electrical generators with capacity to run the air conditioning system. This might also require water for the chillers if this is the method of delivering cold air.
- Install sufficient controls in the hospital to be able to identify the areas with mold and mildew problems, and have them cordoned off quickly.
- Install HVAC duct cleanout locations, so that any mold or mildew that begins to grow in the ductwork can be easily cleaned out.
- Create air-conditioning zones (where practical), so that crucial operations can be cooled with a minimum amount of air-conditioning.

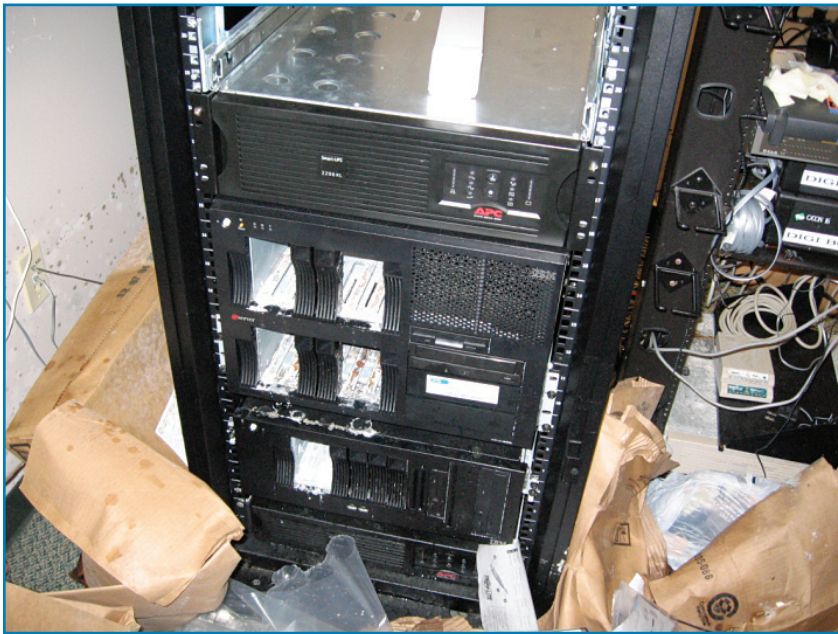
Figure 4-14:
Damaged computer
network equipment at
Hancock Medical Center

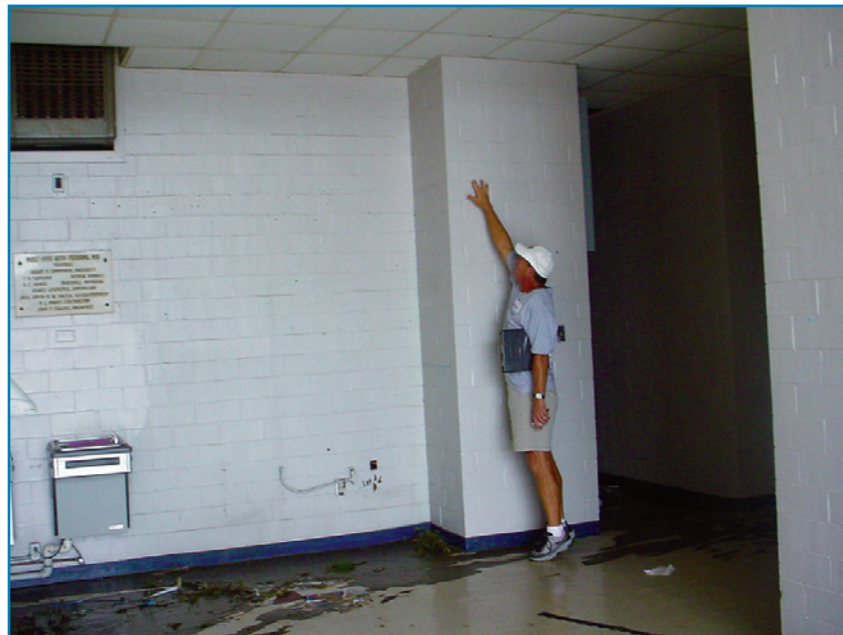
Figure 4-16:
D'Iberville Middle School
was flooded to the depth
of 8 feet

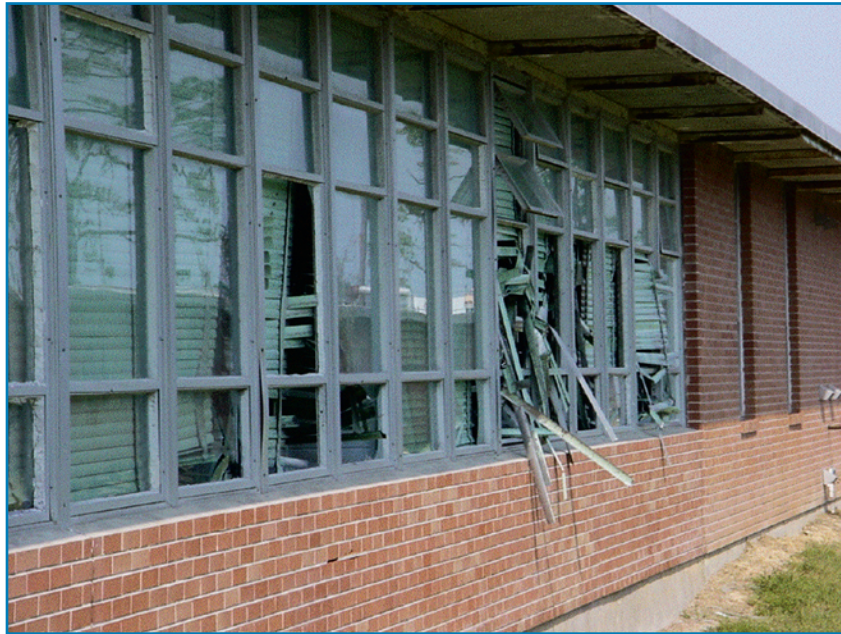
Figure 4-17:
Broken windows at
D'Iberville High School

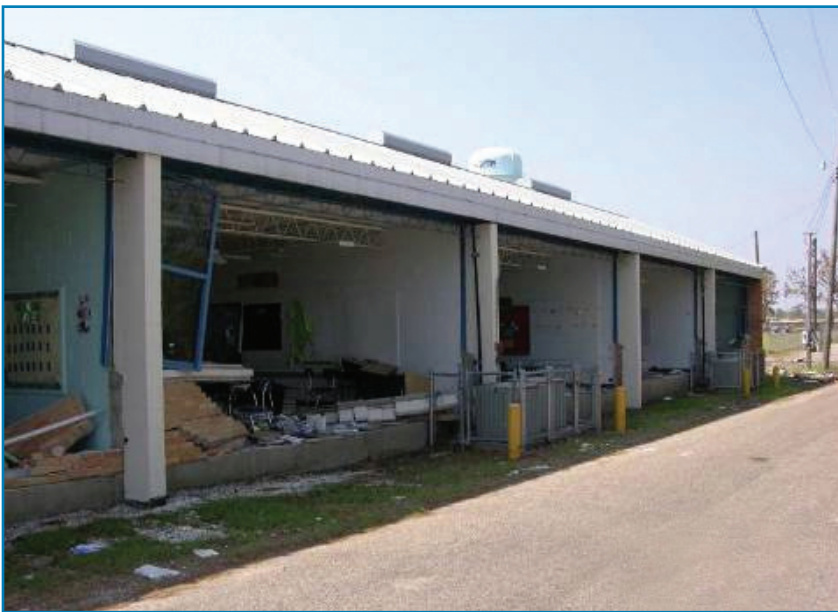
storm surge flooding. The massive storm surge devastated parts of Northbay Elementary School in Bay St. Louis, Mississippi, a single-story building located in a mapped flood zone. Exterior walls collapsed, and most of the interior and contents were destroyed (see Figure 4-19).

Figure 4-19:
Exterior walls at Northbay
Elementary School

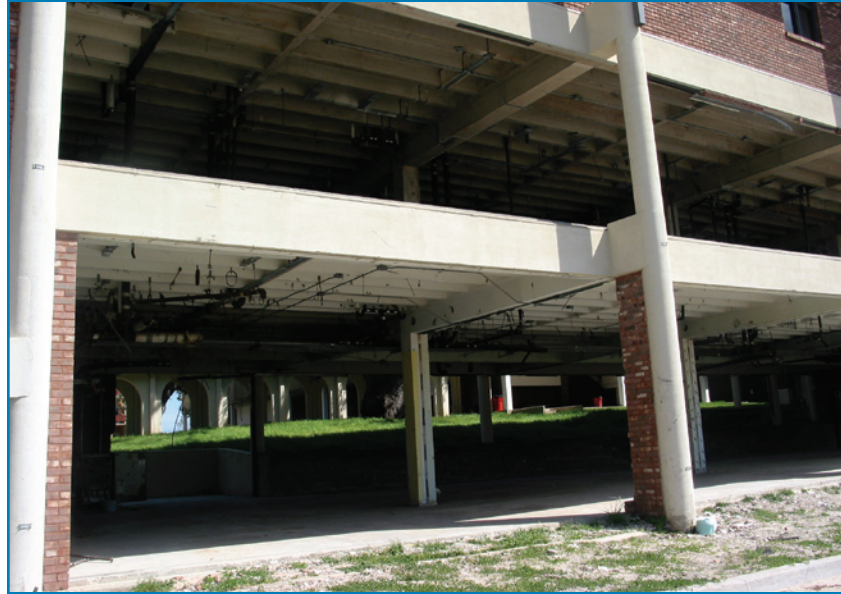
Figure 4-20:
Lower floors washed away
by the storm surge at St.
Stanislaus campus

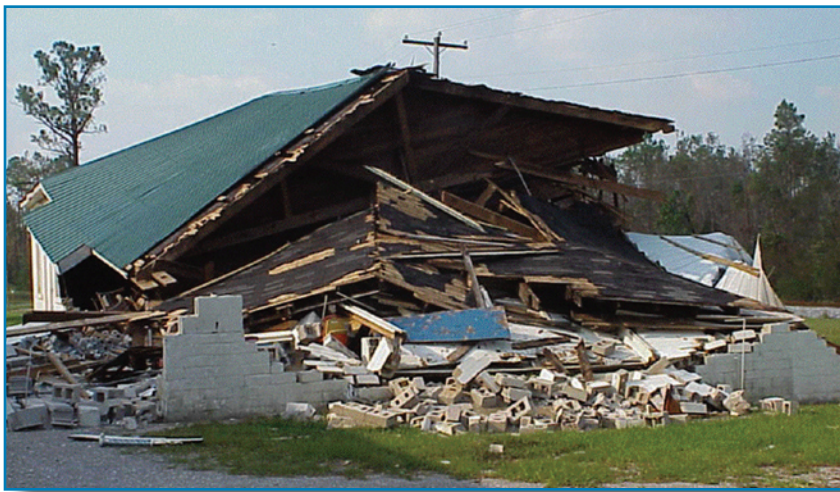
Figure 4-21:
Collapsed portion of the
Lyman Elementary School
Building

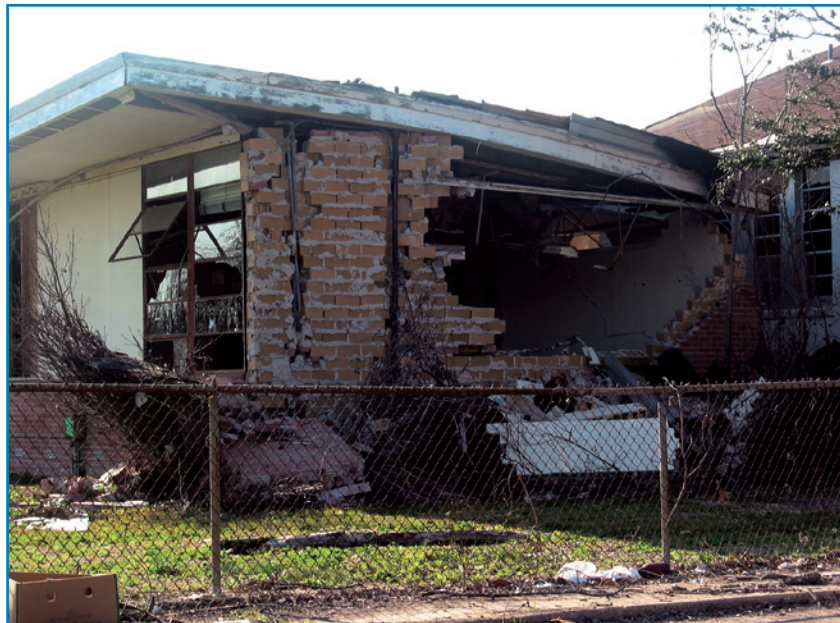
Figure 4-22:
Damaged exterior walls
at Charles B. Murphy
Elementary School

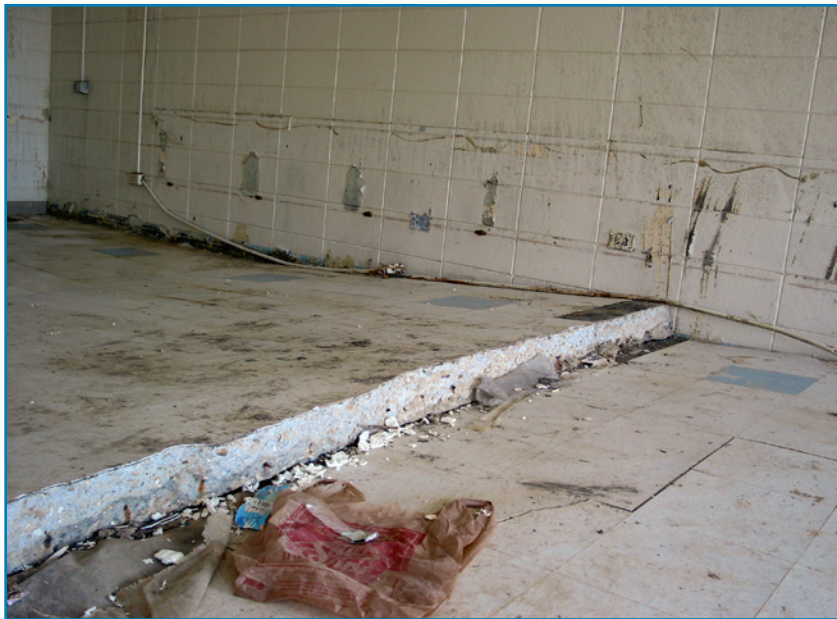
At Charles P. Murphy Elementary School, many of the infill masonry walls were displaced, and the concrete slabs on grade were uplifted and severely cracked in several classrooms (see Figure 4-23). A similar slab failure also occurred at D'Iberville Middle School. The cause of this type of failure was an increase in upward hydrostatic pressure below the slab, causing it to burst upward.

Figure 4-23:
Cracked concrete floor
slab at Charles B. Murphy
Elementary School

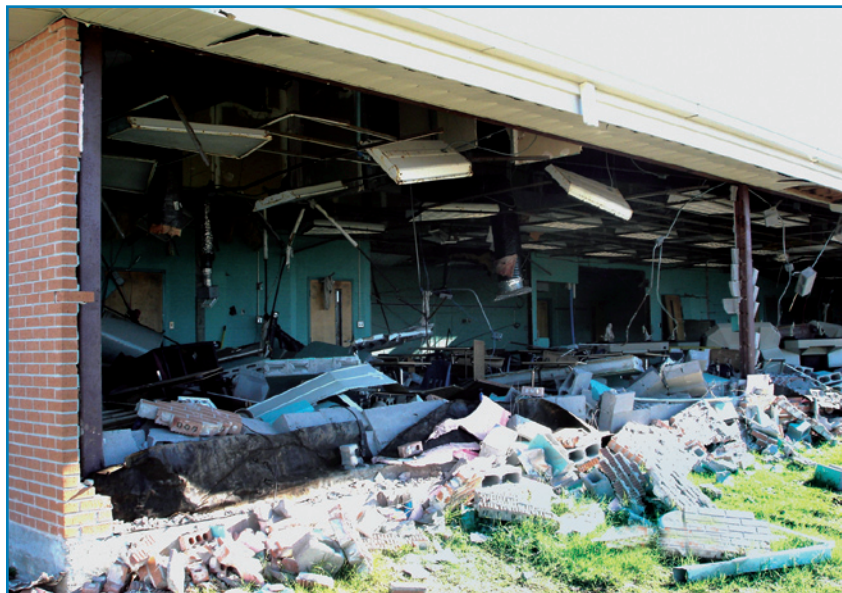
Figure 4-25:
Collapsed exterior
masonry wall at Port
Sulphur school campus

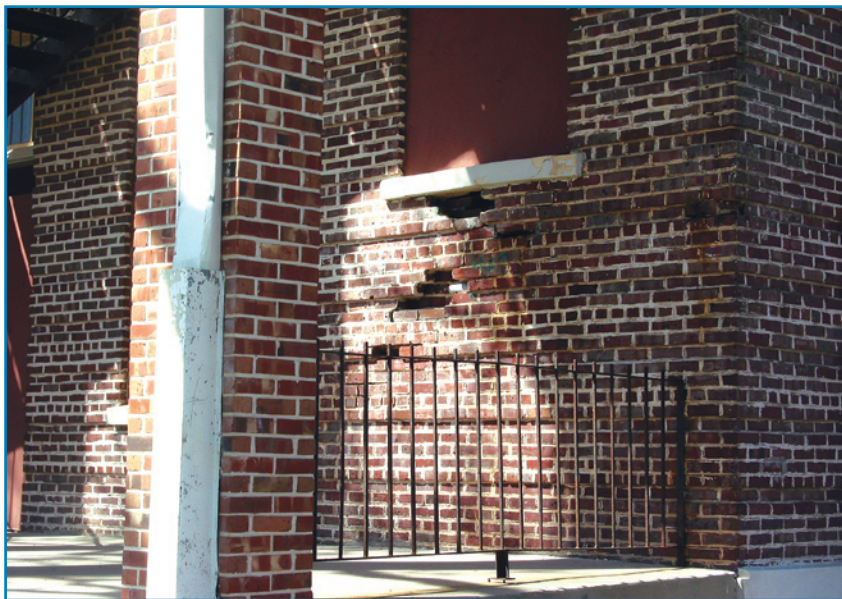
The exterior brick veneer walls at the Pass Christian Middle School and at St. Stanislaus cracked and separated from the wall framing under the impact of storm surge (see Figure 4-26). This kind of damage usually results from a failure of brick ties that did not manage to hold the brick in place. In many cases these attachments can corrode and allow the brick veneer to move under lateral pressure. Such damage allows the penetration of water into the interior, where additional damage to building contents is inevitable.

Figure 4-26:
Cracked brick veneer at
St. Stanislaus High School

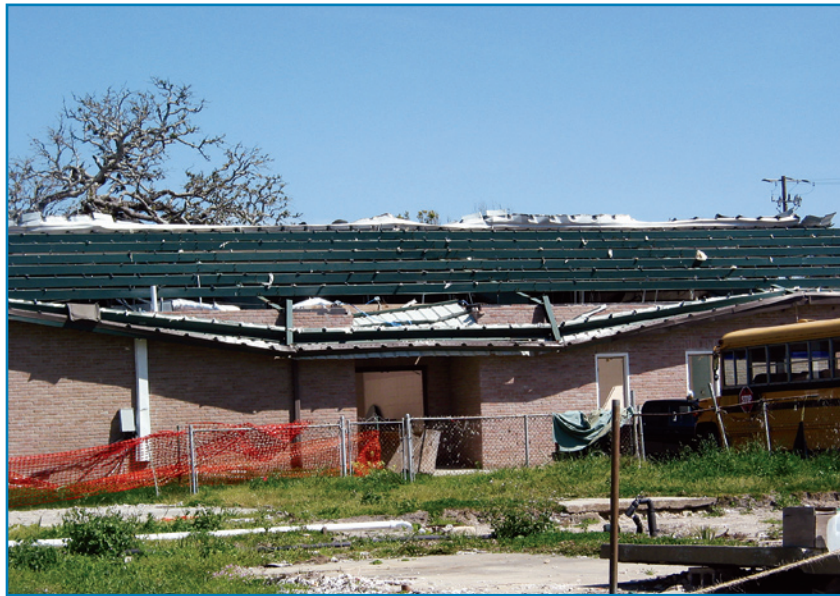
Figure 4-27:
Metal roof covering peeled
away at a St. Stanislaus
campus building

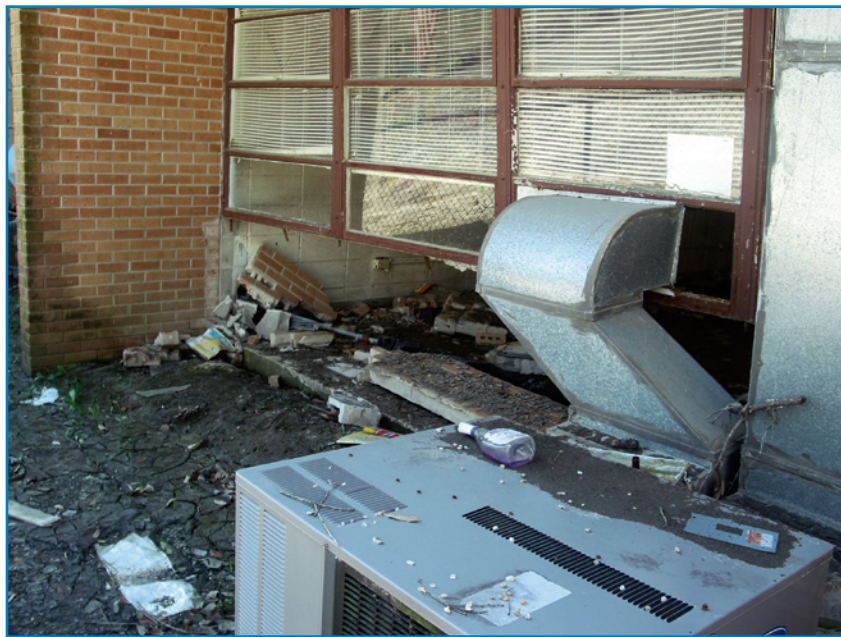
Figure 4-28:
Damaged HVAC unit
at Charles B. Murphy
Elementary School

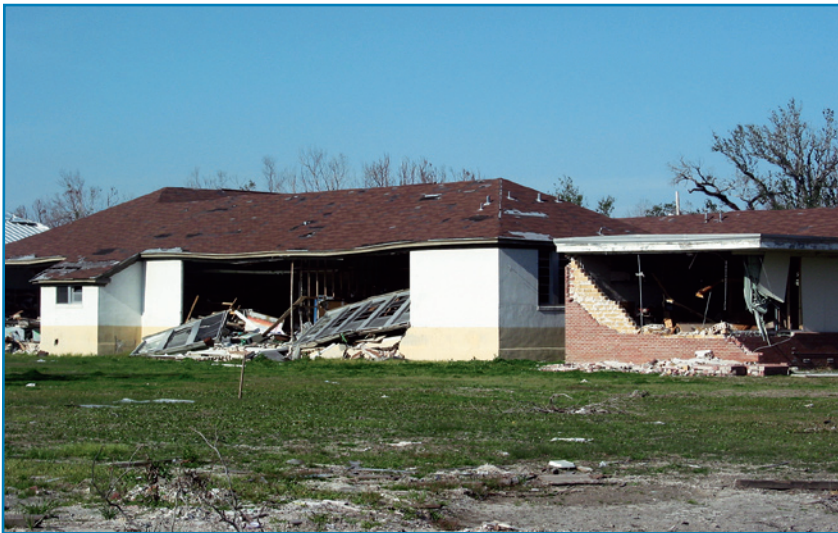
The majority of interior walls were constructed of un-reinforced concrete masonry. Portions of these walls and some exterior non-load-bearing walls at Charles P. Murphy Elementary School were knocked down by the storm surge (see Figures 4-29 and 4-30). If the buildings had been occupied during the storm, people could have easily been injured by falling debris. Although many of these walls are used as partitions and are consequently not load-bearing, their mass poses a threat to life and property should they collapse.

Figure 4-29:
Damaged non-load-bearing walls at Charles B. Murphy Elementary School

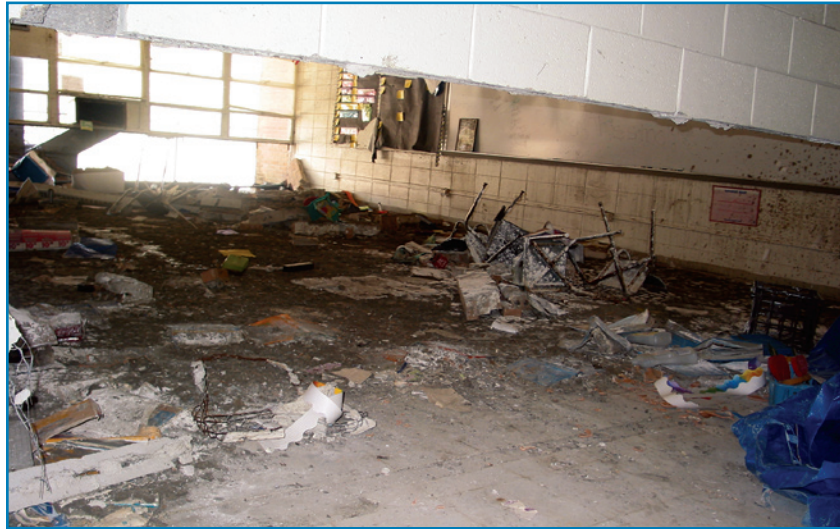
Figure 4-30:
Interior damage at Charles
B. Murphy Elementary
School

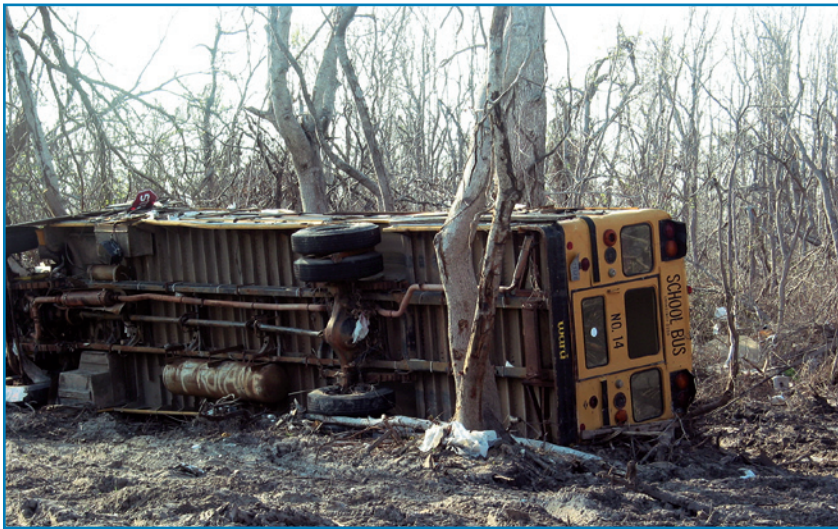
Figure 4-31:
School bus washed away
by the storm surge

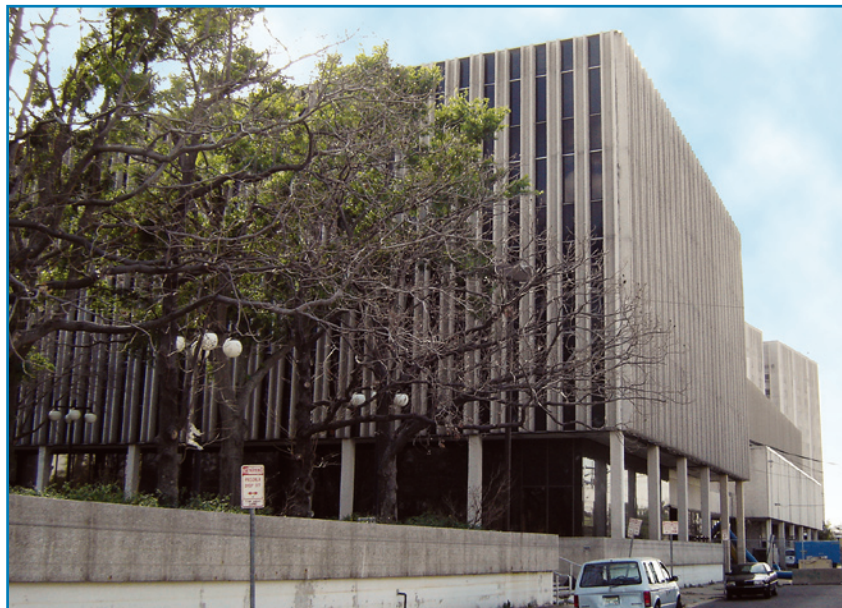
Figure 4-34:
New Orleans Police
Department Headquarters

The headquarters of the New Orleans Police Department had approximately 2- to 3-foot deep water on the first floor, and a completely flooded basement (see Figure 4-34). The surrounding areas were also under water, isolating the facility and preventing its normal operation. All operations had to be transferred to other police facilities in the city.

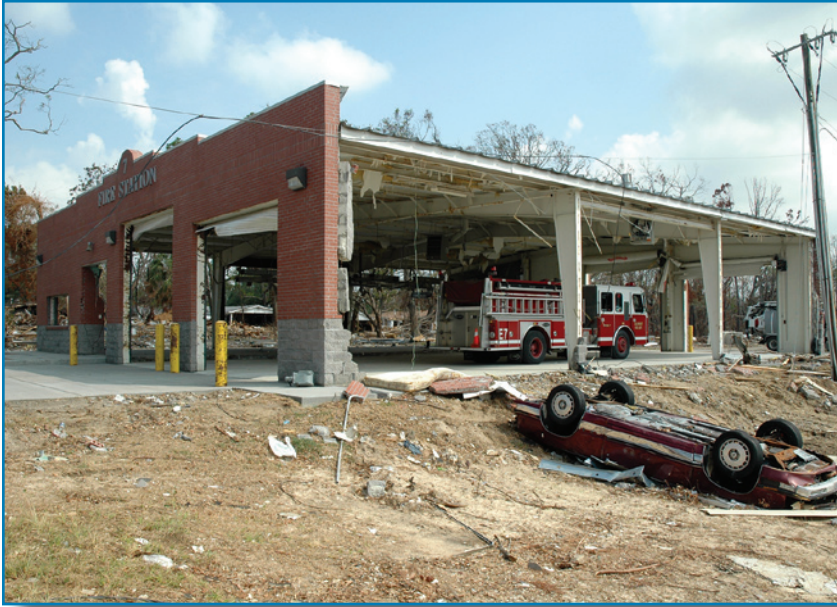
Figure 4-40:
Exterior walls on the
Gulfport Fire Station #7
washed away by the
storm surge

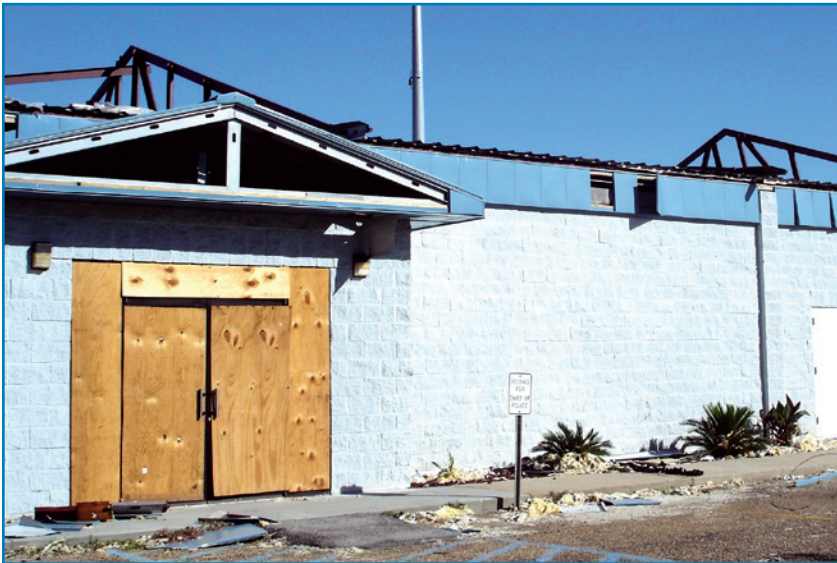
Figure 4-41:
Longbeach Police Station

Longbeach Police Station sustained heavy damage to its roof trusses, metal roof, and siding that allowed wind and rainwater to saturate the interior of the building. The police officers had to scramble to evacuate the prisoners and valuable records before they abandoned the building in the middle of the storm (see Figure 4-41).

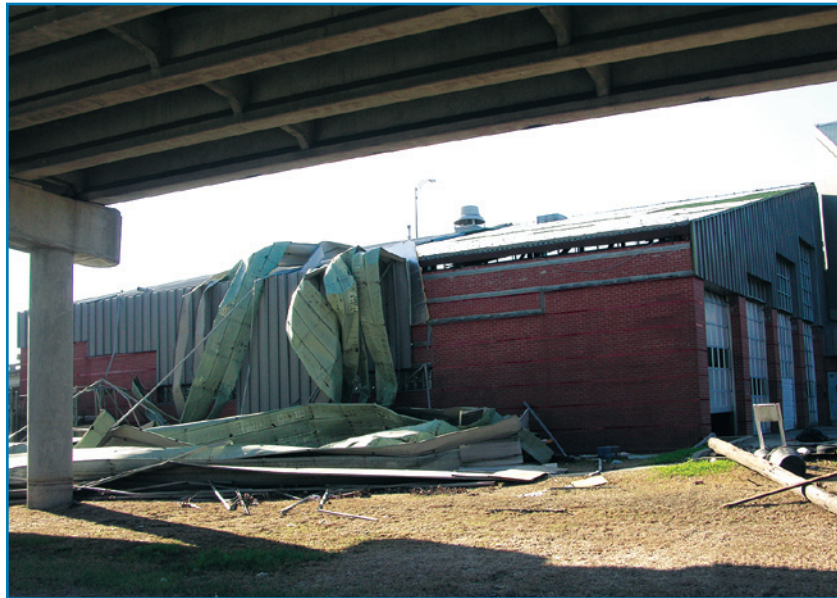
Figure 4-42:
Metal roof and wall
panels peeled off the Third
District Fire Station in New
Orleans

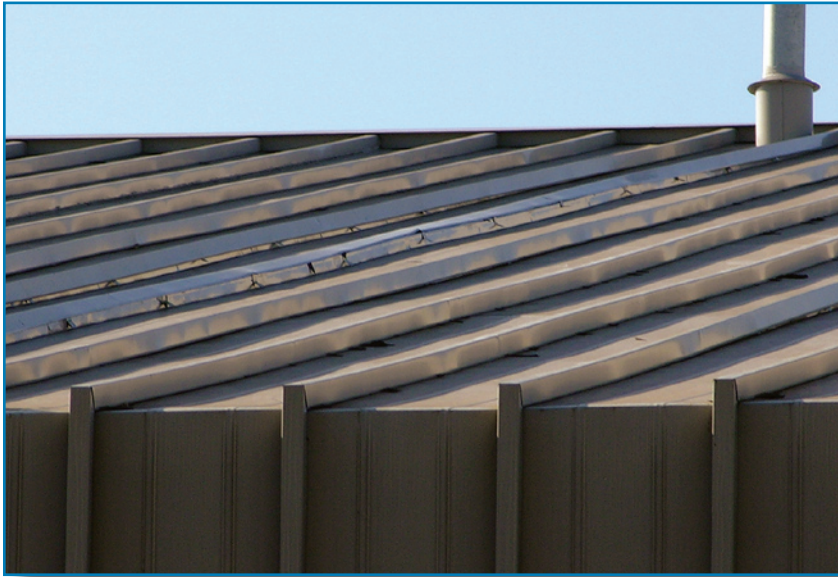
Figure 4-43:
Lifted batten covers on
Third District Fire Station
metal roof

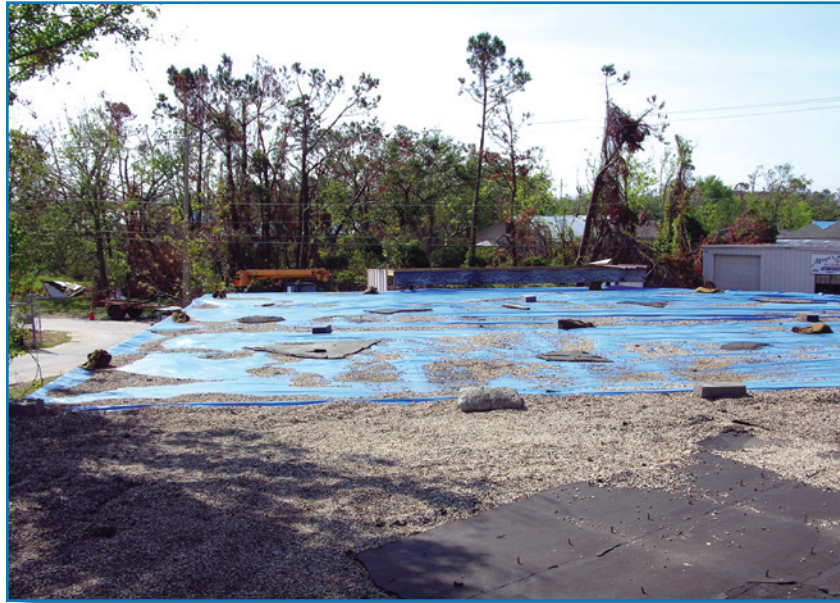
Figure 4-44:
Roof damage at Hancock
County EOC

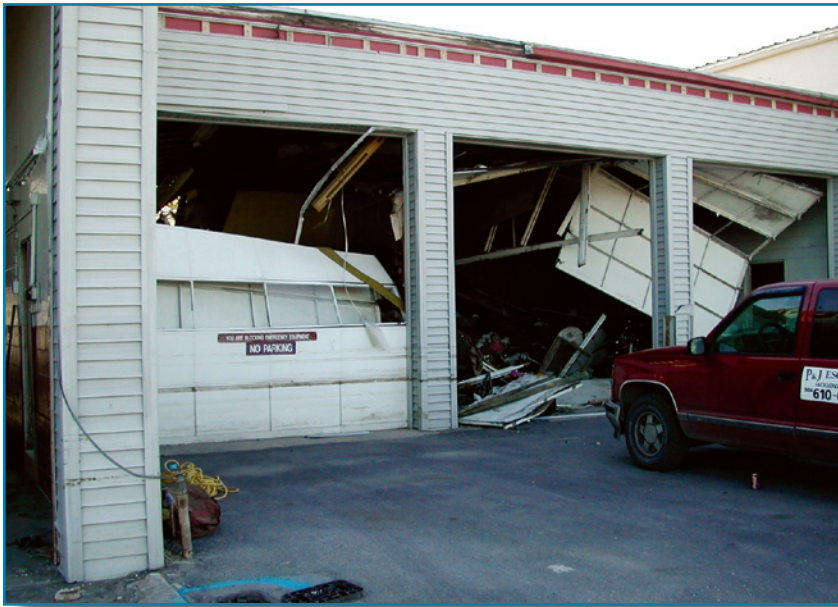
Fire stations are especially susceptible to breaches of the building envelope, because of their large sectional and rolling doors that are usually not strong enough to resist wind forces, and even less so the hydrodynamic forces of storm surge. The apparatus bay doors failed in many fire stations affected by flooding. (see Figures 4-39 and 4-45).

Figure 4-45:
Damaged apparatus bay
doors at Port Sulphur
Volunteer Fire Department.

All doors and windows can also be replaced with modern, impact-resistant systems that would reduce the chances of building pressurization and rainwater infiltration, which resulted in heavy losses to equipment and contents during Katrina. Rooftop units that were blown off and damaged the building envelope by puncturing the roof covering should be securely anchored to prevent such damage in the future.

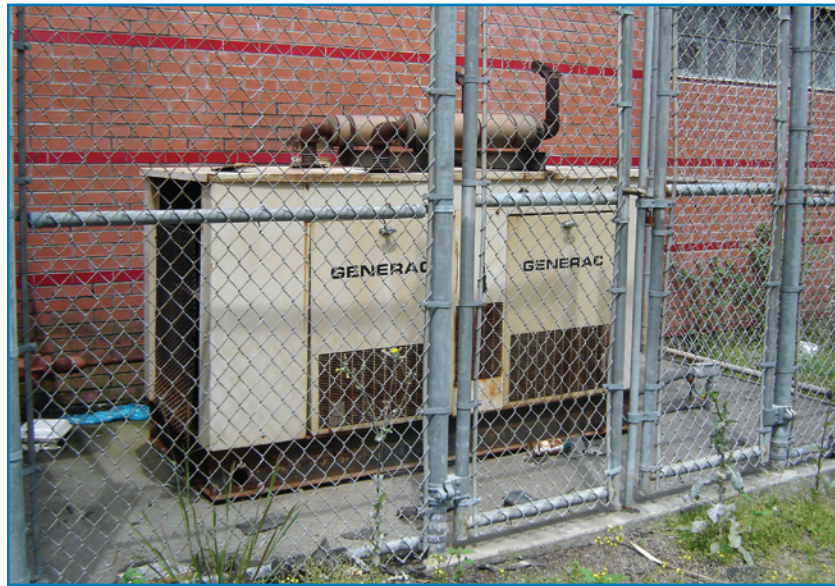
Figure 4-47:
Generator mounted at
grade level damaged by
flooding

The need to provide a back-up generator at a safe and elevated location is confirmed by the experiences during Hurricane Katrina. Many facilities were without power because of the low elevation and subsequent flooding of their generators. Jackson County EOC had its emergency power station elevated and protected in a separate enclosure, which allowed the facility to operate without interruption (see Figure 4-48).

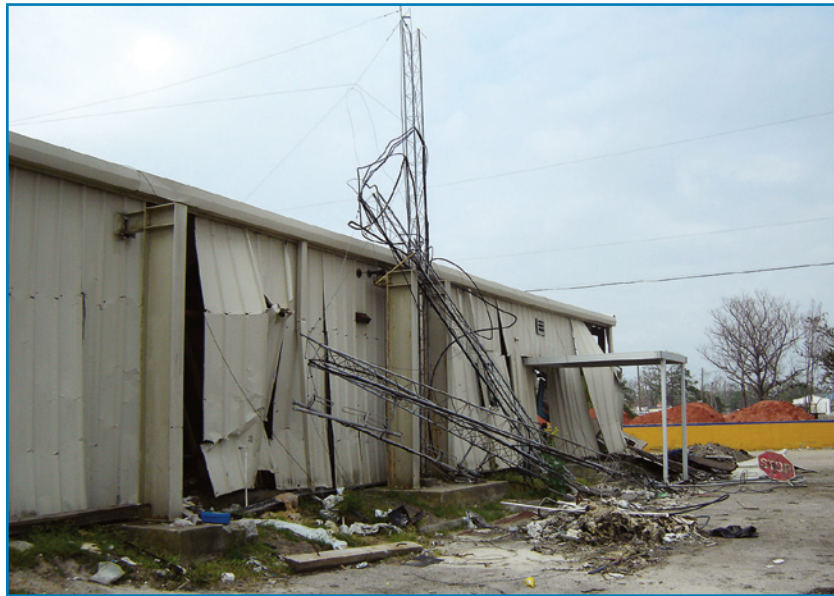
Figure 4-49:
Broken communications
masts at Pass Christian
Police Station
