U.S.-Canada Power System Outage Task Force

**Interim Report:
Causes of the
August 14th Blackout
in the
United States and Canada**

November 2003

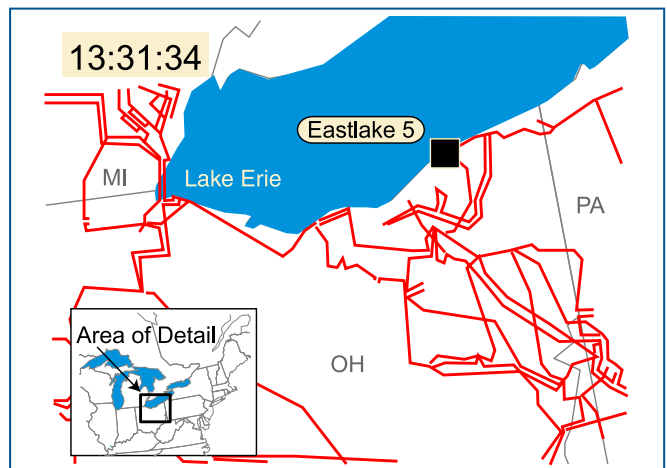
Figure 4.3. Eastlake Unit 5

system was consuming so much reactive power that it was a net importer, bringing in about 132 MVAR.

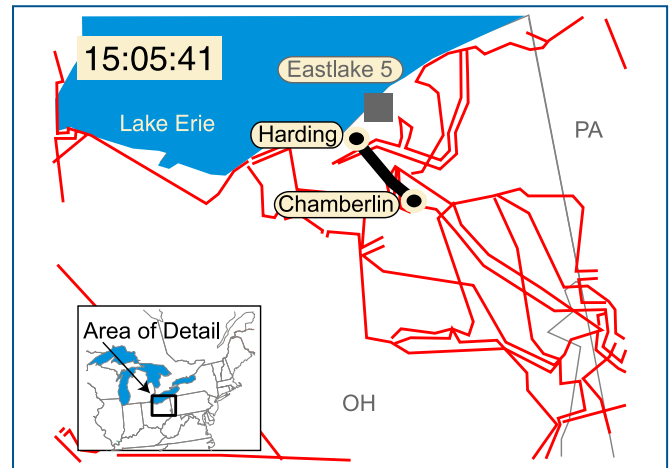
Figure 4.8. Harding-Chamberlin 345-kV Line

line's status change, this was presented to MISO operators as breaker status changes rather than a line failure. Because their EMS system topology processor had not yet been linked to recognize line failures, it did not connect the breaker information to the loss of a transmission line. Thus, MISO's operators did not recognize the Harding-Chamberlin trip as a significant contingency event and could not advise FE regarding the event or its consequences. Further, without its state estimator and associated contingency analyses, MISO was unable to identify potential overloads that would occur due to various line or equipment outages. Accordingly, when the Harding-Chamberlin 345-kV line tripped at 15:05 EDT, the state estimator did not produce results and could not predict an overload if the Hanna-Juniper 345-kV line were to fail.²⁵

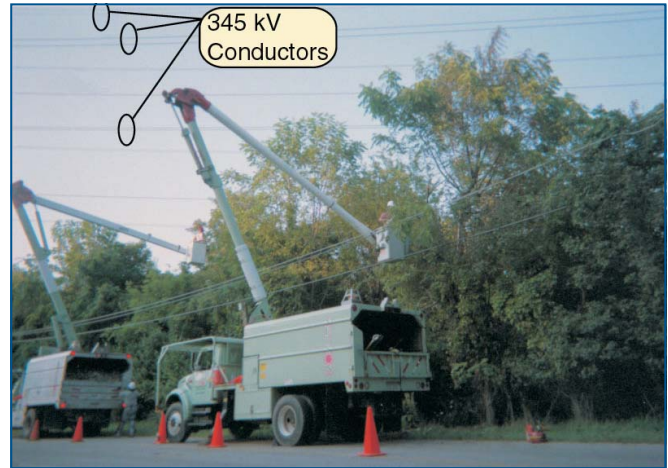
Figure 4.10. Cause of the Hanna-Juniper Line Loss

This August 14 photo shows the tree that caused the loss of the Hanna-Juniper line (tallest tree in photo). Other 345-kV conductors and shield wires can be seen in the background. Photo by Nelson Tree.

This combination of events on August 14 across much of Ohio and Indiana caused transmission lines to heat and sag. If a tree had grown into a power line's designed clearance area, then a tree/line contact was more likely, though not inevitable. An outage on one line would increase power flows on related lines, causing them to be loaded higher, heat further, and sag lower.

Hanna-Juniper was loaded at 87.5% of its normal and emergency rating when it tripped. With this line open, almost 1,000 MVA had to find a new path to reach its load in Cleveland. Loading on the remaining two 345-kV lines increased, with Star-Juniper taking the bulk of the power. This caused Star-South Canton's loading to rise above its normal but within its emergency rating and pushed more power onto the 138-kV system. Flows west into Michigan decreased slightly and voltages declined somewhat in the Cleveland area.

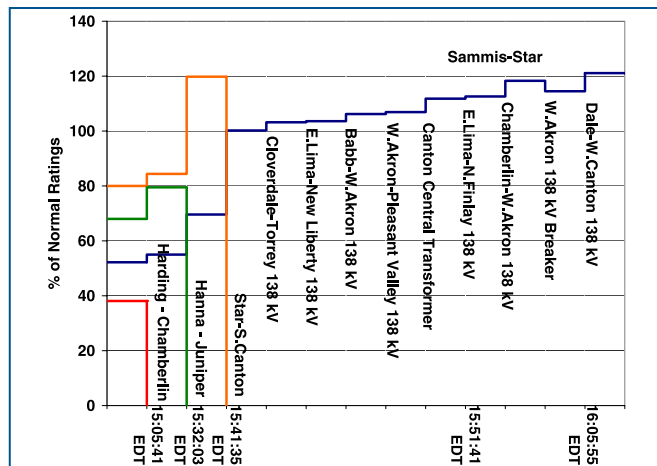
Figure 4.12. Cumulative Effects of Sequential Outages on Remaining 345-kV Lines

According to extensive investigation team modeling, there were no contingency limit violations as of 15:05 EDT prior to the loss of the Chamberlin-Harding 345-kV line. Figure 4.12 shows the line loadings estimated by investigation team modeling as the 345-kV lines in northeast Ohio began to trip. Showing line loadings on the 345-kV lines as a percent of normal rating, it tracks how the loading on each line increased as each subsequent 345-kV and 138-kV line tripped out of service between 15:05 EDT (Harding-Chamberlin, the first line above to stair-step down) and 16:06 EDT (Dale-West Canton). As the graph shows, none of the 345- or 138-kV lines exceeded their normal ratings until after the combined trips of Harding-Chamberlin and Hanna-Juniper. But immediately after the second line was lost, Star-South Canton's loading jumped from an estimated 82% of normal to 120% of normal (which was still below its emergency rating) and remained at the 120% level for 10 minutes before tripping out. To the right, the graph shows the effects of the 138-kV line failures (discussed in the next phase) upon the two remaining 345-kV lines—i.e., Sammis-Star's loading increased steadily above 100% with each succeeding 138-kV line lost.

Operationally, once FE's system entered an N-1 contingency violation state, any facility loss beyond that pushed them farther into violation and into a more unreliable state. After loss of the Harding-Chamberlin line, to avoid violating NERC criteria, FE needed to reduce loading on these three lines within 30 minutes such that no single contingency would violate an emergency limit; that is, to restore the system to a reliable operating mode.
