Safety Bulletin

U.S. Chemical Safety and Hazard Investigation Board

No. 2005-03-B | January 2006

EXPLOSION AT ASCO: DANGERS OF FLAMMABLE GAS ACCUMULATION

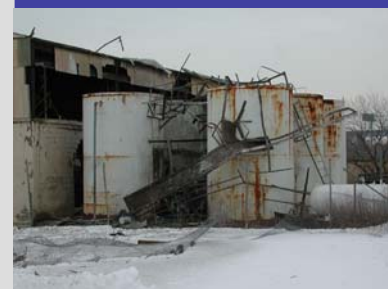
Figure 1. Damage to the north side of the ASCO facility.*

*Building 46 and debris around the decanting water tanks.

The shed was completely destroyed. Its walls were highly fragmented, essentially reduced to splinters. Debris was hurled as far as 450 feet from the site. The explosion blew two large holes in the masonry wall of Building 46, toppling several cylinder manifolds and scattering acetylene cylinders across the filling room floor. Windows were shattered and several doors were blown into the building or knocked off their hinges or rails. No fire occurred after the explosion.

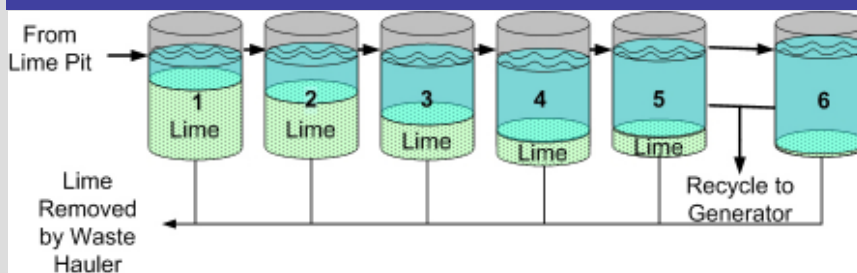
Figure 4. Decanting Tank Arrangement.

The ASCO facility included a wooden shed constructed in-between the six decant tanks. It was approximately 15 feet wide by 28 feet long and had a roof that sloped from 8 feet to 6 feet in height. The shed was constructed using the tank shells to make up portions of the walls, as shown in Figure 2. The concrete pad that supported the tanks served as the shed floor.

The shed housed two electrically driven pumps: one to off-load settled lime sludge from the decanting tanks and the other to recycle the decanted water to the generator. It also contained electrical breakers, pump control switches and an overhead fluorescent light. The shed was heated by a wall-mounted propane space heater that prevented freezing of the pumps and associated piping. The shed had no mechanical ventilation.

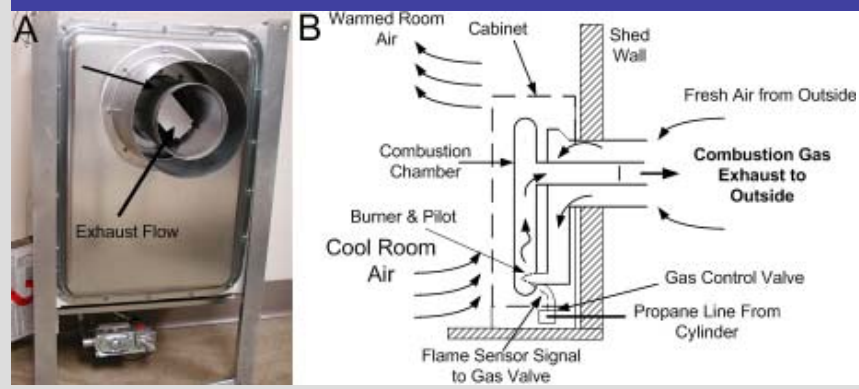
Figure 5. A. An exemplar of the ASCO shed heater (same make and model).
B. Schematic diagram of the heater.

A direct-vent propane space heater rated for residential use was mounted on the wall of the shed (Figure 5).⁵ The heater drew in outside air for combustion through the outer of two concentric pipes. Exhaust gases exited through the inner pipe. The combustion chamber was completely sealed from the shed interior. The air in the shed did not come in contact with the flame or the products of combustion.

The heater warmed the room by natural convection.⁶ The outer skin of the combustion chamber was approximately 1100°F during operation. The heater was also equipped with an automatic shut-off valve designed to stop the supply of propane to the combustion chamber if the pilot light went out. Testing after the incident found that this automatic shut-off valve functioned as designed.

Due to the extremely cold weather and the lack of insulation in the shed, the heater was likely running or frequently cycling on and off at the time of the incident. Acetylene is reported to autoignite¹⁴ at 580°F, well below the heater’s combustion chamber surface temperature of 1100°F.

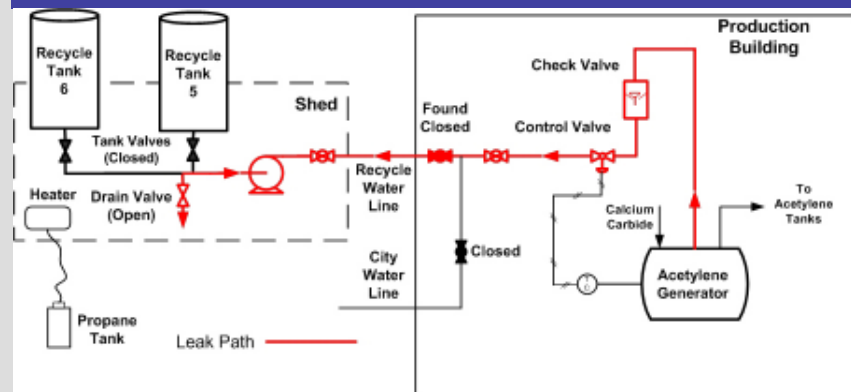
Figure 6. Simplified acetylene system flow diagram. The red line shows the leak path of acetylene from the generator into shed.¹¹

Acetylene produced in the generator flowed back past the check valve through the recycled water line into the shed by way of the open drain valve (Figures 6 and 7). The acetylene gas accumulated inside the shed, ignited, and exploded.

¹¹ The CSB could not positively ascertain the position of the valve labeled "Found Closed." The plant manager stated after the incident that he closed "some" valves immediately after the explosion, one of which may have been the valve labeled "Found Closed." This valve was later tested at OSHA's Utah laboratory. The testing confirmed that this valve leaked significantly in the closed position.

It was normal practice at ASCO to leave the decant water line open at night to drain to the shed floor through a low-point valve. This protected the outside section of the line from damage due to freezing during cold weather. The open valve created a potential pathway for acetylene to flow from the generator into the shed; an enclosed space that was not designed for the presence of

acetylene. This potential hazard was not recognized by ASCO.

- Examine lines connected to acetylene-containing equipment and piping to identify vent and drain points that could create hazards in the event of an acetylene backflow or leak. Relocate all such vents and drains to safe locations, preferably to the outside.

- Provide an engineered, positive means of isolation in addition to check valves, to ensure that backflow of explosive gases cannot occur.

At ASCO the check valve was relied upon to prevent backflow. An example of positive isolation is a double-block valve arrangement equipped with a bleed valve venting to a safe location.

Improve isolation on acetylene generator water lines by incorporating a double-block-and-bleed with a vent to a safe location, or other isolation means of comparable effectiveness. (2005-03-I-NJ-R1)
