**OFFICE OF SURFACE MINING  
REPORT ON  
SEEPAGE BARRIER STABILITY**

**OFFICE OF SURFACE MINING (OSM)  
REPORT ON  
SEEPAGE BARRIER STABILITY**

**PREPARED IN RESPONSE TO THE OCTOBER 11, 2000,  
IMPOUNDMENT BREAKTHROUGH  
AT  
MARTIN COUNTY COAL CORPORATION (MCCC)  
BIG BRANCH SLURRY IMPOUNDMENT**

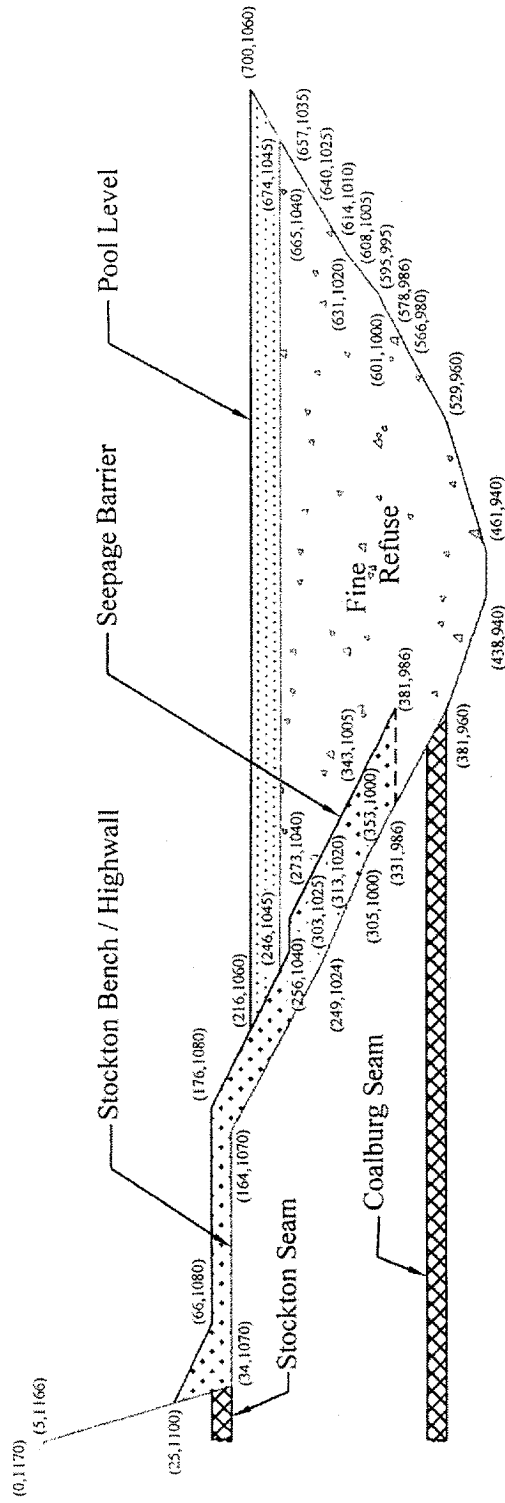
Figure 1.

Analyses were run for two separate seepage barrier slope configurations (Figures 1 and 2) under various fine refuse/water levels. A pool level 14 feet above the slurry was assumed for the initial configuration when the slurry was at 986 feet mean sea level (msl) elevation. A pool level of 15 feet above the slurry was assumed for all other configurations (slurry levels of 1,005, 1,025, and 1,045 feet msl elevation). One configuration was based on the designed seepage barrier as represented in the "Impoundment Sealing Plan" dated August 8, 1994. The second configuration was based on the actual constructed slope as represented on drawings contained in the annual certifications for the impoundment and original pre-impoundment surface slope in the area of the breakthrough as shown in the plans.

The analyses for the "Designed" slope configuration indicated minimum FS ranging from 1.3 to 1.5. The configuration for the 1,000-foot pool elevation resulted in a FS of 1.3. All configurations above this level resulted in a minimum safety factor of 1.5.

**MCCC**  
**Seepage Barrier Stability Analysis**  
**Designed Fill Configuration**

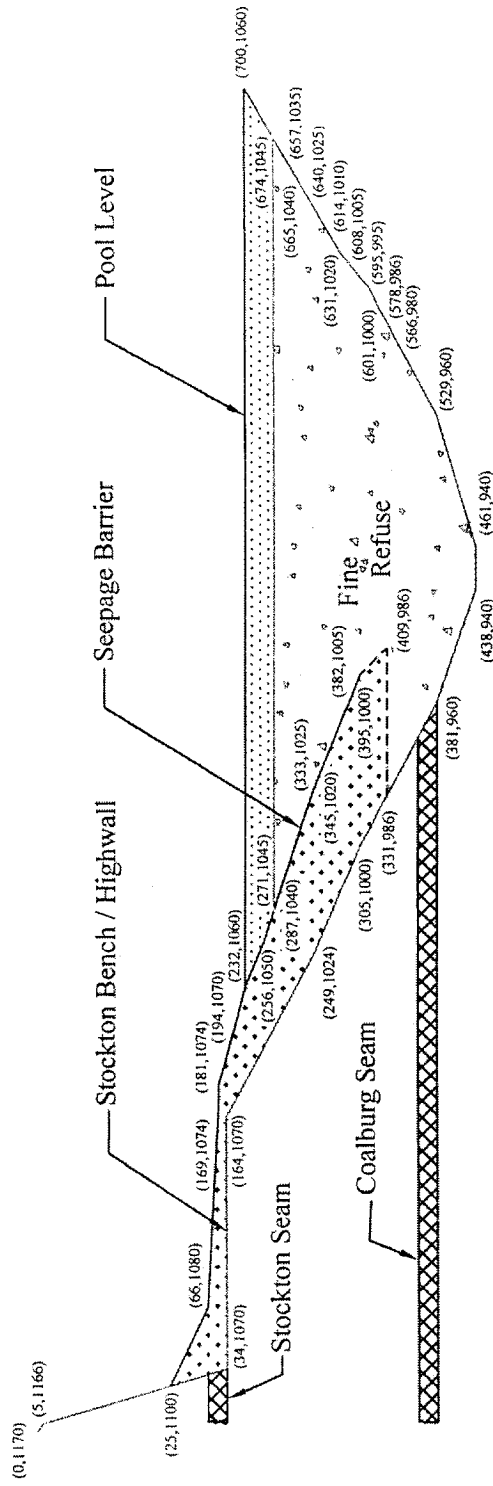
Figure 2.

The analyses for the "Constructed" slope configuration resulted in minimum FS from 1.1 to 2.0. Configurations above the 1,000-foot pool elevation resulted in FS of 1.6 or greater indicating a stable barrier slope.

The 1.1 FS occurred at the 1,000-foot pool elevation level. The corresponding failure surface indicates sloughing of the barrier from just above the 1,000-foot water surface down to the slurry level (approximately 986 feet msl). This would have occurred before slurry was added to the impoundment. If a failure occurred that was so minor as not to be noticed (i.e., not reported by the company and/or noted in the annual certification), it would have been filled as the slurry level was increased. It is not likely that such a failure would have been significant enough to threaten the overall stability of the barrier fill or contribute to the 2000 breakthrough.

**MCCC**  
**Seepage Barrier Stability Analysis**  
**Constructed Fill Configuration**

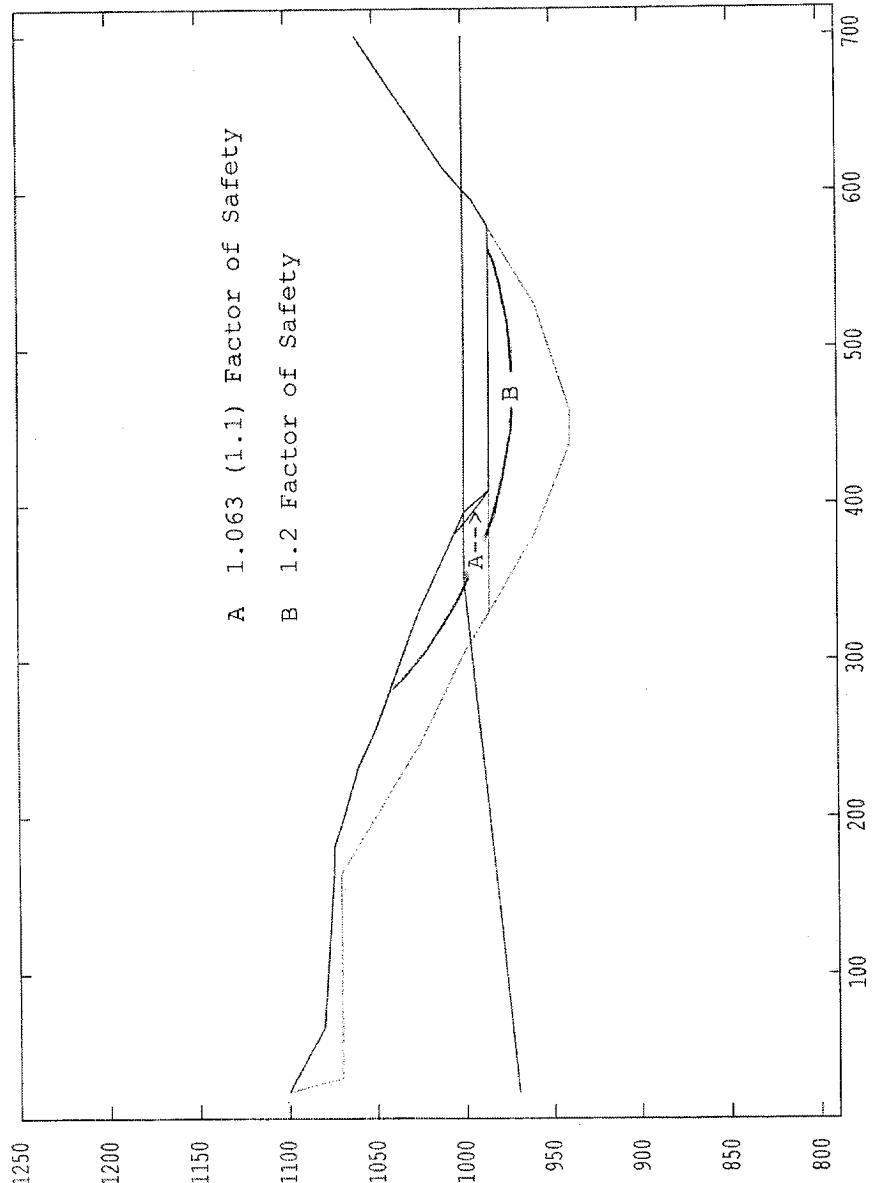
Figure 3.

Critical (minimum)  
Factor of Safety: 1.063

Project: MCCC Seepage Barrier 1000 (Constructed / Unconsolidated Fine Refuse)

Water Level 1000; Fine Refuse Level 986
