REPORT ON OCTOBER 2000 BREAKTHROUGH AT THE BIG BRANCH SLURRY IMPOUNDMENT

1.0 INTRODUCTION

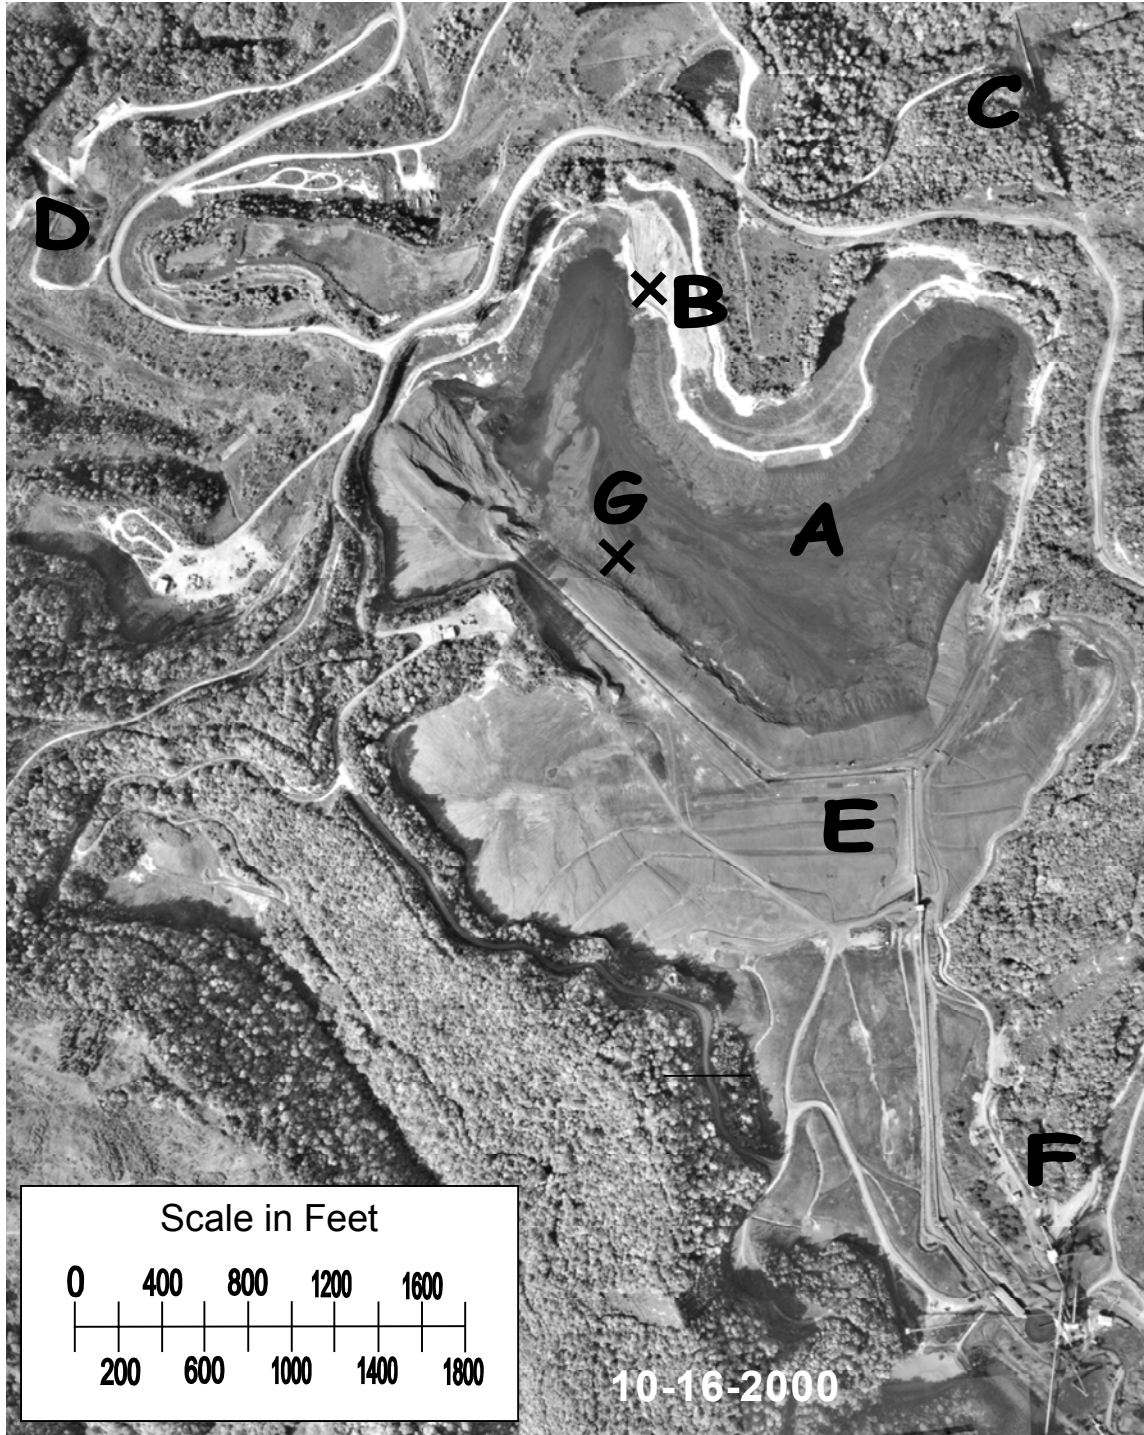
On October 11, 2000, a combination of coal slurry and water from the Martin County Coal Corporation (MCCC) Big Branch slurry impoundment in Martin County, Kentucky, broke through into an underground mine adjacent to the impoundment, consequently discharging into the receiving streams (Figure 1 [Page 2] and Photo 1 [Page 3]). The purpose of this study, performed by the Office of Surface Mining (OSM), U.S. Department of the Interior, was to evaluate the conditions and sequence of prior events primarily to determine the probable breakthrough mechanism. Also, OSM evaluated other factors, such as designs and approvals, which could have contributed to the 2000 breakthrough. To achieve this, OSM examined documentary evidence of MCCC's activities in and near the impoundment over a period of 30 years.

Photo 1. Aerial Photograph of Big Branch Slurry Impoundment - October 16, 2000. Source: Photo Science, Inc. A) Impoundment. B) 2000 breakthrough location. C) Number 2 North Mains Portals. D) South Mains Portal. E) Embankment (dam). F) Preparation plant. G) 1994 breakthrough location.

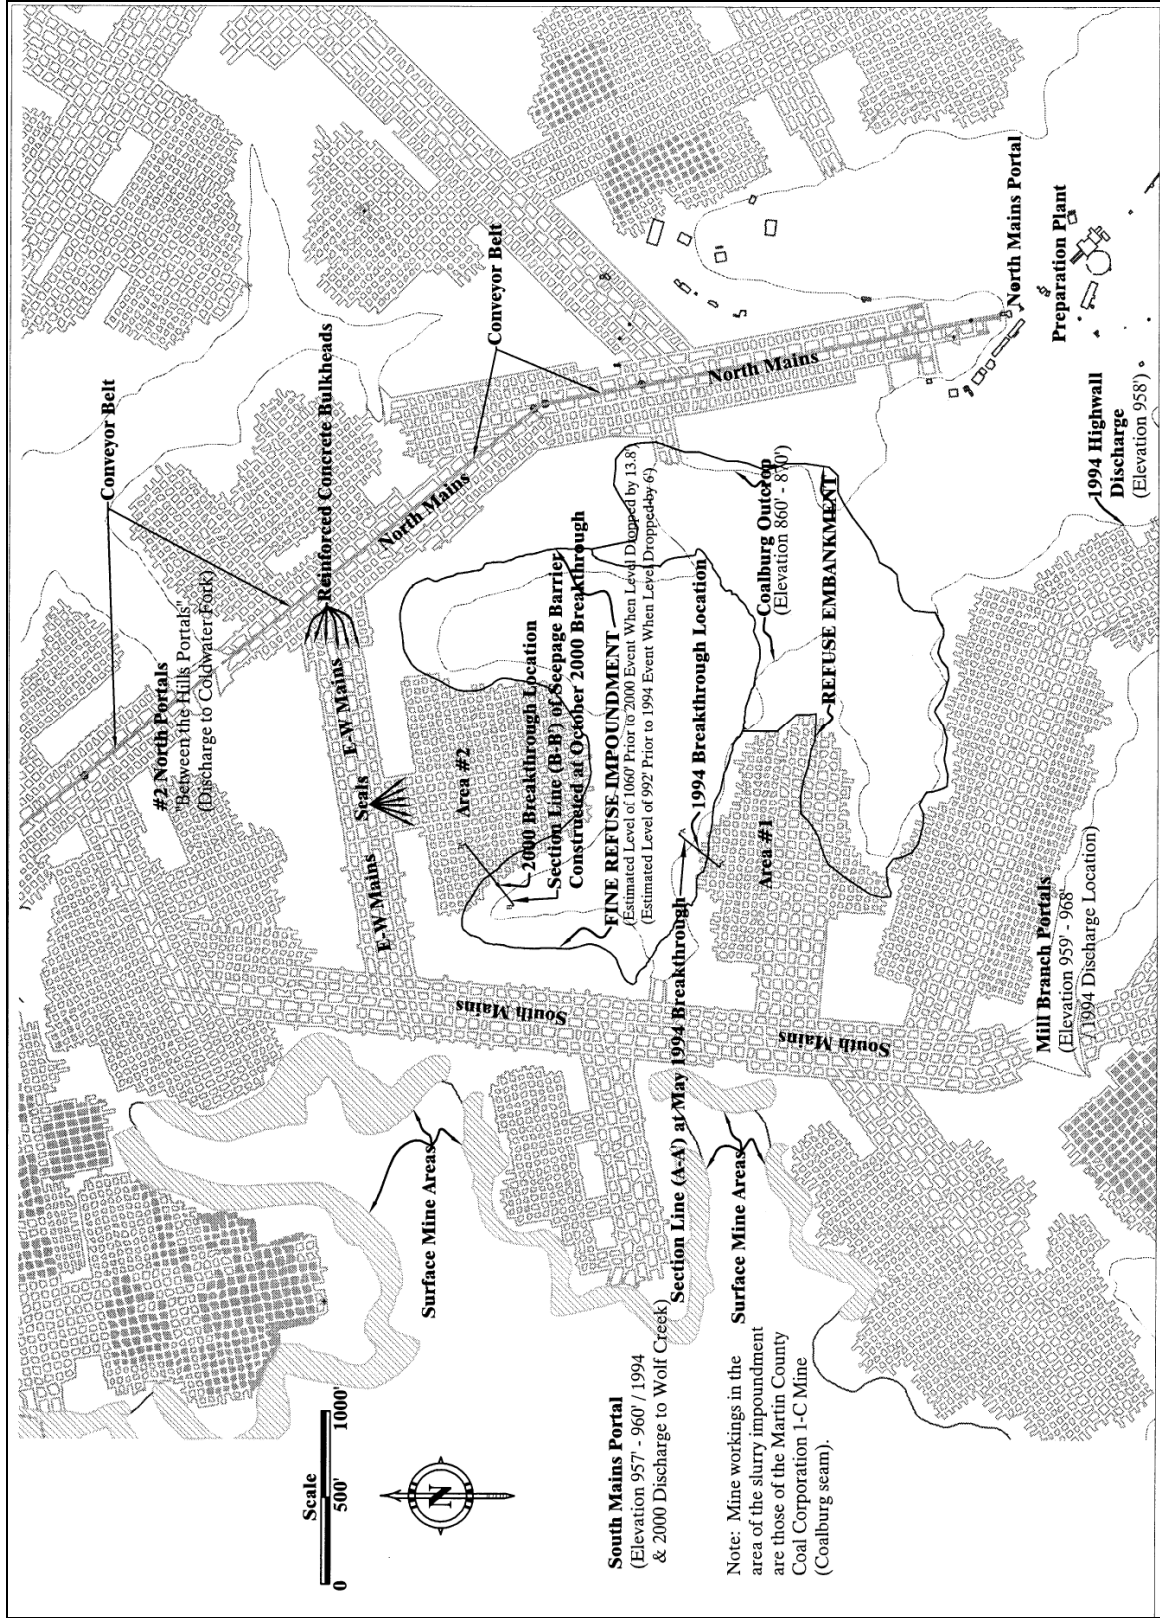
Figure 2. Mine Map.

An estimated 306 million gallons of water and fine coal refuse slurry (hereinafter referred to as slurry) drained from the MCCC impoundment into the adjacent underground mine (Figure 2 [Page 4]; Photos 2 and 3 [Pages 5 and 6]). Approximately 245 million gallons of the water and slurry discharged from the underground mine at the Number 2 North Portals and the South Mains Portal (Photos 4 and 5 [Pages 7 and 8]). The remainder of the slurry was contained in the underground mine. The breakthrough into the underground mine was first noticed about 12:05 a.m. and ended about 4:40 a.m. A detailed chronology of events surrounding the breakthrough is presented in Section 2.3. The discharge from the north portals entered Coldwater Fork, and the discharge from the south portals entered Wolf Creek. This was the second breakthrough event at this impoundment, the first having occurred in May 1994.

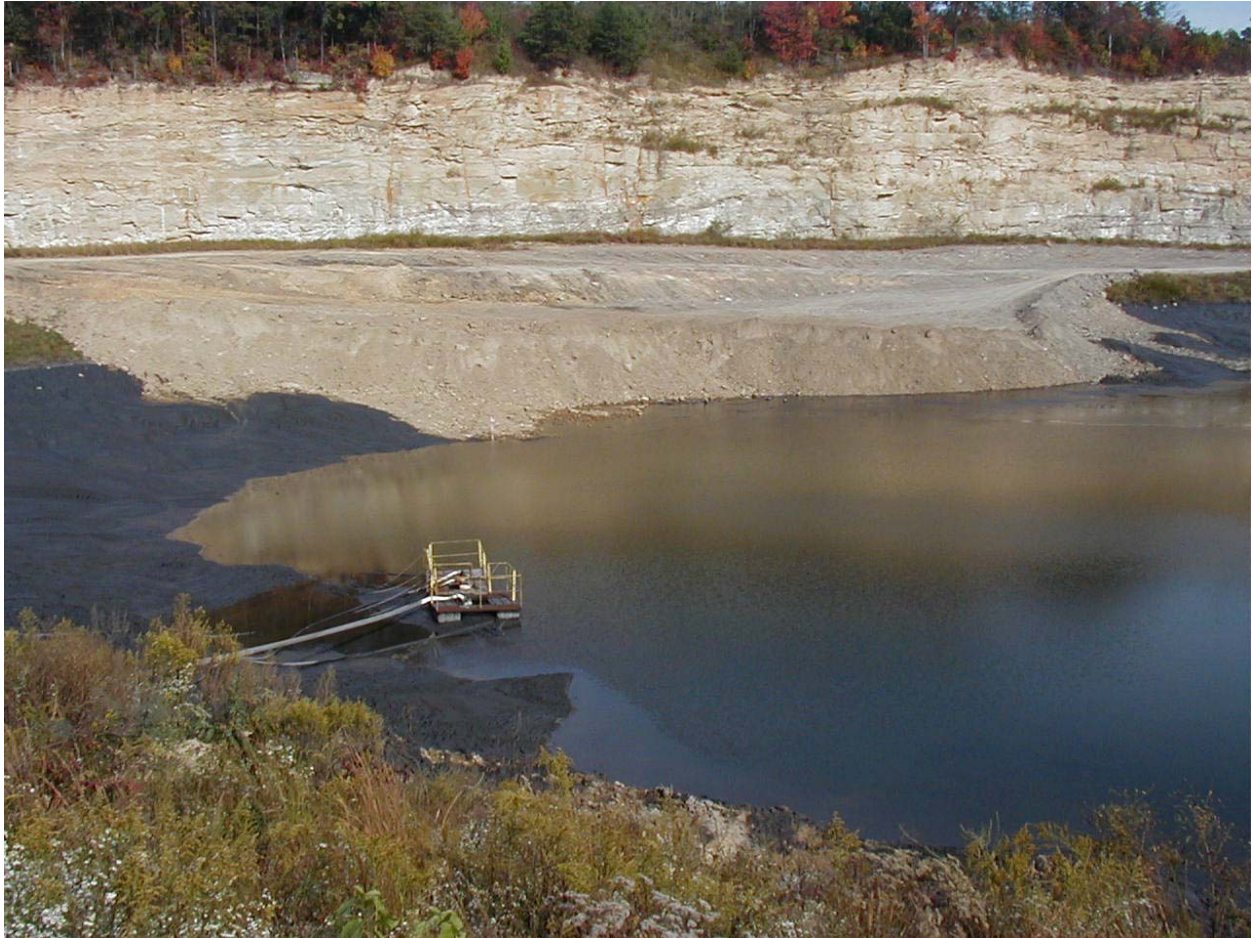
Photo 2. 2000 Breakthrough Area - October 16, 2000. Source: OSM. Pool elevation about 1,060 feet msl prior to breakthrough and 1,046 feet msl after breakthrough. Mine roof elevation 973 feet msl.

Redirecting of the discharge of the fine refuse slurry was not performed. Consequently, approximately 2 feet of water was present against the highly permeable shot sandstone portion of the seepage barrier at the location of the breakthrough. The absence of a fine refuse layer between the water and the shot sandstone in this area made the seepage barrier more permeable than intended. The seepage barrier failed to restrict flow through the barrier into the 1-C Mine, as the approved plan intended.

Martin County Coal Corporation’s failure to follow the approved plan resulted in internal erosion (“piping”) occurring at the location of the breakthrough. Over a period of time, the seepage into this area began to carry sand (weathered material) into the mine opening. As material was carried away, a “pipe” (void) formed and worked its way toward the impoundment. As more material was carried in the mine, a larger seepage path was created allowing more and larger particles to be carried away. This process continued until the void developed close enough to the impoundment that the remaining plug of material failed suddenly, allowing the contents of the impoundment to discharge uncontrolled into the mine.”

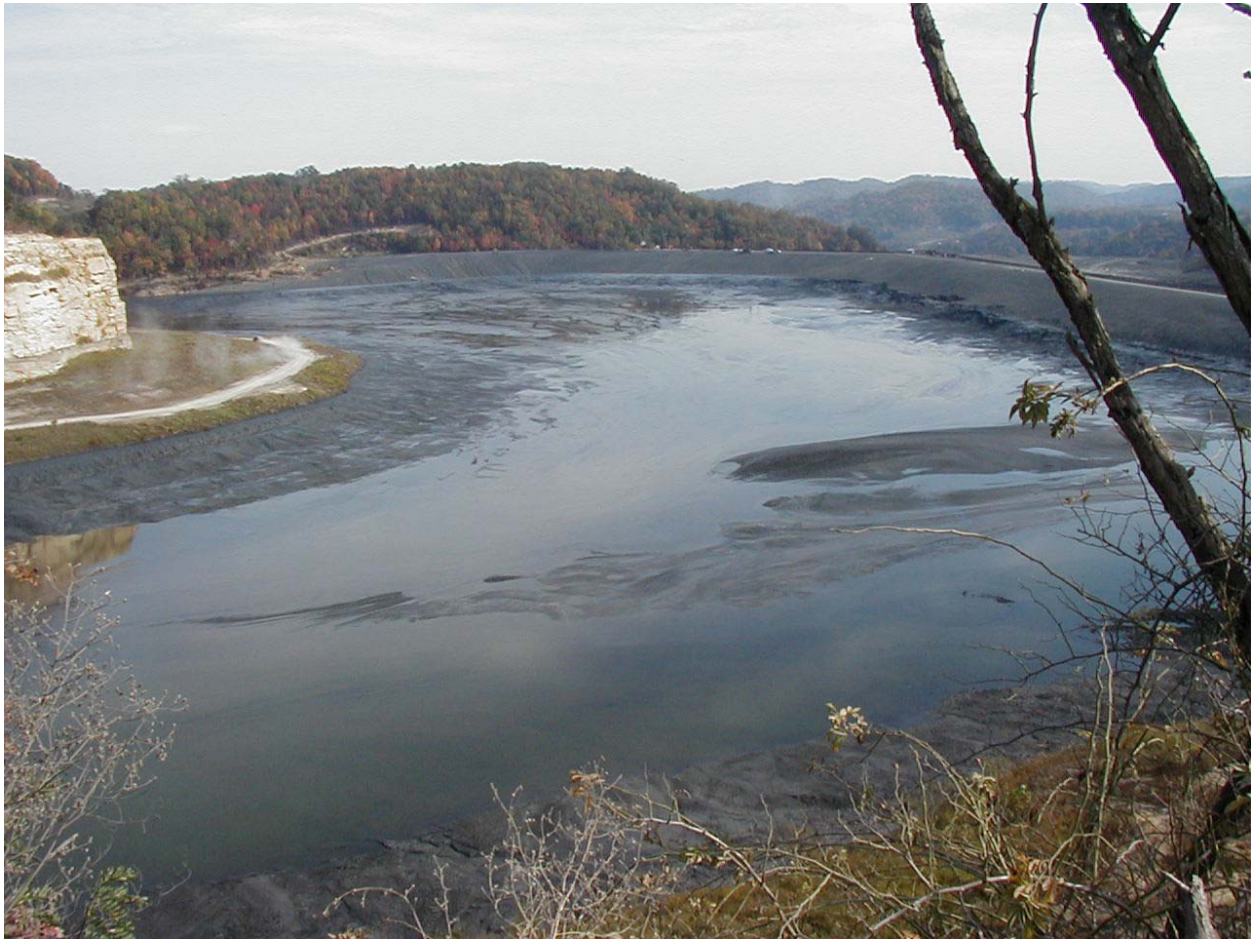
**Photo 3. General View of Impoundment and Embankment - October 16, 2000.
Source: OSM. 2000 breakthrough area to left of photo, out of view.**
