### **3.0 THE IMPOUNDMENT BREAKTHROUGH INVESTIGATION**

#### **3.1 OSM Investigative Approach**

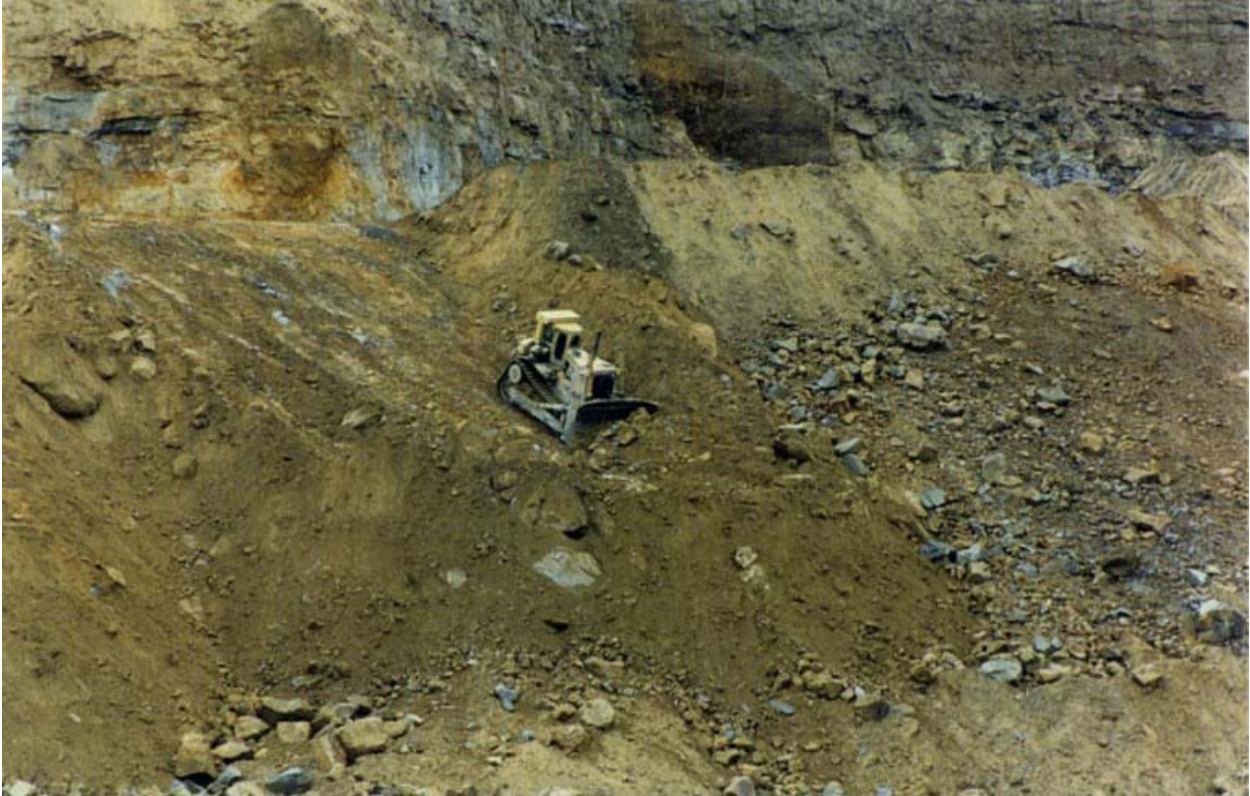
**Photo 9. Construction of Seepage Barrier (Dozer Work) - March 6, 1995. Source: GAI. The work is being conducted at the southwest side of the impoundment.**

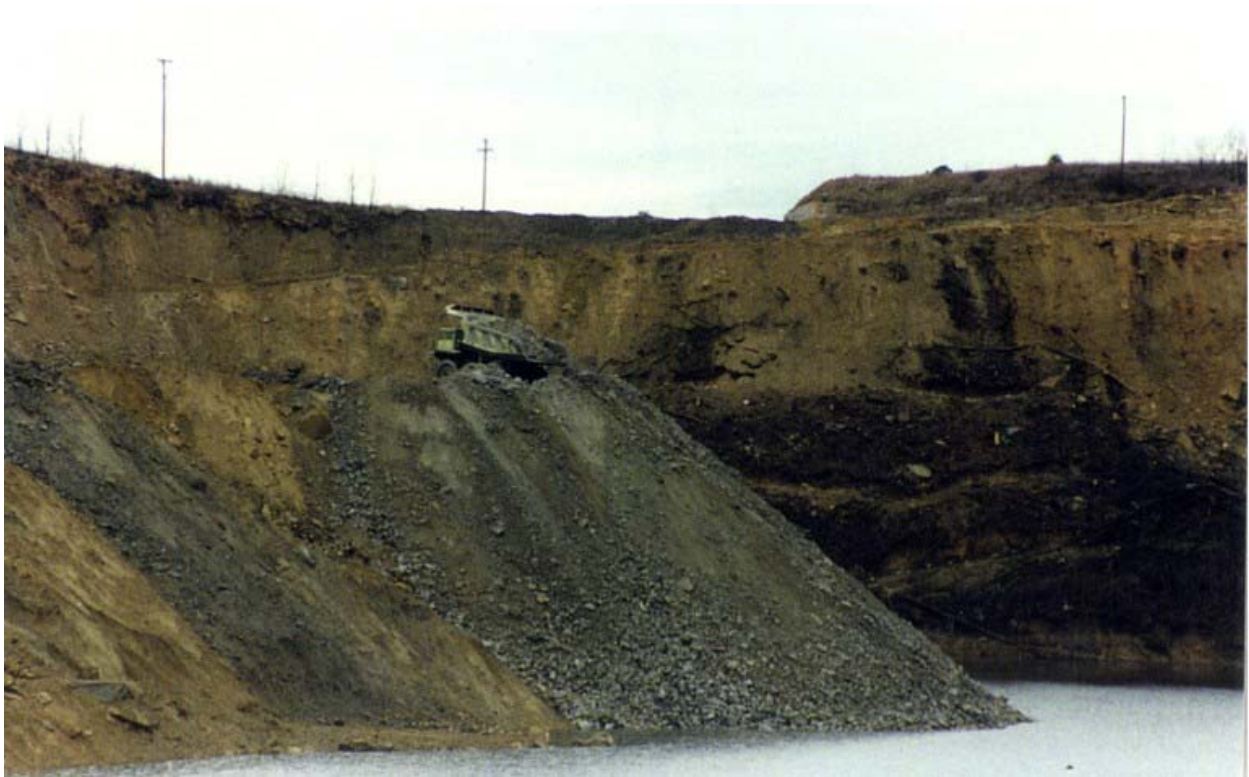
**Photo 10. Construction of Seepage Barrier (End Dumping by Rock Truck) - March 6, 1995. Source: GAI. The work is being conducted at the southwest side of the impoundment.**

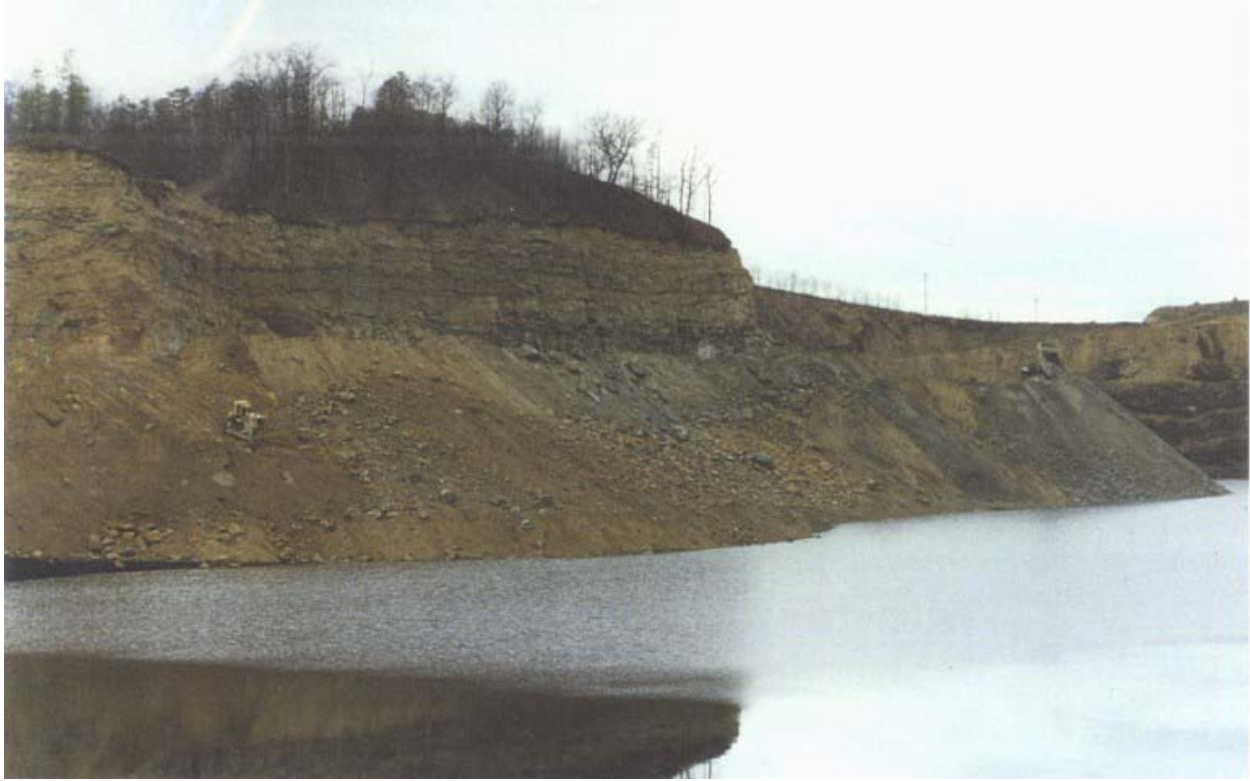
**Photo 11. Construction of Seepage Barrier (Long View of Dozer and Truck) - March 6, 1995. Source: GAI. The work is being conducted at the southwest side of the impoundment. Pool elevation 1,000 feet msl. Mine roof elevation 964 feet msl.**

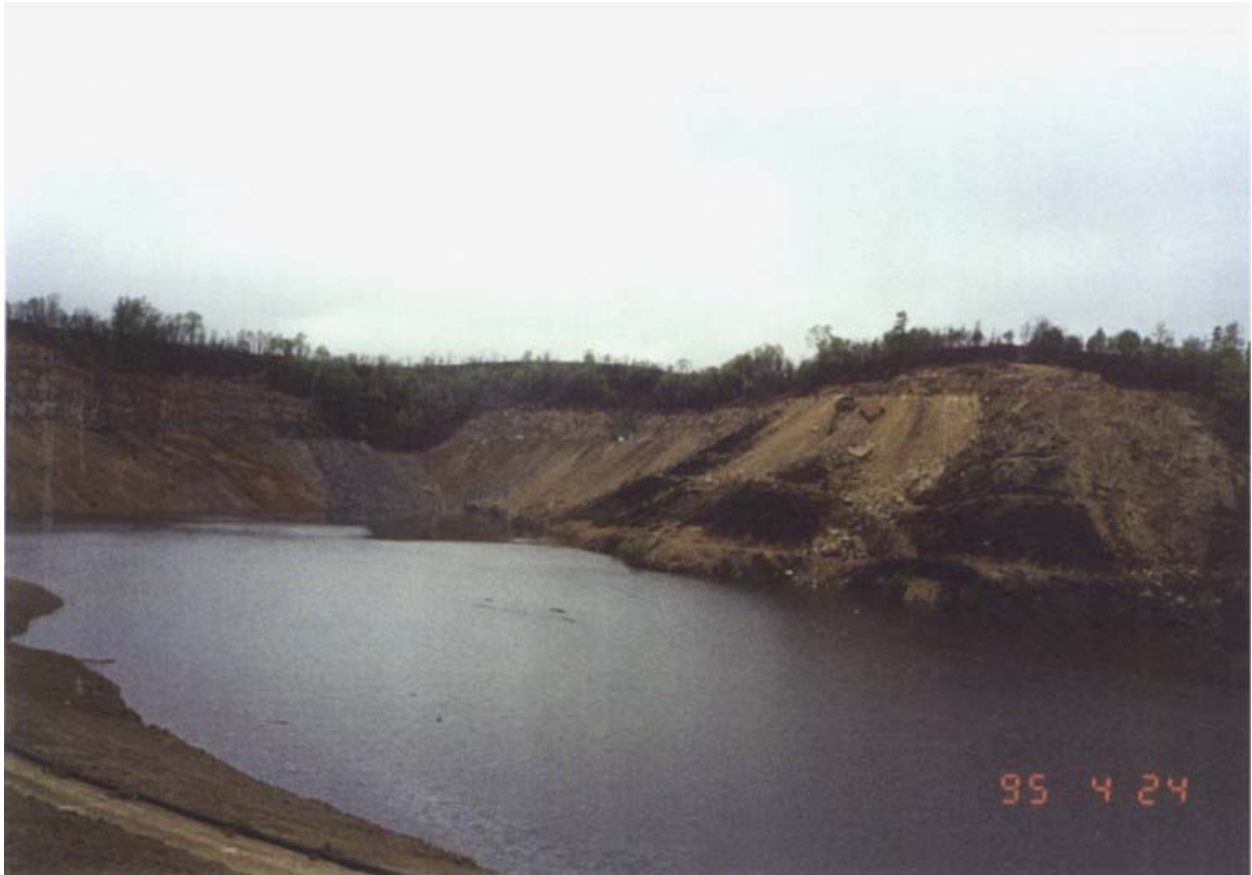
**Photo 12. Seepage Barrier by 2000 Breakthrough (During Construction) - April 24, 1995. Source: GAI. The 2000 breakthrough area is located at the left-center of the photo. Pool elevation 1,000 feet msl. Mine roof elevation 973 feet msl.**

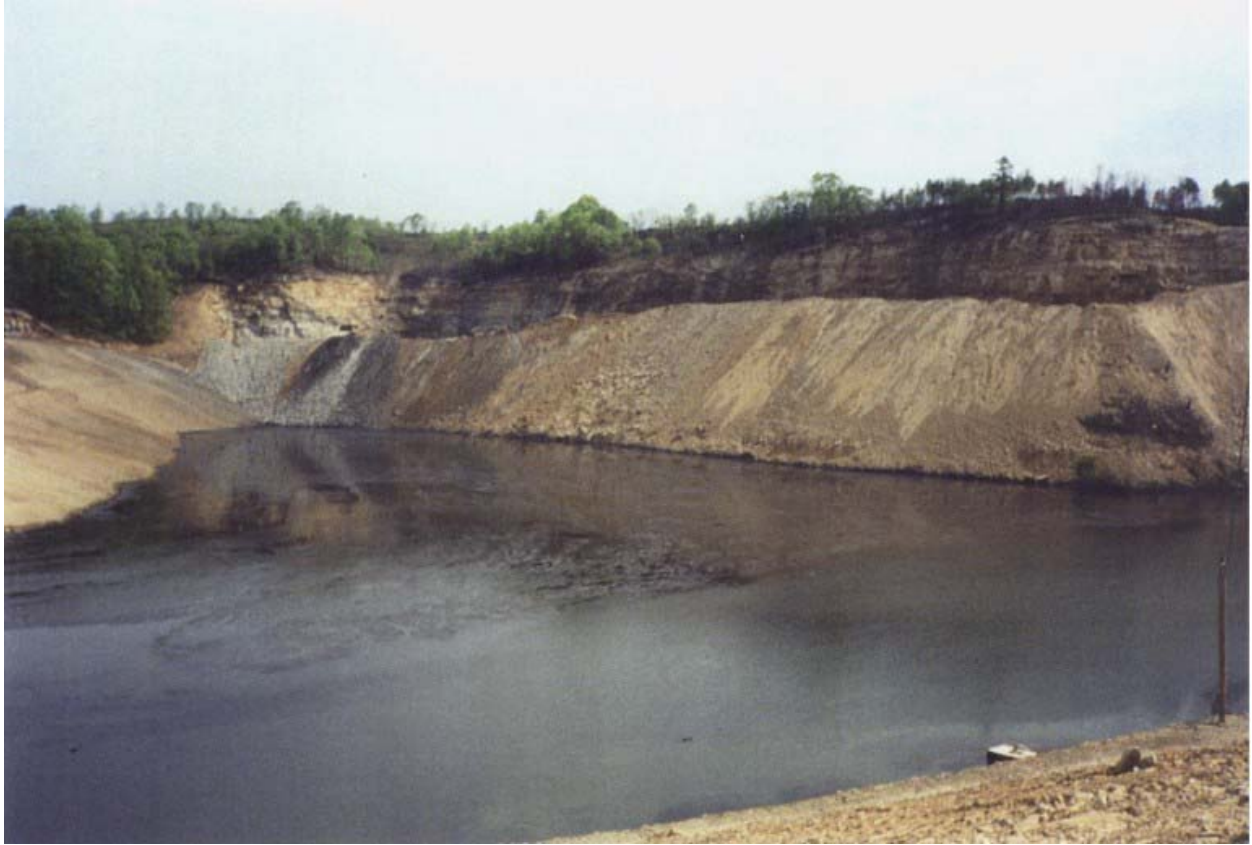
**Photo 13. Seepage Barrier by 2000 Breakthrough (During Construction) - June 8, 1995. Source: GAI. The 2000 breakthrough area is located at the left-center of the photo. Pool elevation 1,001 feet msl. Mine roof elevation 973 feet msl.**

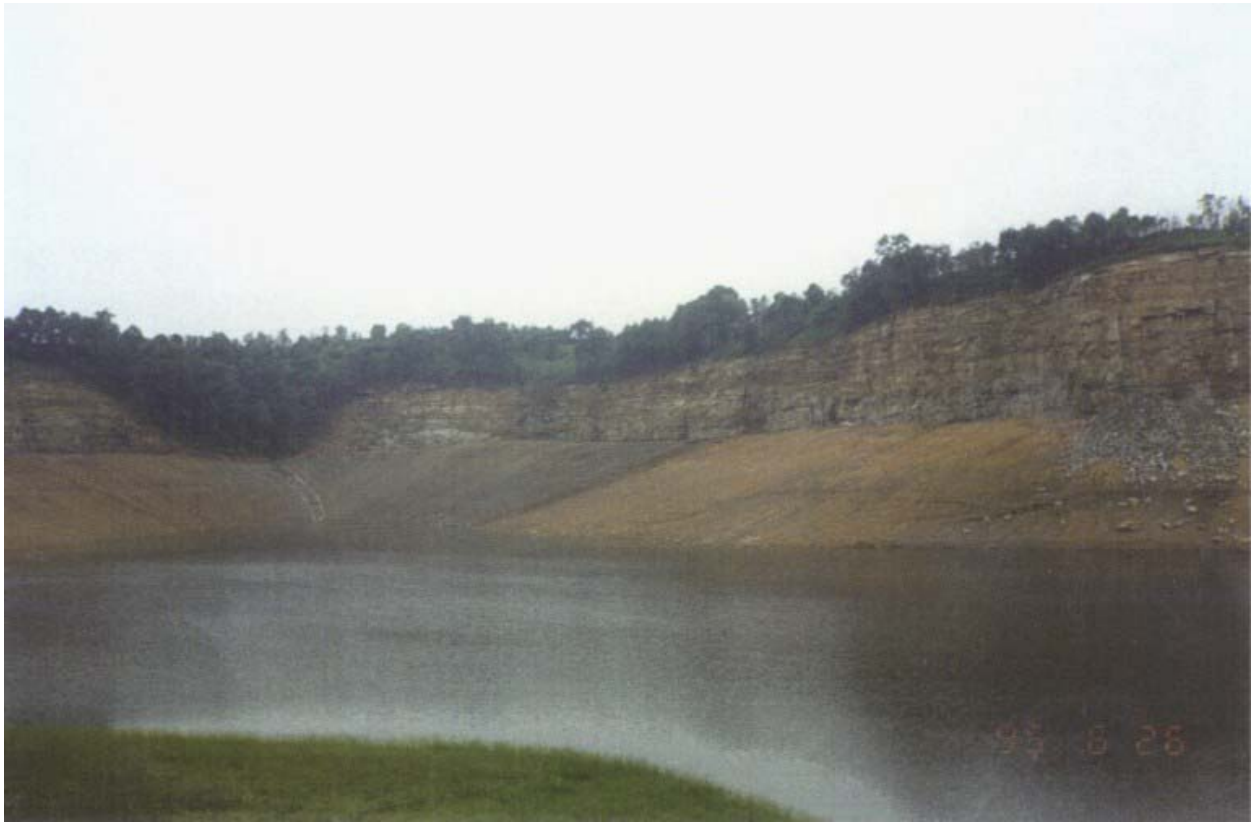
**Photo 14. Seepage Barrier by 2000 Breakthrough (After Construction) - June 26, 1995.**  
**Source: GAI. The 2000 breakthrough area is located at the left-center of the photo.**  
**Pool elevation 1,006 feet msl. Mine roof elevation 973 feet msl. Contour bench elevation 1,075 feet msl.**
