**ASSESSMENT OF DRILLING & WORKOVER RIG STORM SEA  
FASTENINGS ON OFFSHORE FLOATING PLATFORMS DURING  
HURRICANE IVAN  
PHASE 1: Data Collection Report**

**E.G. Ward (OTRC) and J.M. Gebara (Technip)**

**Prepared for the Minerals Management Service**

**August 1, 2006**

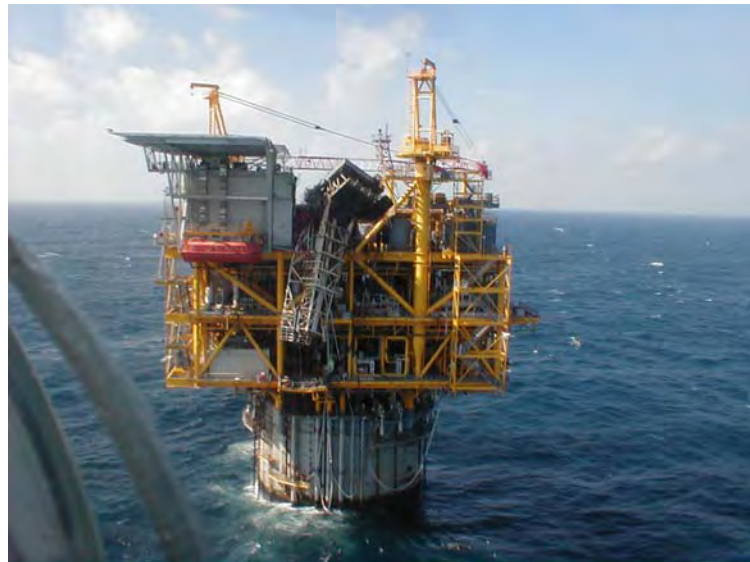
The derrick scraped the living quarters and put a slight indentation into a support member of one of the cranes. Little damage to platform - "it fell in the best possible place"

**Figure 1 - Side View of Medusa Platform after Hurricane Ivan**

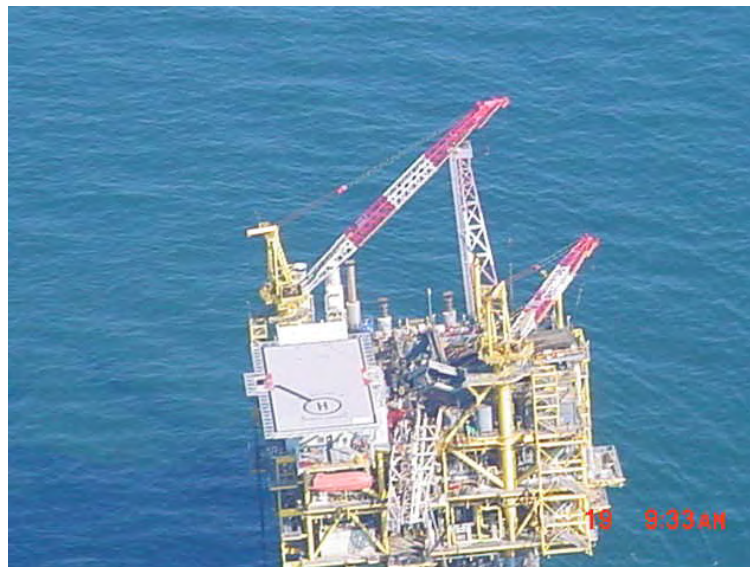
**Figure 2 - Overhead View of Medusa Platform after Hurricane Ivan**

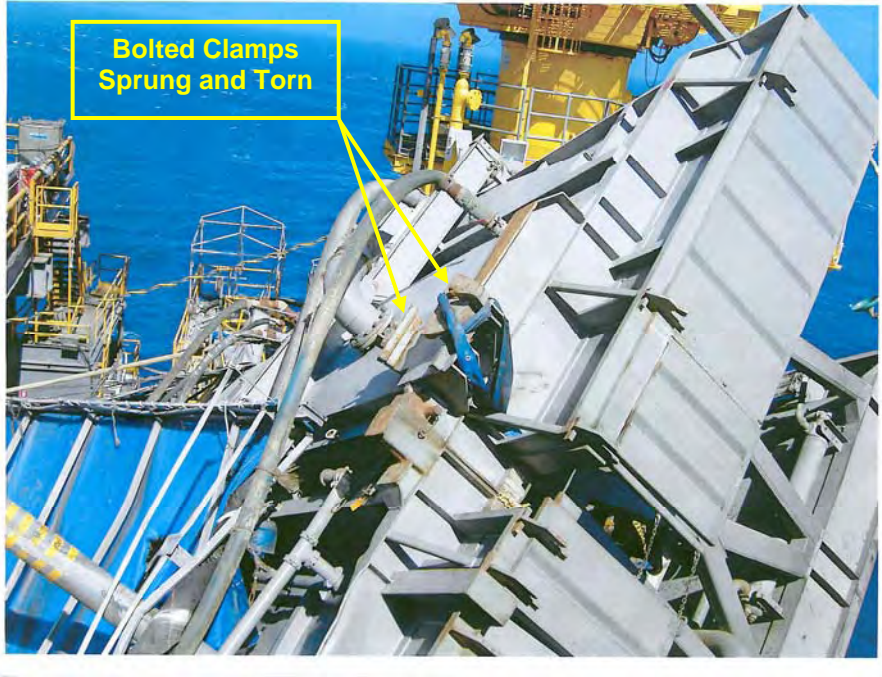
The clamps failed to prevent movement at both levels.

The sea fastening system failed to prevent the drilling rig from skidding off the skid base and falling over the side of the spar.

**Figure 3 - Bolted Clamps Sprung and Torn on Medusa**

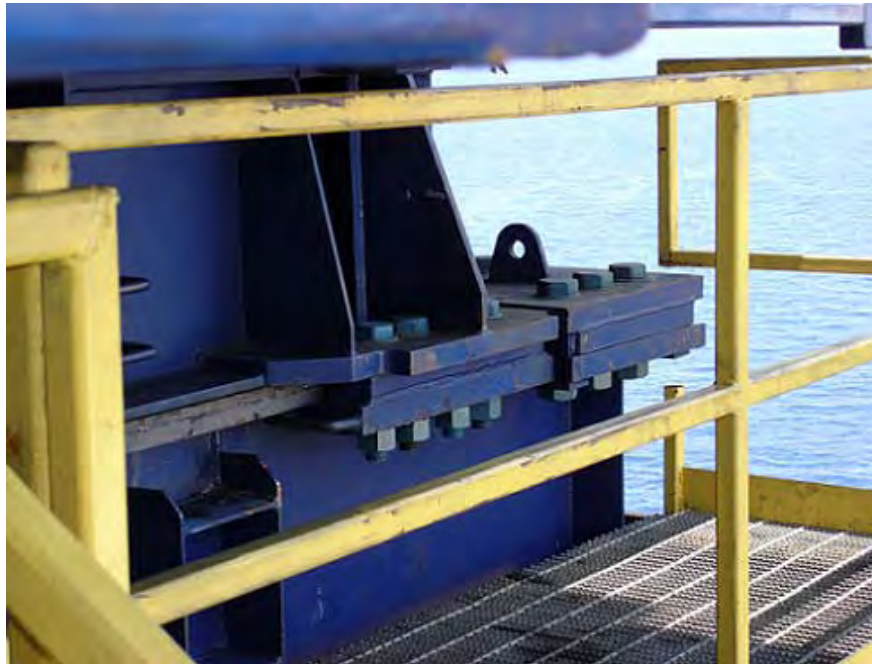
**Figure 7 - Rig Clamps at End of Skid Beam on Front Runner**

In the process of installing additional clamps on Front Runner, Murphy/Nabors ran into some practical challenges, which relate to having enough space or the correct geometry to locate 2 new clamps adjacent to each original clamp. In one case, Murphy/Nabors replaced one of the two additional clamps with a welded shear plate on the skid beam because a bracket underneath the skid beam flange prevented addition of a clamp. (See Figure 5) In another case, which is on the drill floor, there was no room for a welded plate in one direction, so a welded piece was added between the two skid beams on a separate structure. (See Figure 7)

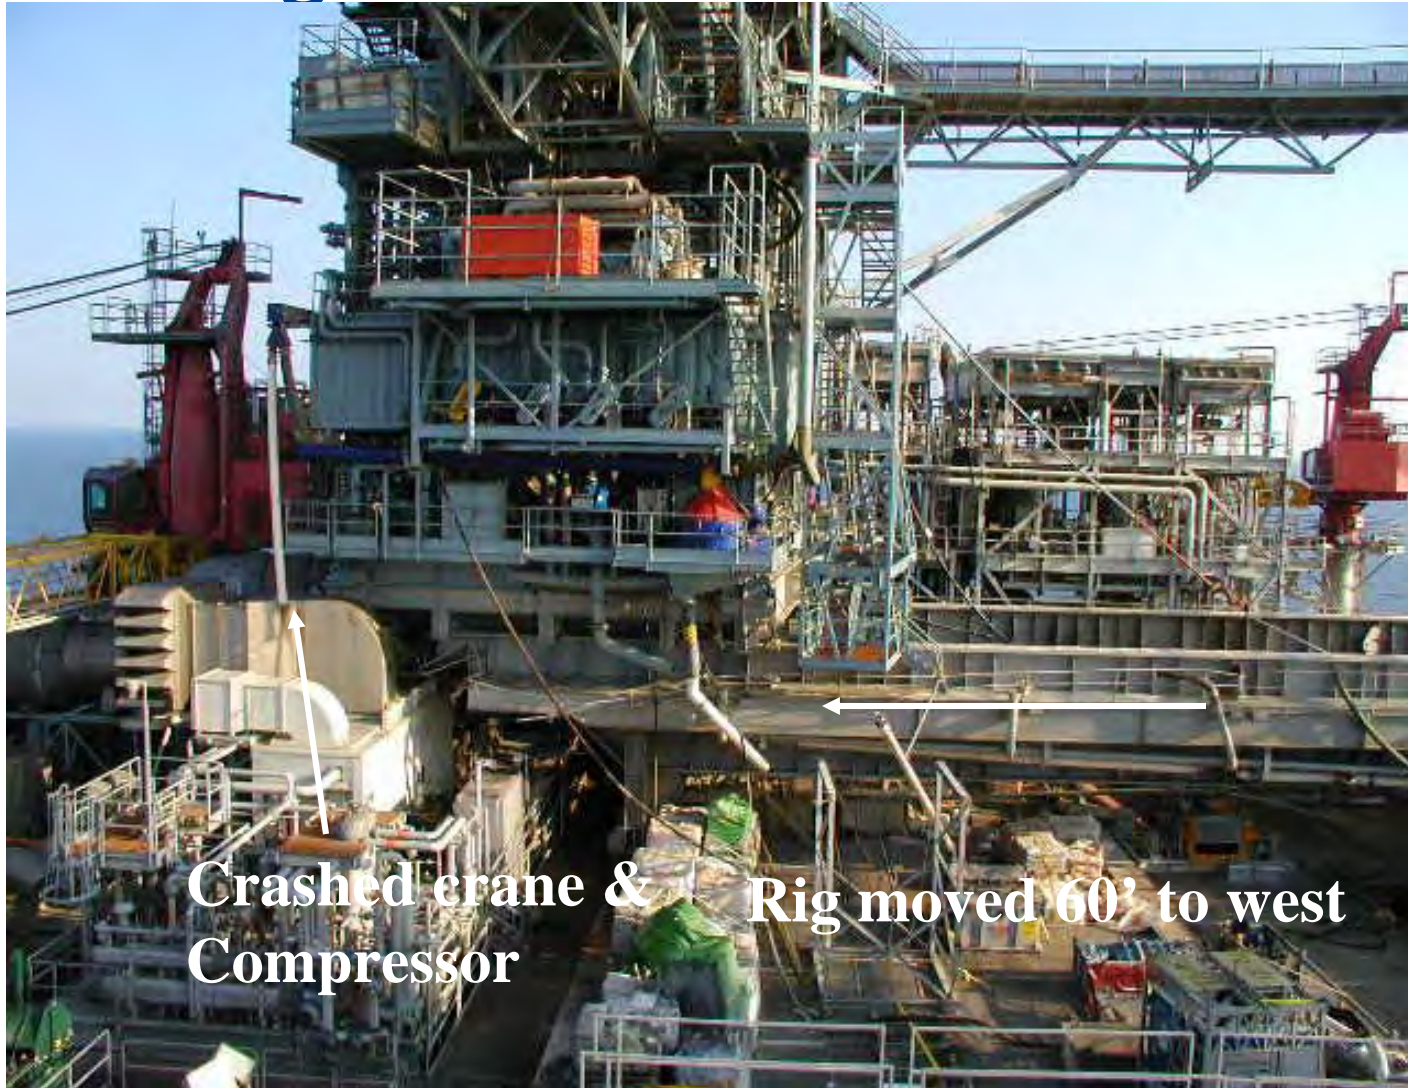
Crashed crane &  
Compressor

Rig moved 60' to west

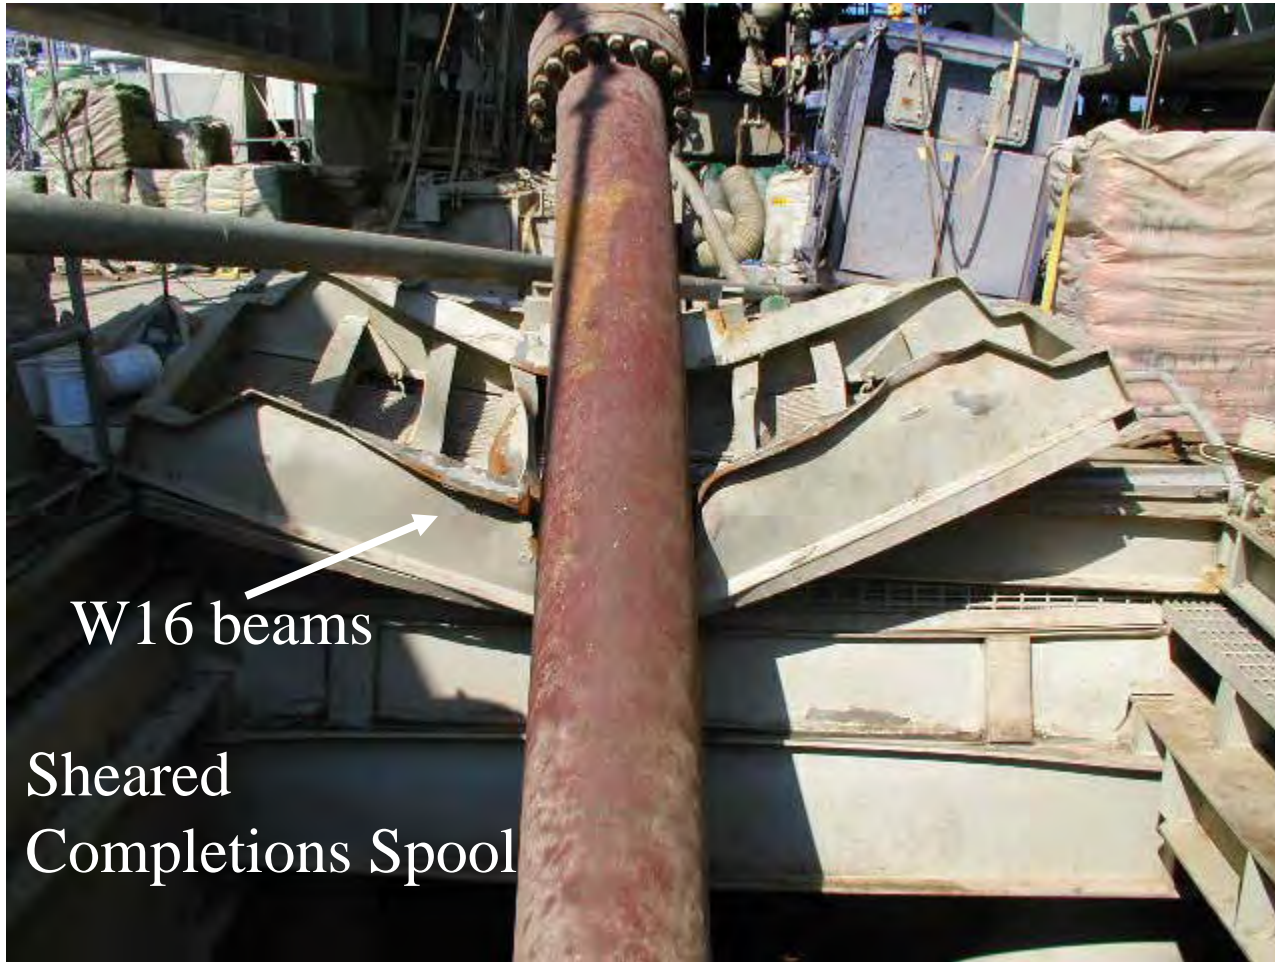
W16 beams

Sheared  
Completions Spool

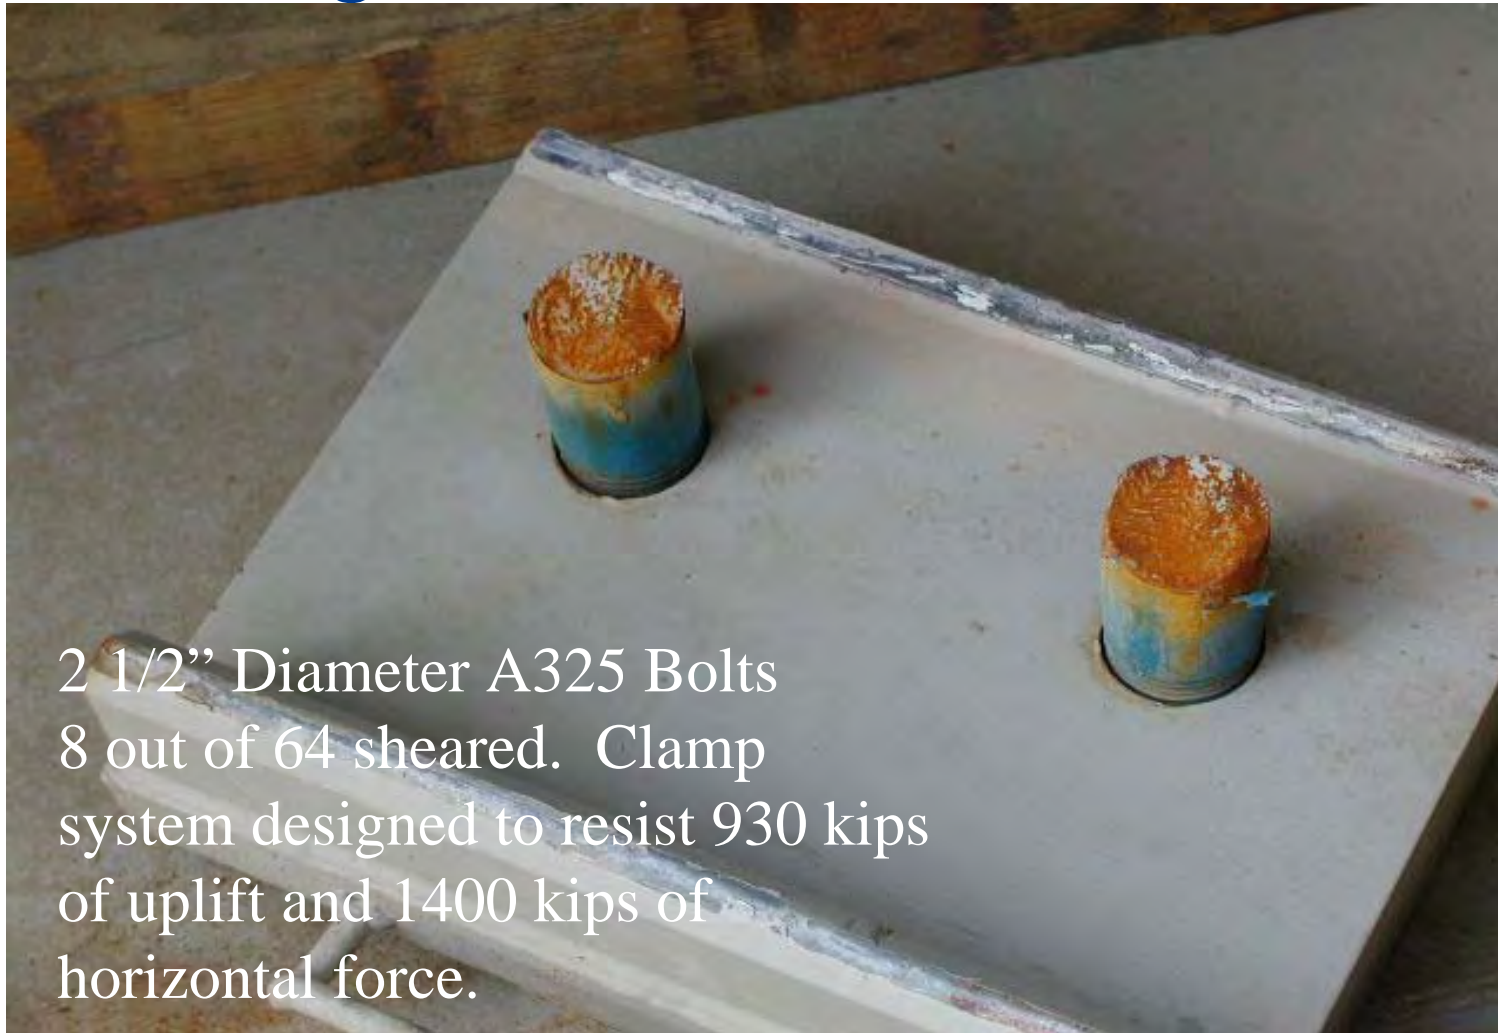
2 1/2" Diameter A325 Bolts  
8 out of 64 sheared. Clamp  
system designed to resist 930 kips  
of uplift and 1400 kips of  
horizontal force.

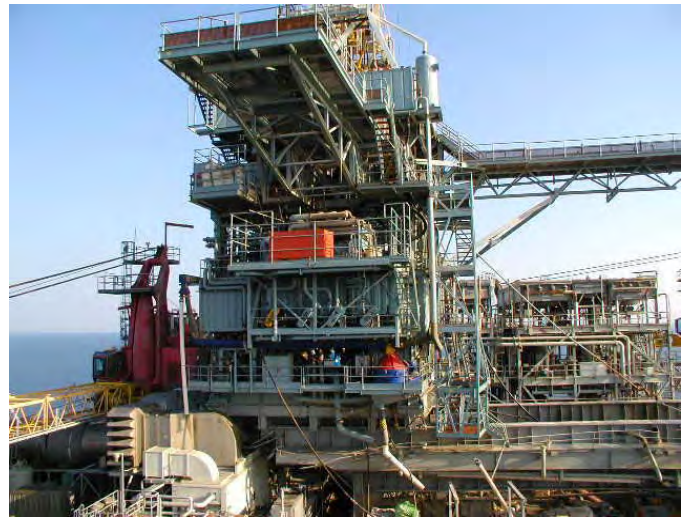
Figure 7 – Ram Powell rig after moving 60 feet to the west from storm motion

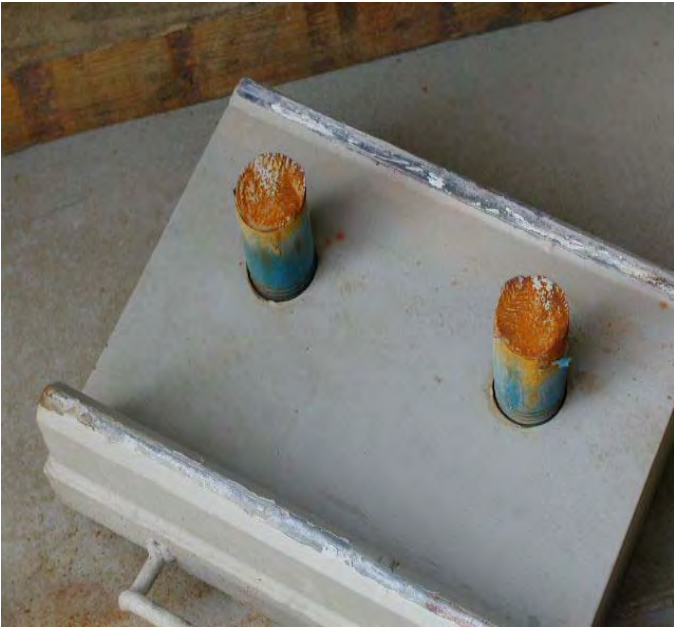
Figure 8 – Sheared bolts in Ram Powell rig hurricane clamps

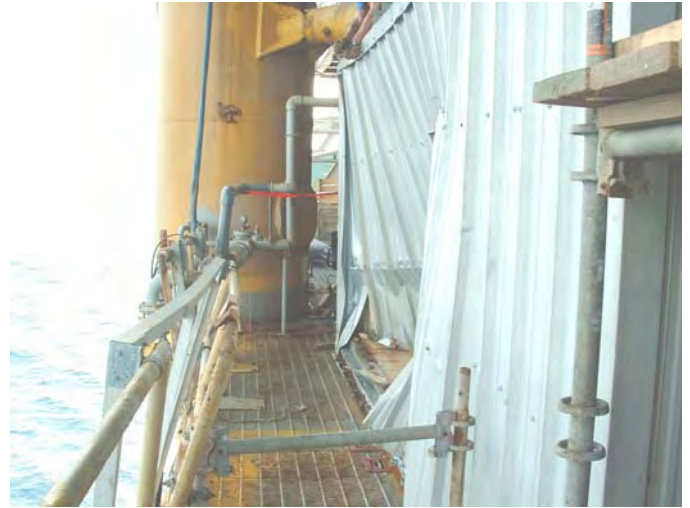
Figure 11 – Cognac damage

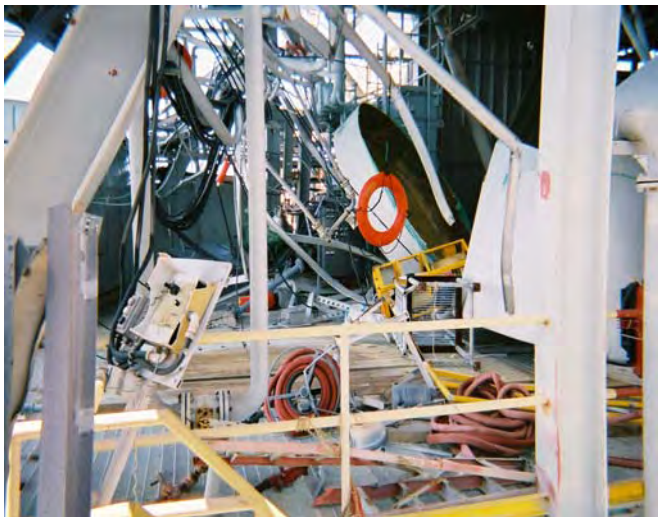
Figure 10 – Main Pass 252 damage

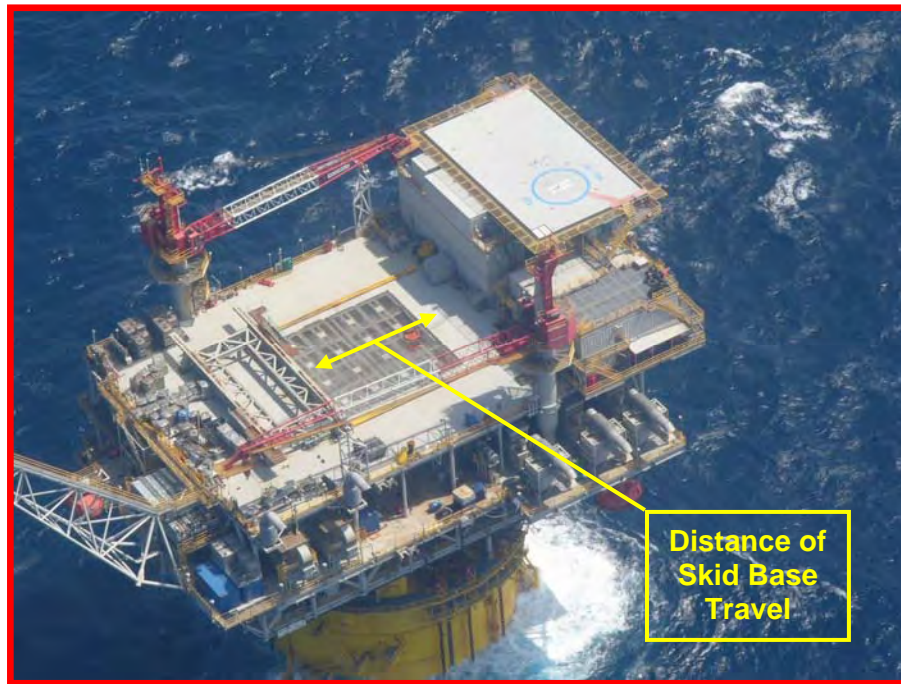
**Figure 15 - Horn Mountain Aerial View Showing Rig Skid Base Off Skid Beams**

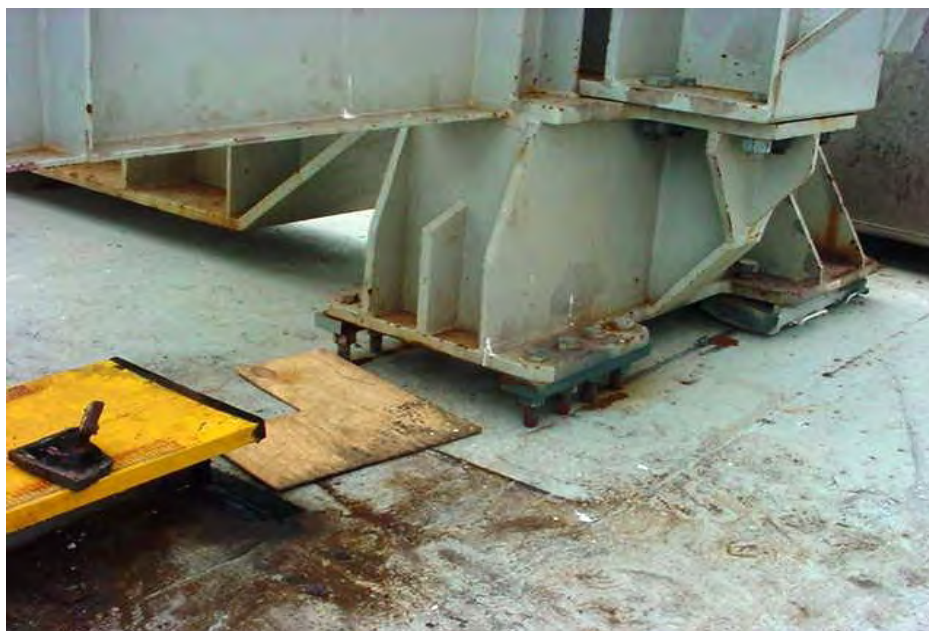
**Figure 16 - Horn Mountain Rig Skid Beam Damage From Hurricane Ivan**
