APACHE CORPORATION HURRICANE IVAN OVERVIEW

CARL HEINRICHS

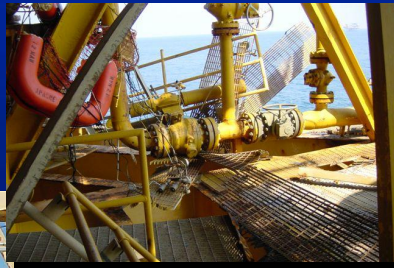
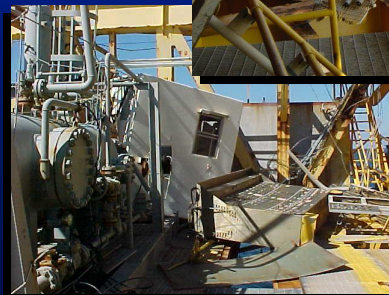
Hurricane Ivan Topside Damage

- Major Process Reconstruction
 - South Pass 62 A/B/C/D Platforms
 - Main Pass 290 A/B Platforms
 - Main Pass 296 B/C/D Platforms
 - Main Pass 311 A/B Platforms
- Moderate Process Reconstruction
 - Main Pass 275 A
 - Main Pass 310 A

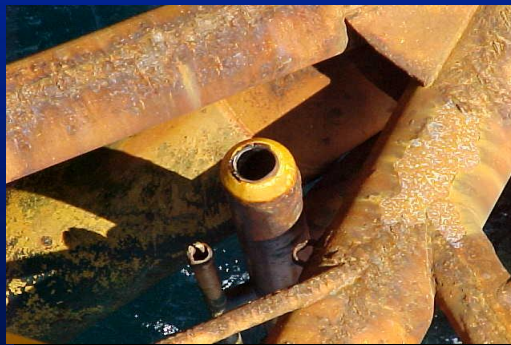
Hurricane Ivan Pipeline Damage / Repair

- Main Pass 275 A – Pipeline Displaced / New Pipeline Installed
- Main Pass 151 A – Oil & Gas Pipeline Displaced / Abandoning Field
- Mississippi Canyon 148 A – Parted 3” Riser / Repaired
- Main Pass 290 A – Parted 6” Riser / Repaired
