Shell's Experience with Hurricane Ivan

Shell Exploration and Production Co.

API – 2005 Hurricane Readiness and Recovery
Conference

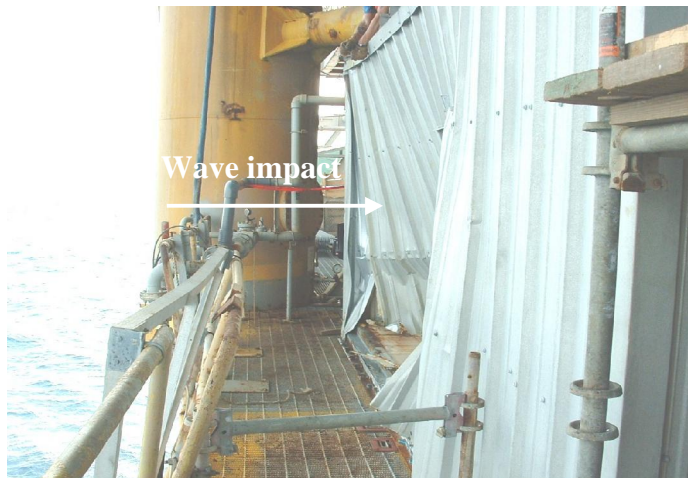
Damage Assessments – MC 194

- Evidence of Green Water in the deck, 45 feet above the water line; platform 100 miles from the eye of the storm.

- Platform damage consisted of:
 - ❖ Missing Grating and Handrails
 - ❖ Minor Facilities equipment
 - ❖ Gaugers Shack

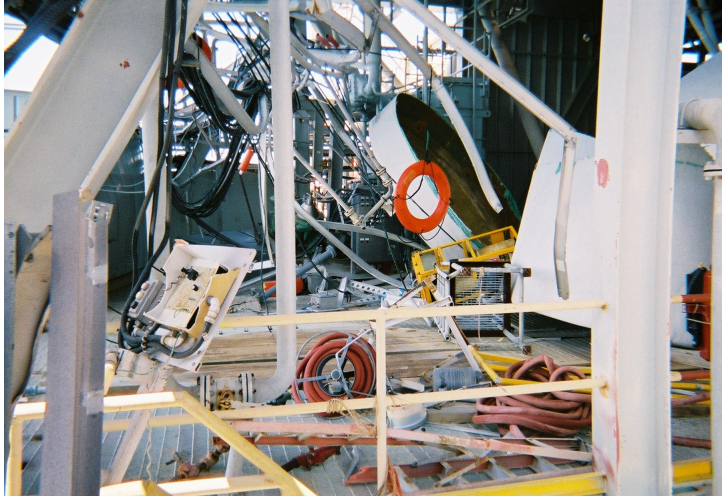
Damage Assessments – MP 252

- Evidence of Green Water in the deck, 50 feet above the water line. Platform was near the eye of the storm.
- Estimated wave height 65 - 70 ft which corresponds to the maximum design wave of 72 feet.
- Platform damaged consisted of:
 - ❖ Missing Grating and Handrails (100 % at boatlanding to 20 % on lower deck)
 - ❖ Facilities equipment, cable tray and mostly support utilities

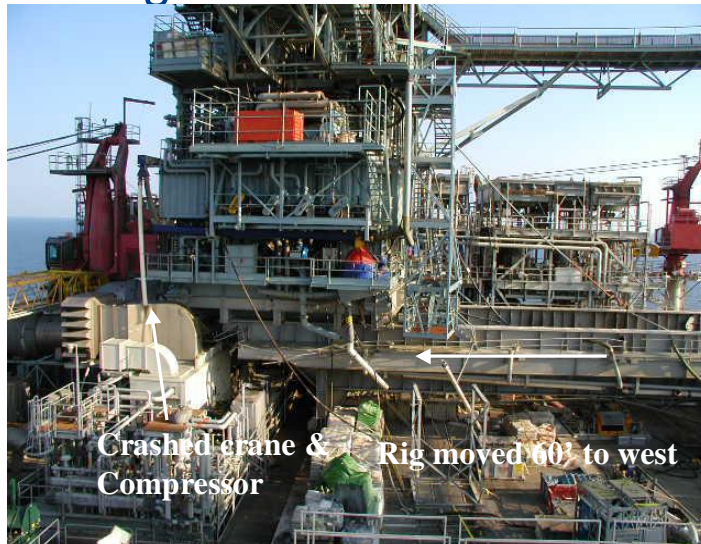
Damage Assessments – VK 956

- Evidence of Green Water in the deck, 90 feet above the water line. Platform near the eye of the storm.
- Estimated wave height at this location is around 100 ft. Design wave was around 87 ft.
- Platform damaged consisted of:
 - ❖ Drilling rig moved off location
 - ❖ FGC 2 exhaust
 - ❖ Missing Grating and Handrails (100 % at boatlanding to 20 % on lower deck)
 - ❖ Facilities equipment, cable tray and mostly support utilities

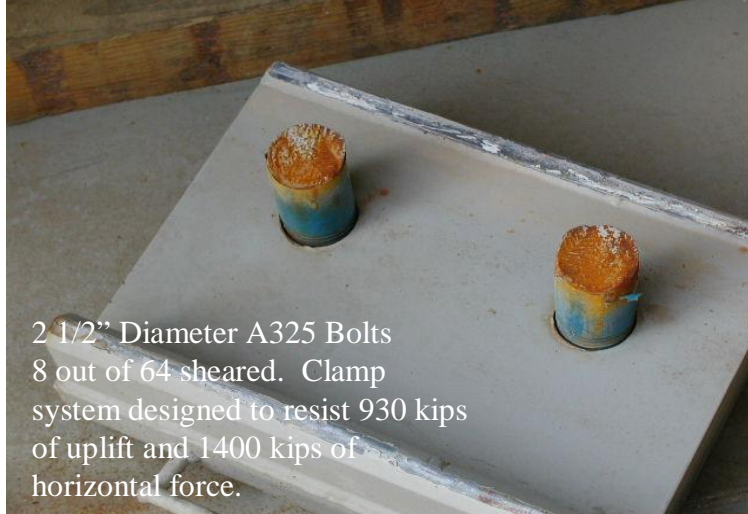
Damage Assessments – VK 956

2 1/2" Diameter A325 Bolts
8 out of 64 sheared. Clamp
system designed to resist 930 kips
of uplift and 1400 kips of
horizontal force.

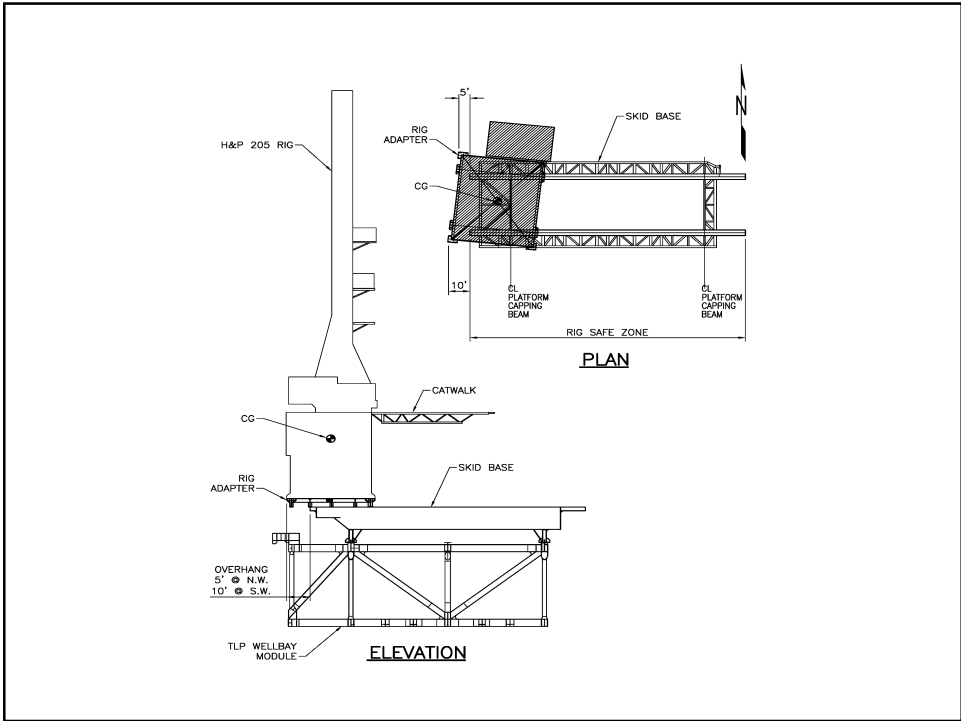
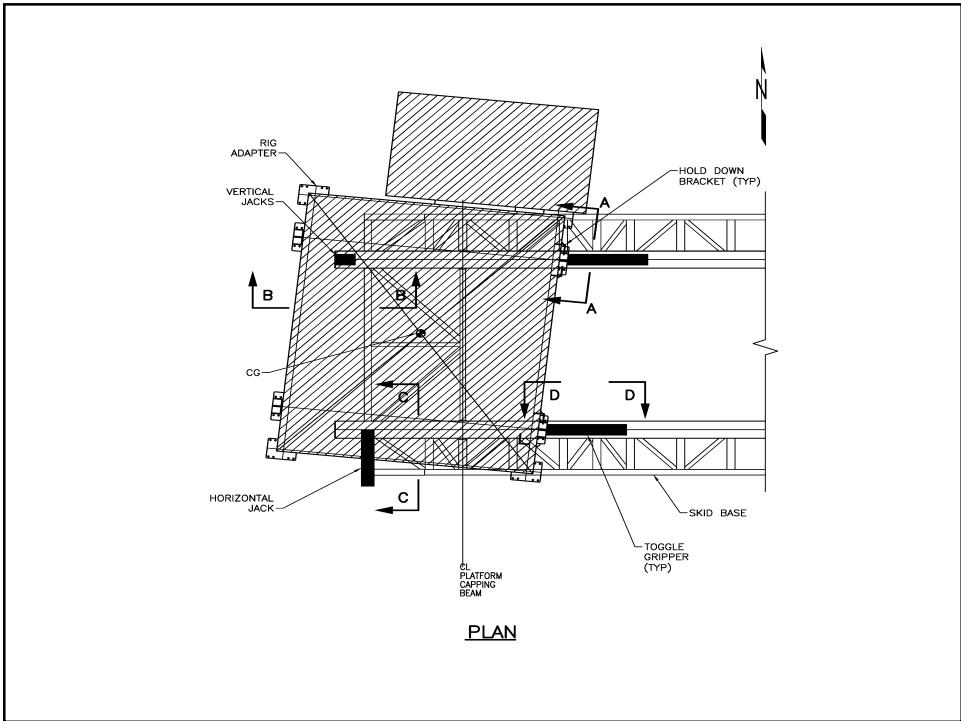
VK 956 A – Drilling Rig Recovery

- Rig was located in potentially unstable position.
- Rig had to be secured to prevent further damage.
- 2500 ton rig to be a) lifted vertically then slid back into position or b) disassembled and then reassembled.
- Option a) was selected
