Some Observations Petronius and Vk 900

2005 Offshore Hurricane Readiness & Recovery

26-27 July 2005

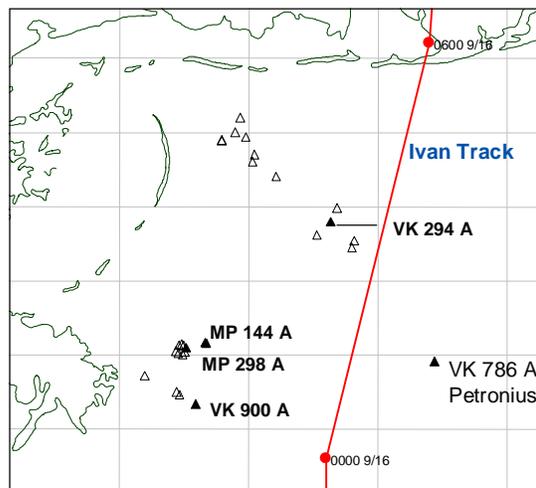
Fleet Impact

▲ Platform Damaged
△ Platform Undamaged
