***ASSESSMENT OF FIXED OFFSHORE
PLATFORM PERFORMANCE IN HURRICANES
ANDREW, LILI AND IVAN***

January 2006

Prepared for:
**U.S. Department of the Interior
Mineral Management Service
Engineering and Research Branch
381 Elden Street
Herndon, VA 20170**

Prepared by:
**Energo Engineering, Inc.
3100 Wilcrest Drive, Suite 240
Houston, Texas 77042**

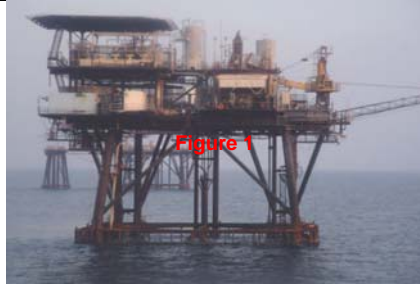
Platform Damage Summary			
Platform	Main Pass 144A		
Operator	Chevron		
Platform Description			
Water Depth	206 ft

Deck Height	65 ft		
No. of Slots	14		
No. of Conductors	12+2		
Installation Date	1968		
API 2A Assessment Category	L2		
Jacket Type	Platform		
No. of Piles	2 + 2 sets of 6 conductors		
Distance from Shore	24 mi		
Bracing Configuration	K bracing for top and bottom bay; XH bracing for middle bay		
Storm Exposure			
Min. Distance/Direction from Eye	36 mi		Maximum Storm Surge 1.3 ft
Maximum Wave Height	66 ft		Maximum Wind Speed 64 kts
Significant Wave Height	37 ft		Current Speed 2.5 kts
Wave Crest Elevation	41 ft		
Storm Damage			
Structural Damage	Yes		Evidence of Wave in Deck No
Structural Damage Description	Many deck members in a 13' x 60' cantilever deck section sustained significant damage during the storm. All other damage to the platform were either known from previous inspections or from a marine vessel collision which occurred after the storm in November 2004.

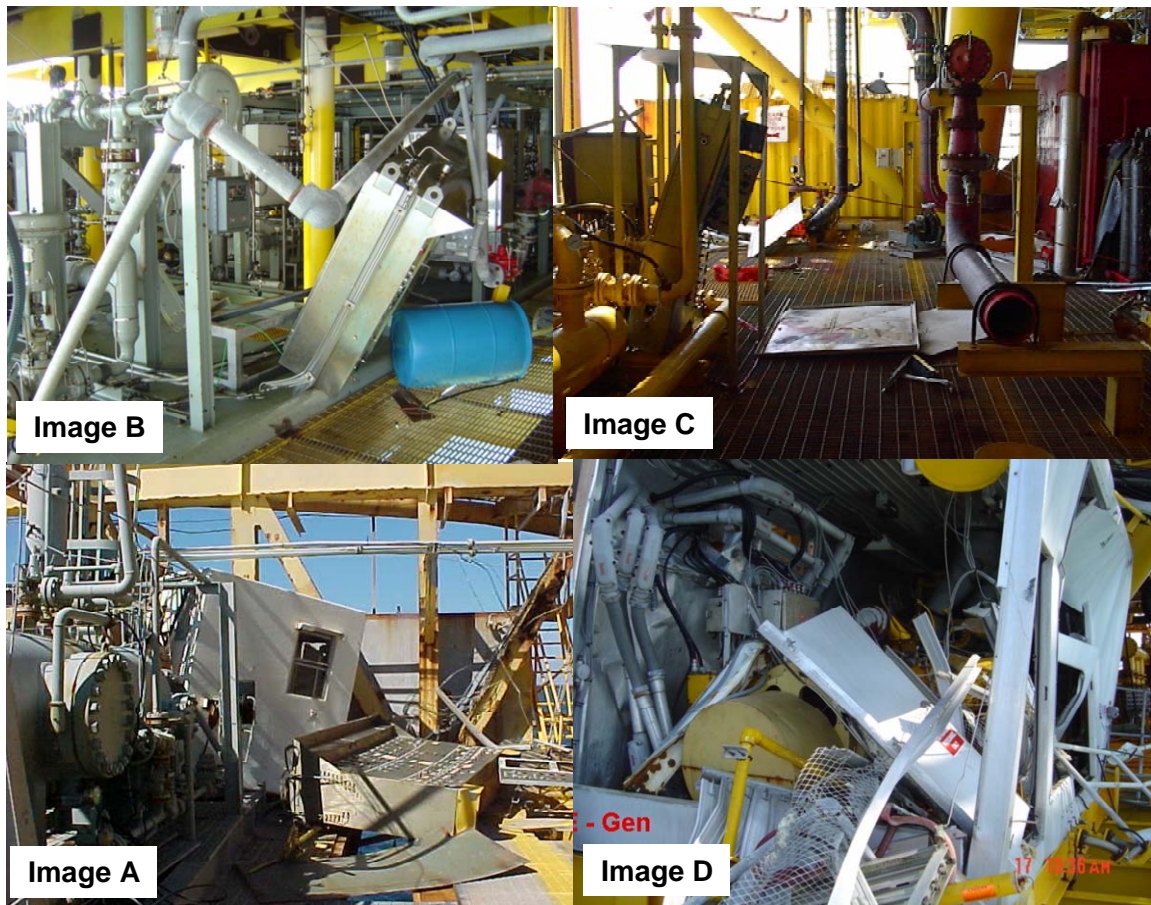
Figure 2.6 – Typical Non-Structural Topside Damage Caused by Wave-in-Deck

One other observation regarding the wave-in-deck damage was the apparent wave and wave crest heights during Ivan. Many of the platforms that had evidence of wave in deck observed damage in the upper regions of the cellar deck. For example in the case of the Pompano platform, the deck damage was observed at an elevation of +63 feet above the water level. This equates to a postulated 105 ft maximum wave height when using present design calculation methods. This estimate is well above the hindcast estimates for maximum wave. For the Pompano location, the hindcast estimates put the maximum wave height at approximately 80 feet [O'Connor, 2005]. These sorts of discrepancies between the calculated wave heights based on damage and the hindcast estimates are highlighted in the Section 2.5. Although this report is limited to fixed platforms, Ivan caused wind damage on deepwater platforms (floating) that are not covered in this study.

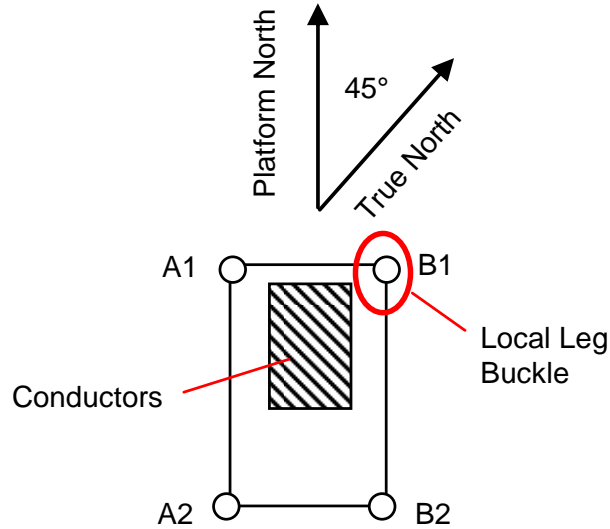
Figure 2.9 – Platform Orientation of MP 306F Platform

Another platform that sustained local leg buckling was MP 306F. This platform also sustained major damage to the main jacket bracing. The platform is a 4 pile with 4 skirt piles and there is no batter in the Row A and B direction. Rows A and B sustained major damage to the upper three bays of X-bracing. The platform orientation is shown in Figure 2.9. Similar to the SP 62 platforms, the buckled leg was on the Northern leg or leeward side of the platform with respect to the storm track.

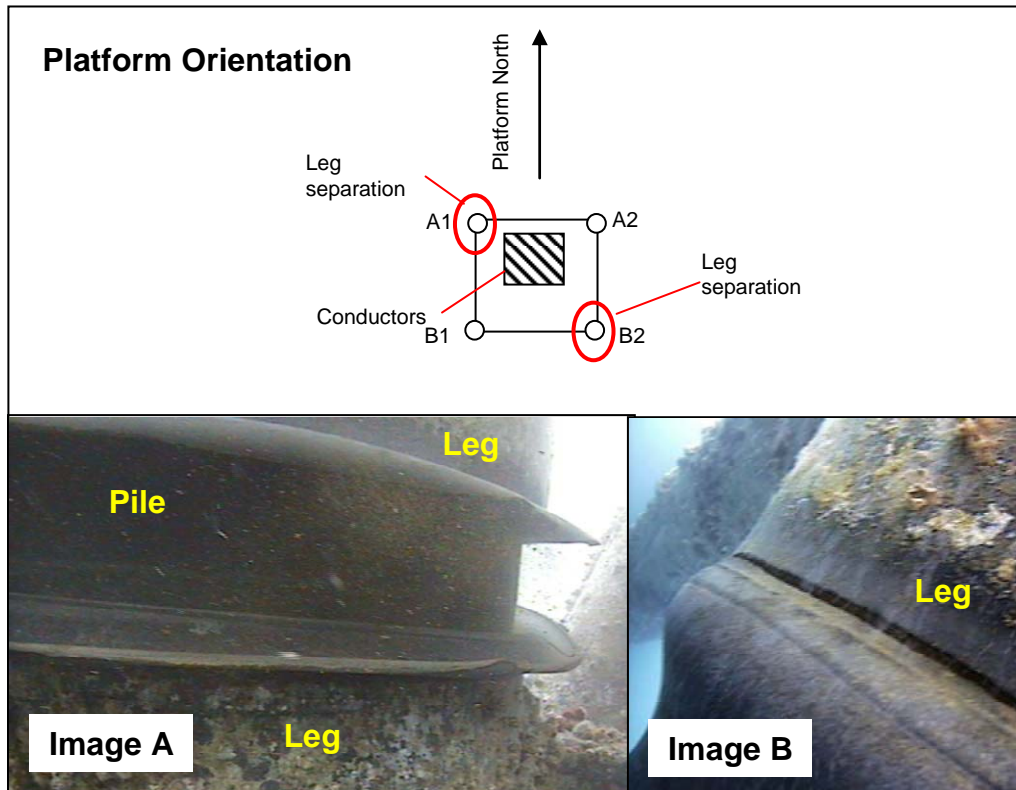
Figure 2.10 – Platform Orientation of MP 281 A Platform and Photos of Leg Damage

MP 281 A sustained leg buckling and separation on the two diagonally opposed legs. The platform is a four pile platform and the A1 and B2 legs were observed to be separated. The X-bracing was also separated at two locations near the leg damage. The specific orientation was not shown in the documents but the inspection report shows the conductors to be on the north face of the platform. The orientation of the platform and photos of the observed damage are shown in Figure 2.10. Note that the wave action and subsequent movement of the platform caused the leg to expand outward at the both ends. Similar damage was seen in Lili [Puskar, 2004]. This is shown in Figure 2.10, Image B.

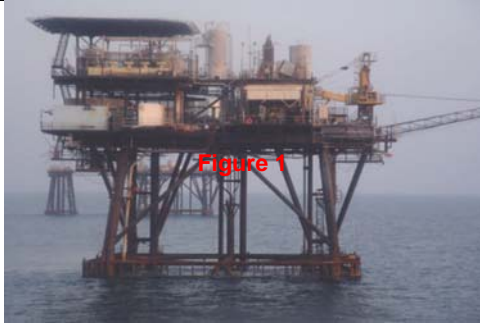
Platform Damage Summary			
Platform	Main Pass 144A		
Operator	Chevron		
Platform Description			
Water Depth	206 ft

Deck Height	65 ft		
No. of Slots	14		
No. of Conductors	12+2		
Installation Date	1968		
API 2A Assessment Category	L2		
Jacket Type	Platform		
No. of Piles	2 + 2 sets of 6 conductors		
Distance from Shore	24 mi		
Bracing Configuration	K bracing for top and bottom bay; XH bracing for middle bay		
Storm Exposure			
Min. Distance/Direction from Eye	36 mi	Maximum Storm Surge	1.3 ft
Maximum Wave Height	66 ft	Maximum Wind Speed	64 kts
Significant Wave Height	37 ft	Current Speed	2.5 kts
Wave Crest Elevation	41 ft		
Storm Damage			
Structural Damage	Yes	Evidence of Wave in Deck	No
Structural Damage Description	Many deck members in a 13' x 60' cantilever deck section sustained significant damage during the storm. All other damage to the platform were either known from previous inspections or from a marine vessel collision which occurred after the storm in November 2004.

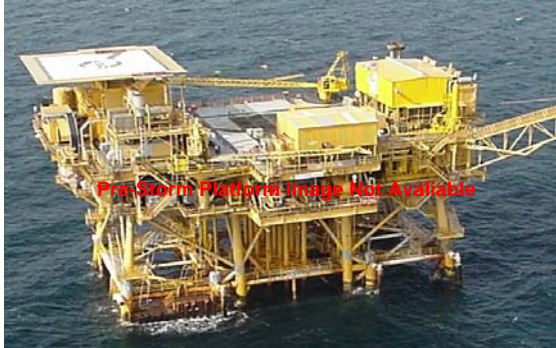
Platform Damage Summary			
Platform	Main Pass 311 B		
Operator	Apache Corporation		
Platform Description			
Water Depth	246 ft

Deck Height	52 ft		
No. of Slots	18		
No. of Conductors	15		
Installation Date	1980		
API 2A Assessment Category	L2		
Jacket Type	Platform		
No. of Piles	8 piles and 8 skirt piles		
Distance from Shore	19 mi		
Bracing Configuration	Long frame: XH for center bays; / for outer bays; Tran Frame: XH bracing		
Storm Exposure			
Min. Distance/Direction from Eye	38 mi	Maximum Storm Surge	1.1 ft
Maximum Wave Height	67 ft	Maximum Wind Speed	61 kts
Significant Wave Height	38 ft	Current Speed	2.4 kts
Wave Crest Elevation	41 ft		
Storm Damage			
Structural Damage	Yes	Evidence of Wave in Deck	No
Structruual Damage Description	1. 6"L x 4"W x 2"D dent on a small vertical member (VM) on row A near the water line. 2. 1.5"W x 19.25"L crack at end of VM at the connection of X-brace vertical diagonal. VM appears to have torn away from the X-brace resulting in a large crack near the weld, propogating outward along the length of the vertical diagonal. 3. 18"L x 18"W x 4"D dent on a HZ at the (-)46.5' elev. connecting leg B1 to leg A1. Notes in inspection report indictate that this is not anticipated to have been caused by the storm.

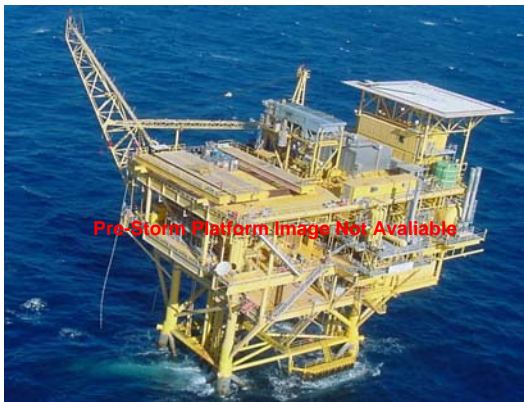
Platform Damage Summary			
Platform	Main Pass 281 A		
Operator	Dominion E & P		
Platform Description			
Water Depth	307 ft

Deck Height	52 ft		
No. of Slots	9		
No. of Conductors	6		
Installation Date	1997		
API 2A Assessment Category	L2		
Jacket Type	Platform		
No. of Piles	4		
Distance from Shore	57 mi		
Bracing Configuration	The platform has XH long frame and tran frame bracing.		
Storm Exposure			
Min. Distance/Direction from Eye	5 mi		Maximum Storm Surge 1.3 ft
Maximum Wave Height	74 ft		Maximum Wind Speed 75 kts
Significant Wave Height	41 ft		Current Speed 1.8 kts
Wave Crest Elevation	44 ft		
Storm Damage			
Structural Damage	Yes	Evidence of Wave in Deck	Yes
Structural Damage Description	1. Two members were found to be flooded; VD A1(+12' to A2(-)65' and VD A1(+12' to B1(-)65'. 2. A2 jacket leg has complete separation 360 degrees around the jacket leg at (-)58' level. 3. B2 jacket leg has complete separation 360 degrees around the jacket leg at (-)6' level. 4. VD A1(+12' to A2(-)65' has a bulge 2' below the X-brace, a break at -47' level and another bulge at -64' level. 5. VD A1(+12' to B1(-)65' has a bulge 1' below the X-brace, a break at the -40' area and a second bulge at the -62' level.

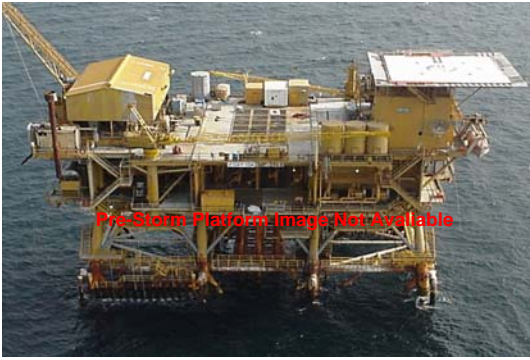
Platform Damage Summary			
Platform	Main Pass 296 B		
Operator	GOM Shelf LLC		
Platform Description			
Water Depth	225 ft

Deck Height	52 ft		
No. of Slots	18		
No. of Conductors	19		
Installation Date	1982		
API 2A Assessment Category	L2		
Jacket Type	Platform		
No. of Piles	8 Piles and 4 Skirt piles		
Distance from Shore	24 mi		
Bracing Configuration	Tran Frame: Rows 1 & 4: K bracing for bottom bay and XH bracing above it. Rows 2 & 3: XH bracing on one vertical half side and / bracing on the other. Long Frame: Bottom bay of both faces have XH bracing. Among the top bays, the center bay has XH bracing and the end bays have / bracing.		
Storm Exposure			
Min. Distance/Direction from Eye	35 mi	Maximum Storm Surge	1.2 ft
Maximum Wave Height	68 ft	Maximum Wind Speed	63 kts
Significant Wave Height	38 ft	Current Speed	2.4 kts
Wave Crest Elevation	41 ft		
Storm Damage			
Structural Damage	Yes	Evidence of Wave in Deck	No

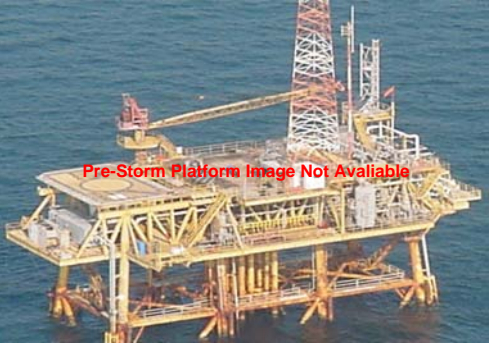
Platform Damage Summary			
Platform	Main Pass 289 B		
Operator	Apache Corporation		
Platform Description			
Water Depth	301 ft

Deck Height	45 ft		
No. of Slots	18		
No. of Conductors	16		
Installation Date	1968		
API 2A Assessment Category	L1		
Jacket Type	Platform		
No. of Piles	8 main piles and 4 skirt piles		
Distance from Shore	39 mi		
Bracing Configuration	Long Frame: All the bays have / bracing except the bottom end bays, which have a K bracing. Tran Frame: Rows 1&4 have K bracing for the bottom bay and / bracing for the ones above. Rows 2&3 have K bracing for the bottom row, XH bracing for the 2 bays above it and / bracing for the top 2 bays.		
Storm Exposure			
Min. Distance/Direction from Eye	20 mi	Maximum Storm Surge	1.2 ft
Maximum Wave Height	73 ft	Maximum Wind Speed	71 kts
Significant Wave Height	41 ft	Current Speed	1.8 kts
Wave Crest Elevation	44 ft		
Storm Damage			
Structural Damage	Yes	Evidence of Wave in Deck	Yes

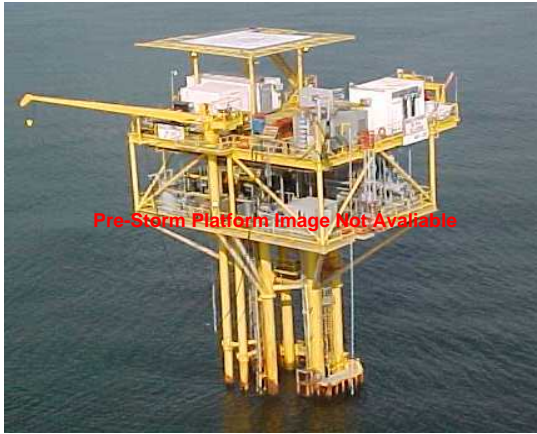
Platform Damage Summary			
Platform	Main Pass 138 A		
Operator	Newfield Exploration Company		
Platform Description			
Water Depth	158 ft

Deck Height	55 ft		
No. of Slots	6		
No. of Conductors	Not Documented		
Installation Date	Not Documented		
API 2A Assessment Category	L2		
Jacket Type	Platform		
No. of Piles	4		
Distance from Shore	16 mi		
Bracing Configuration	A sea-horse type platform with XH bracing at the bottom bay on all four faces.		
Storm Exposure			
Min. Distance/Direction from Eye	46 mi		Maximum Storm Surge 1.6 ft
Maximum Wave Height	58 ft		Maximum Wind Speed 59 kts
Significant Wave Height	33 ft		Current Speed 2.7 ft
Wave Crest Elevation	37 ft		
Storm Damage			
Structural Damage	Yes	Evidence of Wave in Deck	Yes
Structural Damage Description	1. A diagonal brace on row 2 from the cellar deck (2A) to the main deck (2B) broke loose at the weldment on the cellar deck level. The brace is bowed. 2. A 24" major diagonal on row B from (-)7'-6" level to the (-)80' level had a 22"L x 9"W x 2"H dent at the (-)56' elevation. 3. A 16" HZ at the (-)80' level on row B from leg B1 to B2 had a 3"W x 12"L x 0.5"H hump close to leg 2.

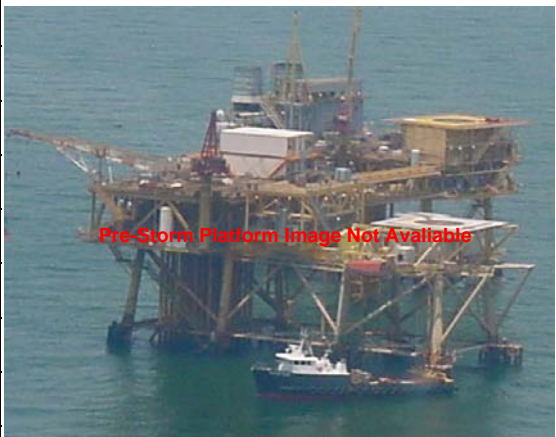
Platform Damage Summary			
Platform	South Pass 62 C		
Operator	Apache Corporation		
Platform Description			
Water Depth	328 ft

Deck Height	47.8 ft		
No. of Slots	18		
No. of Conductors	18		
Installation Date	1967		
API 2A Assessment Category	L2		
Jacket Type	Platform		
No. of Piles	8 main piles and 8 skirt piles		
Distance from Shore	19 mi		
Bracing Configuration	<p>Long Frame: All the bays have / bracing except the bottom end bays, which have a K bracing.</p> <p>Tran Frame: Rows 1&4 have K bracing for the bottom bay and / bracing for the ones above. Rows 2&3 have K bracing for the bottom row, XH bracing for the 3 bays above, and / bracing for the topmost bay.</p>		
Storm Exposure			
Min. Distance/Direction from Eye	37 mi	Maximum Storm Surge	0.9 ft
Maximum Wave Height	71 ft	Maximum Wind Speed	60 kts
Significant Wave Height	40 ft	Current Speed	1.3 ft
Wave Crest Elevation	42 ft		
Storm Damage			
Structural Damage	Yes	Evidence of Wave in Deck	Yes

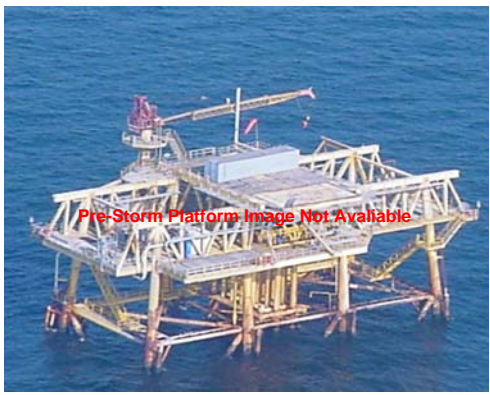
Platform Damage Summary			
Platform	Main Pass 290 A		
Operator	Apache Corporation		
Platform Description			
Water Depth	288 ft

Deck Height	44 T.O.S		
No. of Slots	18		
No. of Conductors	18		
Installation Date	1966		
API 2A Assessment Category	L2		
Jacket Type	Platform		
No. of Piles	8 piles		
Distance from Shore	38 mi		
Bracing Configuration	Long Frame: Both the faces have / bracing throughout. Tran Frame: All four faces have K bracing in the bottom bay alone and / bracing all that way above it.		
Storm Exposure			
Min. Distance/Direction from Eye	22 mi	Maximum Storm Surge	1.1 ft
Maximum Wave Height	68 ft	Maximum Wind Speed	67 kts
Significant Wave Height	38 ft	Current Speed	1.8 ft
Wave Crest Elevation	41 ft		
Storm Damage			
Structural Damage	Yes	Evidence of Wave in Deck	Yes
Structural Damage Description	<ol style="list-style-type: none"> 1. A VD from leg A1 at (-)50' level to leg A2 at (-)94' level had a dent 36"L x 23"W x 4.75"D at (-)74' elevation. 2. A VD from leg A1 at (-)150' level to leg A2 at (-)218' level had a dent 12"L x 20"W x 2"D at (-)169' elevation, a dent 44"L x 24"W x 3.625"D at (-)184' elevation and had a scrape 26"L x 3"W x 0.25"D at (-)190' elevation. In addition, at elevation (-)218' the manufactured weld seam had a crack along the seam. 3. VD from A2 to B2 has a 2"L x 2"W x 0.5"D pit at the cap of the weld, at the B2 leg (-)49' elevation. 4. VD from A1 to A2 has a 2"L x 2"W x 0.5"D pit at the cap of the weld, at the A1 leg (-)49' elevation. 5. A HD at the (-)218' elevation, from the mid points of A1-A2 to A2-B2 was damaged and required repair.

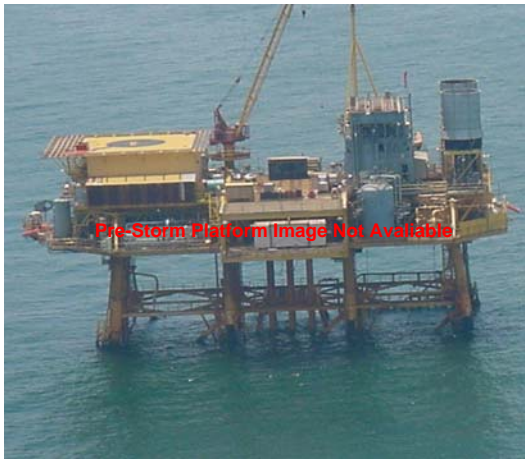
Platform Damage Summary			
Platform	South Pass 62 B		
Operator	Apache Corporation		
Platform Description			
Water Depth	322 ft

Deck Height	44 ft		
No. of Slots	18		
No. of Conductors	18		
Installation Date	1968		
API 2A Assessment Category	L2		
Jacket Type	Platform		
No. of Piles	8 main piles and 8 skirt piles		
Distance from Shore	19 mi		
Bracing Configuration	<p>Long Frame: All the bays have / bracing except the bottom end bays, which have a K bracing.</p> <p>Tran Frame: Rows 1&4 have XH bracing in the center of the bottommost bay and / bracing on both sides of the XH bracing. All bays above have / bracing. Rows 2&3 have K bracing for the bottom row, XH bracing for the 3 bays above, and / bracing for the top bays.</p>		
Storm Exposure			
Min. Distance/Direction from Eye	37 mi	Maximum Storm Surge	0.9 ft
Maximum Wave Height	73 ft	Maximum Wind Speed	63 kts
Significant Wave Height	41 ft	Current Speed	1.2 ft

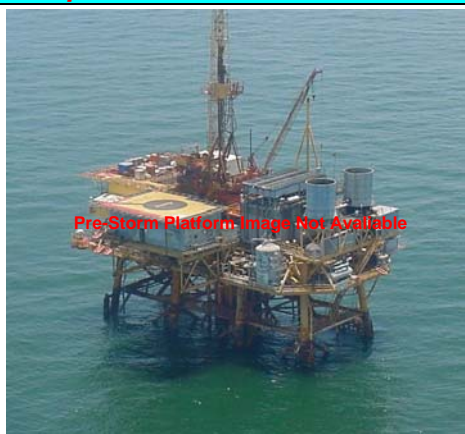
Platform Damage Summary			
Platform	South Pass 62 A		
Operator	Apache Corporation		
Platform Description			
Water Depth	340 ft

Deck Height	44.0 ft		
No. of Slots	18		
No. of Conductors	18		
Installation Date	1967		
API 2A Assessment Category	L1		
Jacket Type	Platform		
No. of Piles	8 main piles and 8 skirt piles		
Distance from Shore	19 mi		
Bracing Configuration	<p>Long Frame: Both the faces have / bracing throughout.</p> <p>Tran Frame: Rows 1&4 have XH bracing in the center of the bottommost bay and / bracing on both sides of the XH bracing. All bays above have / bracing. Rows 2&3 have K bracing for the bottom row, XH bracing for the 3 bays above, and / bracing for the top bays.</p>		
Storm Exposure			
Min. Distance/Direction from Eye	37 mi	Maximum Storm Surge	0.9 ft
Maximum Wave Height	71 ft	Maximum Wind Speed	60 kts
Significant Wave Height	40 ft	Current Speed	1.3 ft
Wave Crest Elevation	42 ft		
Storm Damage

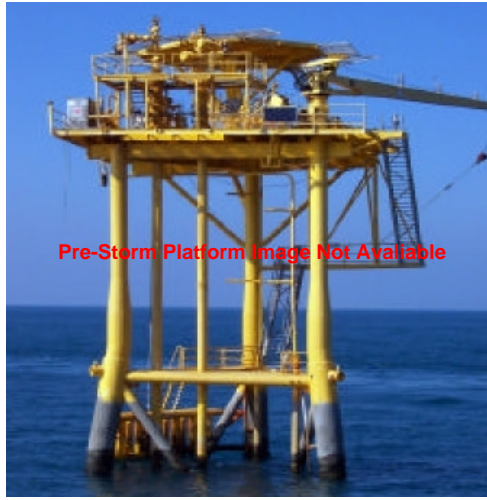
Platform Damage Summary			
Platform	Main Pass 280 C		
Operator	Dominion E & P		
Platform Description			
Water Depth	302 ft

Deck Height	52 ft		
No. of Slots	Unknown		
No. of Conductors	Unknown		
Installation Date	1998		
API 2A Assessment Category	L2		
Jacket Type	Platform		
No. of Piles	3		
Distance from Shore	55 mi		
Bracing Configuration	Unknown		
Storm Exposure			
Min. Distance/Direction from Eye	7 mi		Maximum Storm Surge 1.3 ft
Maximum Wave Height	74 ft		Maximum Wind Speed 75 kts
Significant Wave Height	41 ft		Current Speed 1.8 ft
Wave Crest Elevation	44 ft		
Storm Damage			
Structural Damage	Yes		Evidence of Wave in Deck Unknown
Structrual Damage Description	1. One jacket member was damaged.		
Non-structural Damage (wiring, piping, safety systems, etc.)	None documented		
Major Infrastructure Damage (Pipelines)	-

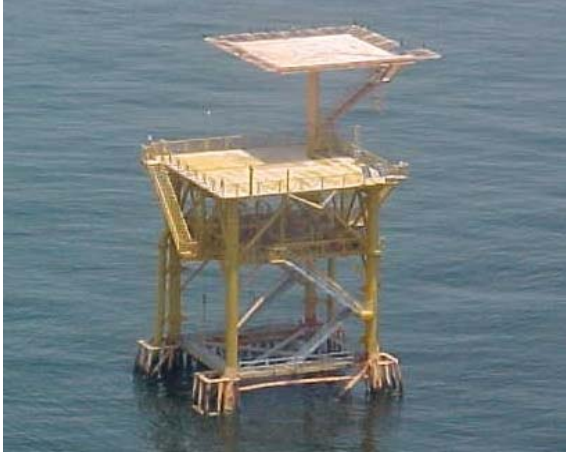
Platform Damage Summary			
Platform	Main Pass 293 SONAT		
Operator	Southern Natural Gas		
Platform Description			
Water Depth	226 ft

Deck Height	45 ft		
No. of Slots	None		
No. of Conductors	None		
Installation Date	1972		
API 2A Assessment Category	Unknown		
Jacket Type	Platform		
No. of Piles	4		
Distance from Shore	30 mi		
Bracing Configuration	All the faces of the platform have K bracing for the bottom three bays and / bracing for the two bays above them.		
Storm Exposure			
Min. Distance/Direction from Eye	29 mi	Maximum Storm Surge	1.1 ft
Maximum Wave Height	70 ft	Maximum Wind Speed	65 kts
Significant Wave Height	40 ft	Current Speed	2.0 ft
Wave Crest Elevation	43 ft		
Storm Damage			
Structural Damage	Yes	Evidence of Wave in Deck	Unknown
Structural Damage Description	The platform was toppled		
Non-structural Damage (wiring, piping, safety systems, etc.)	The platform was toppled		
Major Infrastructure Damage (Pipelines)	-

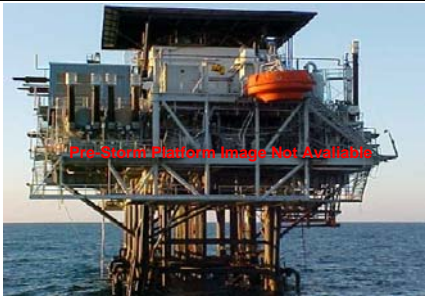
Platform Damage Summary			
Platform	Viosca Knoll 900 A		
Operator	Chevron		
Platform Description			
Water Depth	340 ft

Deck Height	46 ft		
No. of Slots	24		
No. of Conductors	25		
Installation Date	1975		
API 2A Assessment Category	Unknown		
Jacket Type	Platform		
No. of Piles	8 Piles and 4 Skirt piles		
Distance from Shore	22 mi		
Bracing Configuration	<p>Long Frame: The bottom end bays have XH bracing for one half and / bracing for the other. All other bays at other elevations have / bracing.</p> <p>Tran Frame: The bottom 3 bays on all faces have K bracing and the top two have / bracing.</p>		
Storm Exposure			
Min. Distance/Direction from Eye	35 mi	Maximum Storm Surge	0.9 ft
Maximum Wave Height	73 ft	Maximum Wind Speed	61 kts
Significant Wave Height	41 ft	Current Speed	1.1 ft
Wave Crest Elevation	44 ft		
Storm Damage			
Structural Damage	Yes	Evidence of Wave in Deck	Unknown
Structural Damage Description	<p>1. The following members were found to be flooded:</p> <p>a. A HZ A4-B4 at the (-)80' level, has a linear indication at its mid point.</p> <p>b. VD from A1 and (-)32' to A2 at (+)12', was a repaired member.</p> <p>c. HZ A4-B4 at the (-)32' level was separated at the mid point of the member. There is a vertical gap of 5.75" between the centers of the separated members.</p> <p>2. VD A4 at (-)32' level to B4 at (+)12' level is separated where it connects to leg A4 at (-)32'. Leg A4 has a hole 39.5"L x 24"W, resultant of the VD being torn from the leg and the VD retaining the coupon. A tear was noted on the A4 leg at 7:00 with the lip protruding 0.5". At this location, a 3" crack was also noted.</p> <p>3. A dent 6.5"dia. x 1.5"D was found on HZ B4-B3 at (-)32' level 6' from leg B4 from 12:00 to 2:00.</p> <p>4. A dent 12" dia. x 6"D was found on HZ A4-B4 at (+)12' level from 6:00 to 12:00.</p> <p>5. A dent 12"L x 6"W x 4"D was found on HZ A4-B4 at (+)12' level, 7' from Leg A4 from 12:00 to 3:00.</p> <p>6. A linear indication 21.5"L x 0.25"W was found on HD A4-B4 to B3 at (-)80' level from 6:00 to 12:00, on the node side of the weld.</p> <p>7. A suspect visual indication was noted on weld 22/02 in the T.O.W HD A4-B4 to A3 at (-</p>

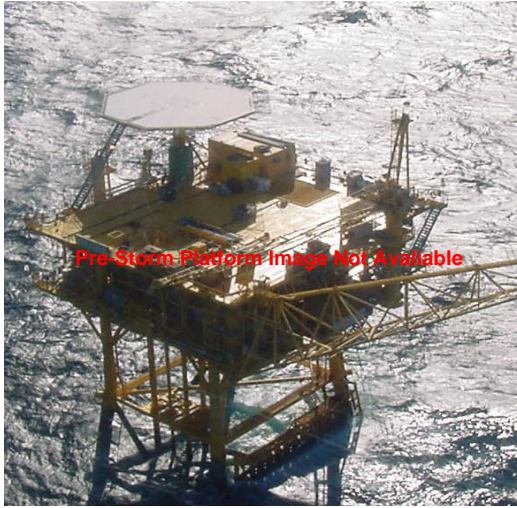
Platform Damage Summary				
Platform	Main Pass 279 B			
Operator	Dominion E & P			
Platform Description				
Water Depth	290 ft

Deck Height	54 ft			
No. of Slots	6			
No. of Conductors	4			
Installation Date	Not Documented			
API 2A Assessment Category	L2			
Jacket Type	Platform			
No. of Piles	4			
Distance from Shore	51 mi			
Bracing Configuration	The bottommost bay of all faces have XH bracing and all the other bays have / bracing.			
Storm Exposure				
Min. Distance/Direction from Eye	10 mi		Maximum Storm Surge	1.3 ft
Maximum Wave Height	74 ft		Maximum Wind Speed	75 kts
Significant Wave Height	41 ft		Current Speed	1.8 ft
Wave Crest Elevation	45 ft			
Storm Damage				
Structural Damage	Yes		Evidence of Wave in Deck	Yes
Structural Damage Description	1. The A1 leg has a buckle at the (-)90' level and is also broken and separated at the (-)110' level.			
Non-structural Damage (wiring, piping, safety systems, etc.)	1. Major damage to the production equipment on the cellar deck. 2. Damage to handrails, grating and stairs.

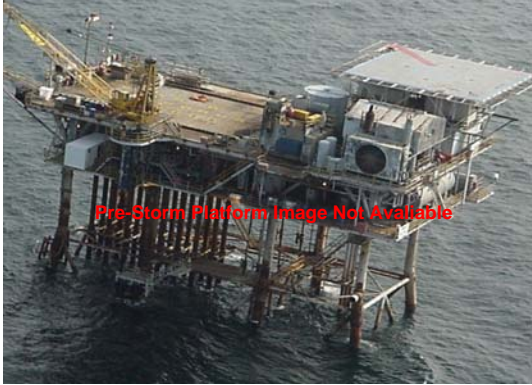
Platform Damage Summary			
Platform	Main Pass 305 A		
Operator	Noble Energy, Inc.		
Platform Description			
Water Depth	244 ft

Deck Height	45 ft		
No. of Slots	24		
No. of Conductors	Not Documented		
Installation Date	1968		
API 2A Assessment Category	L2		
Jacket Type	Platform		
No. of Piles	8 Pile		
Distance from Shore	28 mi		
Bracing Configuration	Long Frame: All the bays of both faces have / bracing. Tran Frame: All four faces have K- bracing on all the bays.		
Storm Exposure			
Min. Distance/Direction from Eye	30 mi	Maximum Storm Surge	1.1 ft
Maximum Wave Height	69 ft	Maximum Wind Speed	64 kts
Significant Wave Height	39 ft	Current Speed	2.2 ft
Wave Crest Elevation	44 ft		
Storm Damage			
Structural Damage	Yes	Evidence of Wave in Deck	No
Structural Damage Description	1. The storm disconnected the conductor tray and damaged several supporting secondary steel members at the (-)40' elevation. 18 anomalies were discovered at this level. A drawing has been provided showing the locations of all these anomalies. 2. A dent 18"L x 10"W x 2"D was found on a VD on row A from leg1 at (+)10' level to leg2 and (-)40' level, 20' from leg A2.

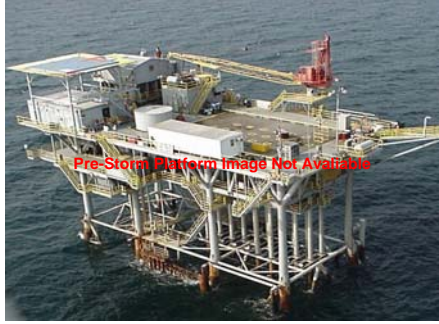
Platform Damage Summary			
Platform	Main Pass 305 B		
Operator	Noble Energy, Inc.		
Platform Description			
Water Depth	241 ft

Deck Height	46 ft		
No. of Slots	24		
No. of Conductors	Not Documented		
Installation Date	1968		
API 2A Assessment Category	L2		
Jacket Type	Platform		
No. of Piles	8 Pile		
Distance from Shore	28 mi		
Bracing Configuration	Long Frame: All the bays of both faces have / bracing. Tran Frame: All four faces have K bracing on all the bays.		
Storm Exposure			
Min. Distance/Direction from Eye	30 mi	Maximum Storm Surge	1.1 ft
Maximum Wave Height	72 ft	Maximum Wind Speed	65 kts
Significant Wave Height	40 ft	Current Speed	1.7 ft
Wave Crest Elevation	44 ft		
Storm Damage			
Structural Damage	Yes	Evidence of Wave in Deck	No
Structural Damage Description	1. The storm disconnected the conductor tray and damaged several supporting secondary steel members at the (-)40' elevation. A total of 22 anomalies were found at the (-)40' elevation. A drawing has been provided showing the locations of all these anomalies. 2. A dent 12"L x 12"W x 2"D was found on HZ A1-A2 at (-)90' elevation, 7' from leg A1 from 12:00 to 10:00. 3. A linear indication 3"L x 0.375"W was found on HD B3/B4 to B4 at (-)243' elevation, 30' from the mid pt. of B3/B4 at 12:00. 4. A hole 1"L x 2.5"W was found on VD B3/A3 at (-)189' to B3 at (-)140', 19' from the mid point of A3/B3 at 9:00. 5. The VD A2 at (-)140' to A3 at (-)90', 5' from A2 is buckled from 7:00 to 3:00. 6. A dent 16"L x 8"W x 2"D was found on VD A3 at (+)10' to A4 at (-)40', 12' from leg A3 at 12:00. 7. A dent 9"L x 5"W x 1.5"D was found on VD B4 at (+)10' to B3 at (-)40', 20' from leg B4 at 12:00. 8. The weld on VM A1/B1 at (-)40' to A1/B1 at (-)90' is broken at the (-)40' attachment to the HZ. 9. A gouge 3"L x 0.25"W x 0.125"D was found on HZ B4-B3 at (-)90' level, 24' from leg B4 at 3:00. 10. Several dents 29"L x 13"W x 3.5"D were found on VD from B3 (-)40' to B3/A3 (-)90', 24' from leg B3 at 12:00.

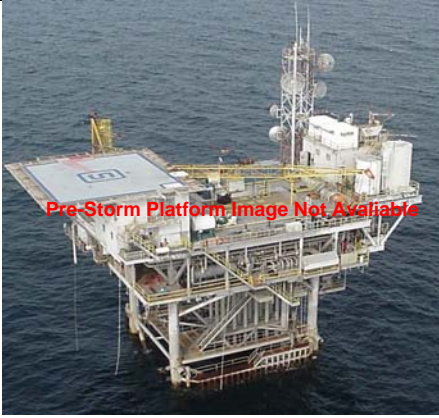
Platform Damage Summary			
Platform	Main Pass 306 F		
Operator	Noble Energy, Inc.		
Platform Description			
Water Depth	293 ft

Deck Height	49 ft		
No. of Slots	18		
No. of Conductors	Not Documented		
Installation Date	1977		
API 2A Assessment Category	L2		
Jacket Type	Platform		
No. of Piles	4 Piles and 4 Skirt Piles		
Distance from Shore	31 mi		
Bracing Configuration	Long Frame: The center bay has XH bracing throughout, on both faces. The end faces have / bracing. Tran Frame: Both the faces have XH bracing, throughout.		
Storm Exposure			
Min. Distance/Direction from Eye	27 mi	Maximum Storm Surge	1.0 ft
Maximum Wave Height	74 ft	Maximum Wind Speed	67 kts
Significant Wave Height	42 ft	Current Speed	1.5 ft
Wave Crest Elevation	45 ft		
Storm Damage			
Structural Damage	Yes	Evidence of Wave in Deck	No
Structural Damage Description	Damage surveys following the hurricane revealed several anomalies to the platform in the upper four cross braces on row A & row B. Damage to the horizontal framing at the (-)28' and (-)75' levels were also discovered. A total of 22 anomalies were discovered. The complete description of the anomalies, as well as drawings of the anomalies are available in the report.
