**UNDERWATER INSPECTION
OPERATIONS REPORT**

CHEVRON PLATFORMS

ST 130 A	INSP. NO 93/070	11/11/93
ST 130 QTRS.	INSP. NO 93/071	11/18/93
ST 151 K	INSP. NO. 93/072	11/16/93 11/17/93

**Chevron's Structures
ST 130 A, ST 130 QTRS, ST 151 K**

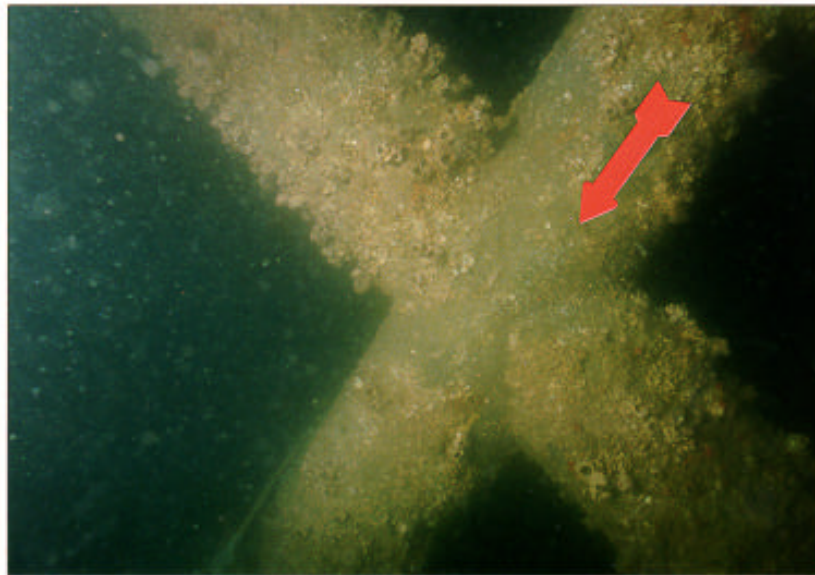
Roll #1-F2 D1/D2 "X" brace taken from outboard side of "X"

D1/D2 -15' "X" brace; no cracks on "C" side, outboard side cracked (See Photos #2 and #3)

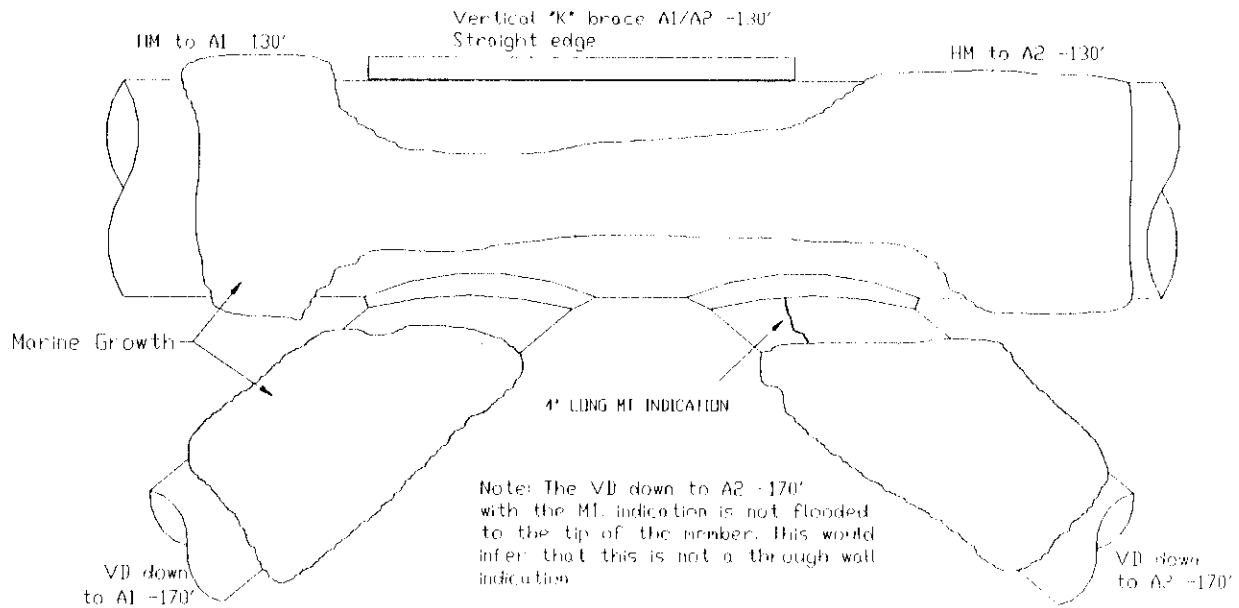
Initially, four nodes were selected for MT inspection. No indications were found on three of these nodes. The "K" brace from A1 -130' to A2 130' had one indication. This member was also one of the flooded members. The member was not completely flooded inferring that the MT indication was not a through wall defect. See MT form number MT-ST130Q #1.

MT Indication : Y (Yes)(No)	MT Indication ID Number : VD MP A1/A2 -100' TO A2 -130'
Clock Position : 11 To 11	Indication's Location Weld : B Tow Haz Bead B Brace Chord
MT Length : 4 Inches (Meas.) (Est.)	Orientation : T Longitudinal Transverse Both
Particle Build-up : H Heavy Moderate Light	Confirmatory Grinding : N (Yes)(No)
Particle Adhesion : S Strong Moderate Weak	Re-Test Indication : N (Yes)(No)
Depth Estimate on Particle Appearance : <1/16 < or > 1/16"	Remedial Grinding : N (Yes)(No)
