# Hurricane Lili's Impact On Fixed Platforms

**June 2004**

**Minerals Management Service**

**ABSC Project No.: 1200044**

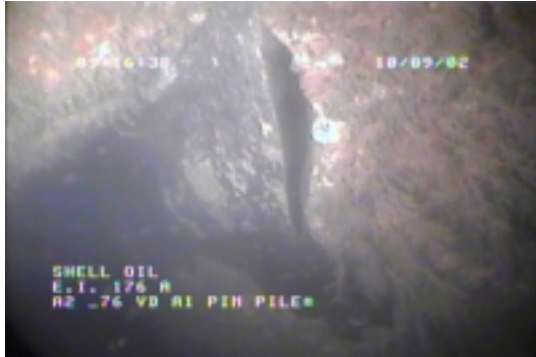
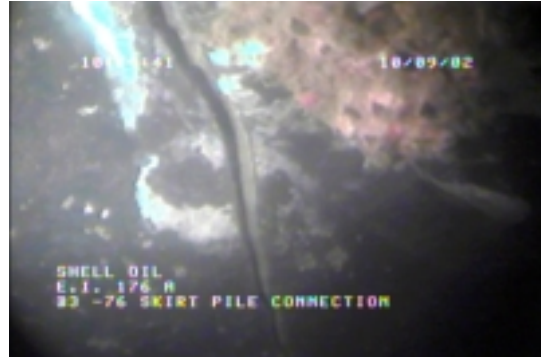
Subsea inspections identified major cracks and tears in the vertical diagonal connections from the main jacket legs to the skirt piles (see the photos below). The platform was non-producing and it was felt that removal was the best option. This was planned for the summer of 2003.

Damage to EI-276-A-VALVE identified during subsea inspections at connections between the skirt piles and the main jacket

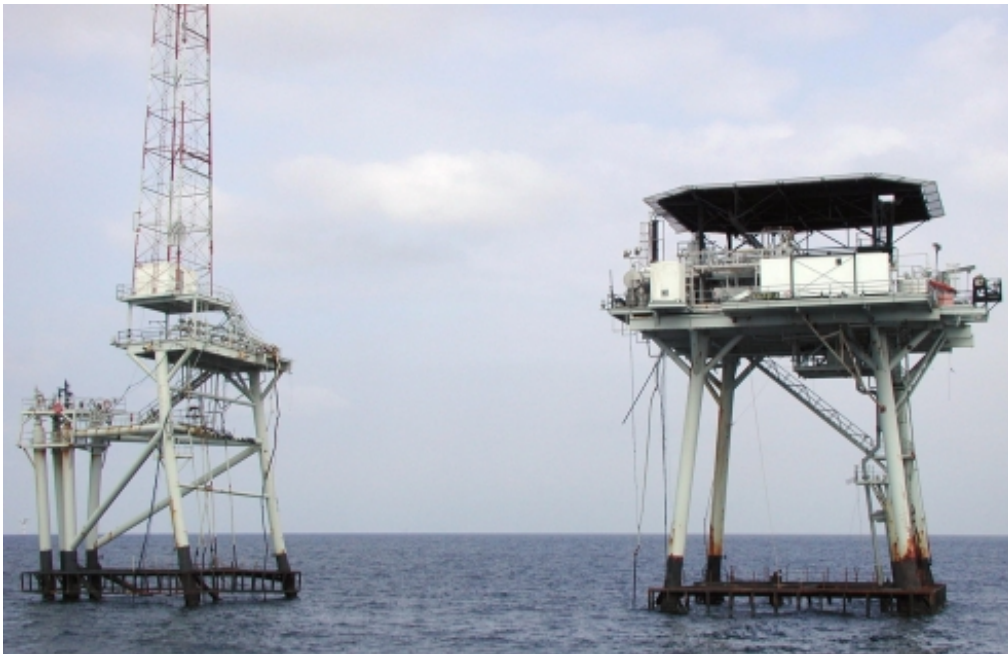
**EI-231-CA is on the left. This is a post-storm photo and the bridge that used to connect the two facilities was destroyed in the storm.**

ChevronTexaco elected not to repair this facility and it was removed in October 2003.

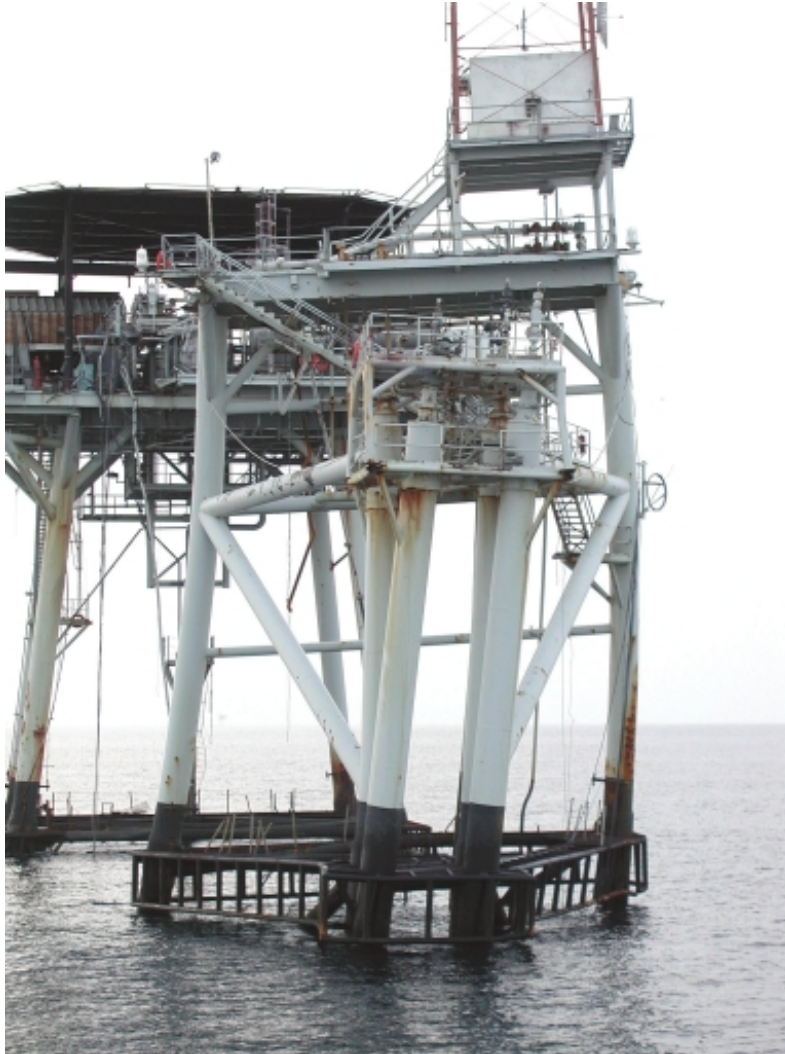
**Note the gross permanent deflection of the structure in this post storm photograph of EI-231-CA**

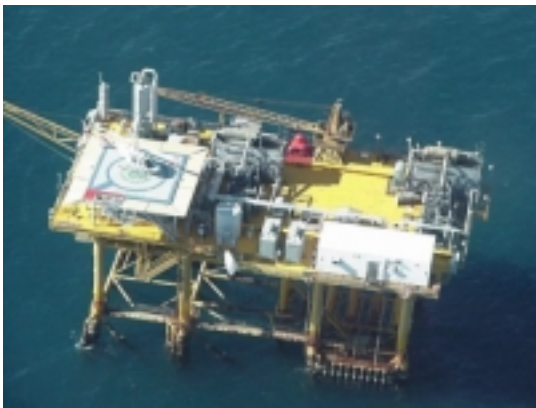
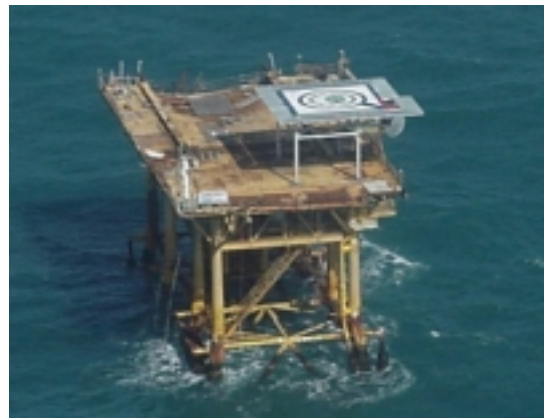
**EI-273-A shown before the storm (left) and after the storm (right). The deck damage apparent in the post-storm photo is due to a well fire incident in 2001. Storm damage is evident in the survey images below.**

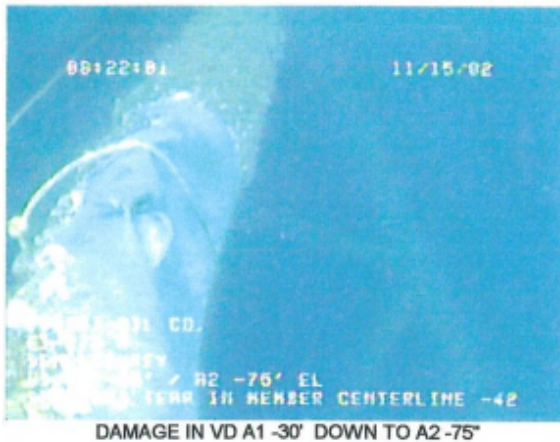
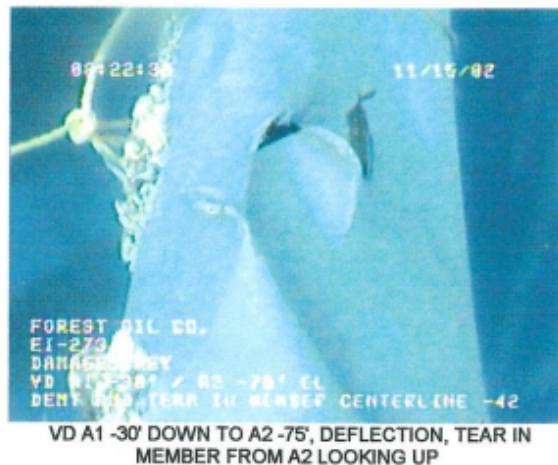
**EI-273-A damage identified during post-storm subsea survey to vertical diagonal member between El. (-)30 and El. (-)75. Damage is believed to be from impact with falling object.**

Analysis of the structure was performed using Sudden Hurricane loads per API RP 2A, Section 17 and additional underwater surveys were performed on highly stressed joints. No additional damage was found. Clamp repairs to the four damaged k-nodes were planned for this structure.

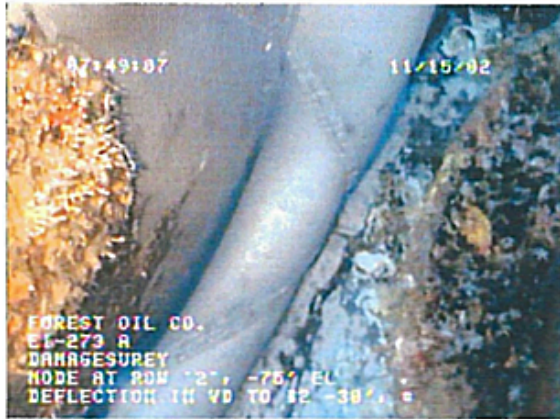
ROW 1 SIDE OF NODE, DEFLECTION IN HZ AND VD B2 AT -30'

EI-273-A damage identified during post-storm subsea survey to k-node at El. (-)75. Note the gross deformation of the steel in the image on the left.

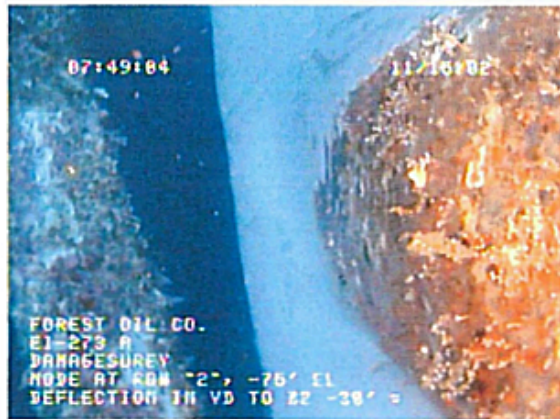
ROW 3 SIDE OF NODE, DEFLECTION IN HZ AND VD TO B2 AT -30'

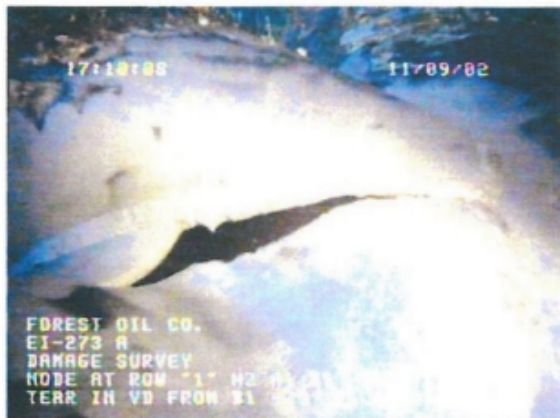
NODE AT ROW 1, HZ A1B1 AT -130', DEFLECTION AND TEAR IN VD FROM B1 @ -75'

EI-273-A damage identified during post-storm subsea survey to k-node at El. (-)130.

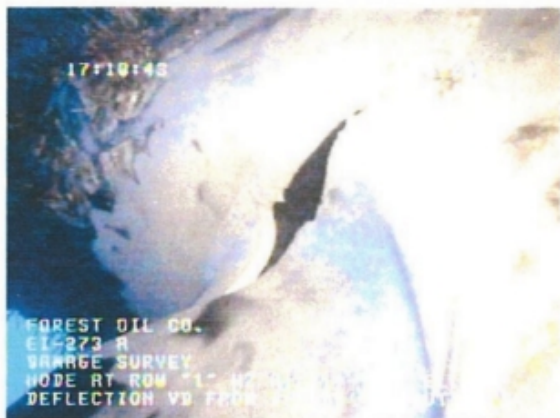
NODE AT ROW 1, HZ A1B1 AT -130', DEFLECTION AND TEAR IN VD FROM B1 @ -75'

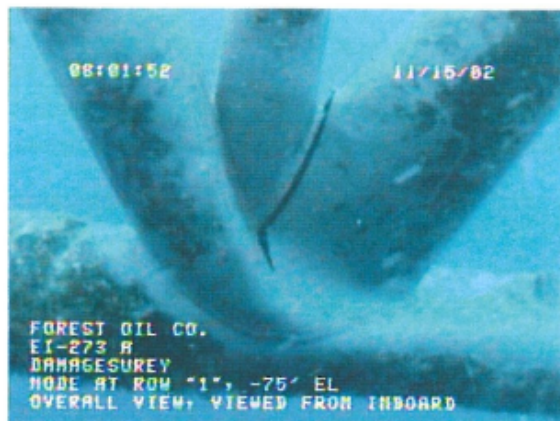
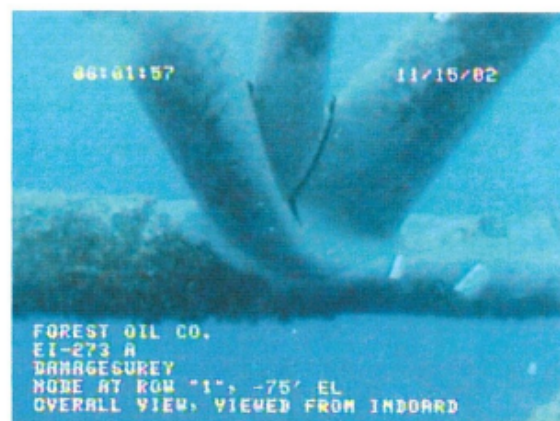
OVERALL VIEW OF NODE, VIEWED FROM INBOARD

EI-273-A damage identified during post-storm subsea survey to k-node at El. (-)75. Note the large crack between the vertical member and the vertical diagonal due to structural overload.

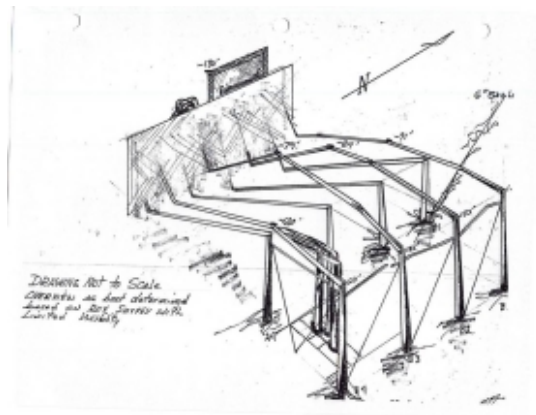
Lili imposed forces on EI-275-A that were much greater than Sudden Hurricane forces and, as a result, the platform collapsed. Due to the assessment process the operator was able to sustain production for an additional 5 years, taking the risk of higher removal cost should the platform be destroyed prior to production ceasing and normal removal operations being completed.

**EI-275-A shown before the storm (left) and after the storm (right) in a sketch based on ROV data. Additional observations indicate that the deck had separated from the jacket – a typical result when waves hit the deck.**

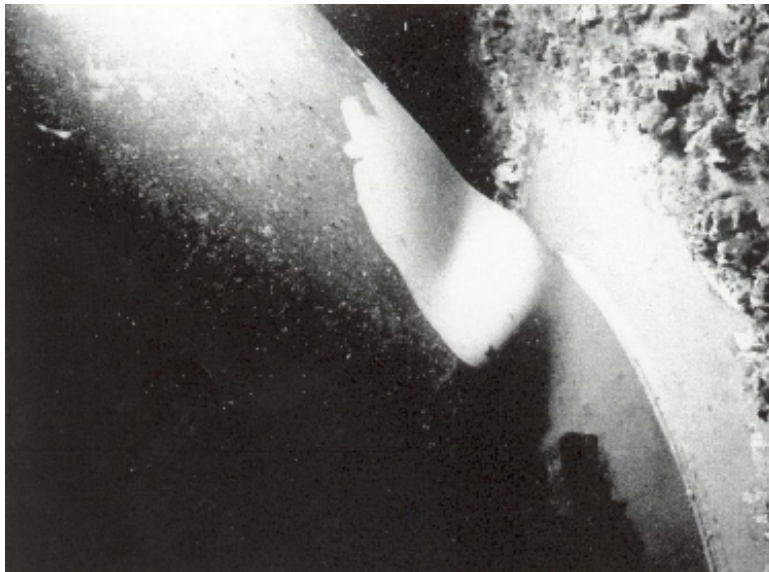
**EI-276-B-Aux damage identified during subsea survey after the storm shows buckling to vertical diagonal brace.**

These repairs were completed in May 2003 and the platform is again operational. In order to limit exposure of personnel during the repairs to possible platform failure due to large waves, , the AUX facility was operated only during periods when a 12-hour weather forecast showed no seas greater than 12.5 feet.

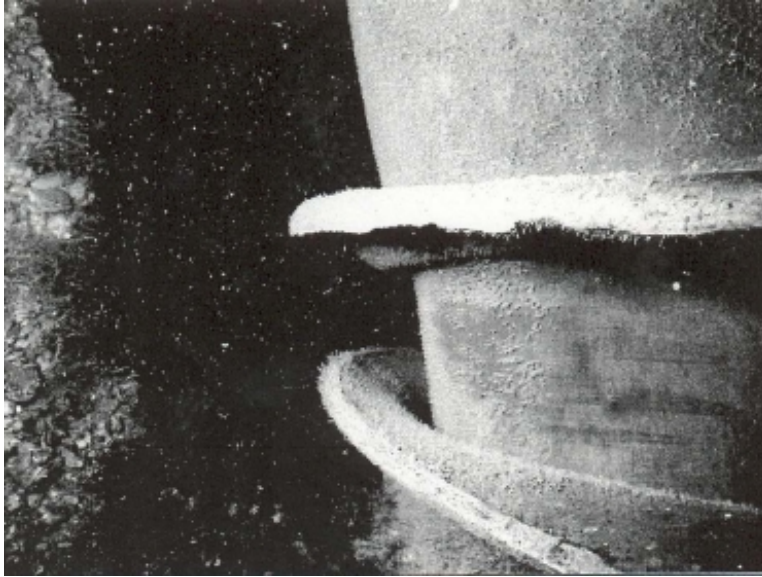
**EI-276-B-Aux damage identified during subsea survey after the storm shows deformation of Leg B2. This photo shows how the leg has been pounded “flat” from the cyclic motions of the platform. The pile can also be seen. The owner repaired this damage using a specially designed clamp.**

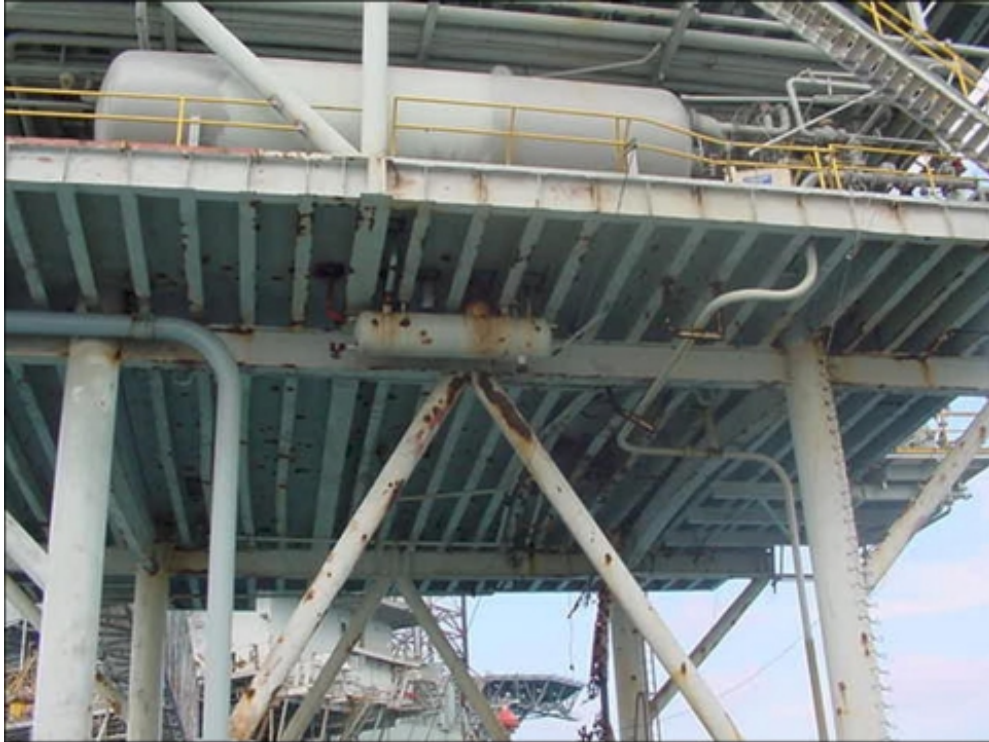
**EI-295-A-PRD deck damage is shown here after the storm. Note the deflected beams on the underside of the deck.**

During assessment, production operations on the “A-PRD” platform were halted and temporary production was established on the “A” platform. After reviewing repair alternatives, the decision was made to permanently abandon operations on the “A-PRD” platform and establish permanent production facilities on the “A” platform including relocation of two risers from “A-PRD” to “A”. The platform and bridge were removed in the summer of 2003.

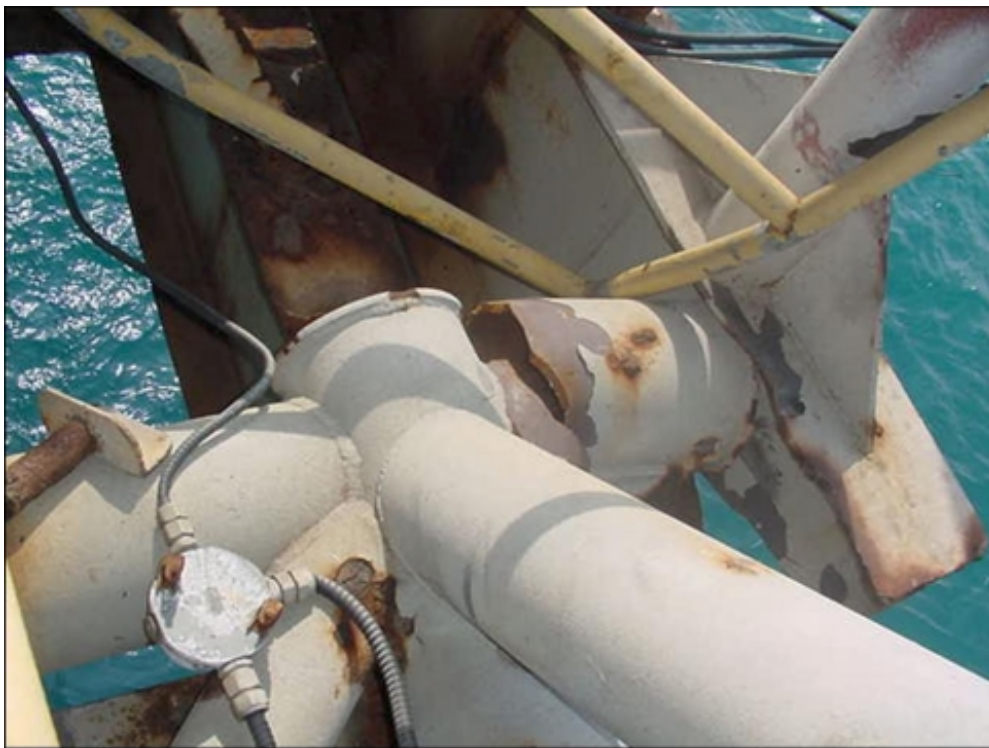
**EI-295-A-PRD bridge damage is shown here after the storm. Note the cracked brace in the center of the photo. The bridge deflected several inches during the storm.**

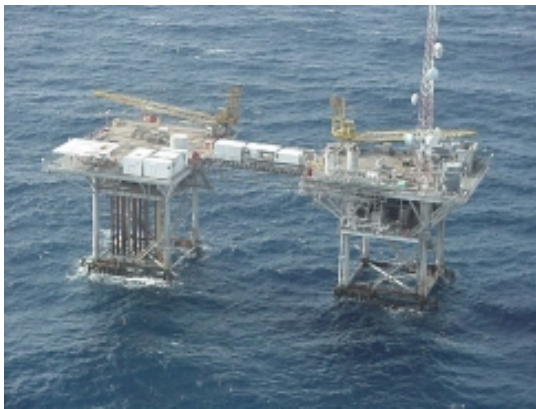
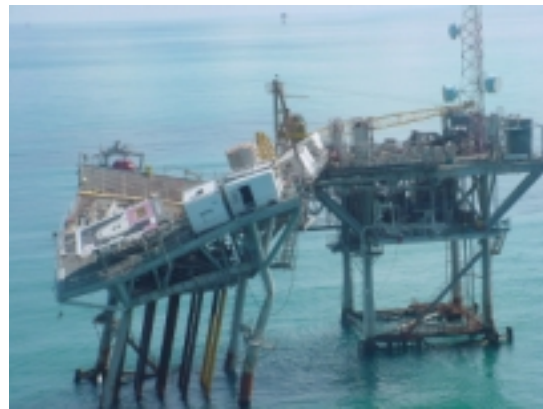
**EI-322-A shown both before the storm (left) and after the storm (right).**

BP determined that they needed to abandon this platform and have work to develop a safe process in which to stabilize the system while the wells could be plugged and abandoned, the topsides equipment removed and the platform ultimately toppled in place. BP also elected to topple the drilling platform. Both platforms were successfully toppled in May 2004. See also OTC 2004 paper Number 16801.

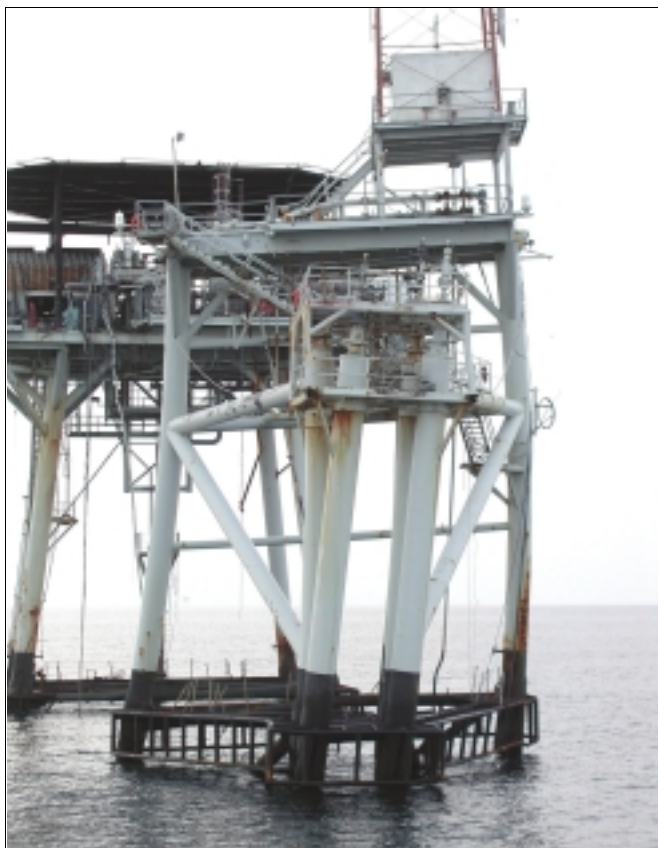
Figure 2 – Leaning Platform

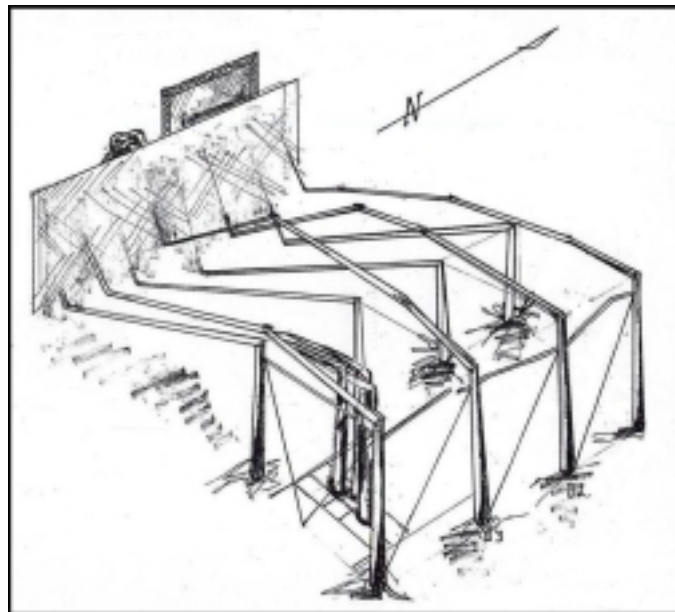
Figure 4 - Eugene Island Platform After Lili. Sketch based upon diver, ROV and sonar data.

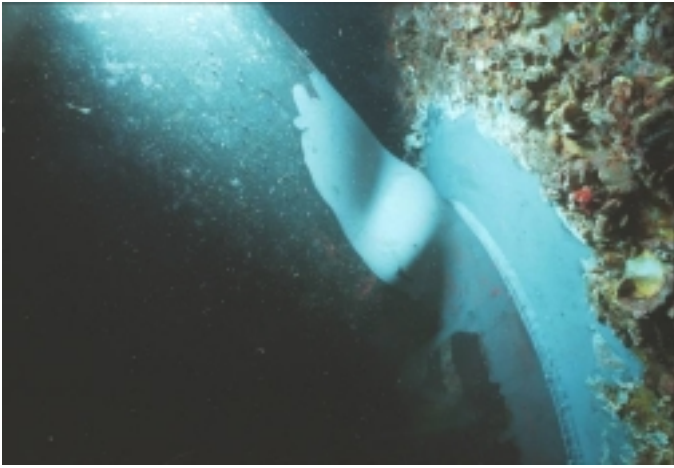
Figure 5 – Local Buckle of a Brace near a Joint

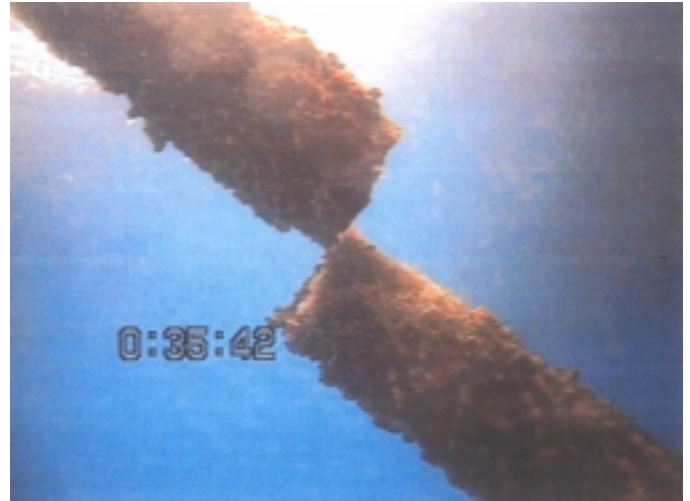
Figure 7 – Severed Brace

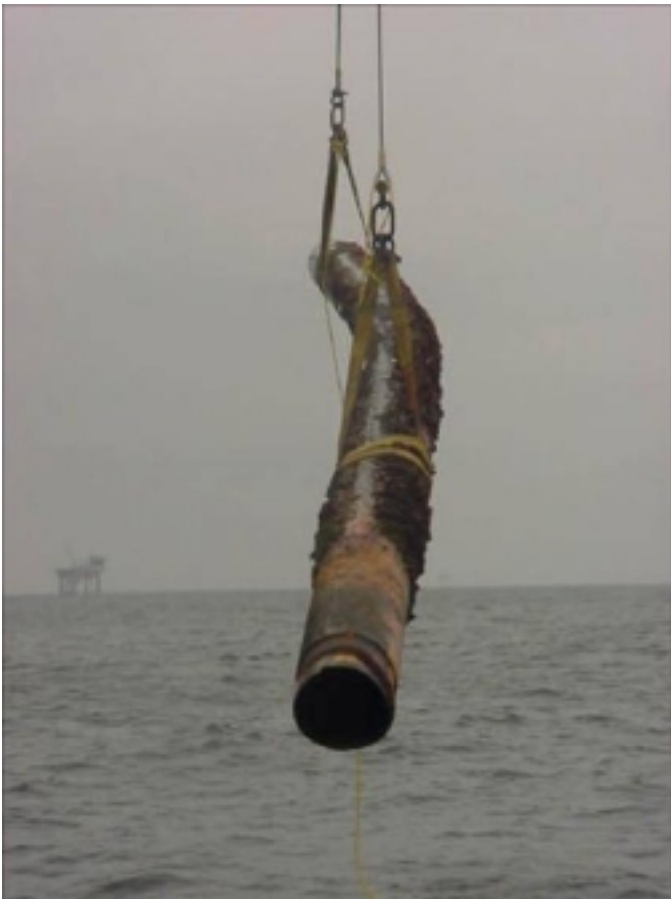
Figure 6– Global Buckle of Brace. Picture taken during removal.

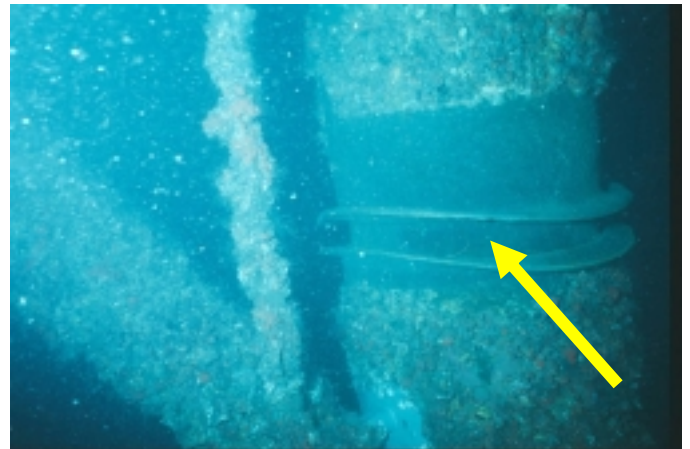
Figure 8 – Severed Leg. Arrow shows exposed pile.

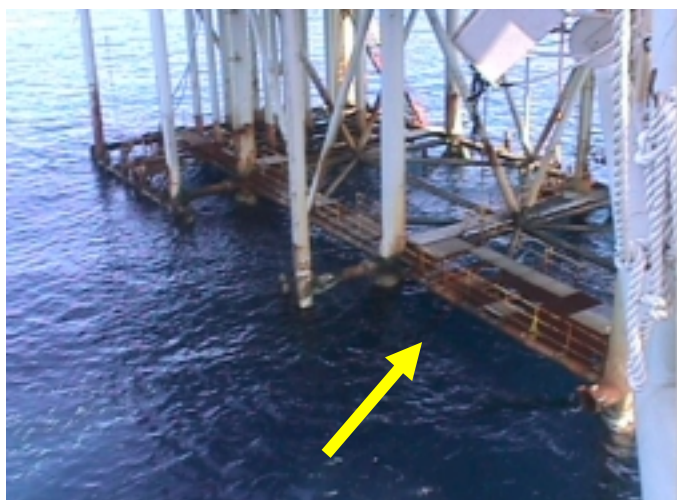
Figure 9 – Missing Boat Landing

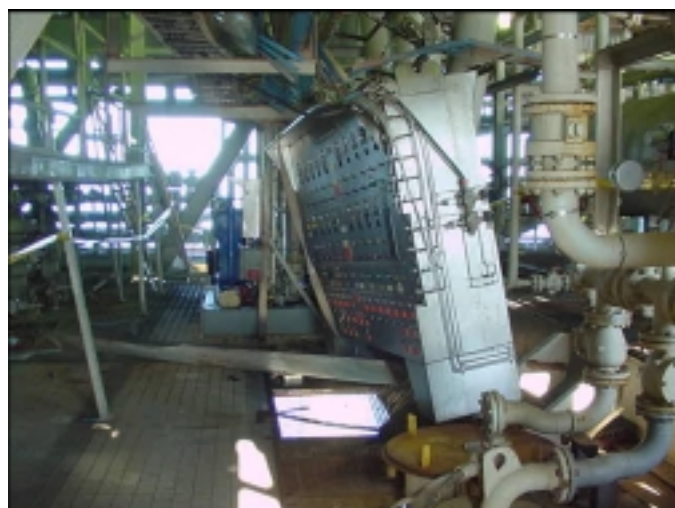
Figure 12 – Damaged Equipment from Wave-in-Deck Forces

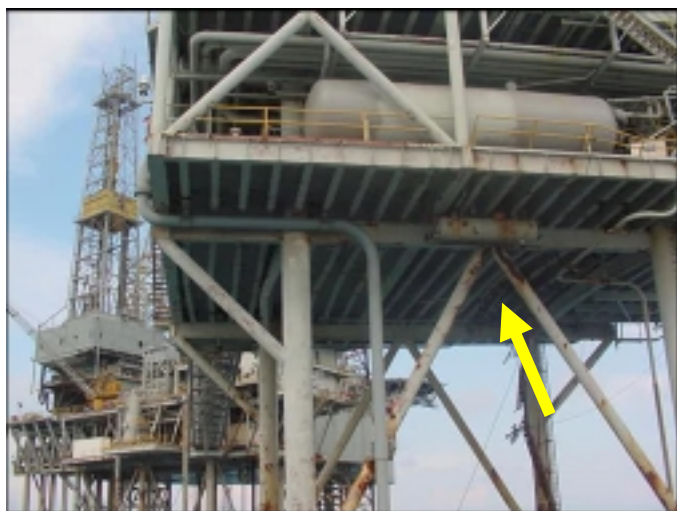
Figure 10 – Bent Beams Under Deck

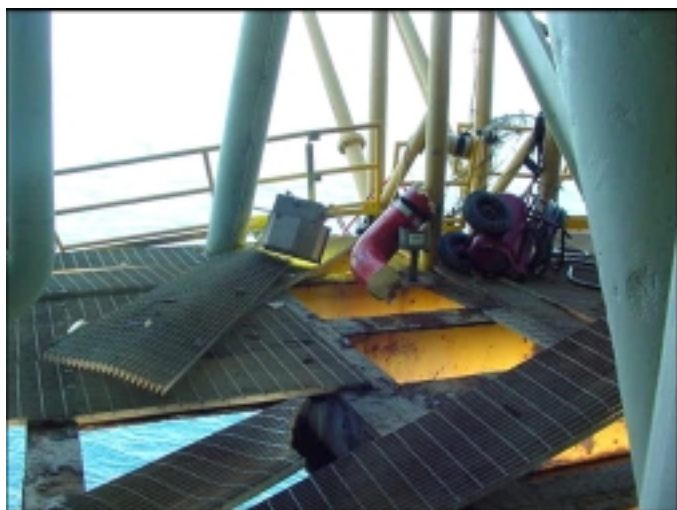
Figure 11 – Displaced Grating from Wave-in-Deck Forces
