**BURNED-AREA REPORT**

A. Fire Name: Buckweed

B. Fire Number: CA-LAC-0723185

F. Forest: Angeles

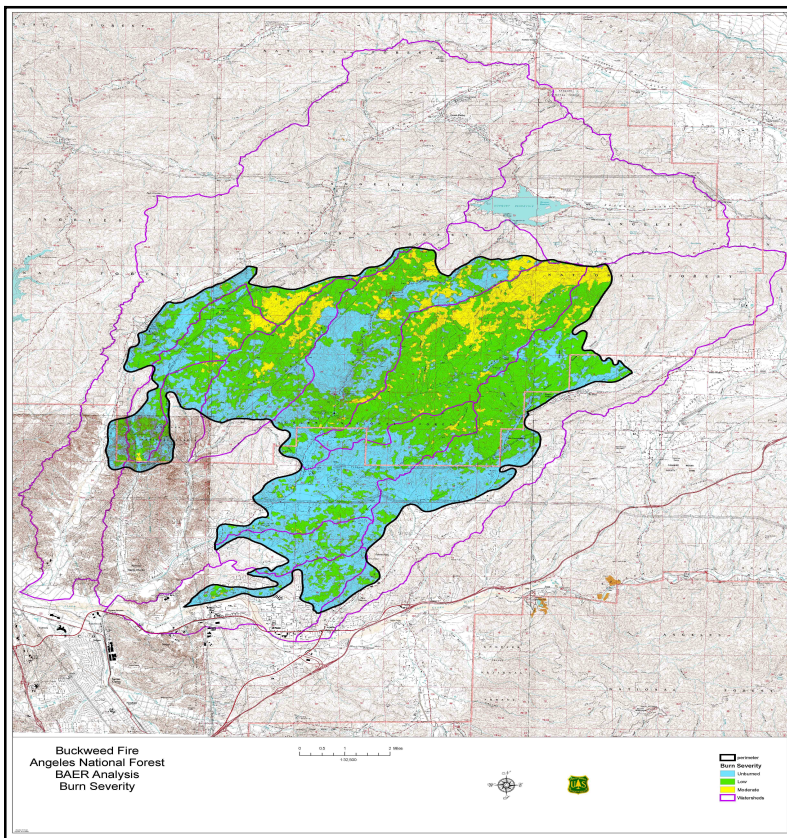
Figure 1 Buckweed Soil Burn Severity Map

Approximately 10% burned at high and moderate severity (see soil burn severity map below). Forest service lands that burned were 72% and the rest was private ownership. The BAER Team coordinated with NRCS, Los Angeles County agencies, and the City of Santa Clarita in the fire assessment.
