Existing Condition of the Leadville Mine Drainage Tunnel

Leadville Mine and Drainage Tunnel Project, Colorado
Great Plains Region

FINAL DRAFT June 2008

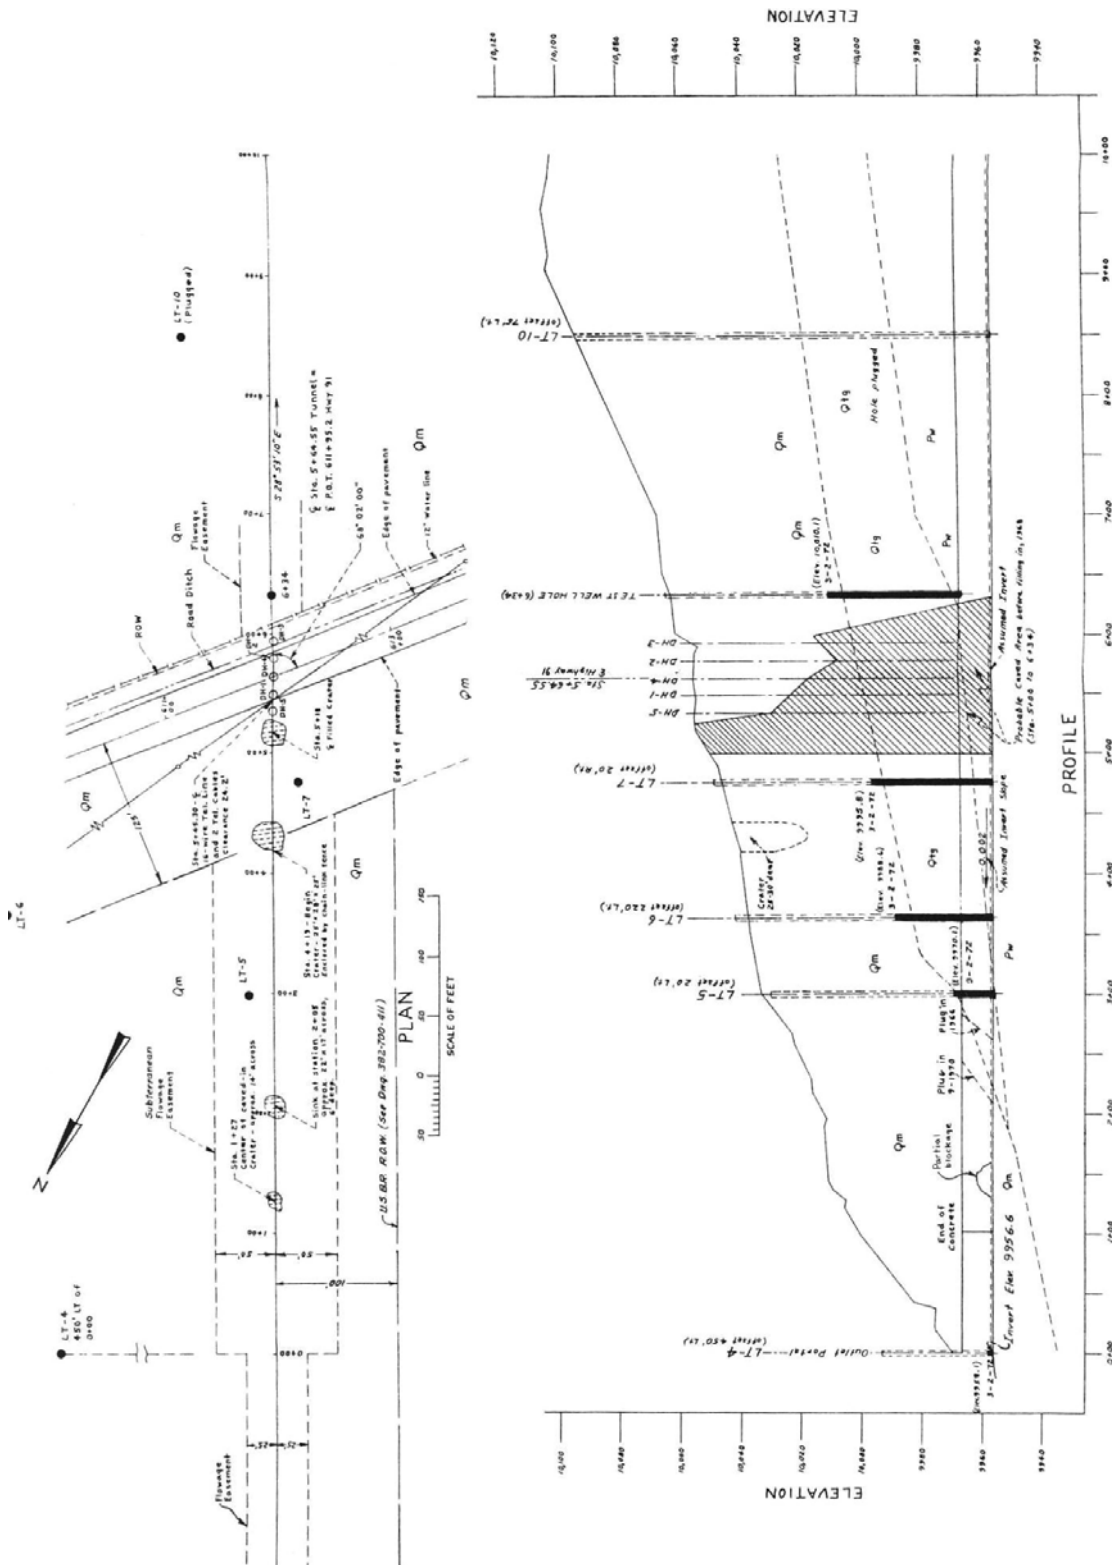
Figure 14. Plan and section showing condition of the LMDT in 1972 including the location of sinkholes, 1968 injection drill holes, and monitoring wells installed in 1968, taken from (Reclamation, 1976).

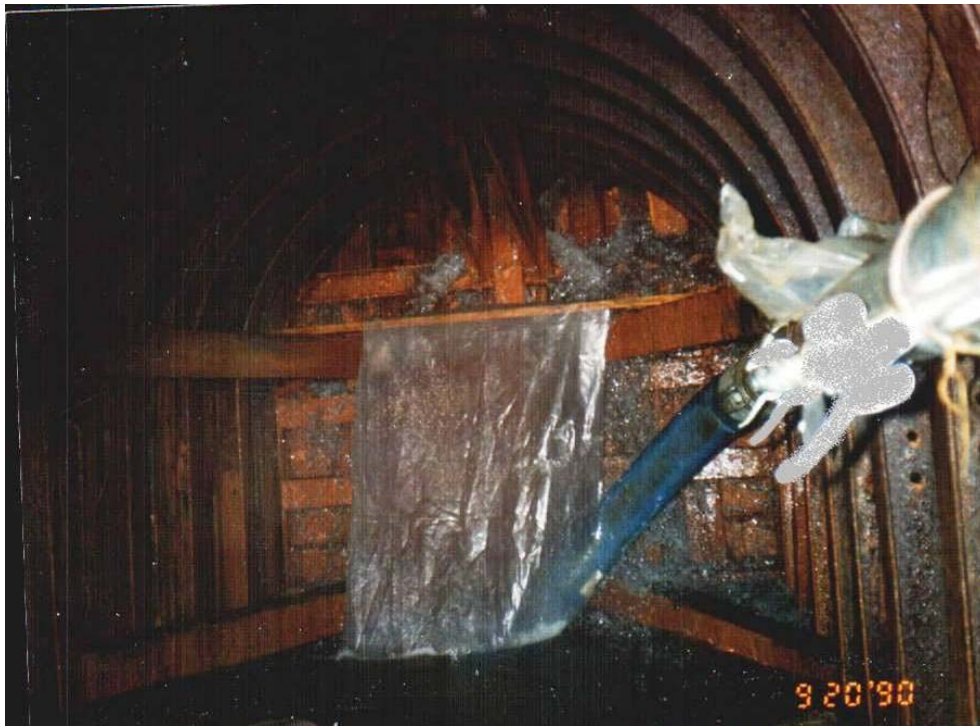
Figure 15. Photograph of the bulkhead located at Station 4+66.

On May 9, 1980, prior to completion of the bulkhead shown in Figure 15, Reclamation visually estimated flows from the vent pipe (250 gpm), cast iron air line (250 to 400 gpm), and there was seepage at the face, for a total of 600 to 800 gpm (Smirnoff and Allen, 1980). Figure 16 shows the locations of the vent pipe and air pipe.

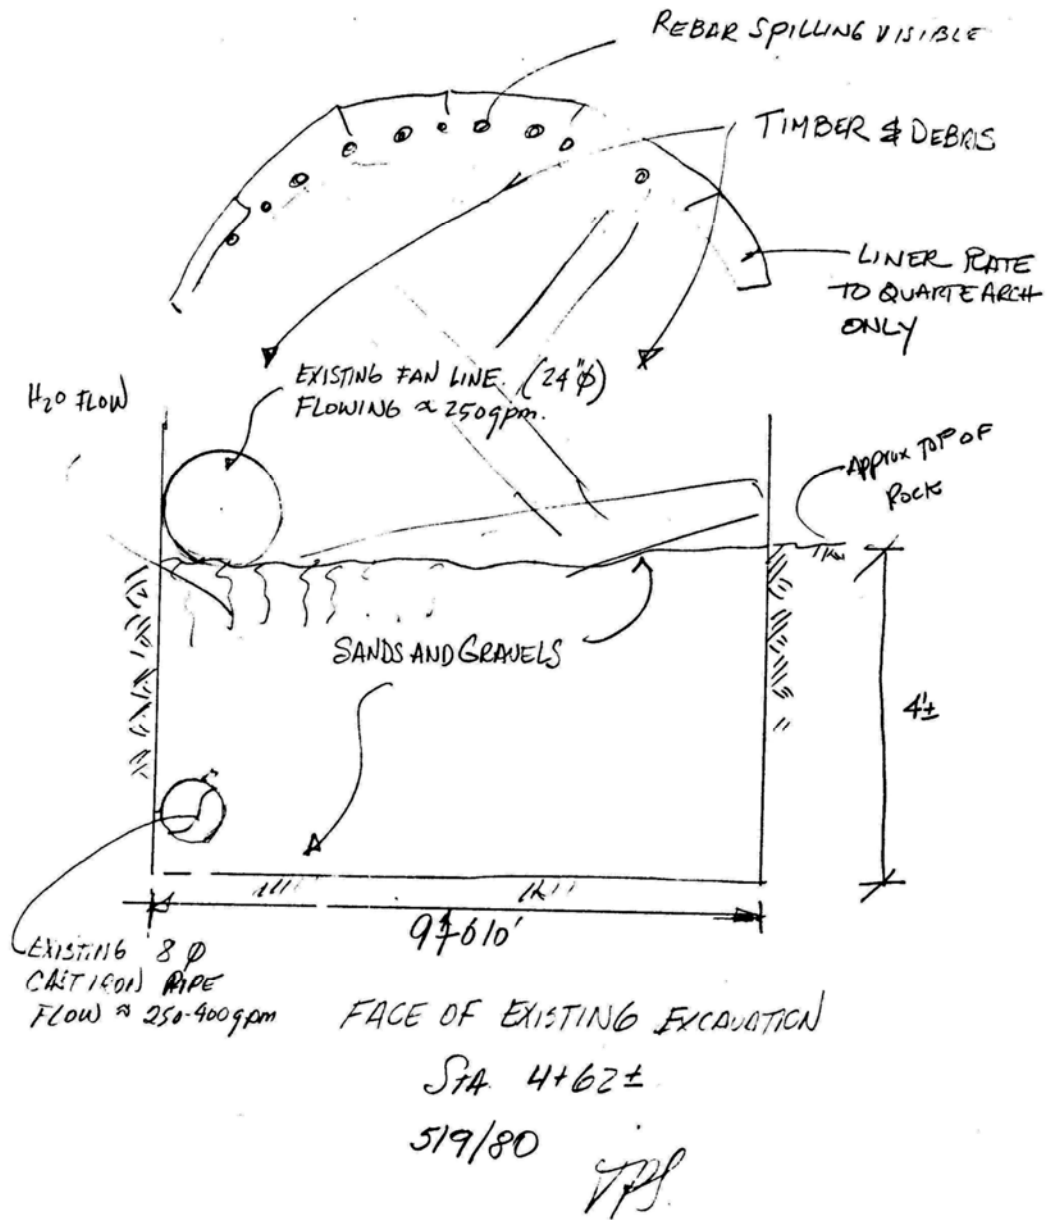
Figure 16. Sketch showing flows from vent pipe and compressed air pipe which extend through collapsed material in the LMDT, taken from (Smirnoff and Allen, 1980).

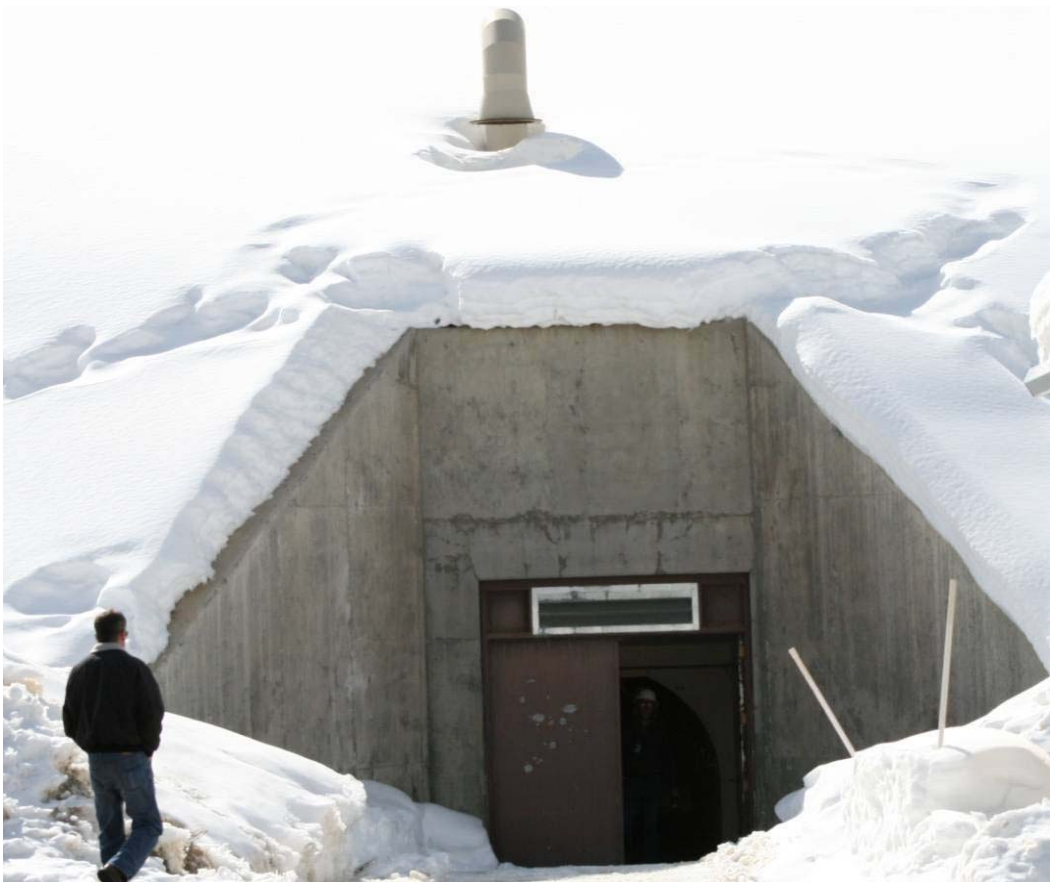
On March 25, 2008, an inspection of the LMDT was made by Reclamation geotechnical engineers Michael Gobla and Jack Touseull, and civil engineer Kevin Atwater for the purposes of evaluating the structural integrity of the portal, tunnel liner, and timber lattice bulkhead. The inspection included the portal structure, drainage ditch, reinforced concrete liner, weep holes, and the timber lattice bulkhead. The concrete is sound and relatively fracture free. One lift line located about 3 feet above the door opening was damp as evidenced in the accompanying photograph in Figure 17. A few short hairline cracks were noted in the portal structure. The portal structure is in overall excellent condition.

Figure 17. Photograph of the LMDT portal structure taken on March 25, 2008.

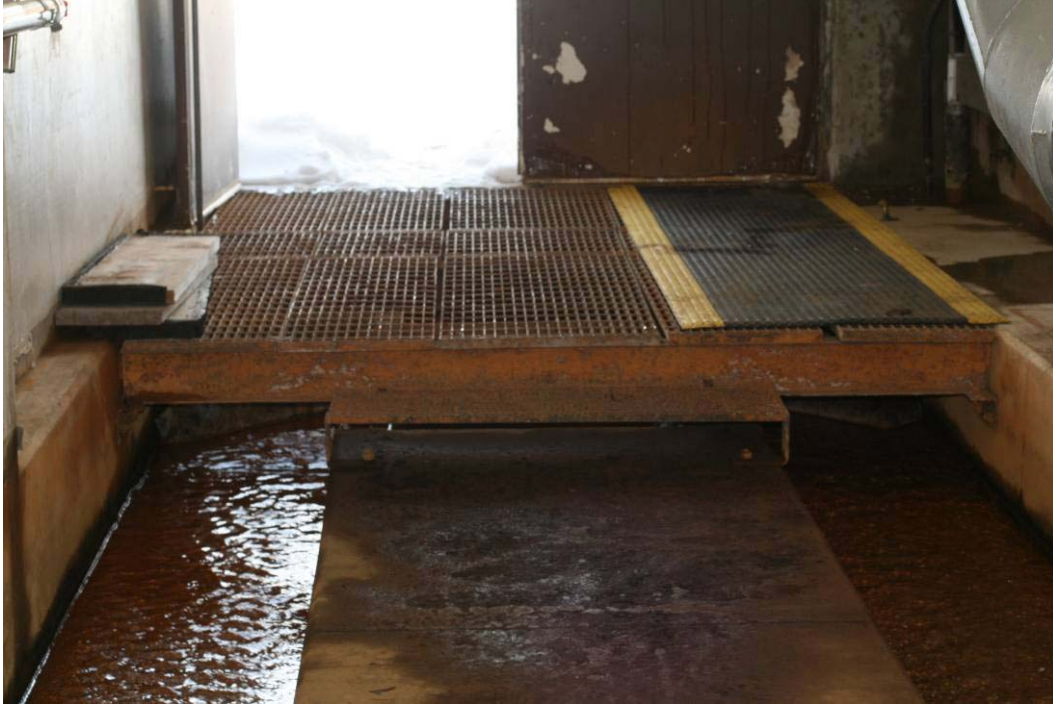
Figure 18. Photograph taken on March 25, 2008 looking at the downstream end of the LMDT showing the concrete center walkway with drainage ditches on either side and steel floor grating.

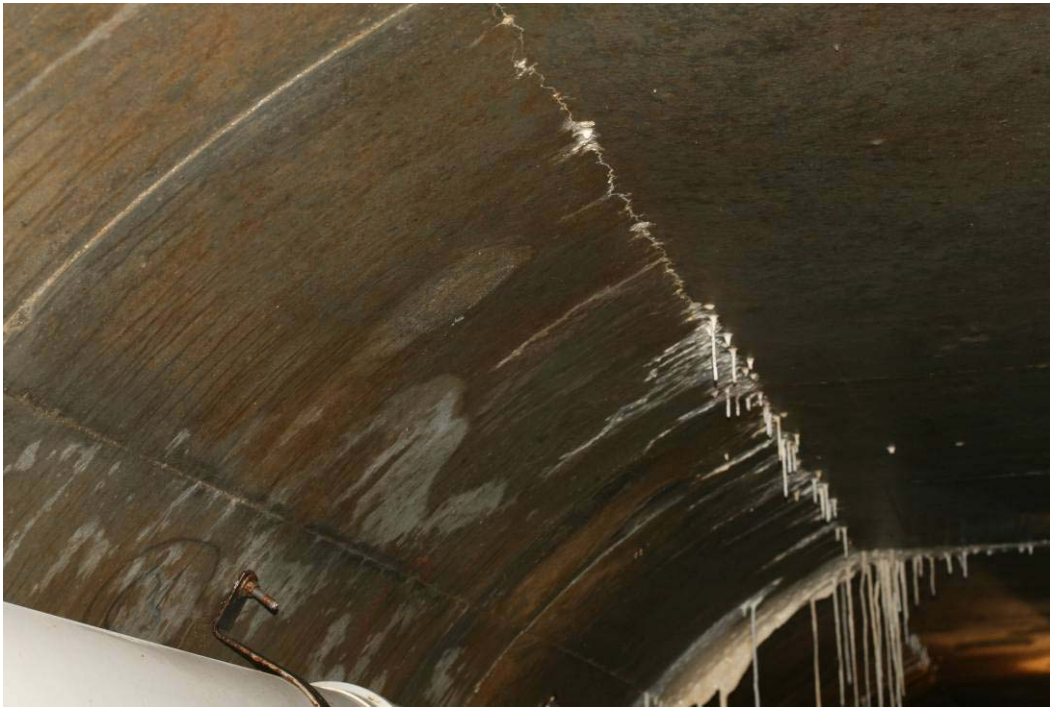
The inside surface of the reinforced concrete tunnel liner in the downstream portion of the tunnel has been coated with a bright white reflective material. The presence of this coating obscures the condition of the concrete. The upstream portion of the reinforced concrete liner (where the liner is under higher soil and water loading) has not been coated. Approximately ten cracks were observed in the concrete lining. The cracks varied from hairline to about 1/16 of an inch wide. The two most significant cracks were found on the left side of the tunnel (looking downstream), one in the crown, (see Figure 20), and one along the wall about 4 feet above the floor. Both of these cracks were about 20 feet long and 1/16-inch wide. A small amount of calcium bearing mineral precipitates are forming from the seepage coming through the cracks. The seepage rates are very slow; at most locations the cracks are wet, but not dripping. The cracks are of little structural concern. Probing with an ice pick it was not possible to dig open the cracks. The concrete is sound and very hard, even right at the edge of the crack. Only one crack near the lattice bulkhead showed minor offsetting of the tunnel lining; at all other cracks, the lining is smooth and even across the crack.

Figure 20. Photograph taken on March 25, 2008 looking downstream from about midway inside the reinforced concrete lined segment of the LMDT. Note the calcium carbonate stalagmites forming from the slow seepage along a thin roof crack and at a joint in the concrete lining.

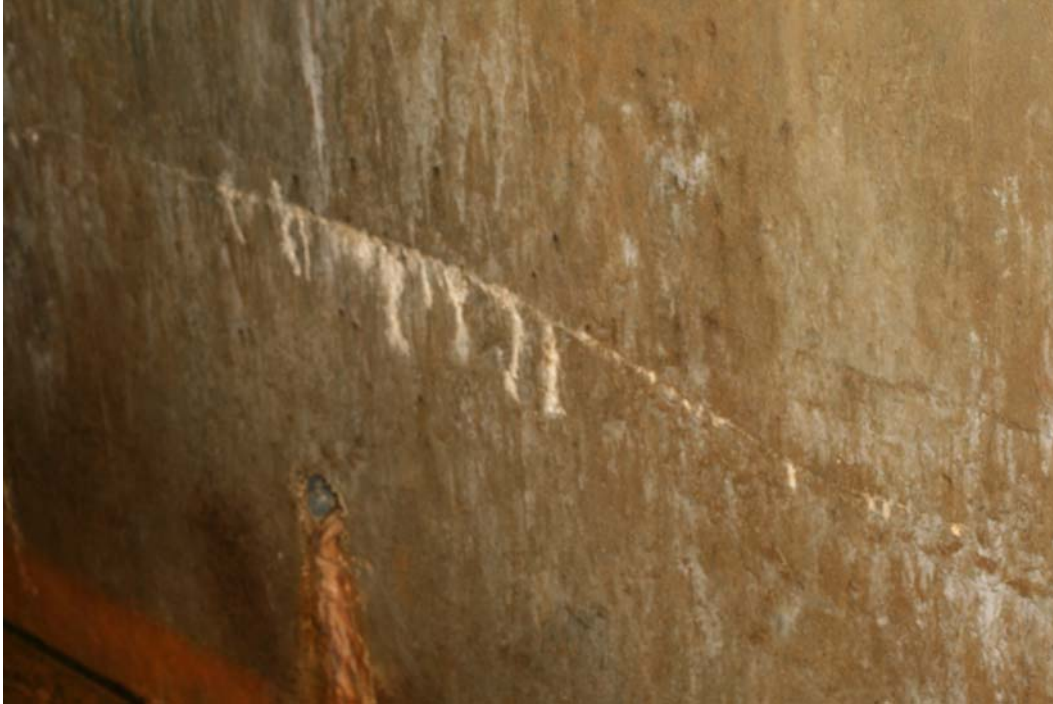
Figure 21. This crack located about 3 feet above the LMDT floor is the only one that showed offsetting of the concrete. The offset is about 1/8 inch.

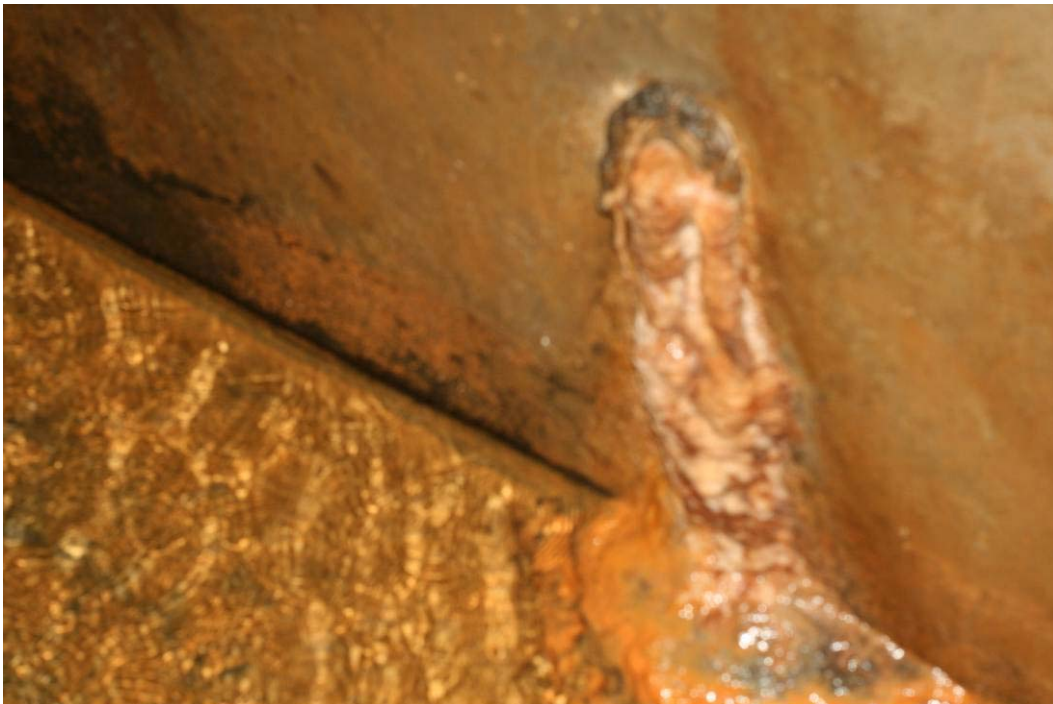
All of the tunnel weep holes show some level of clogging by mineral precipitates. Flow is minimal, and this has been so since their construction. The weep holes were constructed by placing a geotextile-filter-wrapped perforated pipe inside a solid PVC pipe inserted through the concrete liner. Cleaning of the weep holes must be done with care to not rupture the geotextile.

Figure 22. Photograph of a weep hole in the reinforced concrete lining which is almost completely blocked by calcium carbonate precipitates.

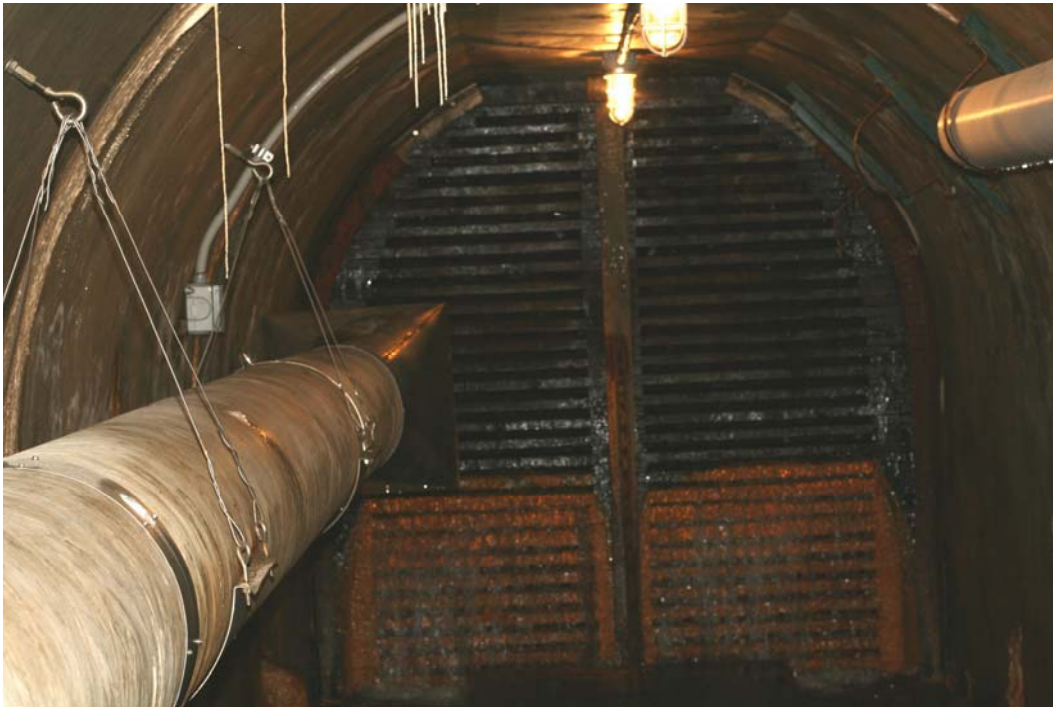
Figure 23. Photograph taken on March 25, 2008 of the cobble and gravel-filled timber-lattice bulkhead at Station 4+61 of the LMDT. At left is the intake end of the ventilation pipeline.

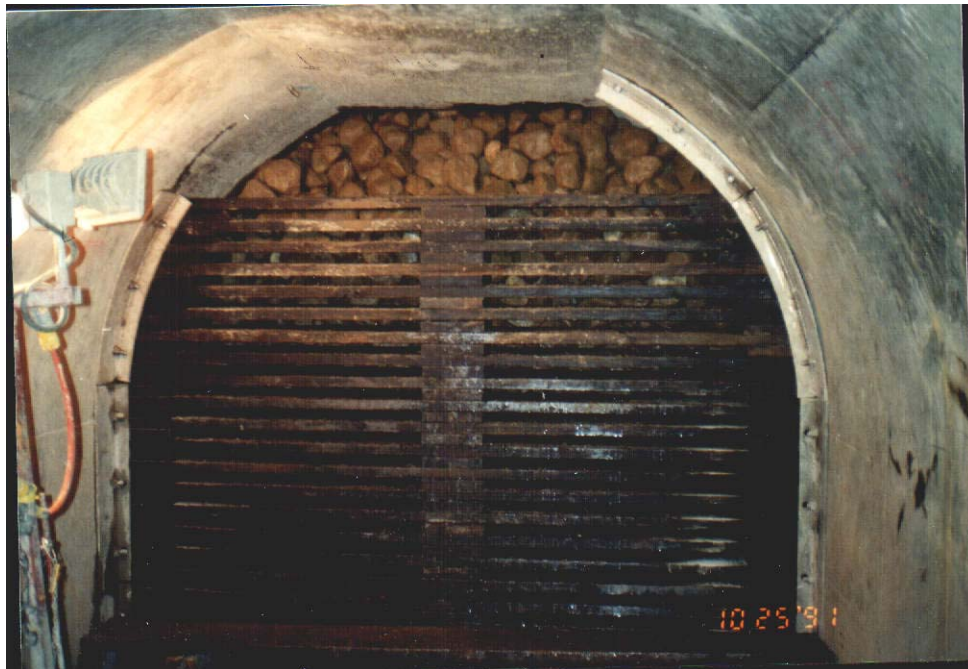
In a Memorandum (Armer, 2001), the stability of the bulkhead at Station 4+60 was evaluated. It was reported that with flow 2.5 feet above the floor (current condition), the bulkhead had a factor of safety of 3.3. If water flow were to rise to the full height of the LMDT, the factor of safety would be greater than 1.0 for the bulkhead assembly.

Figure 26. Construction photograph showing the cobbles behind the timber-lattice bulkhead at Station 4+60 of the LMDT.
