## Potential Failure Modes and Effects Analysis Leadville Mine Drainage Tunnel

Leadville, Colorado  
Great Plains Region

FINAL DRAFT June 2008

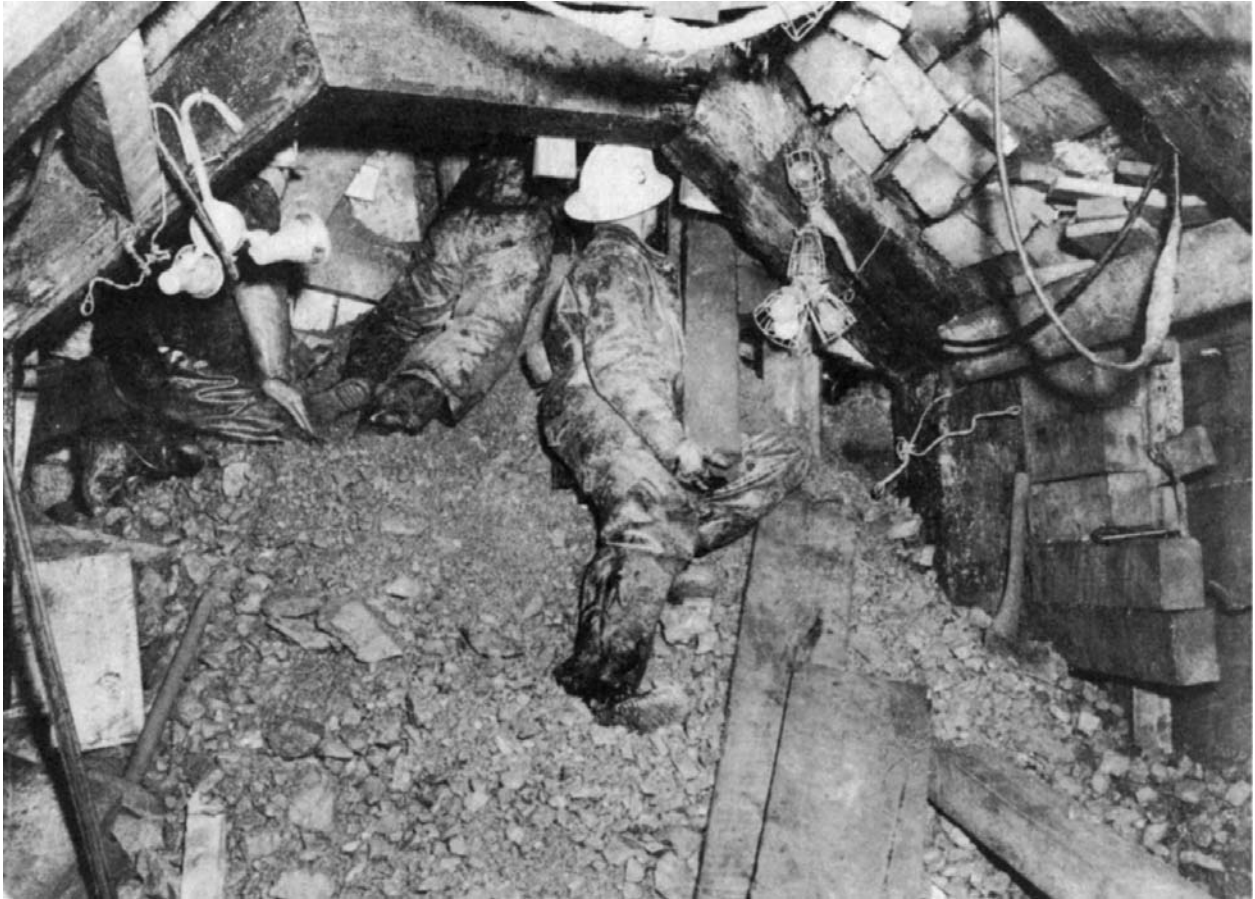
- The debris from the Parting quartzite is likely non-plastic, which would make it more susceptible to seepage erosion. Side pressure, which would increase the normal stress and shear strength of the material comprising the blockage, was not observed during tunneling.

Figure 5. Running Ground in the Parting quartzite (approximate date August/September 1951)

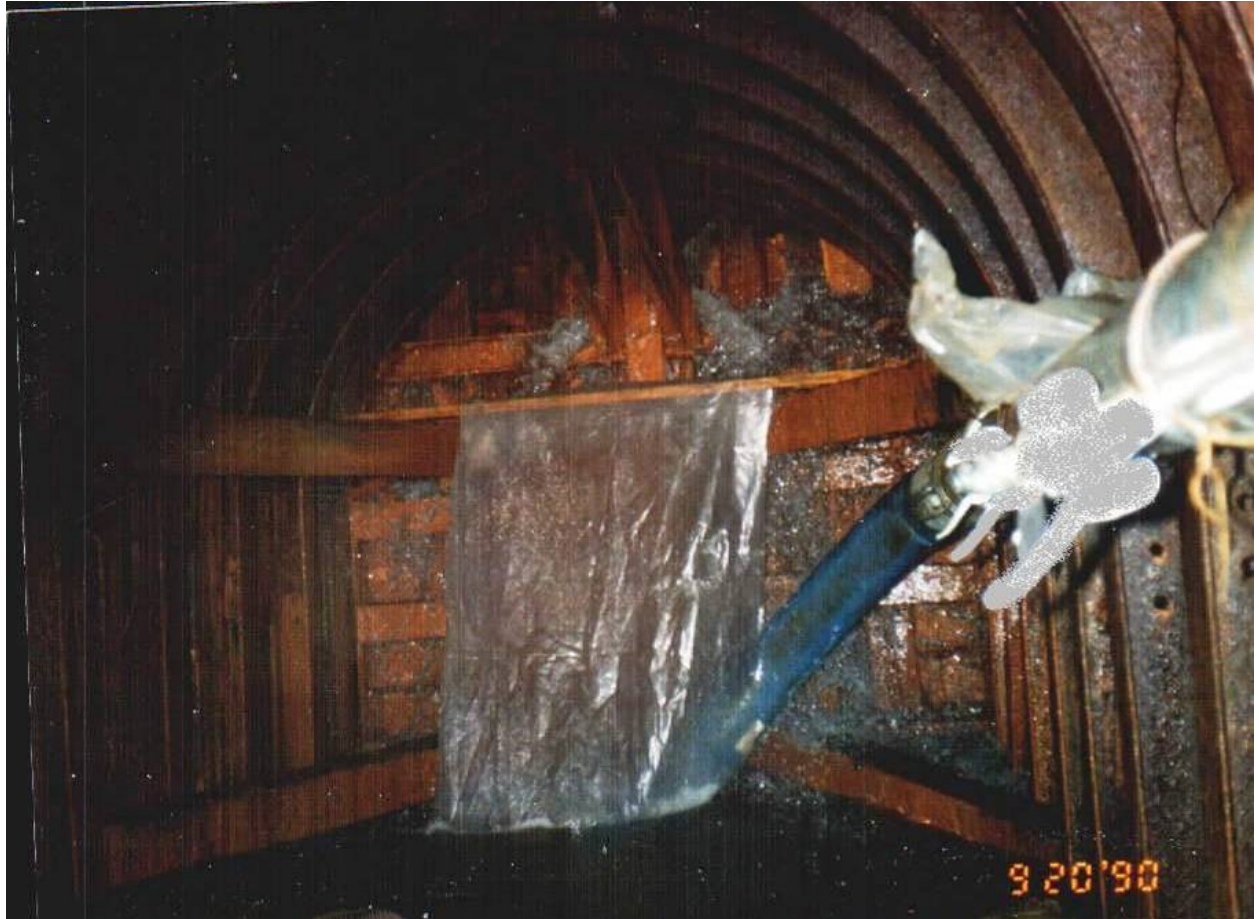
Figure 6. Bulkhead at Station 4+66 (date noted on photo)

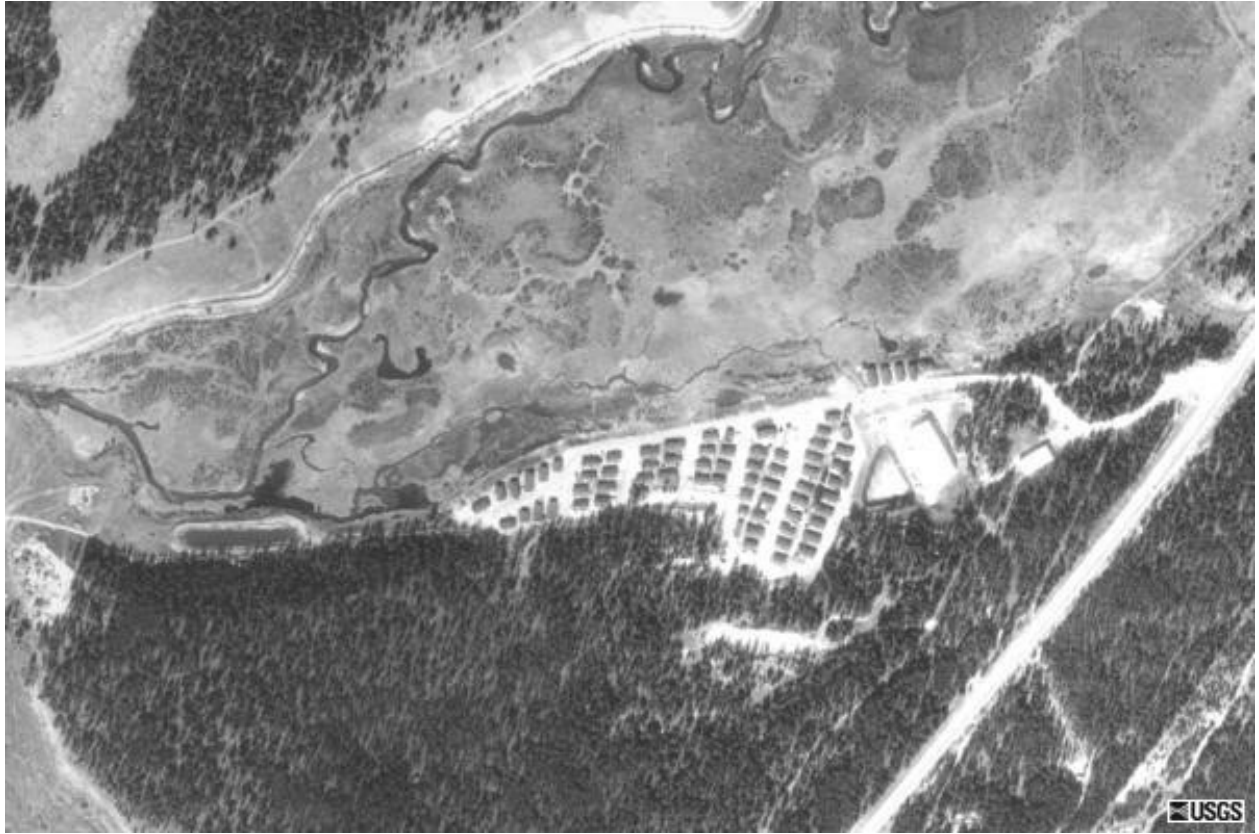
Figure 7. Recent Aerial View of Tunnel Portal Area

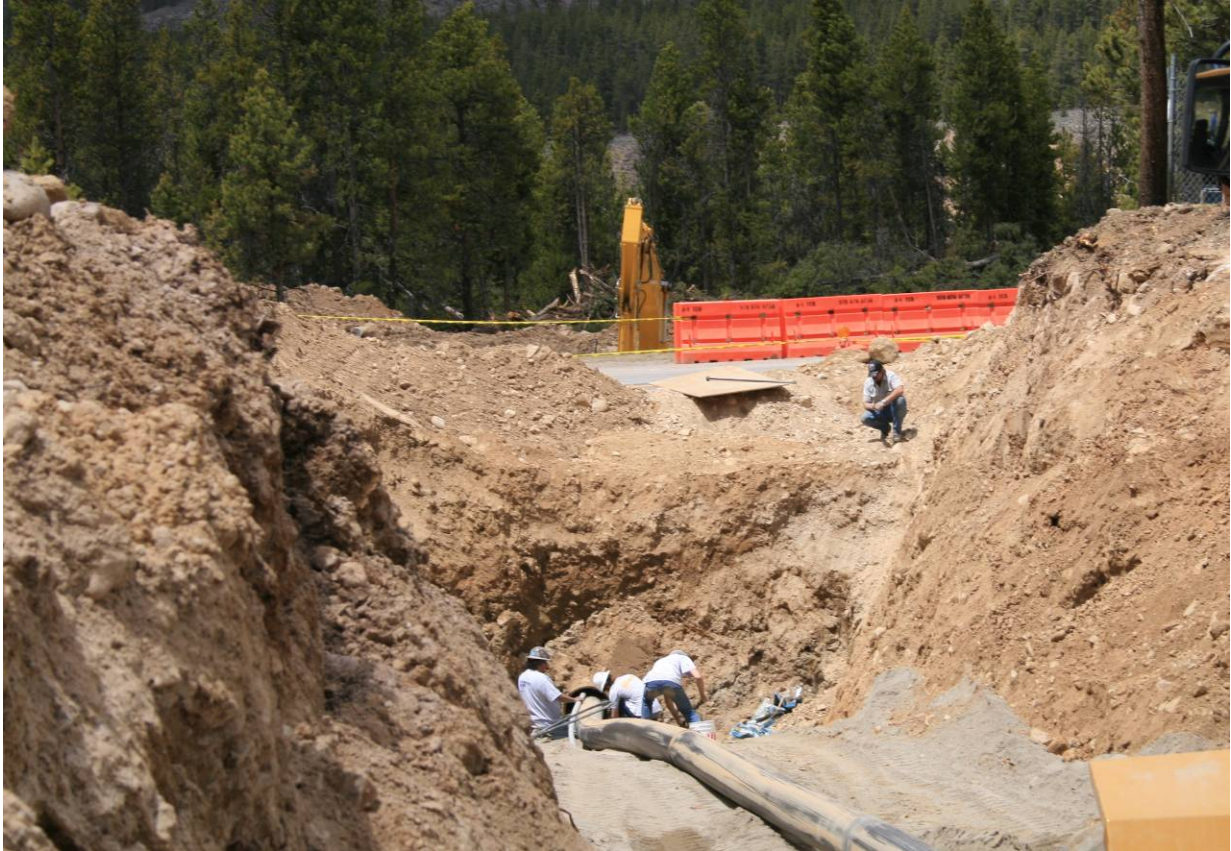
Figure 8. Excavation into the Glacial Moraine at Leadville for installation of a pipeline under Highway 91 along the alignment of the LMDT (late spring 2008)
