Public Meeting

Investigation of the March 23, 2005, Explosion and Fire at the BP Texas City Refinery

March 20, 2007

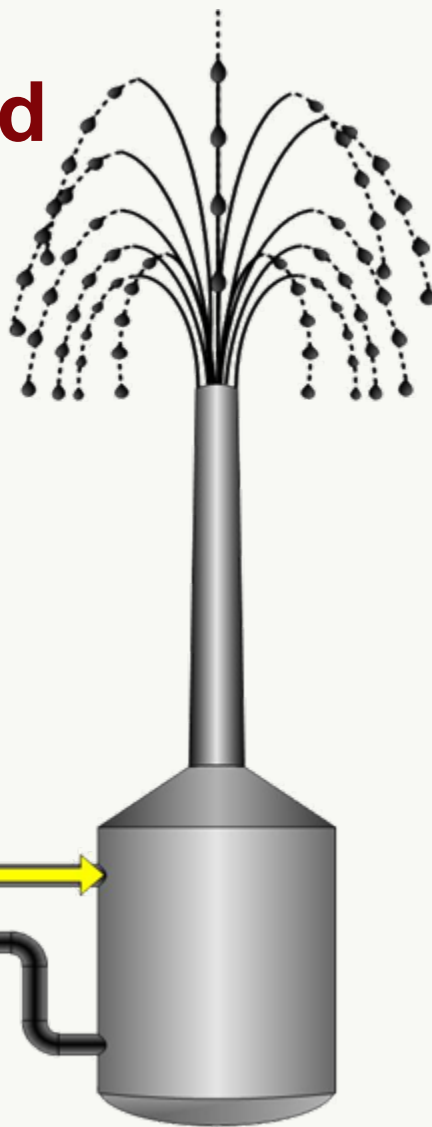
Flammable liquid hydrocarbon release

From raffinate splitter:

51,900 gallons in just over 6 minutes

To sewer:

12,200 gallons

Out the top of blowdown stack:

7,600 gallons in 1.8 minutes

To fill piping and equipment:

31,130 gallons in 4.2 minutes

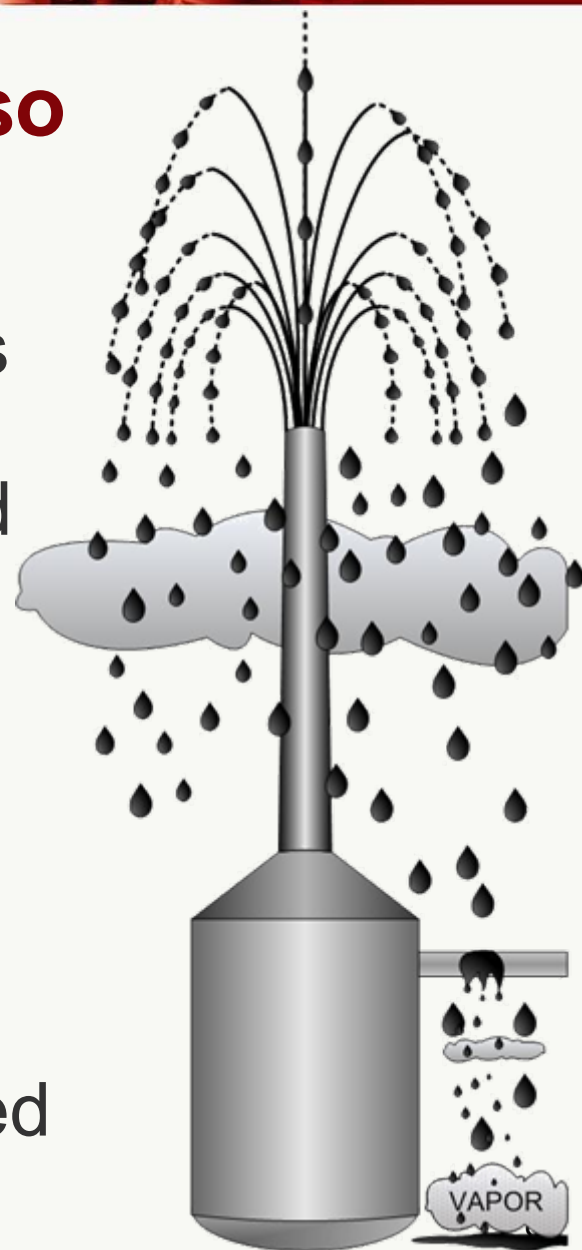
How did the vapor cloud get so large?

- About half the liquid vaporized as droplets were ejected out the stack, dispersed by the wind, and fell to the ground
- Some falling liquid droplets contacted elevated process equipment producing multiple smaller droplets which then vaporized
- Liquid reached the ground, formed a pool and began to vaporize

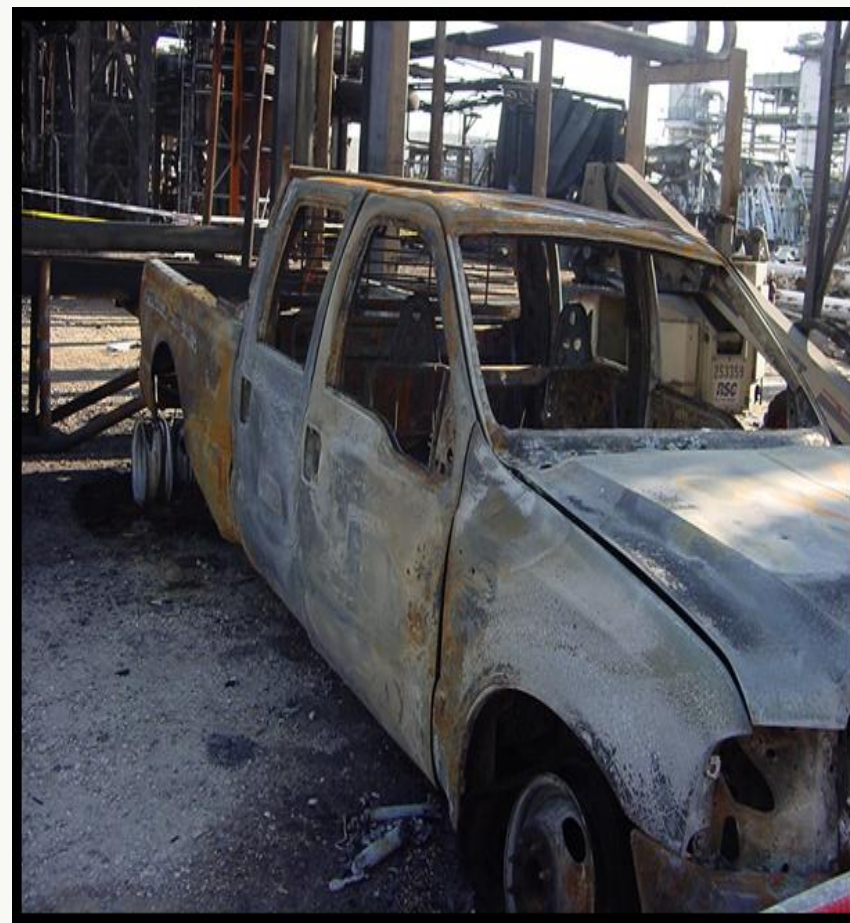
Diesel truck was the ignition source

- Truck parked, but idling, about 25 feet from blowdown drum
- Eyewitness saw engine over-revving and backfiring sparks
- Blast damage analysis and explosion modeling ruled out other potential ignition sources

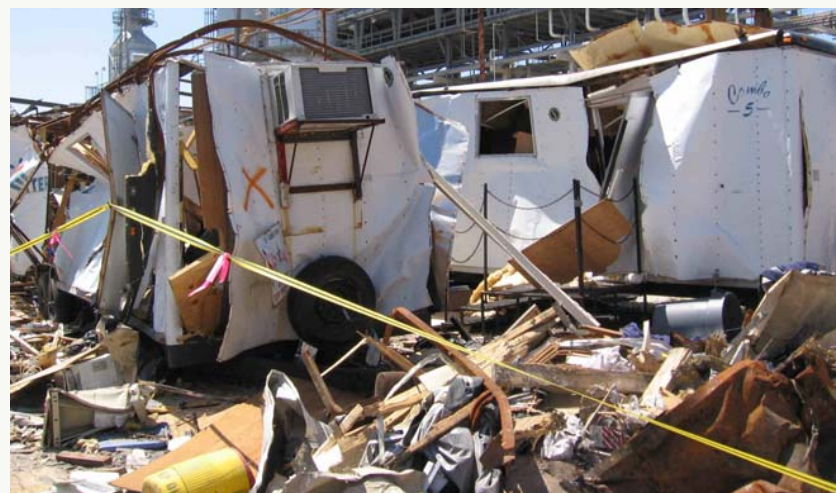
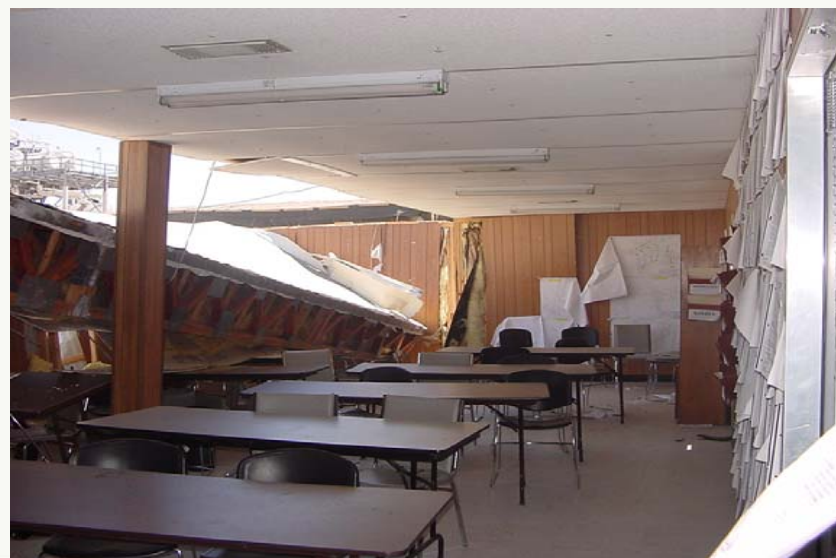
Analysis of trailer damage

- Forty trailers were damaged
 - Thirteen were totally destroyed
- Occupants were injured in trailers as far as 479 feet from the blowdown drum
- Damage was noted in trailers almost 1,000 feet from blowdown drum

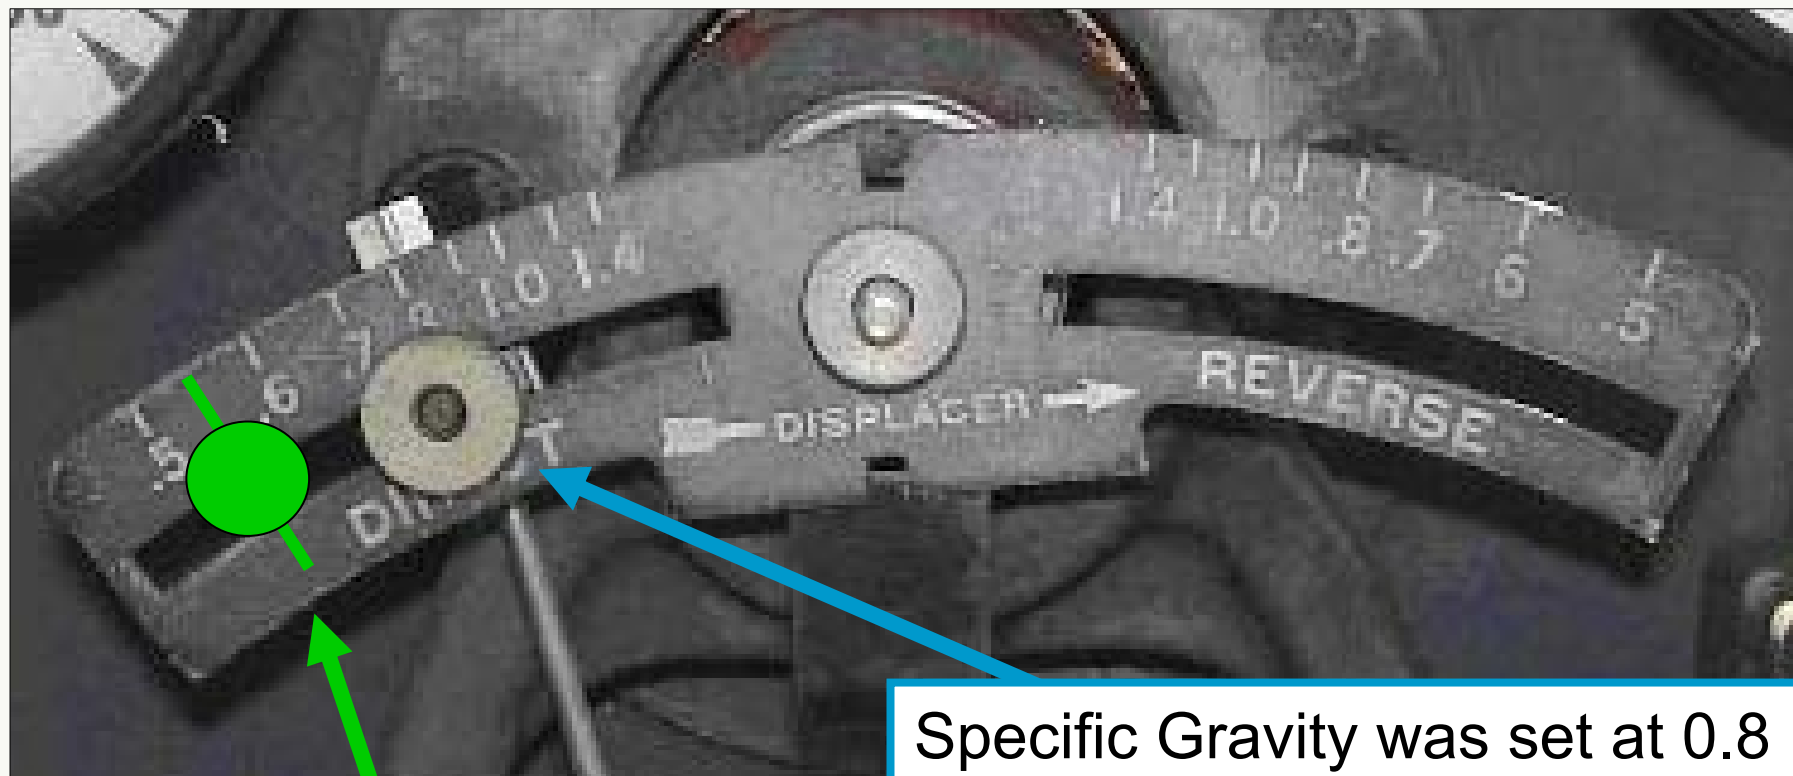
Level transmitter was miscalibrated

Specific Gravity was set at 0.8

Correct setting

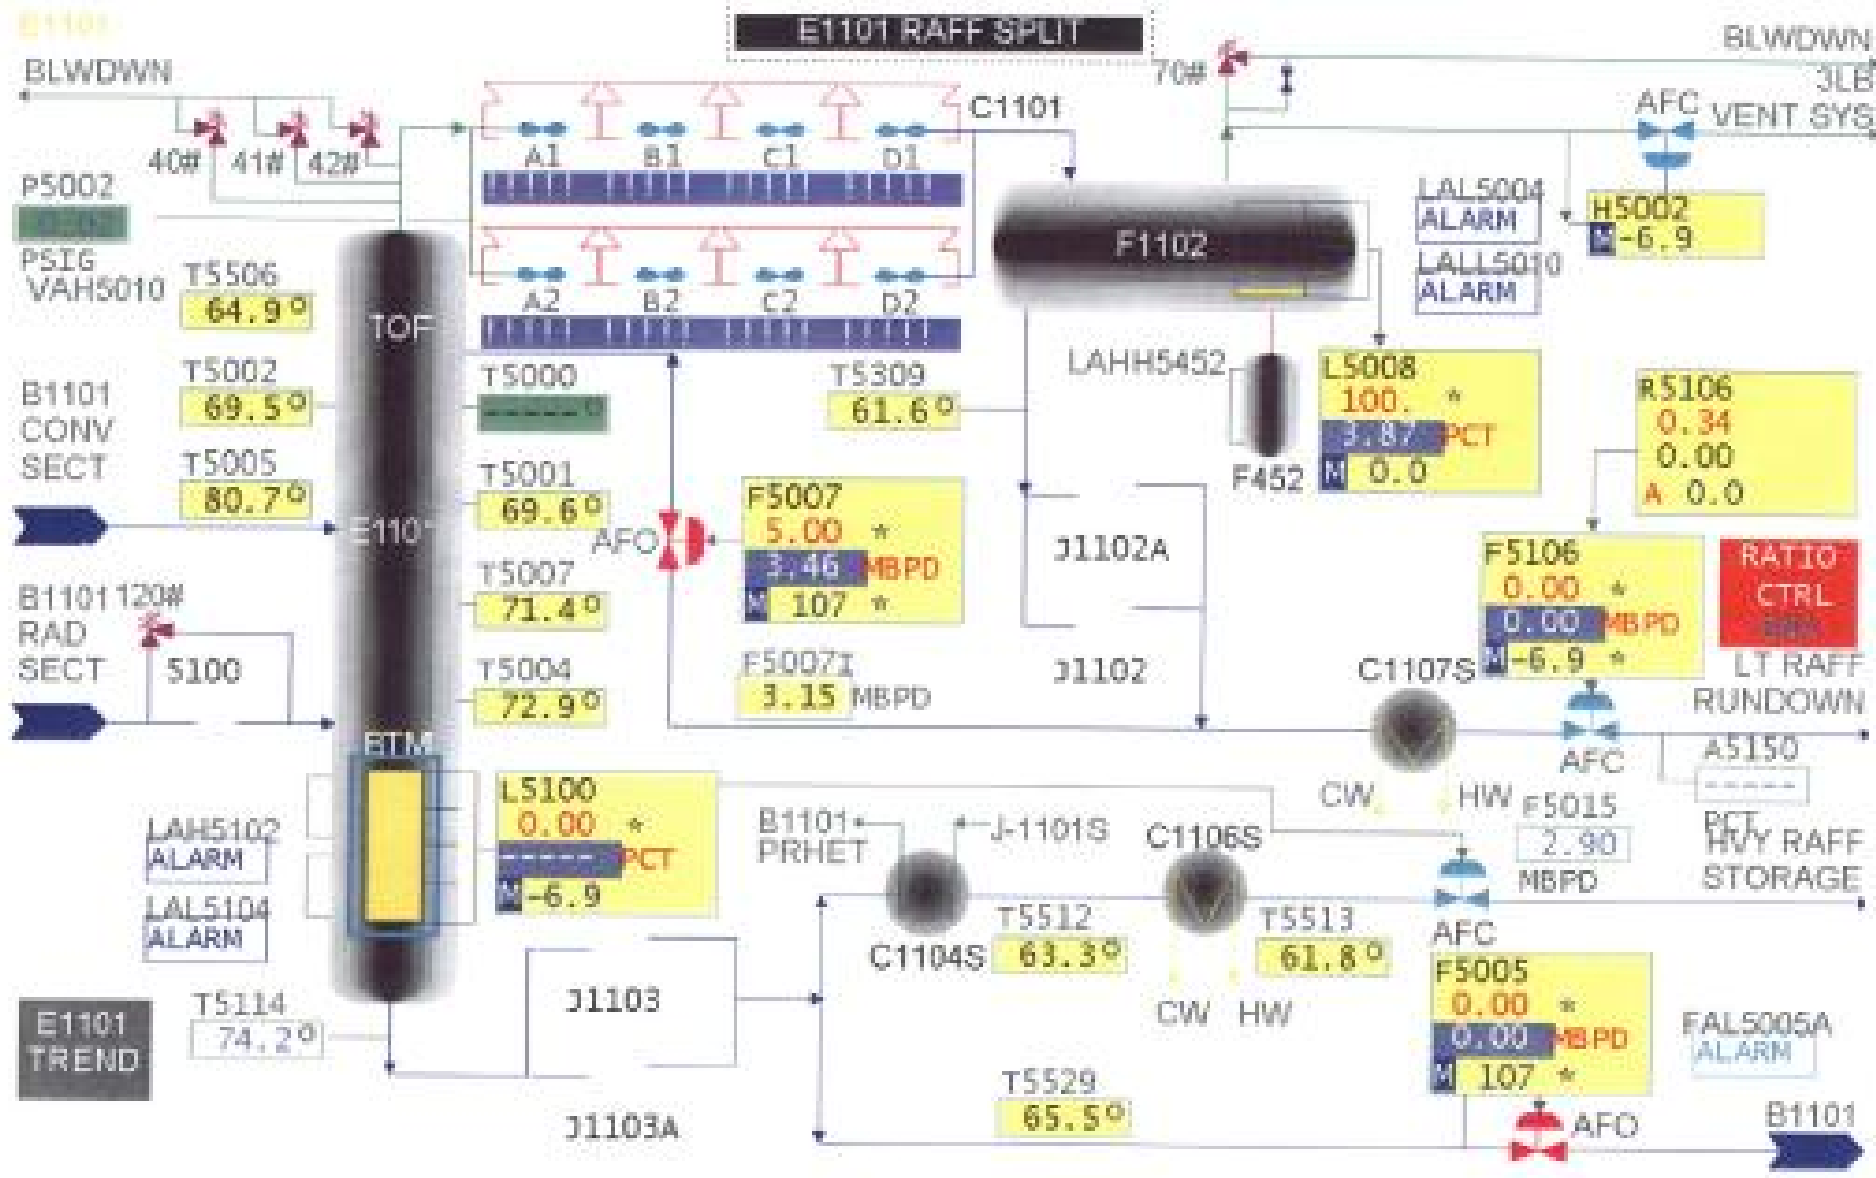
Design of Control Board Display Provided Insufficient Data

- Display lacked adequate indication of how much liquid was in the tower
- Two different screens used to display to operator how much liquid entering and leaving the unit

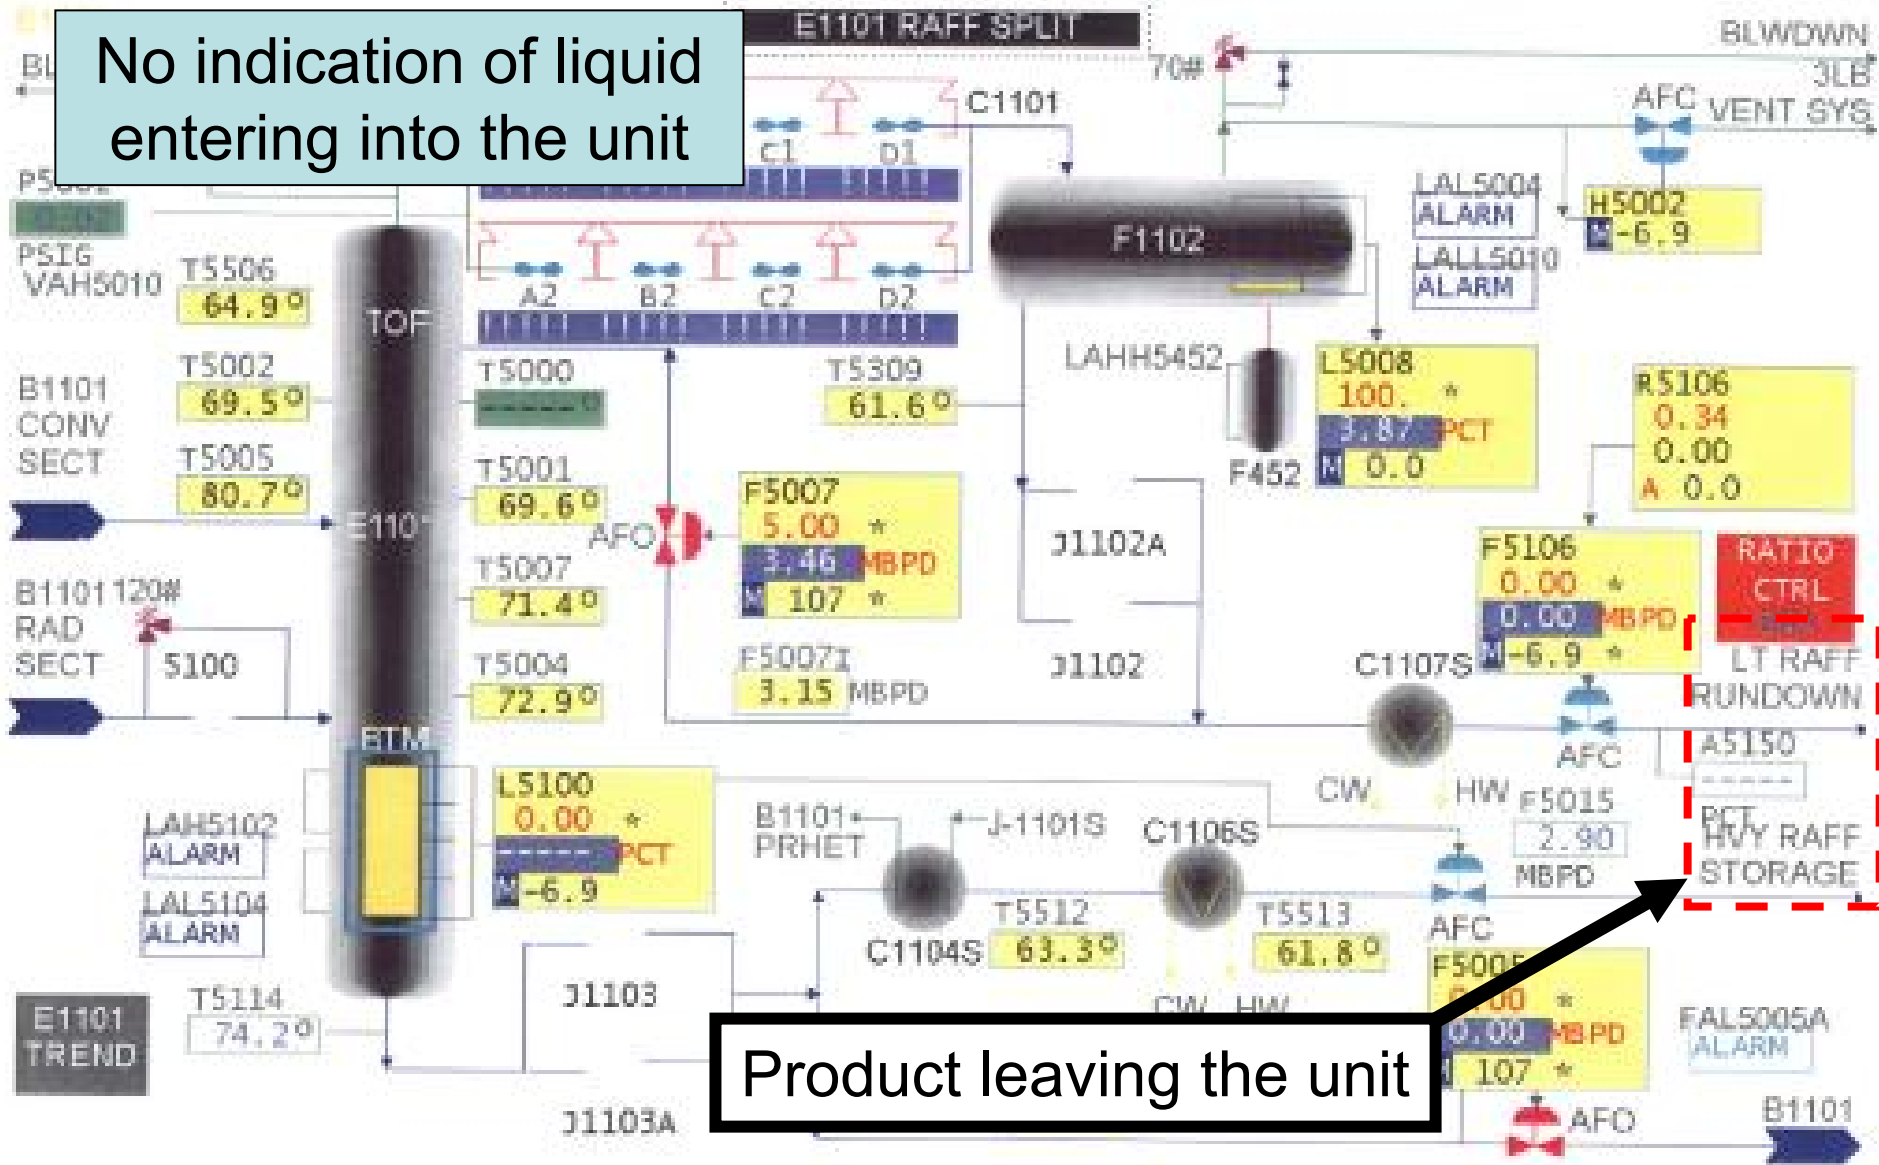
No indication of liquid entering into the unit

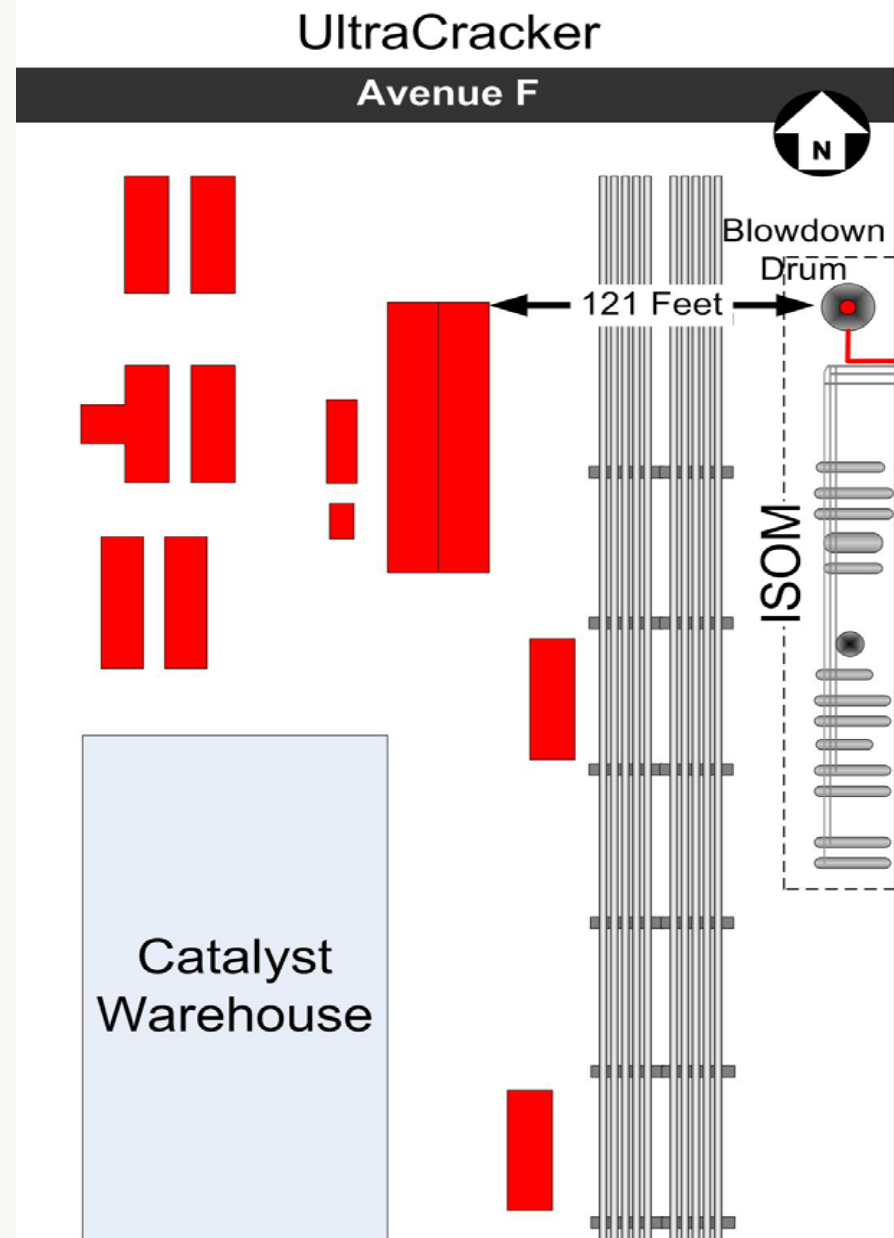
Siting of trailers was unsafe

- Sited for convenience
- Management of change (MOC) procedures were not followed
- Siting methodology was flawed

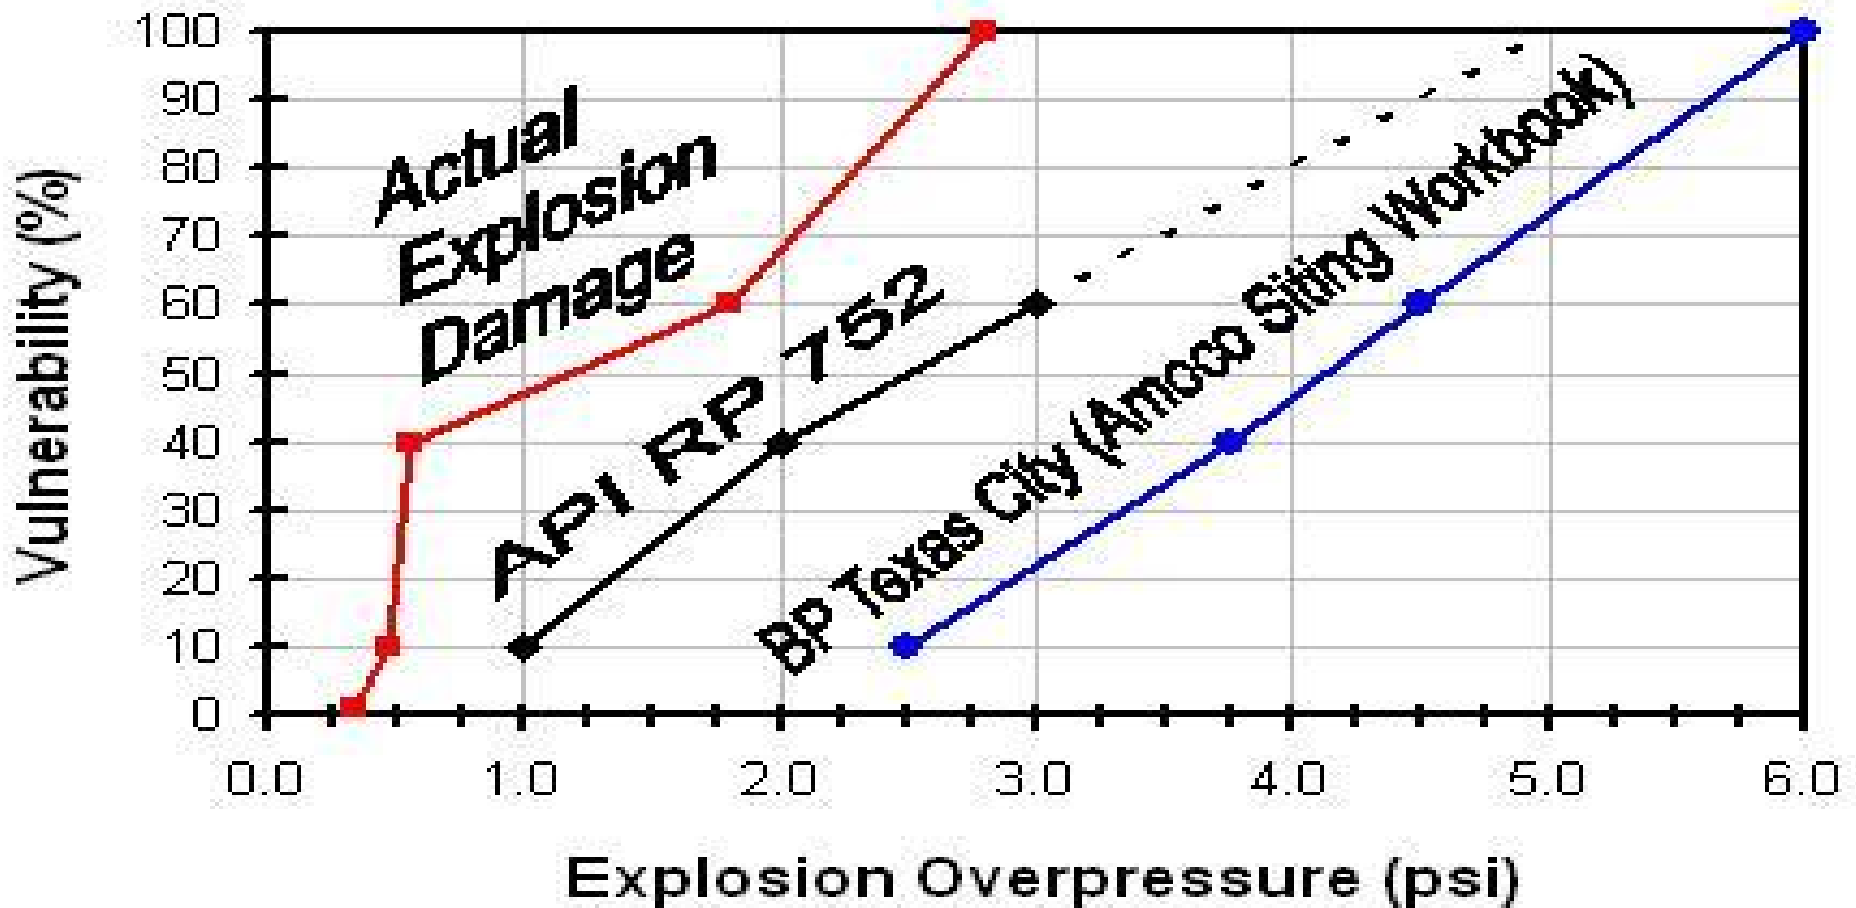
Single Wood Frame Trailers

BP and API siting methods were inadequate
