RAILROAD ACCIDENT REPORT

COLLISION OF AMTRAK TRAIN 304-26
WITH A HIGHWAY VEHICLE AT A
HIGHWAY-RAIL GRADE CROSSING
MCLEAN, ILLINOIS
SEPTEMBER 26, 1999

**NTSB/RAR-01/03
PB2001-916303
Notation 7385
Adopted September 18, 2001**

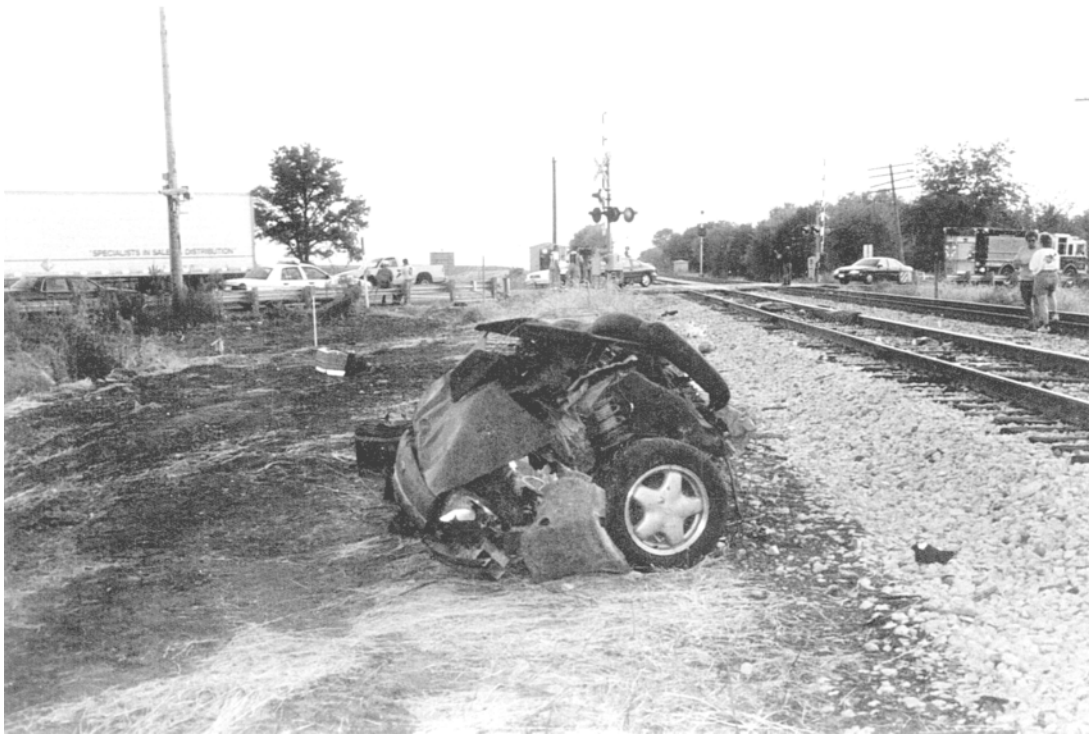
Figure 1. Postaccident scene showing rear of the destroyed vehicle.

The automobile separated into two parts as a result of the impact. The front portion of the automobile became lodged on the front of the locomotive, while the rear portion came to rest about 203 feet north of the crossing and 7 feet east of the railroad tracks. Both automobile occupants were ejected from the vehicle. According to State police reports, windshield obstructions and radio volume settings could not be determined due to the induced damages to the automobile. No brake light lamp filaments from the automobile were available for testing due to collision damage.

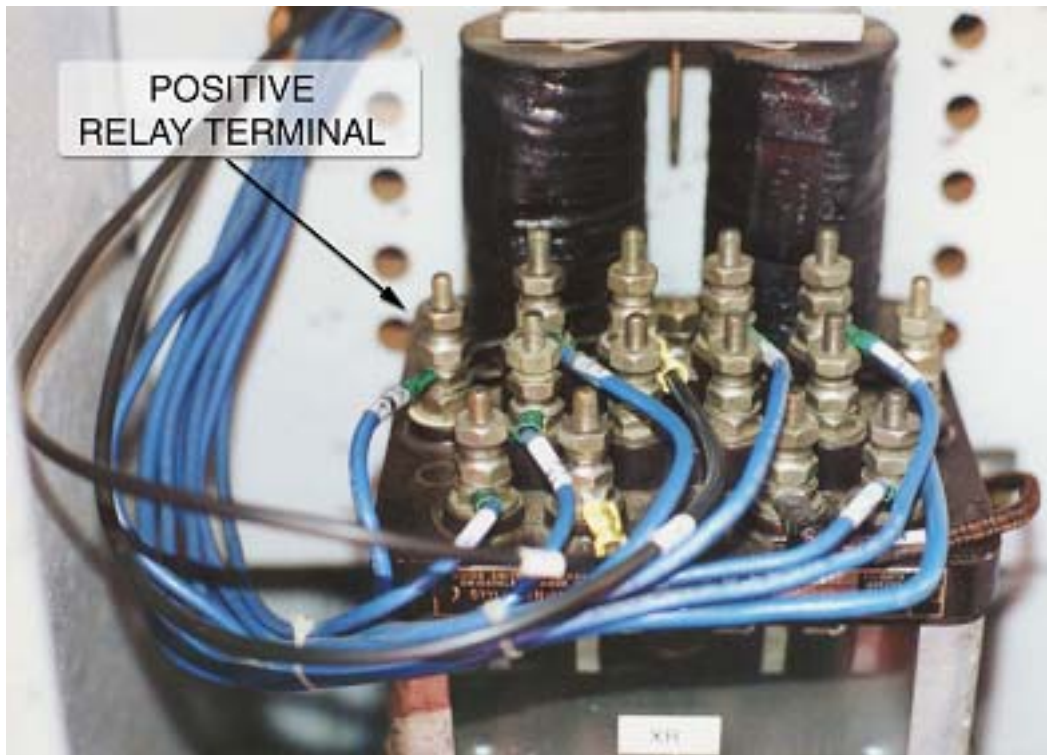
Figure 2. Crossing control relay.

A signal maintainer had recalibrated the railroad grade crossing predictor at the U.S. Route 136 grade crossing about 2:18 p.m. on the day of the accident. When it is operating normally and without intervention, a crossing control relay is energized unless its associated crossing warning system detects the approach of a train. When the crossing detection system detects a train, it automatically de-energizes the crossing control relay, which causes the crossing's flashing lights and gates to activate. The signal maintainer stated that in the hours preceding the accident, to avoid interrupting highway traffic while he went through the calibration process, he interfered with the routine operation of the relay by using a jumper wire to keep the crossing control relay artificially energized during the recalibration. By falsely energizing the relay, the maintainer was circumventing the crossing warning system's ability to activate the crossing's flashing lights and gates. The signal maintainer completed the recalibration of the grade crossing predictor and left the area about 4:30 p.m. Grade crossing predictor data logs showed that the crossing control relay remained energized throughout the recalibration process, after the recalibration was performed, and during the accident.

The Safety Board considered whether an equipment malfunction might have caused the failure of the crossing warning system to activate. Analysis of the data from the grade crossing recording equipment and the vehicle arresting barrier data recorder and video monitoring system indicated that before the accident, the grade crossing warning system was detecting train movements as designed. The system correctly detected and recorded train movements earlier in the day on September 26, 1999. The system also detected and recorded the approach of Amtrak train 304-26 just before the accident occurred. Complete operational tests of the grade crossing warning system were conducted several times during the postaccident investigation. The testing did not identify any deficiencies that would have prevented proper operation of the system. The crossing control relay was subjected to repeated testing following the accident. All tests indicated that the relay was operating within the manufacturer's specifications, and no deficiencies were identified that would have caused the relay to remain stuck in the energized position.

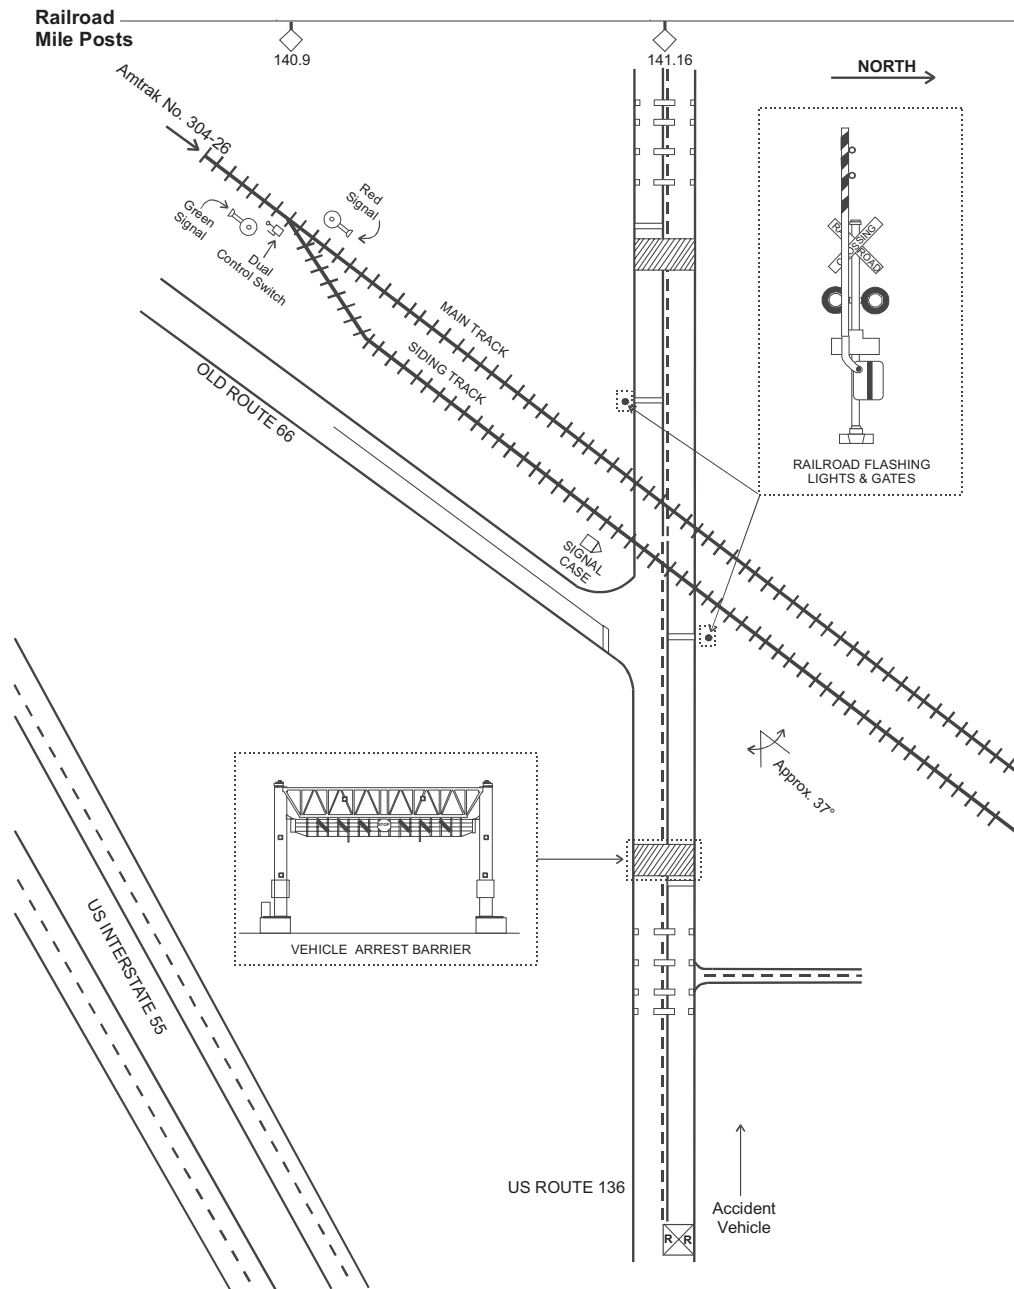
Figure 3. Layout of the accident area.

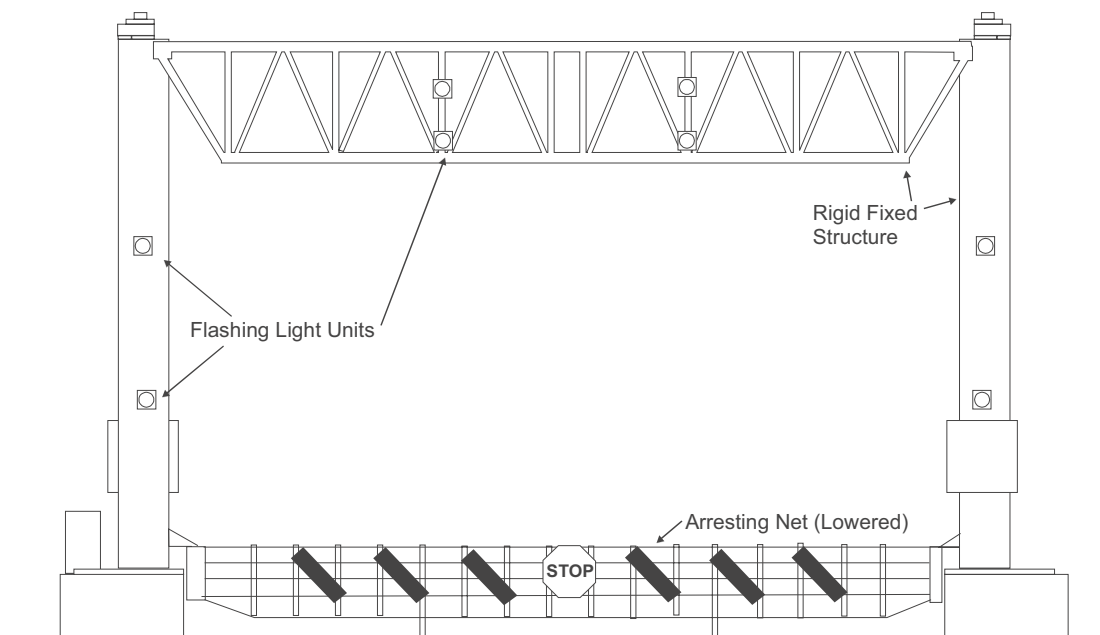
The vehicle arresting barrier system at the U.S. Route 136 highway-rail grade crossing in McLean was installed on October 30, 1998, and put in service on March 16, 1999. The vehicle arresting barrier system comprises two barriers, one located on either side of the crossing on U.S. Route 136. Each barrier has a net assembly consisting of five horizontal wire cables suspended above the roadway between two towers that are connected by a fixed horizontal rigid truss, also located above the roadway. The towers and connecting truss are equipped with eight 8-inch-diameter red flashing light units for east or westbound traffic on U.S. Route 136. When the vehicle arresting barrier is deployed, the flashing light units are activated and the net assembly is lowered to a position across all lanes of U.S. Route 136. (See figure 4.)

Figure 4. Diagram of vehicle arresting barrier with net lowered and deployed.
