U.S. CHEMICAL SAFETY AND HAZARD INVESTIGATION BOARD

## CHLORINE RELEASE

**DPC ENTERPRISES, L.P.**

REPORT NO. 2004-02-I-AZ

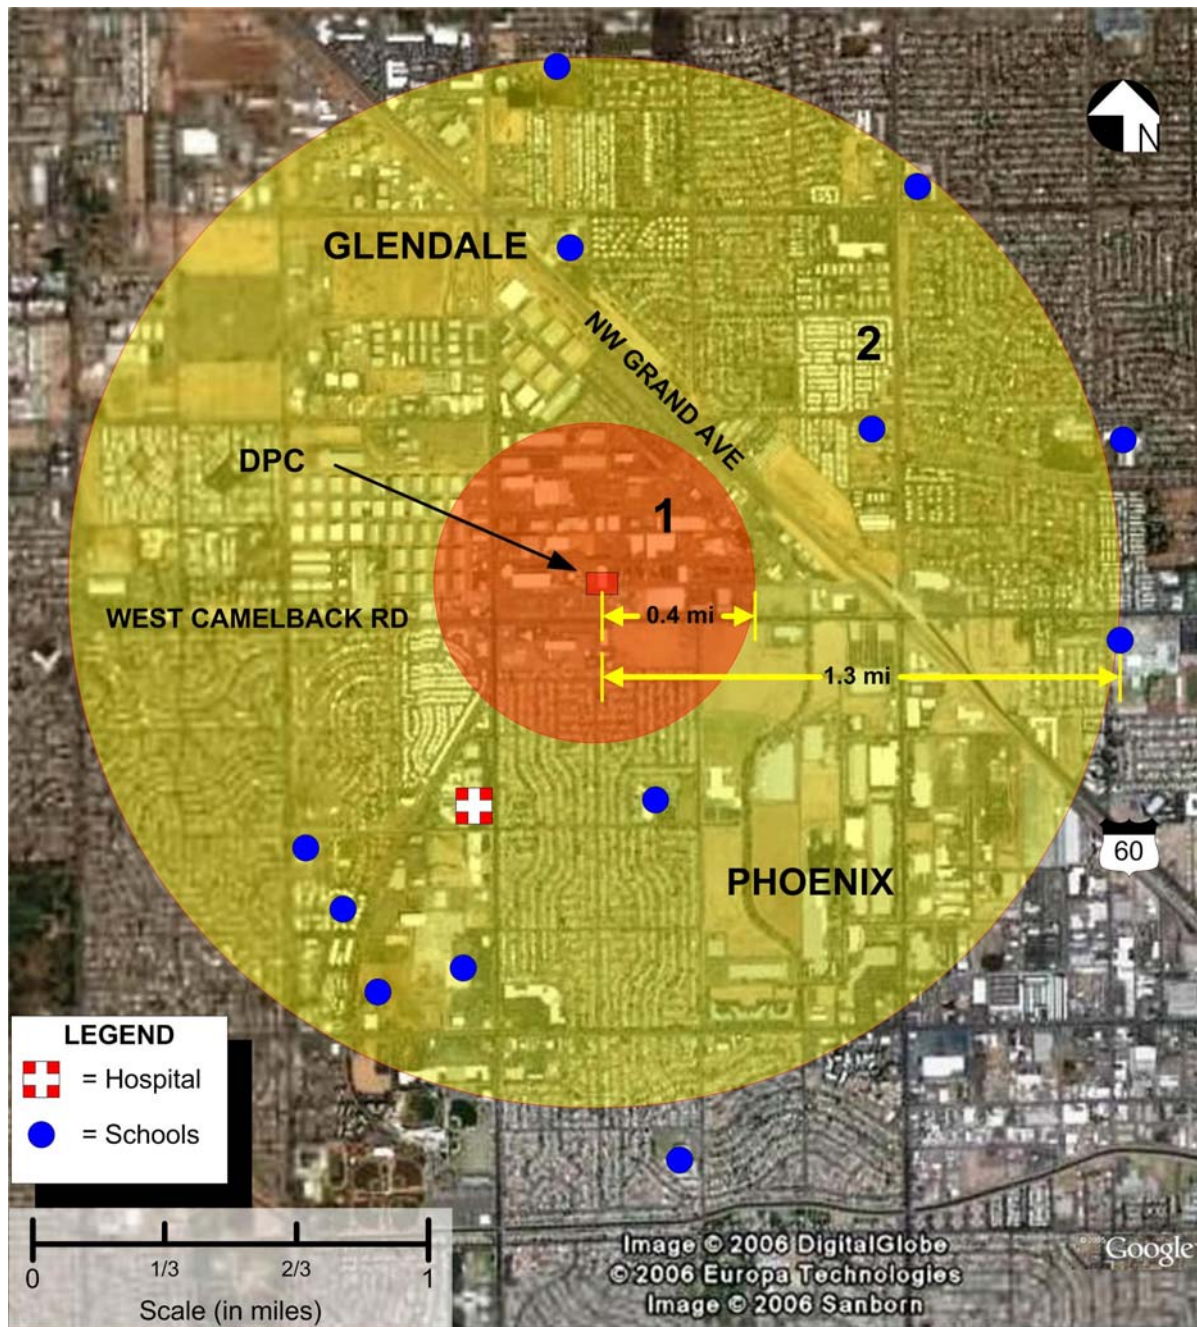
Figure 6. Hazardous chlorine concentration distances

The November 17 chlorine release was serious, and had the potential to significantly harm workers and the community. The CSB investigators estimate that the scrubber could have released up to 1,920 pounds of chlorine (Appendix B). Fortunately, the weather conditions during the incident were favorable for dissipation of the release. Under these conditions, the CSB estimates that hazardous concentrations<sup>20</sup> of chlorine likely extended out as far as 0.4 miles from the site.<sup>21</sup> A similar release under highly stable atmospheric conditions could produce toxic concentrations of chlorine up to 1.3 miles from the DPC site.

The areas of Glendale and Phoenix within these distances of DPC are shown in Figure 6. Approximately 750 people live inside the smaller (0.4 mile radius) circle (Region 1), while nearly 30,000 live inside the larger (1.3 mile radius) area (Region 2). Depending on the wind direction and atmospheric conditions, a 1,920 pound release in this densely populated area could place many people at risk.
