Debris Transport Assessment of Debris Impacting Orbiter Lower Surface in STS-107 Mission

STS-107 MMT

January 24, 2003

STS-107 Debris Impacting Orbiter Wing

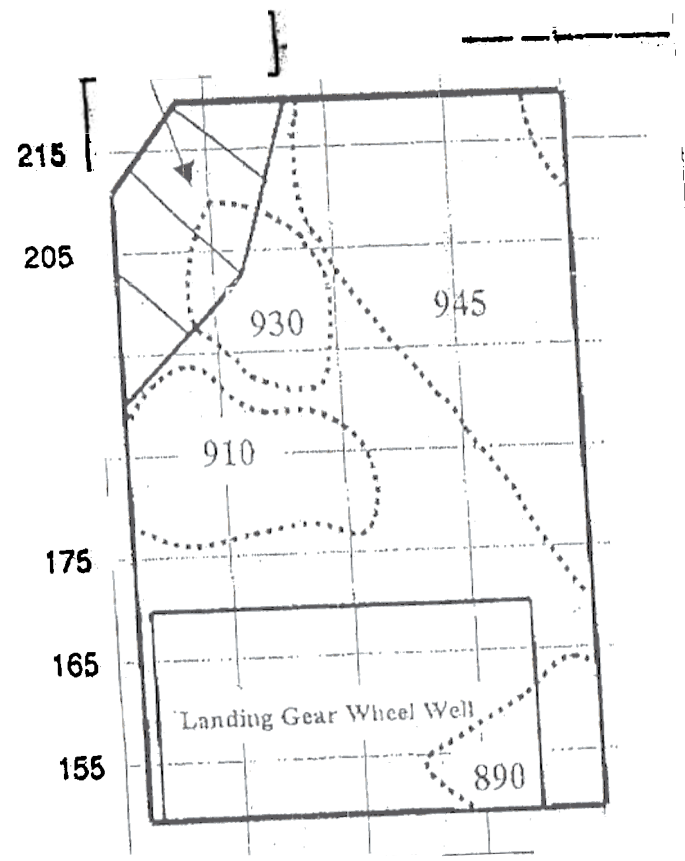
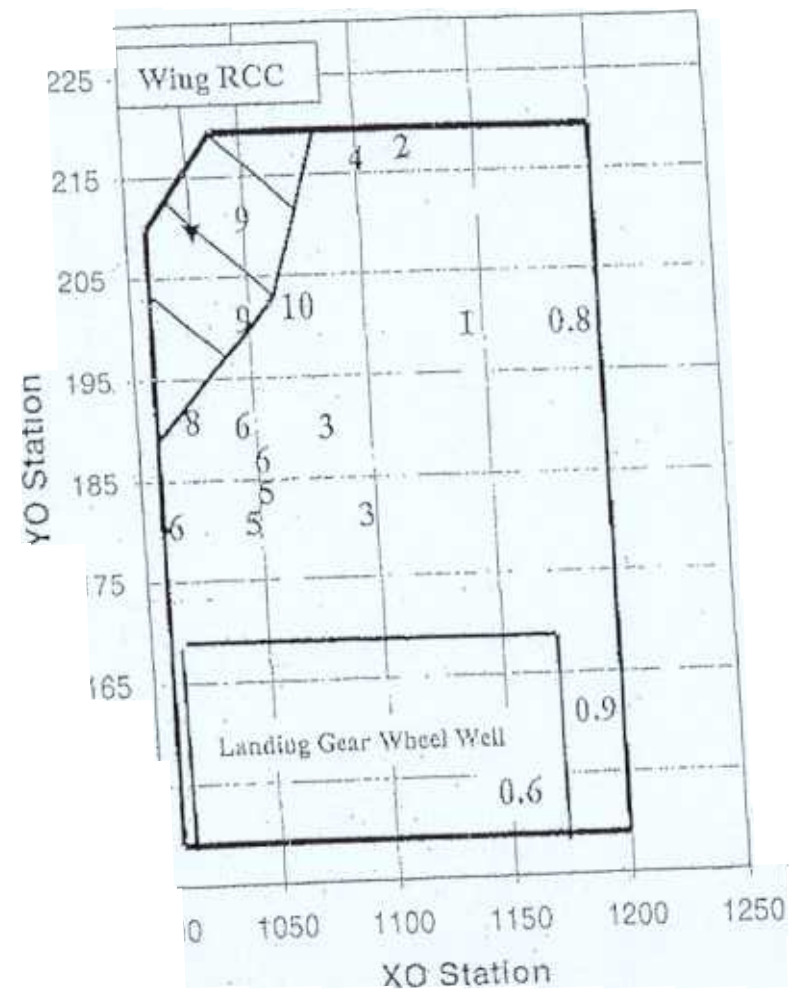
Impact Velocity

Debris Trajectory Analysis estimated the impact conditions for what was observed

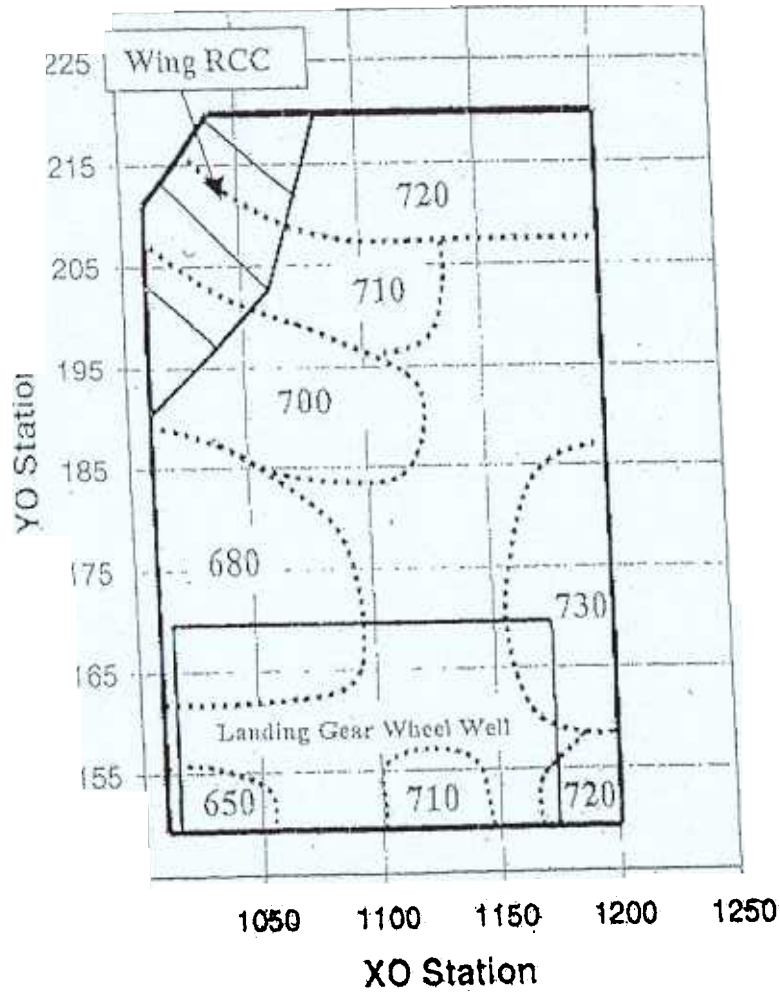
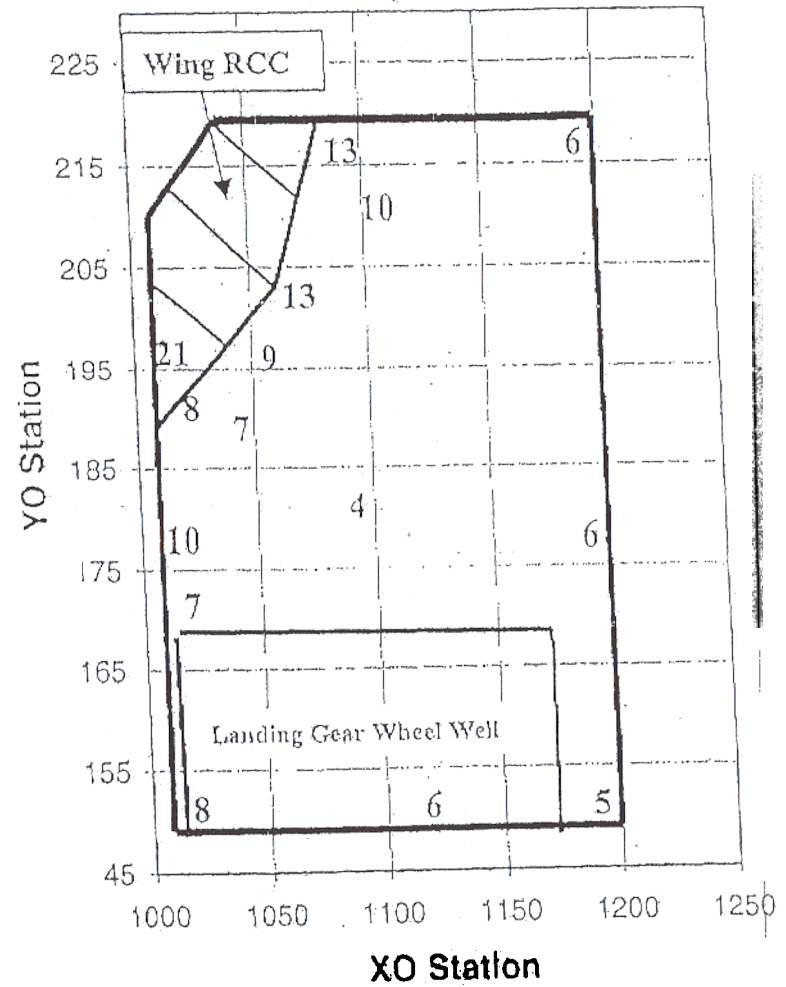
Velocity and Impact Angle Distribution Inside Impact Area

(Debris Size = 20" x 10" x 6", Density = 2.4 lb/ft³)

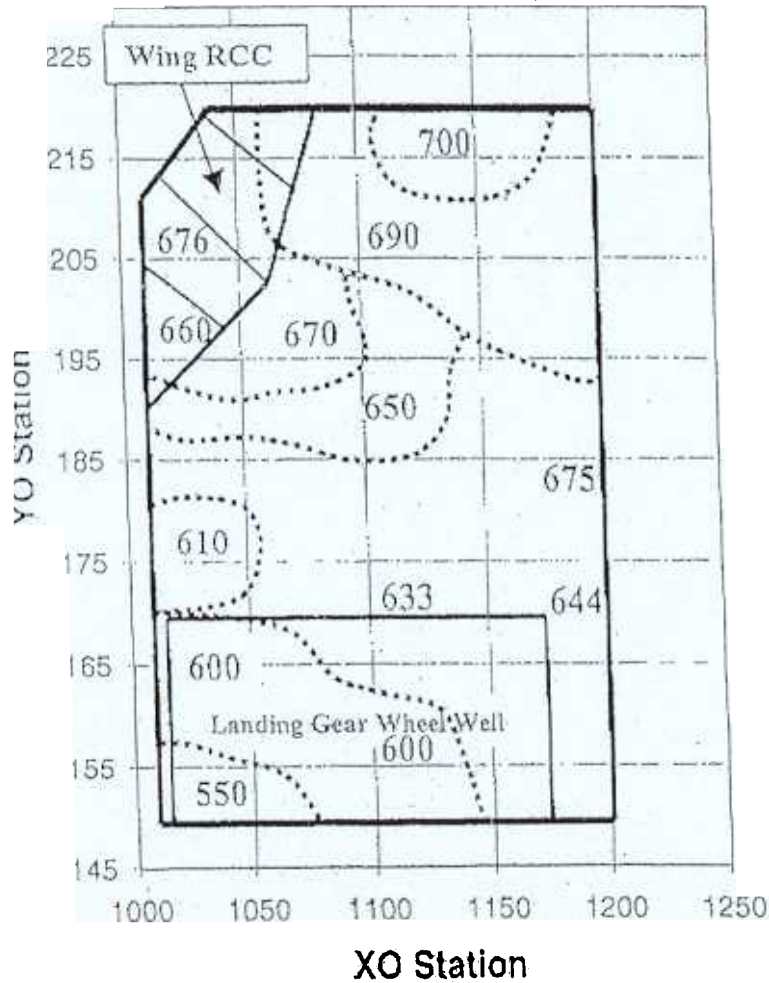
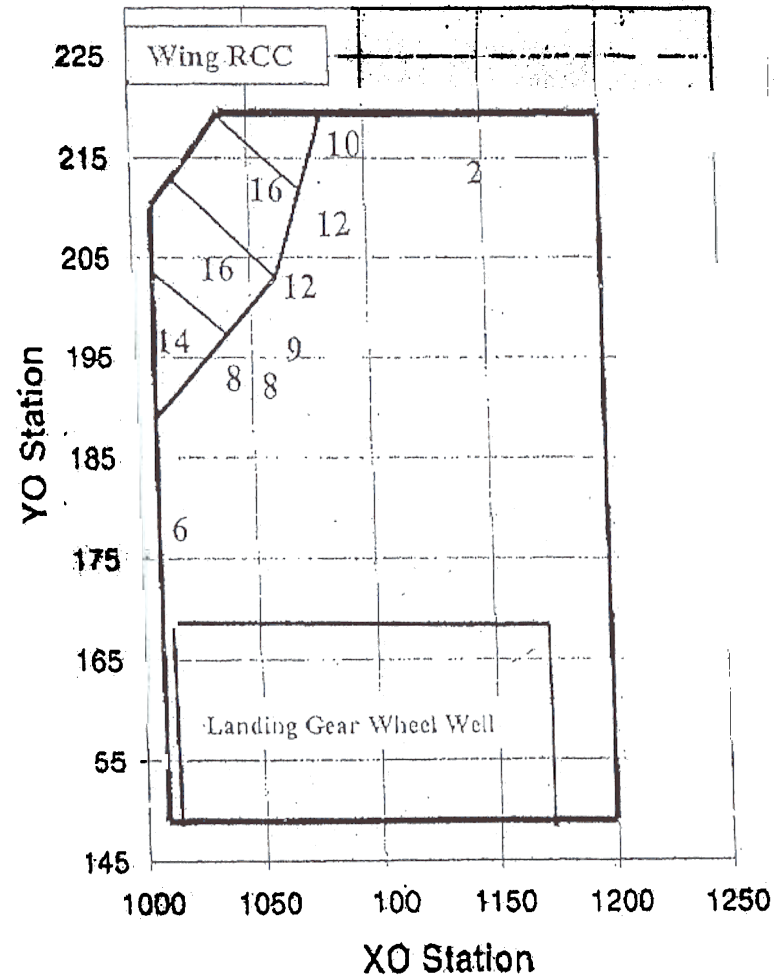
Velocity and Impact Angle Distribution Inside Impact Area

(Debris Size = 20" x 16" x 6", Density = 2.4 lb/ft³)

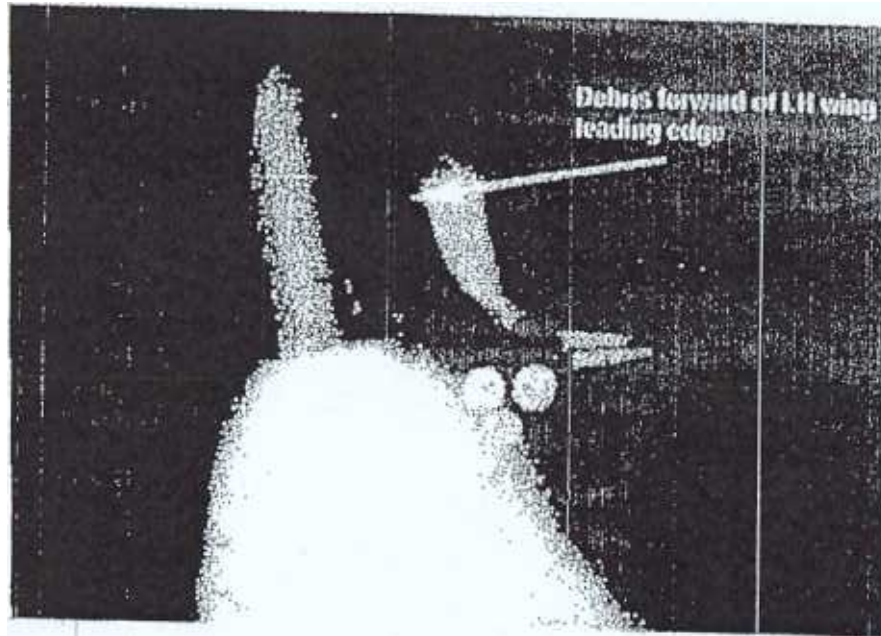
Debris Emanating From Bipod Area Impacts Orbiter Lower Wing
