November 3, 1997

**Space Shuttle
External Tank**

**STS-87/ET-89
Flight Readiness
Review**

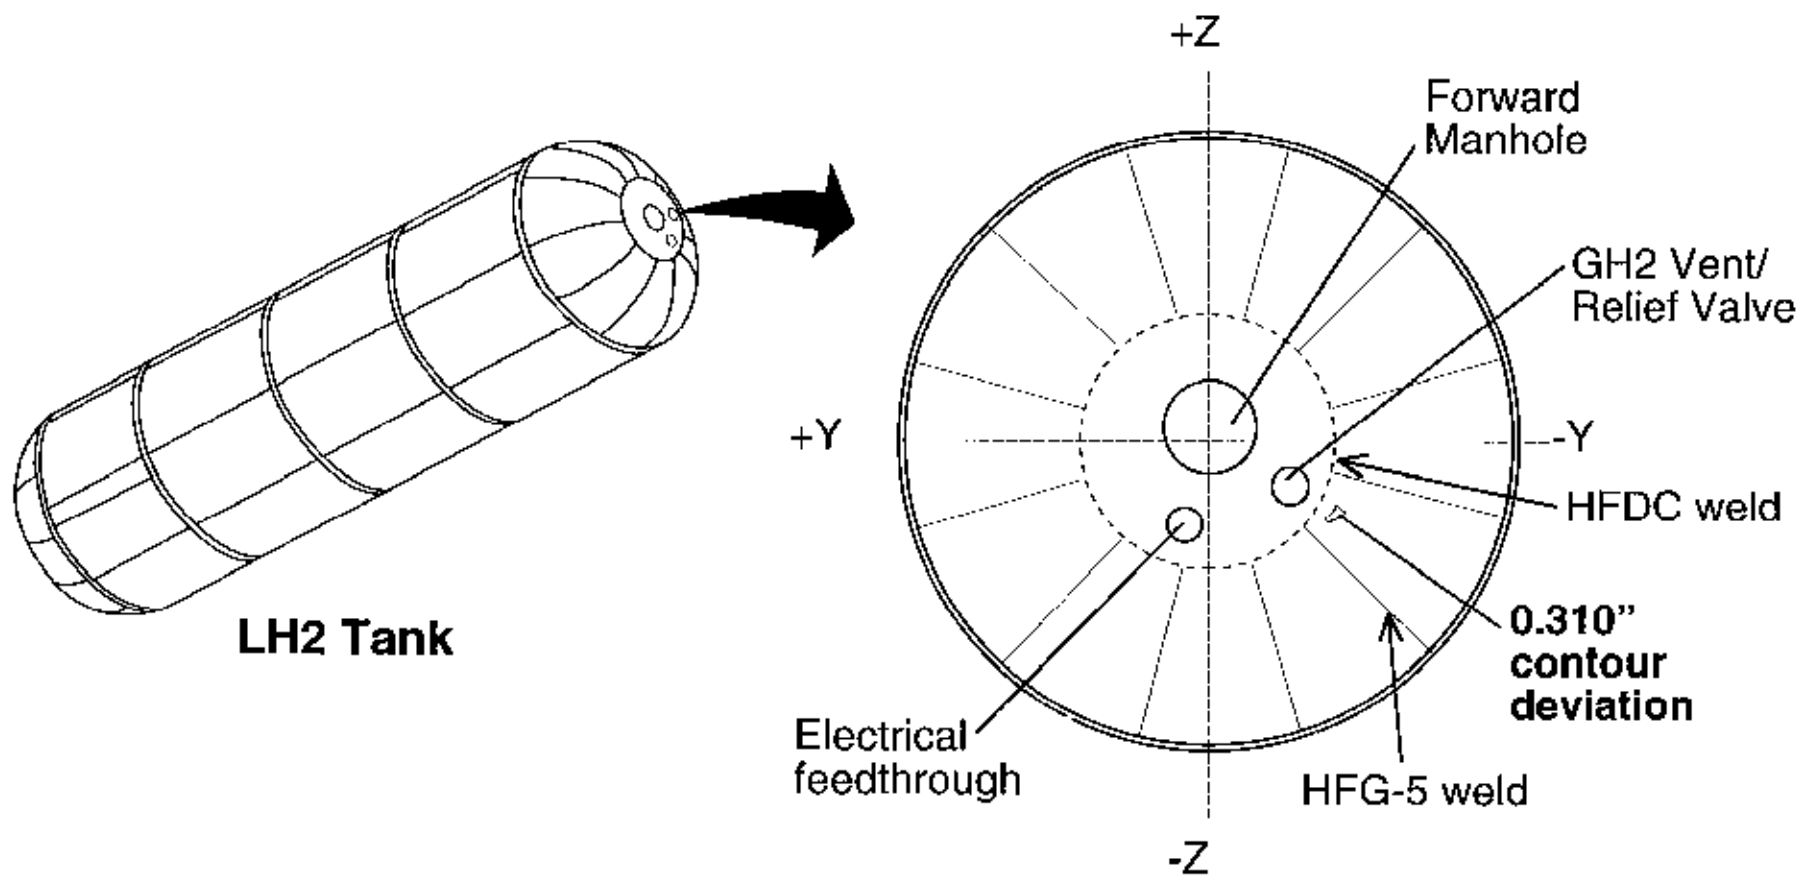
LH2 Forward Dome Contour Deviation

- Negative contour deviation exists on LH2 tank forward dome
 - Maximum allowable deviation = ± 0.125 "
 - Deviation on ET-89 = 0.310"

- During weld of the dome at subassembly level an unscheduled weld machine tailout resulted in a burn-thru with excessive penetration
 - Multiple heat repairs were accomplished
 - 12 planishing passes to improve contour
 - Resulting contour deviation had max depth of 0.250"
 - Contour and weld repairs acceptable by analysis
 - NCD closed
- Dome subsequently welded to LH2 tank
 - Visual observation of dome indicated that contour had changed
 - Re-measurement determined contour deviation increased in size and depth (0.310")
- SMR item because contour was max deviation observed to date

- Initially induced by significant weld repairs
- Contour changed after previous MRB action possibly due to
 - Rounding of dome for mechanical installation
 - Fit up and welding of dome to barrel
 - Orientation of dome from horizontal to vertical

- Use as is

- Proof test
 - HFG-5 and HFDC welds and membranes are adequately proofed from a fracture basis and proofed to 119% of flight limit load from a strength basis
- Stress analysis
 - Structural: Meets required FS (1.25)
 - Shell
 - Was: 1.46
 - Now: 1.33 (failure mode: ultimate tension)
 - Weld
 - Was: 1.79
 - Now: 1.28 (failure mode: ultimate tension)
 - TPS: Meets required FS (1.10)
 - Was: 2.38
 - Now: 1.34 (failure mode: outer fiber strain)
- ET-89 meets all flight requirements

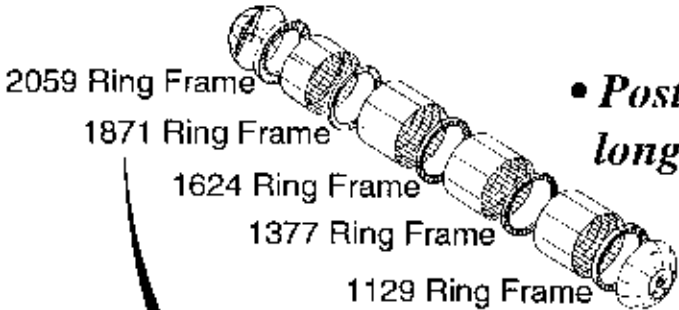
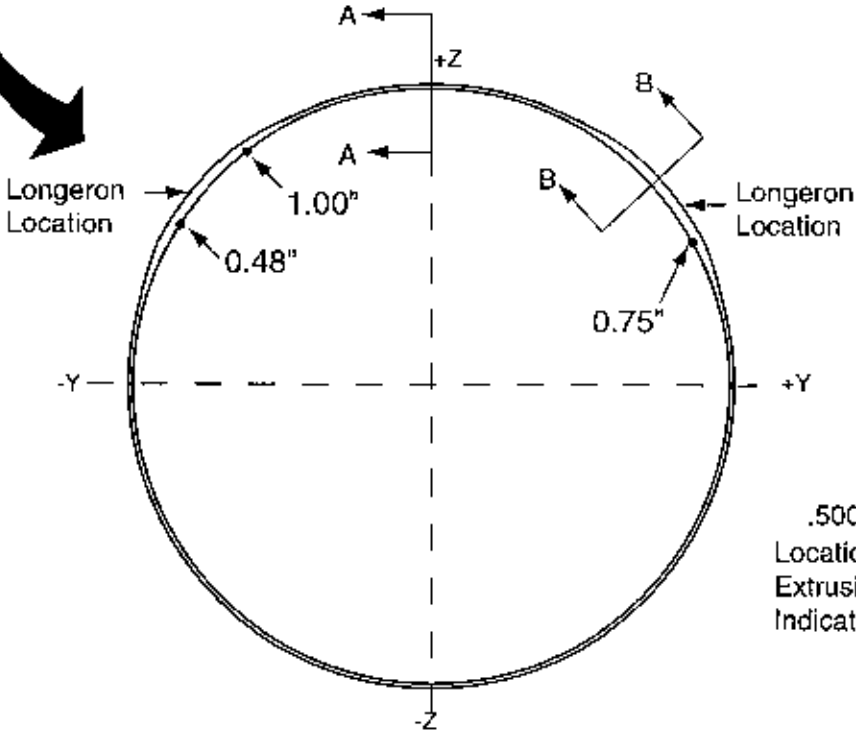
Station 1871 Ring Frame Arrangement

- Three x-ray indications were detected after initial proof test of the ET-89 LH2 tank
 - Located adjacent to weld in extrusion forward of longerons at Station 1871
 - Lengths were 1.00 inch, 0.48 inch and 0.75 inch

• *Post-proof indications were located in the longeron areas of the Station 1871 Chord*
