Pamela Richardson, 10:50 AM 2/13/2003 -0500, Fwd: GRC STS-107 Mishap Investigation Capabilit

GRC STS-107 Support Capability

Columbia Problems Were Caused by Landing Gear Down During ReEntry By Randy Ratterree

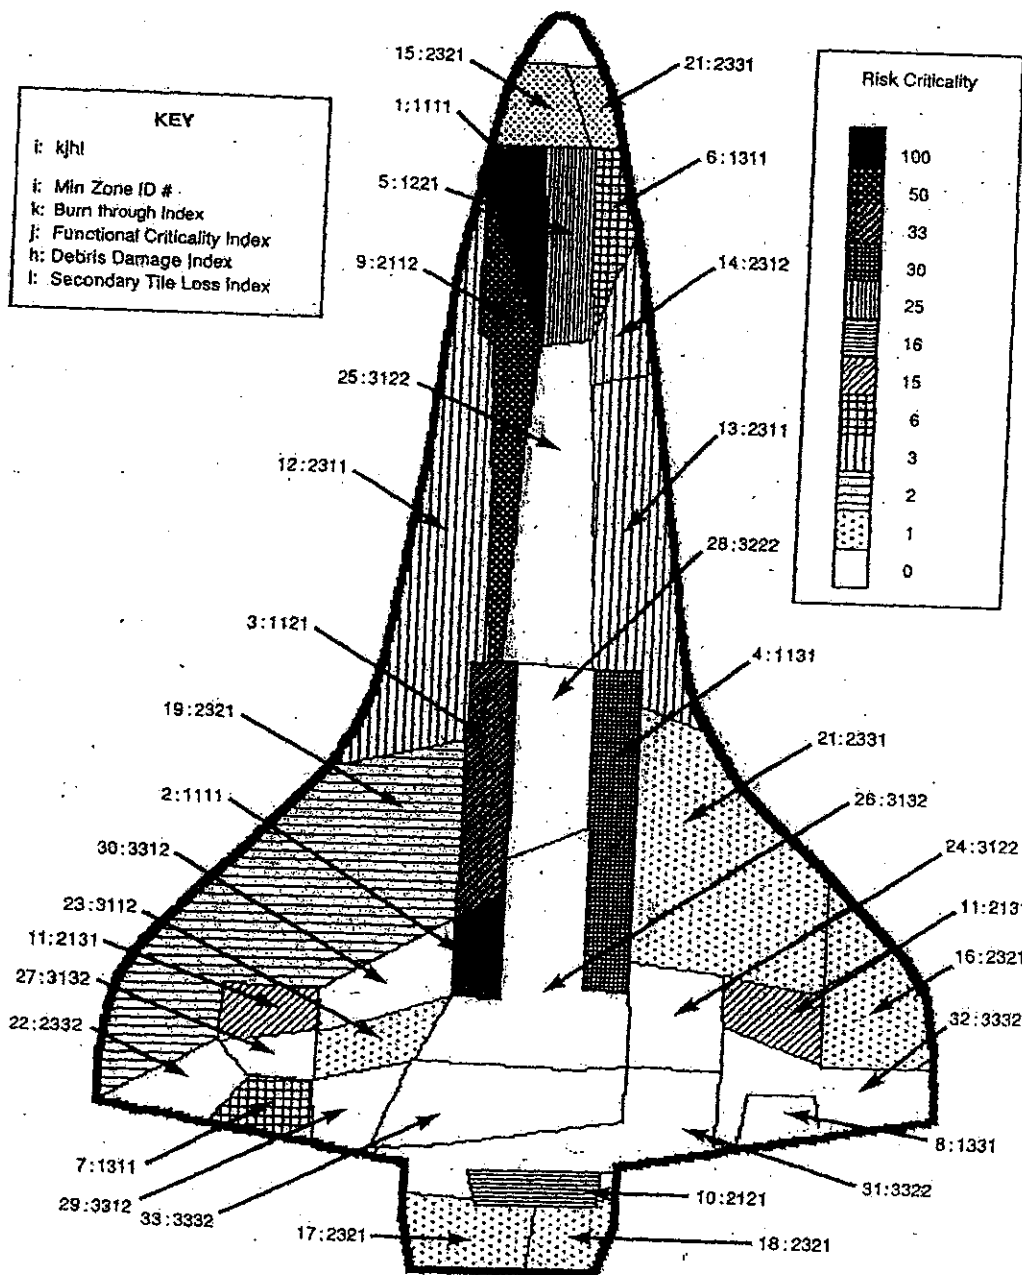
Figure 4: This map of the orbiter, showing the min-zones and the risk criticality of each file, represents the main results of the analysis.

Zones 1, 2, 3, 4, 9, 10, and 11 from Figure 4 contribute 85 percent of the risk of LOV/C through debonding due to factors other than debris, and 51 percent (85 percent of 60 percent) of the total TPS risk through this failure mode alone, even though they represent only 14 percent of the tiles. Zones 1, 2, 5, and 9 are particularly susceptible to debris hits and represent almost 80 percent of the TPS risk due to debris hits even though they represent only seven percent of the tiles (securing these tiles simply increases our confidence in the benefits of preventing the corresponding loss of insulation debris and is not assumed here to add to that figure). We assumed in our model that the two failure modes (debris hits and spontaneous debonding) were mutually exclusive and that the benefits of reducing their contribution to the TPS risks are additive. There-

We focused our process study on two key elements of tile safety: (1) ensuring a strong bond (for example, finding out if there are other tiles on the surface of all orbiters that still have a very weak bond even though they passed the initial pull tests) and (2) preventing controllable debris from hitting critical tiles on the orbiter's surface. New problems will unavoidably surface later: How will the bond age? When will it be time to replace the whole system? Does the pull test weaken the bond in the long run? These uncertainties about the long-term performance of the tiles will require future decisions. The probabilistic risk analysis model provides a way for NASA to prioritize these efforts, for example, instead of using random pull tests, to focus on areas where it is essential that the tiles be well bonded (that is, in the most risk-critical zones shown in Figure 4).
