FAILURE OF CRYOGENIC OXYGEN SYSTEM

PART B6

POSTINCIDENT EVENTS

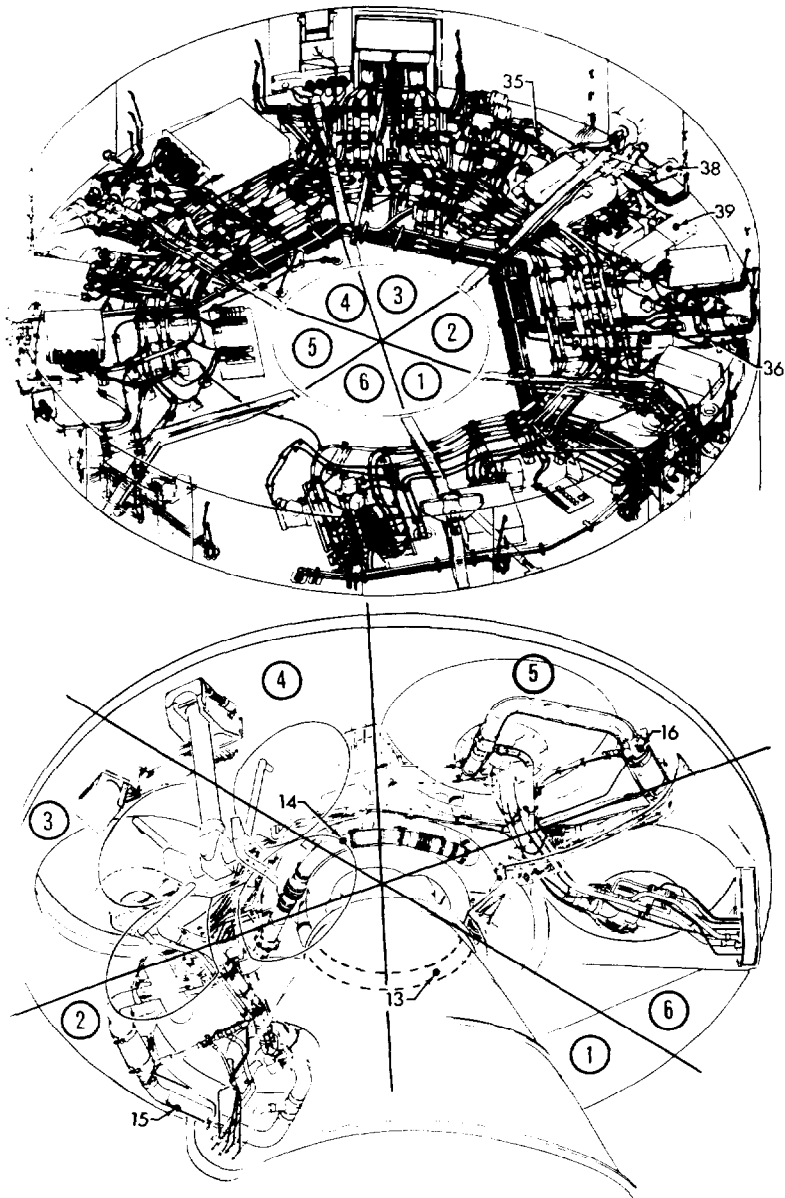
Figure B5-14.- Temperature sensor location in Apollo :

Following the recovery of telemetry data there were a number of temperature changes observed at various locations in the service module. The locations of all temperature sensors in the service module are shown in figure B5-14, and telemetered records from these sensors for the time period of 55:53:40 to 55:56:10 are shown in figure B5-15. From these temperature records the following conclusions can be drawn:

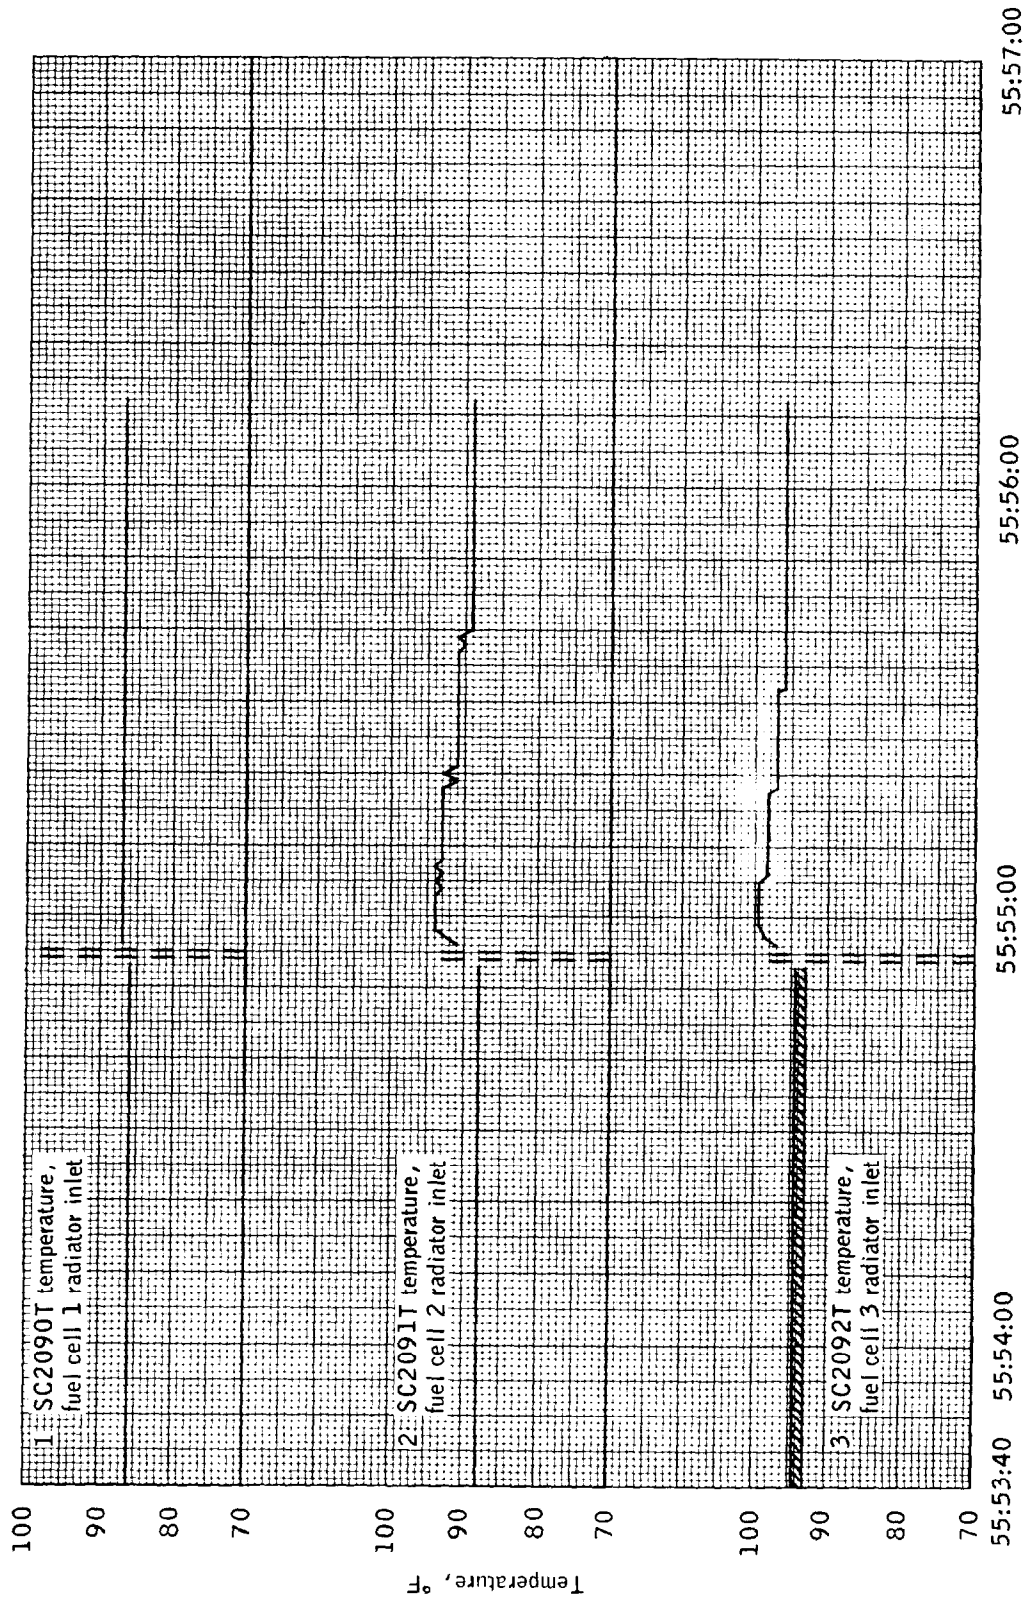
Figure B5-15.- Service module temperature history.

1. Both temperature measurements in bay 3, the bay adjacent to bay 4, increased after 55:54:55, whereas they had been steady prior to that time.
2. The corresponding temperature measurements in bay 5 showed much smaller increases. Bay 5 is adjacent to bay 4.
3. A change was observed in the service propulsion valve body temperature. This sensor, unlike many temperature sensors in the lower part of the service module, is not covered by multiple layers of insulation.
4. Four sensors located in close proximity on the separator between bay 4 and bay 5 showed rapid temperature rises of small magnitude immediately after the recovery of telemetry data. These sensors measure the temperatures of fuel cells 1 and 3 radiator inlets and outlets.
5. The temperature of quad C and D reaction control engines continued the same rate of rise after data loss as before data loss.

Ground elapsed time, hr:min:sec
 (a) Radiator inlet temperatures.

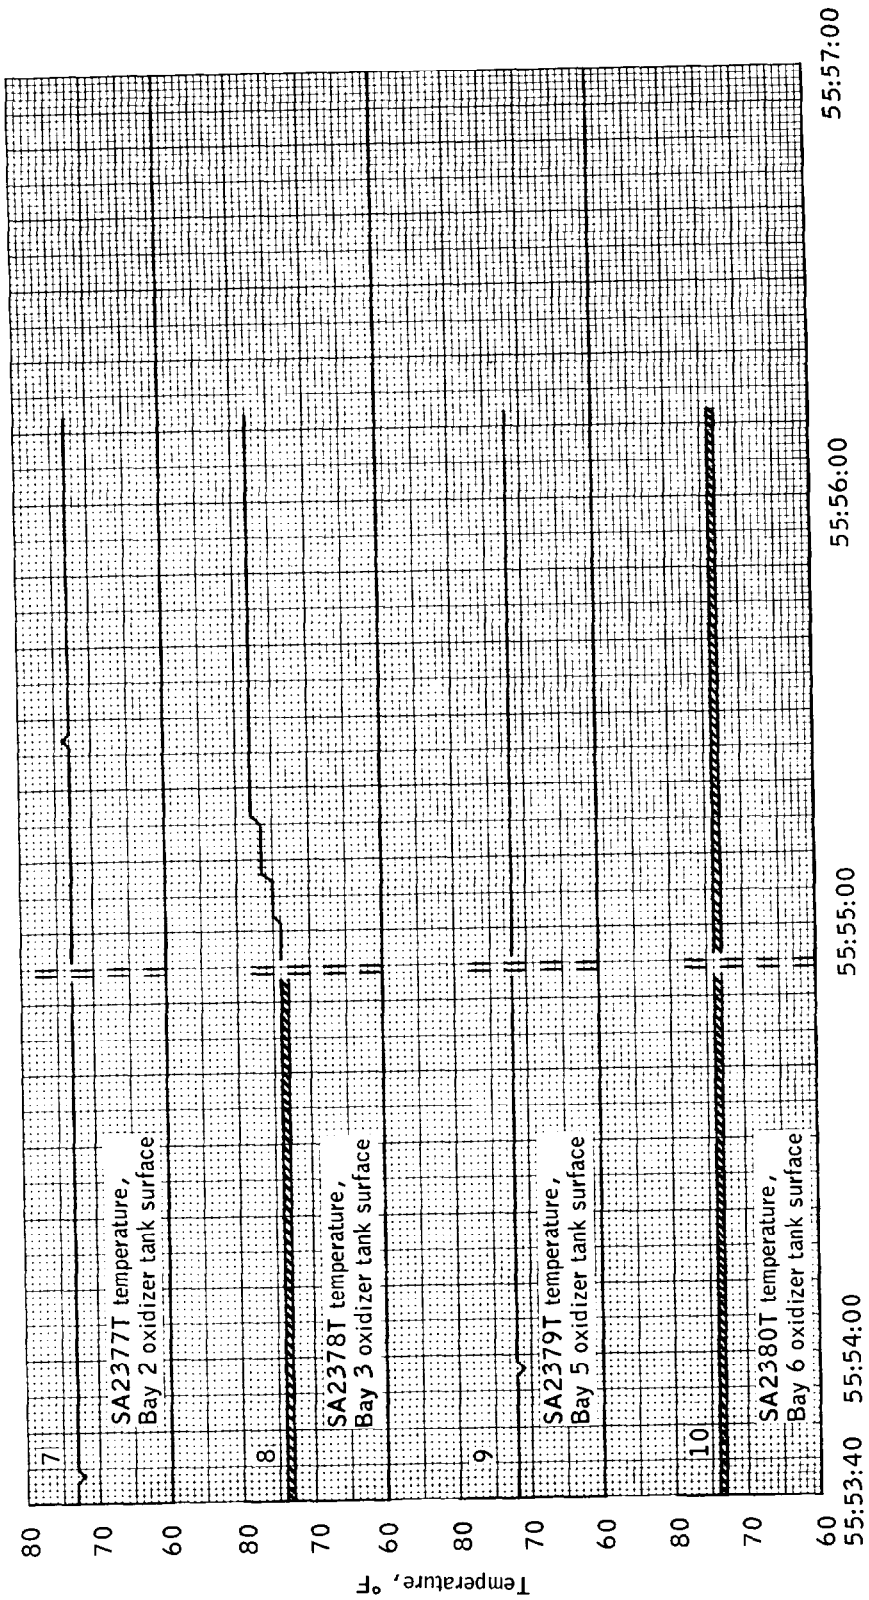
Figure B5-15.- Continued.

(c) Tank surface temperatures.

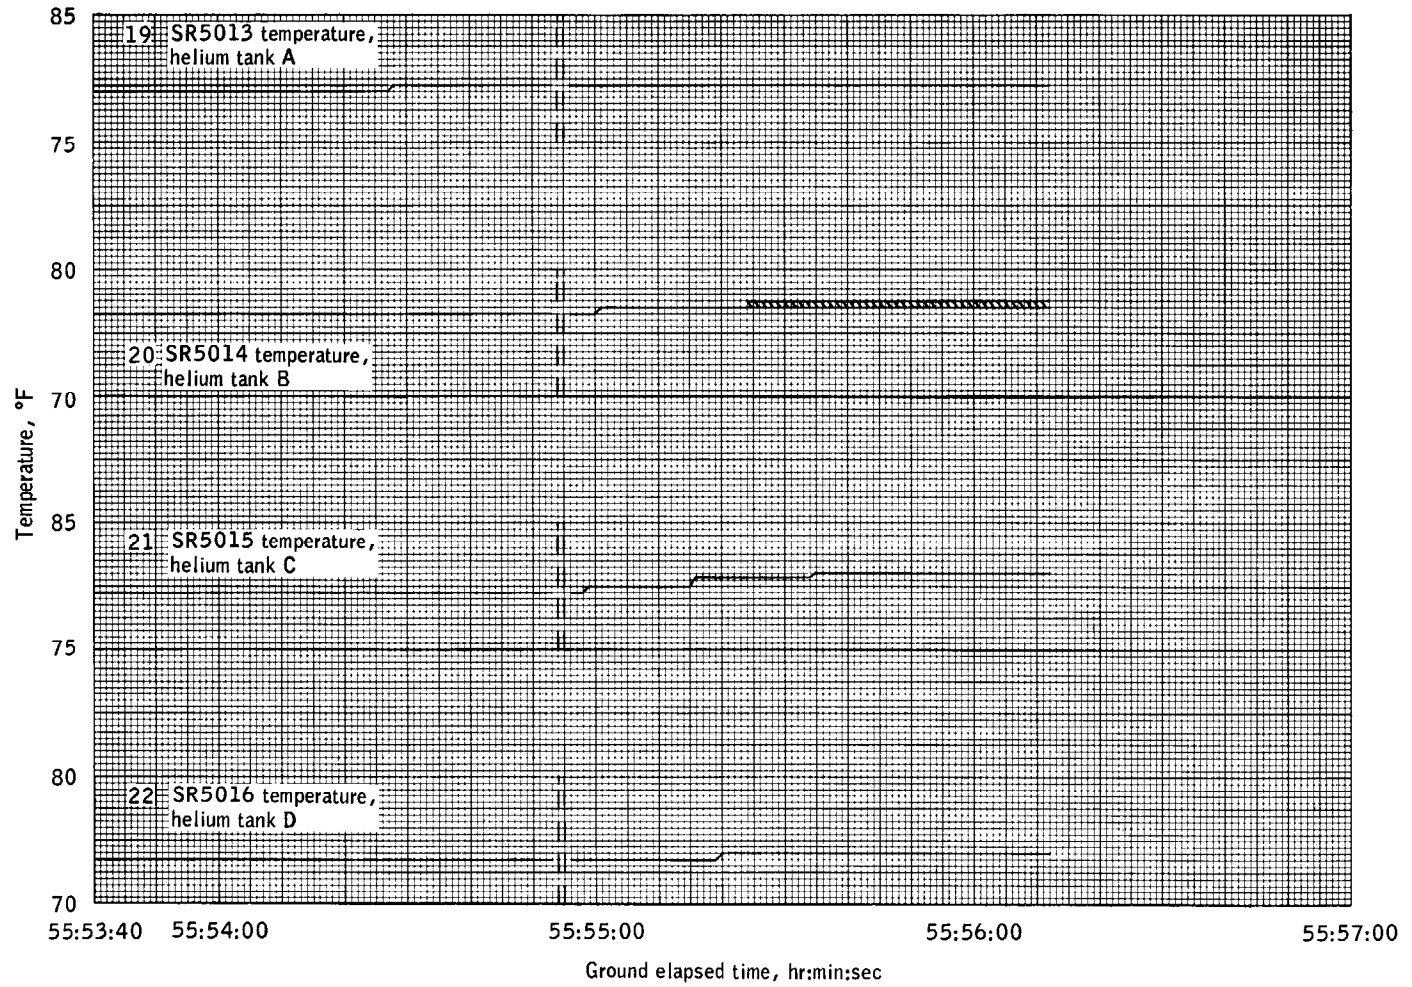
Figure B5-15.- Continued.

(f) Reaction control helium tank temperatures.

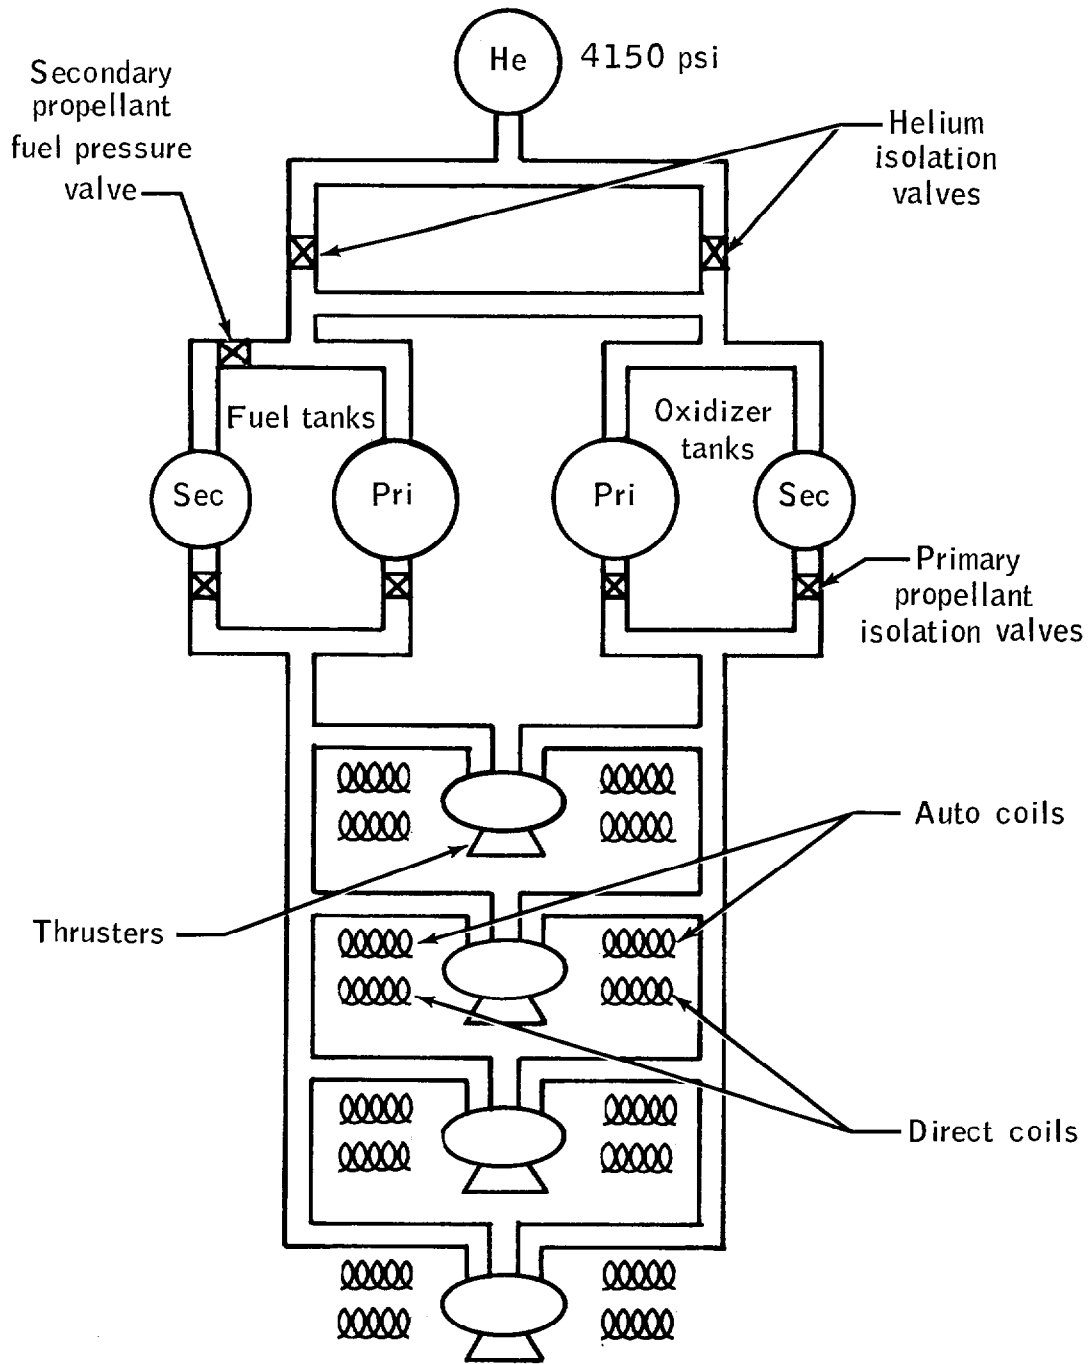
Figure B6-1.- Service module reaction control system one quad (typical of all four).

The valve position indicators in the spacecraft are the flag type which show gray when the valve is open and gray-and-white stripe ("barberpole") when closed; there is no telemetry indication of the valve position. Each valve and its respective indicator are powered from the same main dc bus and cannot be selected to the other bus. The valves in the propellant system for quads B and D are powered from main bus A and quads A and C are powered from main bus B. Therefore, there was no way to determine the status of the RCS propellant and pressurization systems of quads A and C, and there was no way to reposition the valves without powering up main bus B. The ability to open the isolation valves in quads B and D was not affected by the loss of main bus B.
