REPORT OF APOLLO 13 REVIEW BOARD

APPENDIX F - SPECIAL TESTS AND ANALYSES

NATIONAL AERONAUTICS AND SPACE ADMINISTRATION

APPENDIX F
SPECIAL TESTS AND ANALYSES

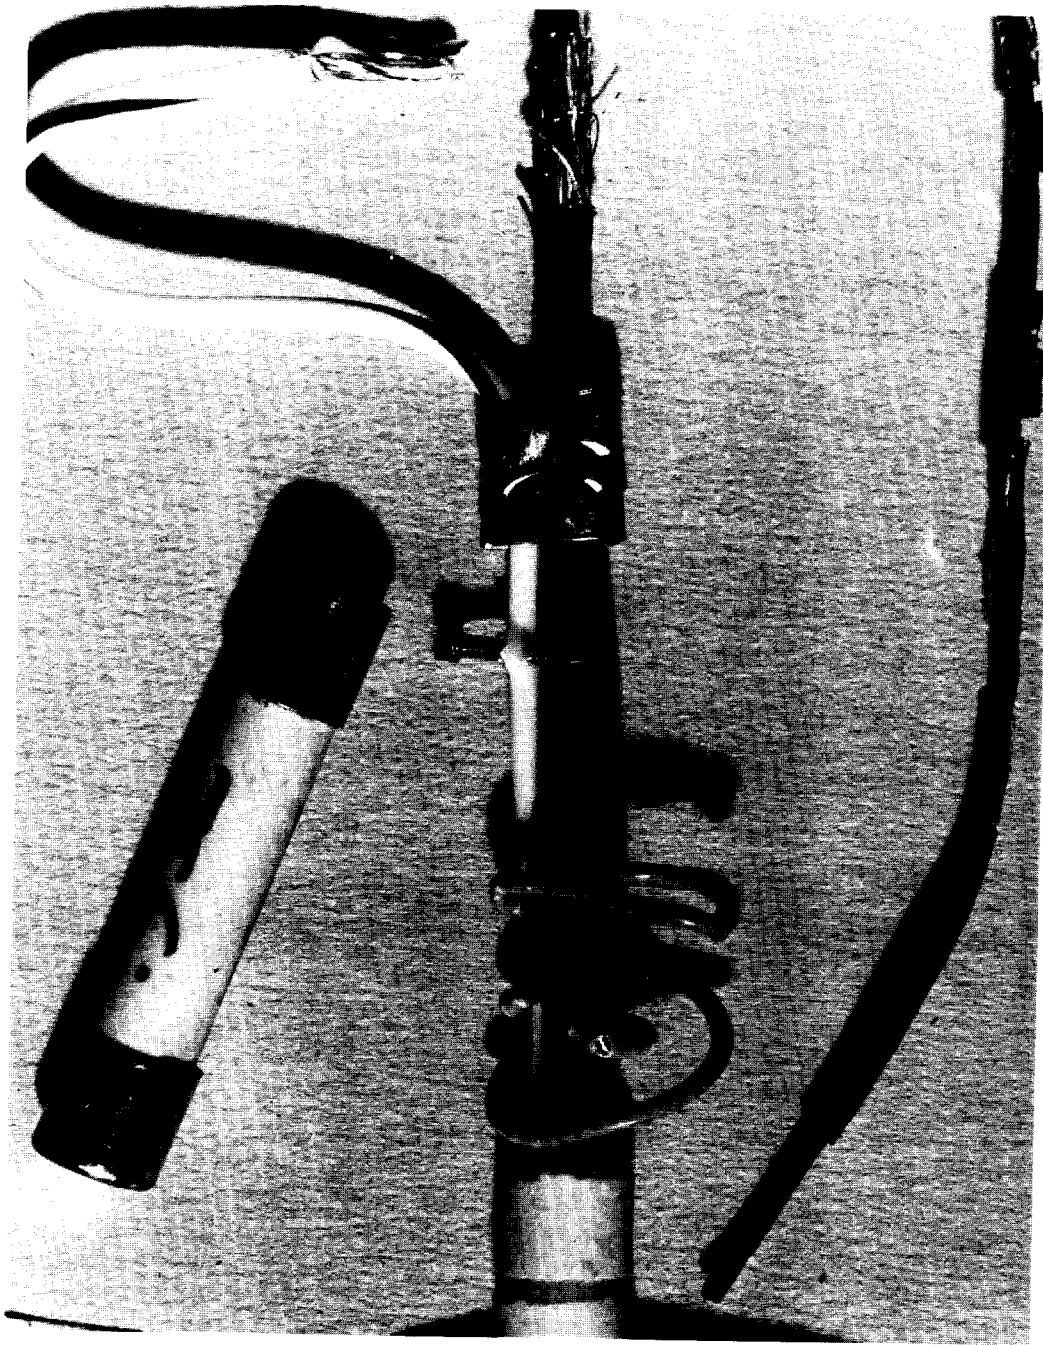
Sample sections of Teflon-insulated conductors obtained from Beech Aircraft Corporation through MSC were baked in oxygen for 5 hours at 572° F, held overnight at room temperature in oxygen, and baked further for 2 hours at 842° F. The Teflon lost its pliability, cracked, and flaked off as shown in figure F3.4-1.

Figure F3.4-1.- Heat degraded wire and test harness replica.

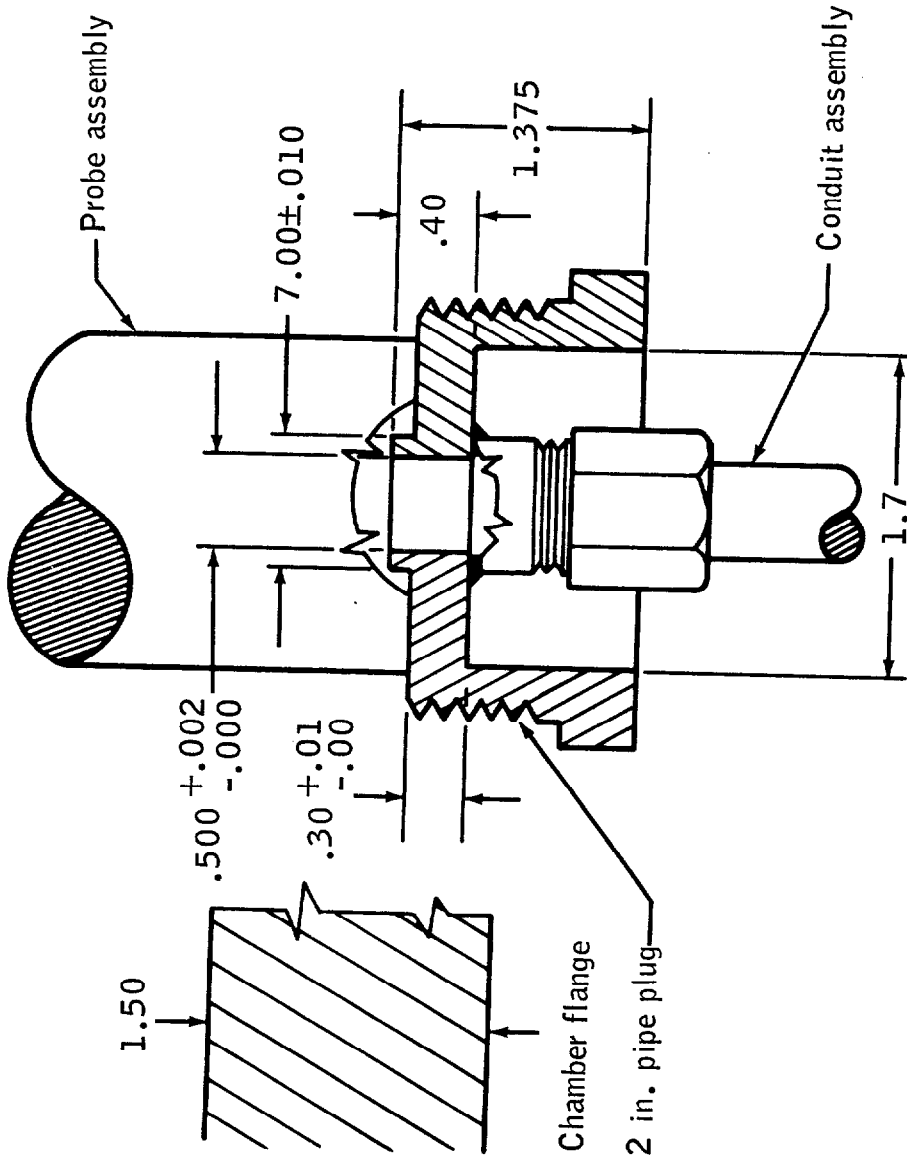
Figure F3.5-2.- Upper quantity probe - conduit interface.

The probe conduit interface consisted of a stainless steel 2-inch pipe plug machined to the dimensions shown in figure F3.5-2. The interface was mounted on the bottom flange of the chamber so that flame propagation would be downward.

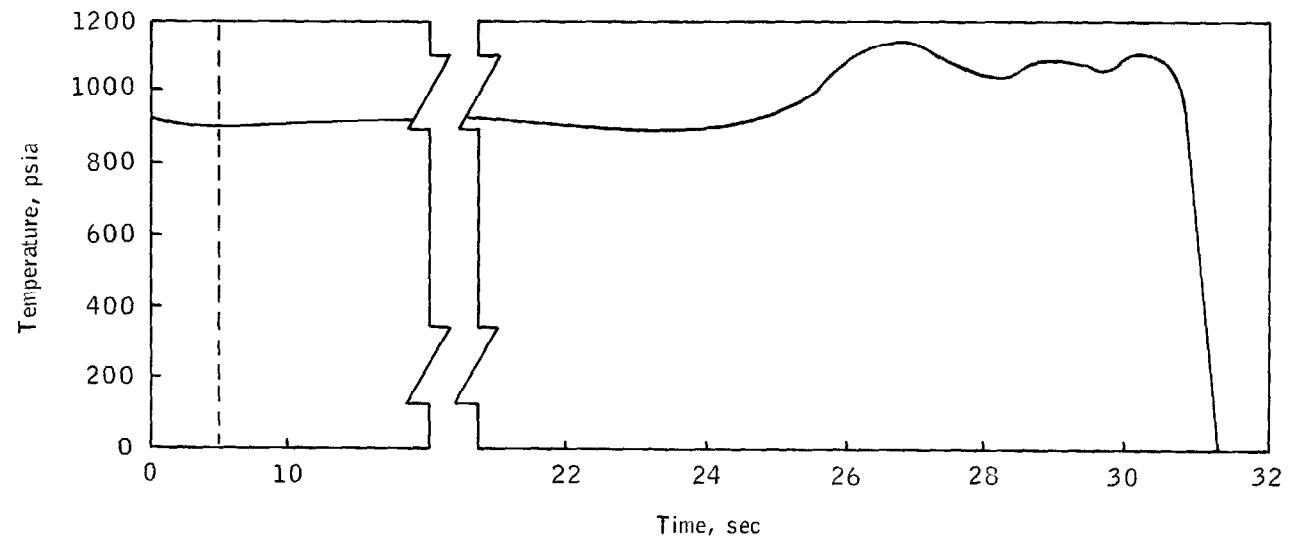
Pressure history of the chamber is shown in figure F3.5-3. The first relief valve opening occurred at approximately 28 seconds. It subsequently reopened 15 times before failure occurred. Fusion of the ignitor is shown on the graph to indicate ignition of the insulation.

Figure F3.5-3.- Quantity probe and conduit assembly test pressure history.
