LOSS OF OXYGEN TANK NO. 2 SYSTEM INTEGRITY

PART 5. APOLLO 13 RECOVERY

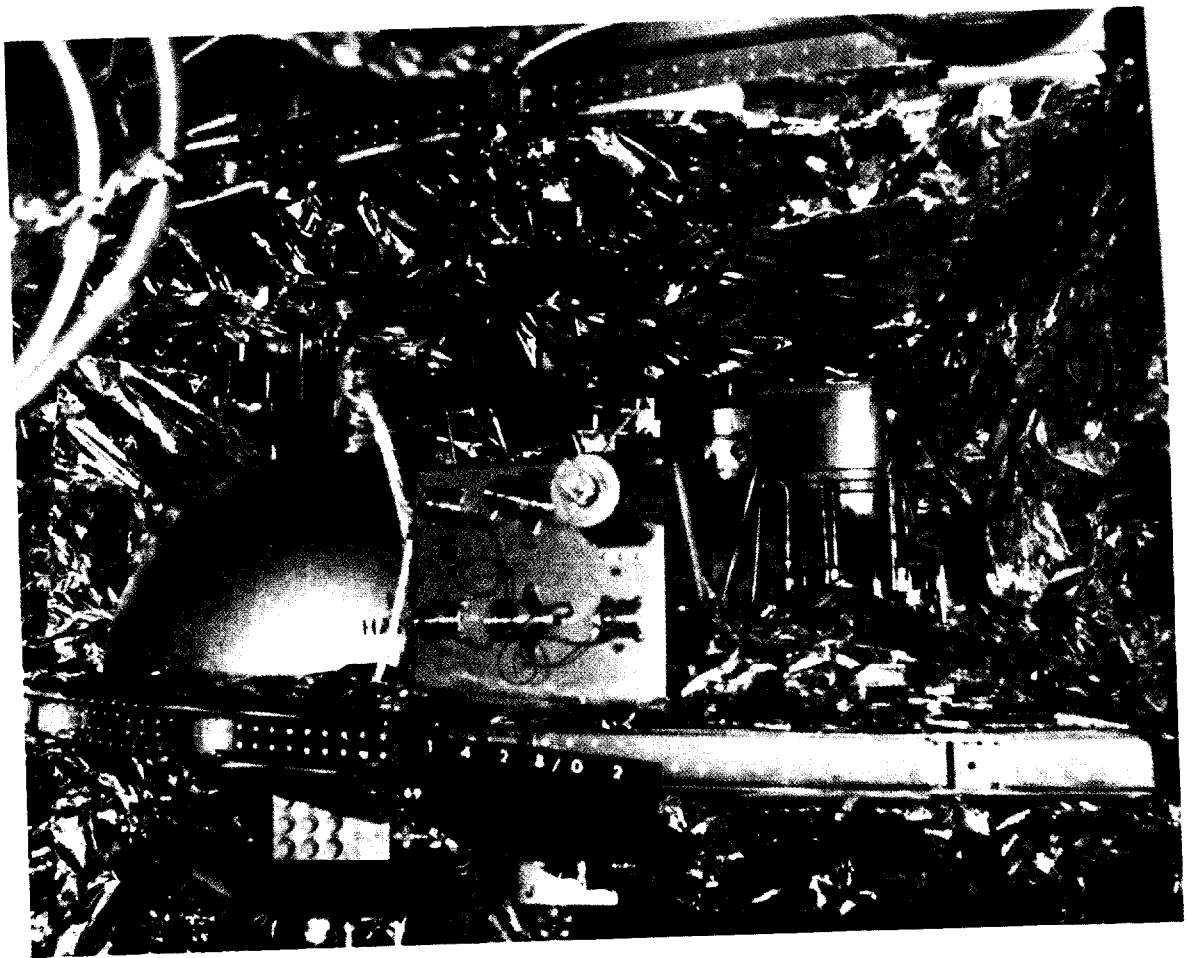
Release of the oxygen then began to pressurize the oxygen shelf space of bay 4. If the hole formed in the pressure vessel were large enough and formed rapidly enough, the escaping oxygen alone would be adequate to blow off the bay 4 panel. However, it is also quite possible that the escape of oxygen was accompanied by combustion of Mylar and Kapton (used extensively as thermal insulation in the oxygen shelf compartment, figure 4-11, and in the tank dome) which would augment the

4-11.-
Figure ~~XX-XX~~ Closeup view of oxygen tank shelf.

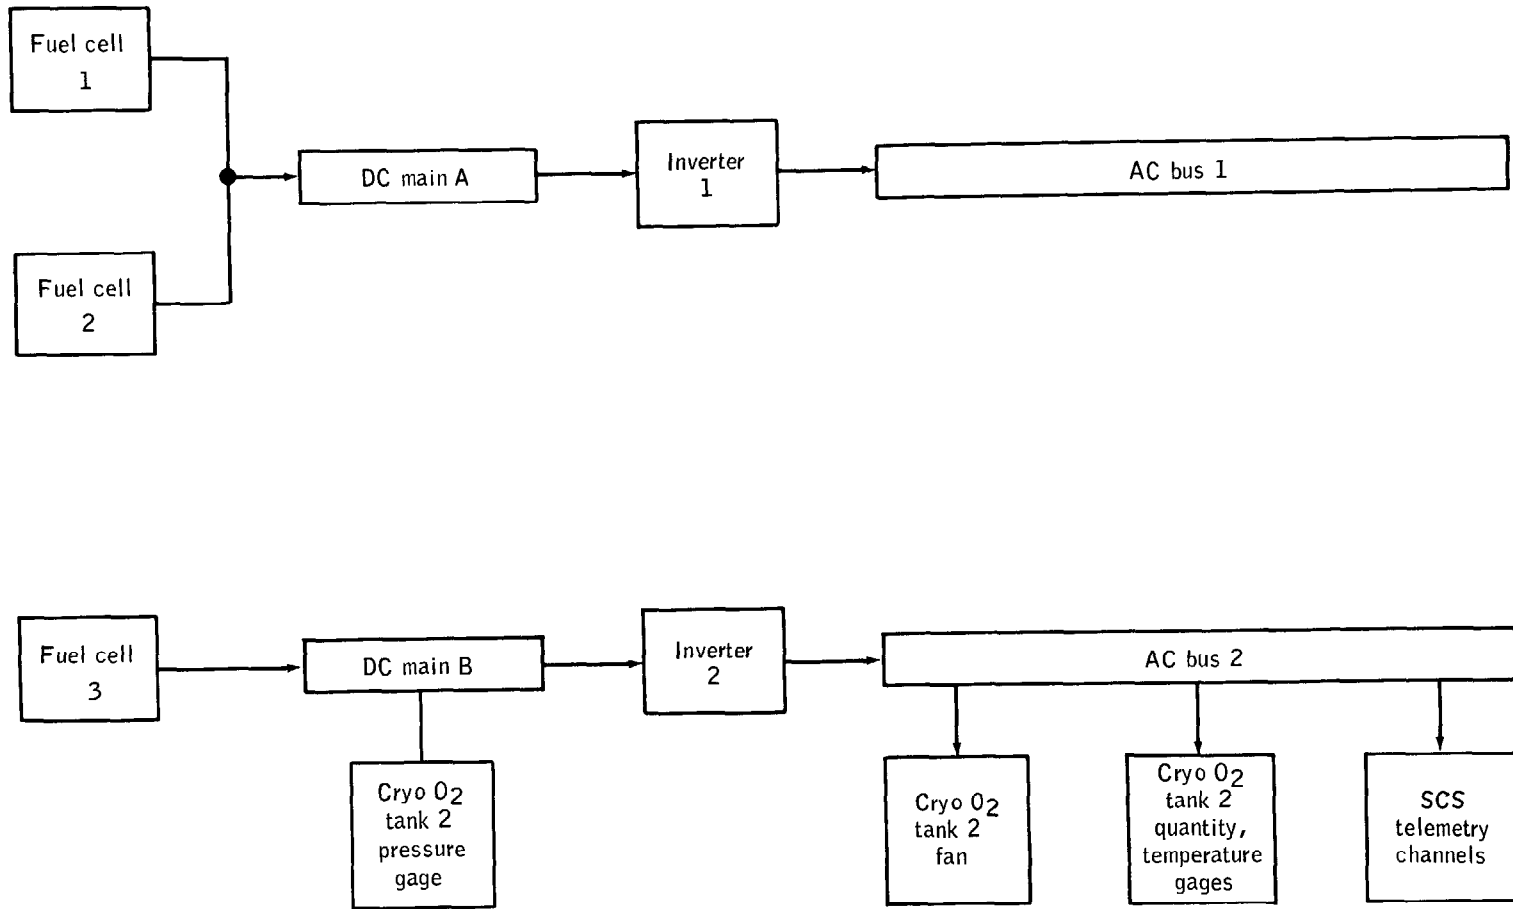
The failure of oxygen tank no. 2 and consequent removal of the bay 4 panel produced a shock which closed valves in the oxygen supply lines to fuel cells 1 and 3. These fuel cells ceased to provide power in about 3 minutes, when the supply of oxygen between the closed valves and the cells was depleted. Fuel cell 2 continued to power ac bus 1 through dc main bus A, but the failure of fuel cell 3 left dc main bus B and ac bus 2 unpowered (see fig. 4-12). The oxygen tank no. 2 temperature and quantity gages were connected to ac bus 2 at the time of the accident. Thus, these parameters could not be read once fuel cell 3 failed at 55:57:44 until power was applied to ac bus 2 from main bus A.

Figure 4-12.- Electrical configuration at 55:54:53 g.e.t.

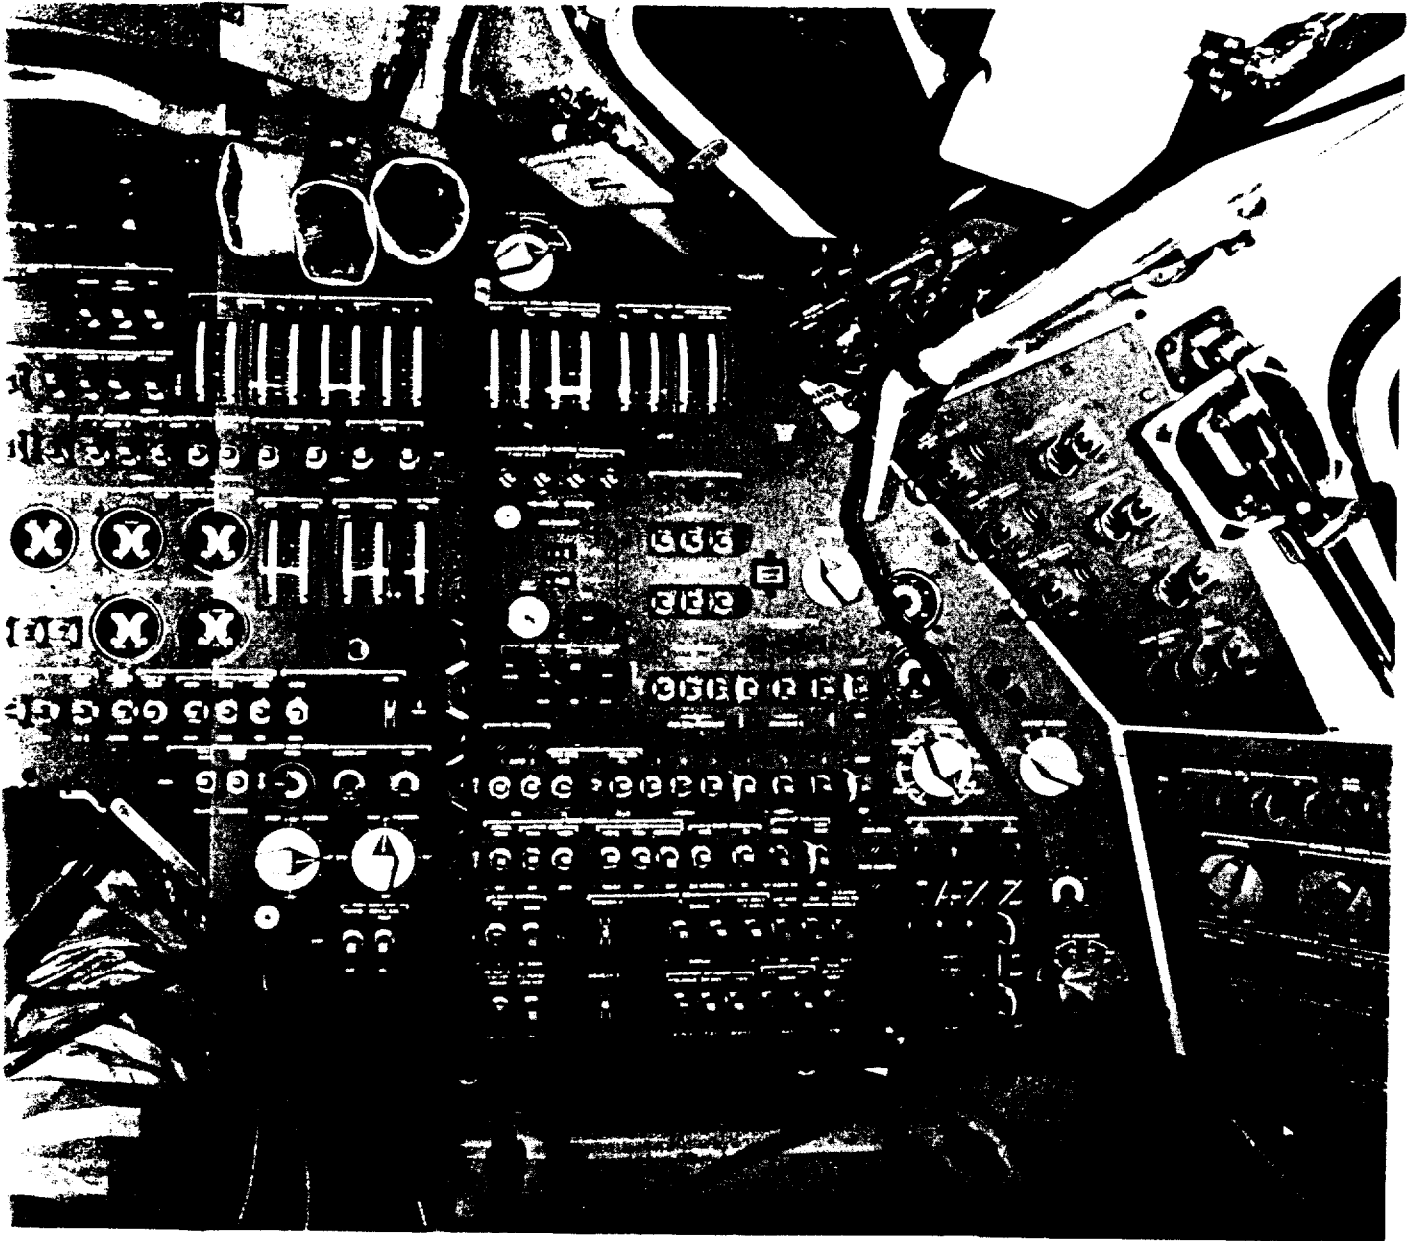
The Lunar Module Pilot was in the tunnel between the CSM and the LM, returning to the CSM. The Command Module Pilot was in the left-hand couch, monitoring spacecraft performance. Because of the master alarm indicating low voltage, the CMP moved across to the right-hand couch where CSM voltages can be observed. He reported that voltages were "looking good" at 55:56:10. At this time, main bus B had recovered and fuel cell 3 did not fail for another 1-1/2 minutes. He also reported fluctuations in the oxygen tank no. 2 quantity, followed by a return to the off-scale high position. (See fig. 4-13 for CM panel arrangement).

Figure 4-13.- Main display panel.

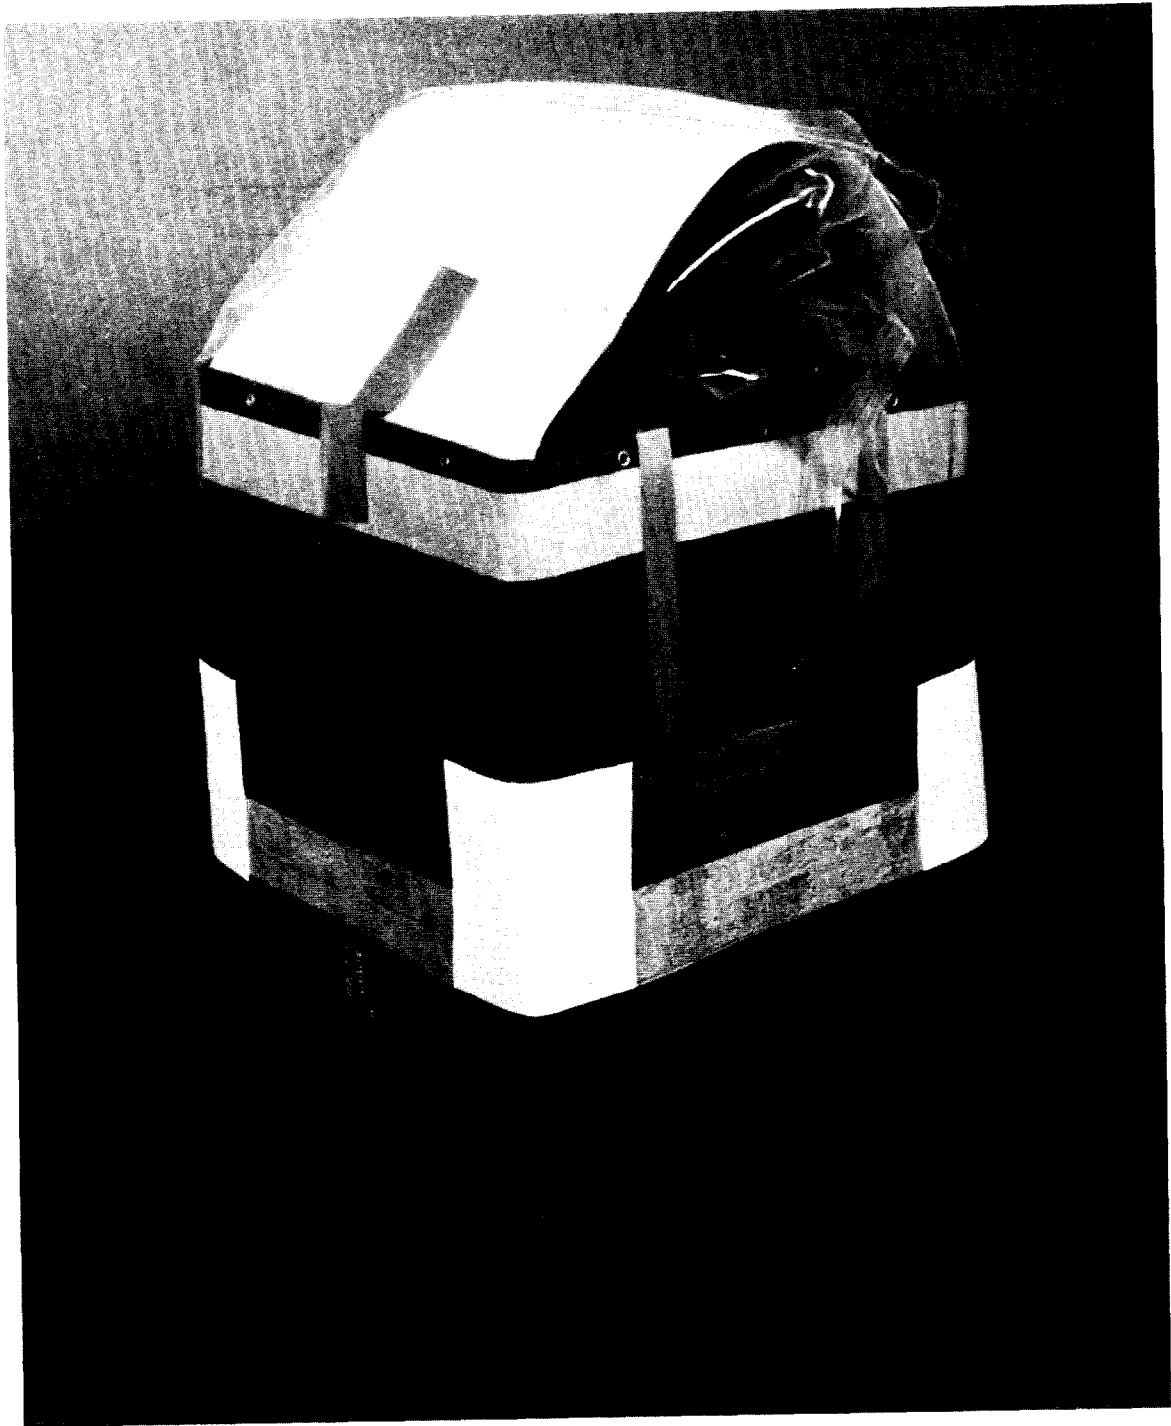
The most critical consumables were water, used to cool the CSM and LM systems during use; CSM and LM battery power, the CSM batteries being for use during reentry and the LM batteries being needed for the rest of the mission; LM oxygen for breathing; and lithium hydroxide (LiOH) filter cannisters used to remove carbon dioxide from the spacecraft cabin atmosphere. These consumables, and in particular the water and LiOH cannisters, appeared to be extremely marginal in quantity shortly after the accident, but once the LM was powered down to conserve electric power and to generate less heat and thus use less water, the situation improved greatly. Engineers at MSC developed a method which allowed the crew to use materials on board to fashion a device allowing use of the CM LiOH cannisters in the LM cabin atmosphere cleaning system (see fig. 4-16). At splashdown, many hours of each consumable remained available (see figs. 4-17 through 4-19 and table 4-III).

Figure 4-16.- Lithium hydroxide canister modification.
