**FINAL REPORT TO BP EXPLORATION
FOR DETERMINING INTERIM
CRITERIA FOR REPLACING
DAMAGED POLYESTER
MOORING ROPE**

**Prepared For
BP America, Inc.
Upstream Technology Group
Deepwater Technology Unit**

December 13, 2001

**FINAL REPORT TO BP FOR DETERMINING INTERIM CRITERIA FOR
REPLACING DAMAGED POLYESTER MOORING ROPE**

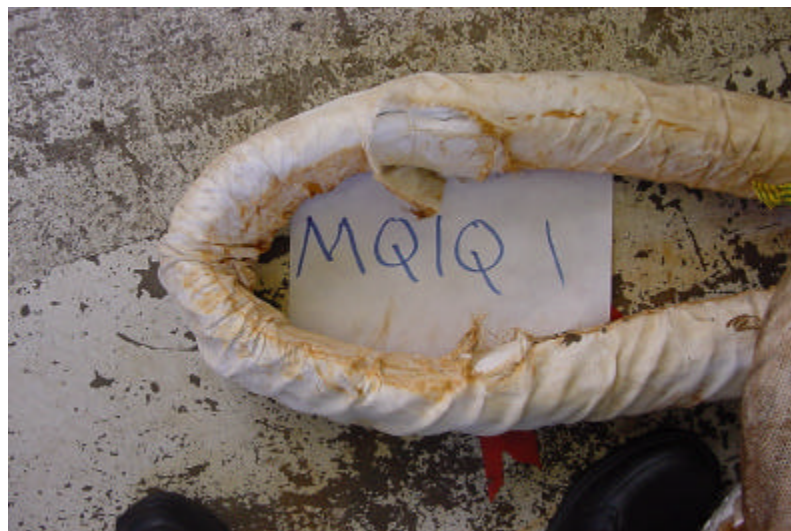
Figure B14. Photo of Wear in Outer Cover at Upper and Lower Tangent Points.

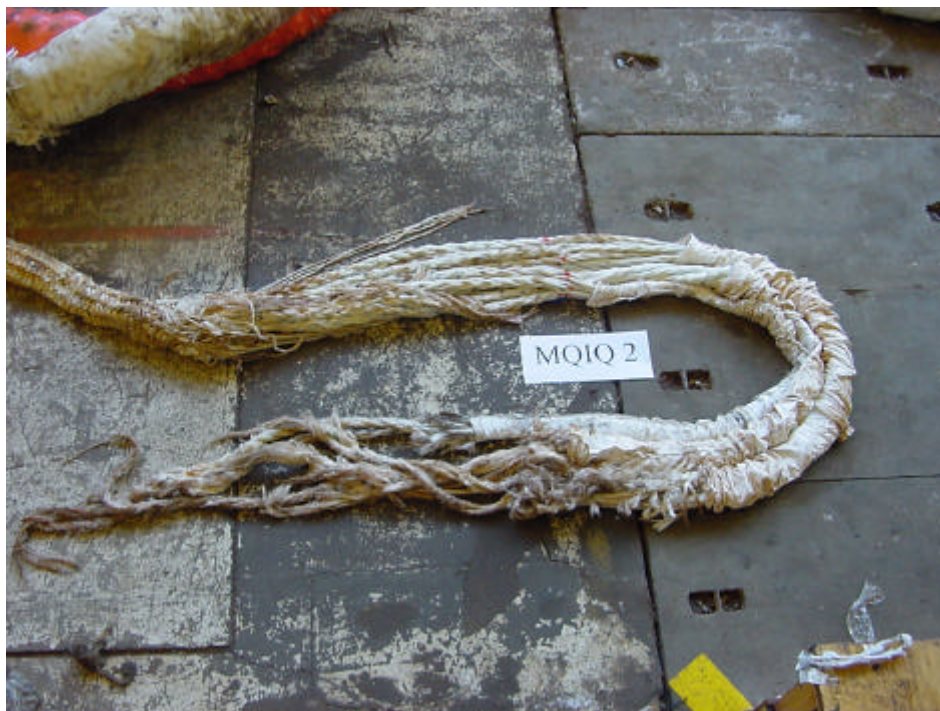
Figure B15. Failure of MQIQ 2 at One of the Eyes.

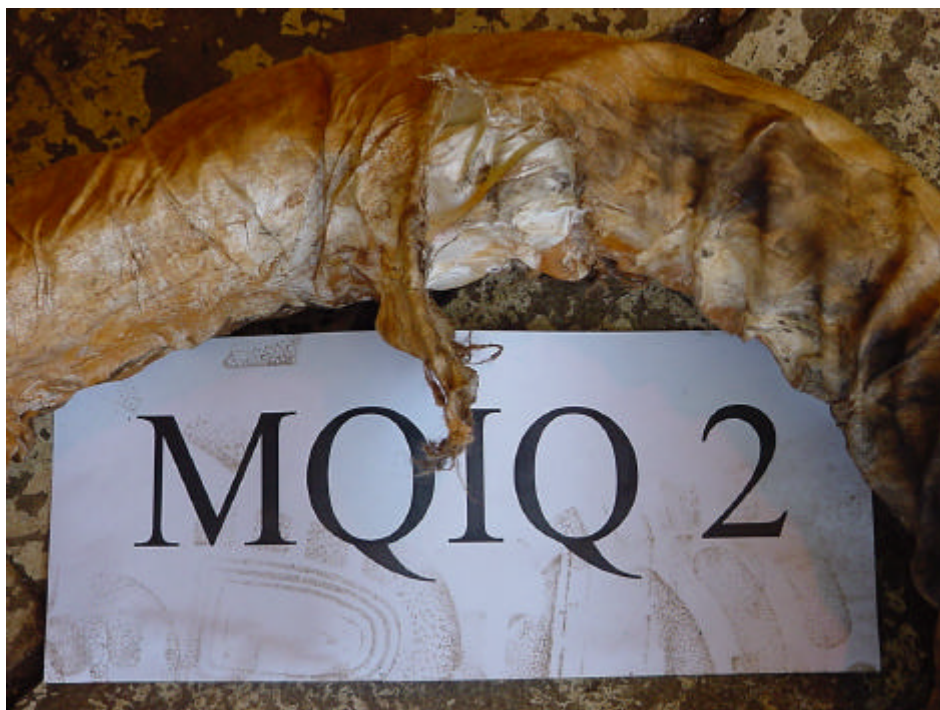
Figure B16. Wear of Eye at Opposite End of MQIQ 2.

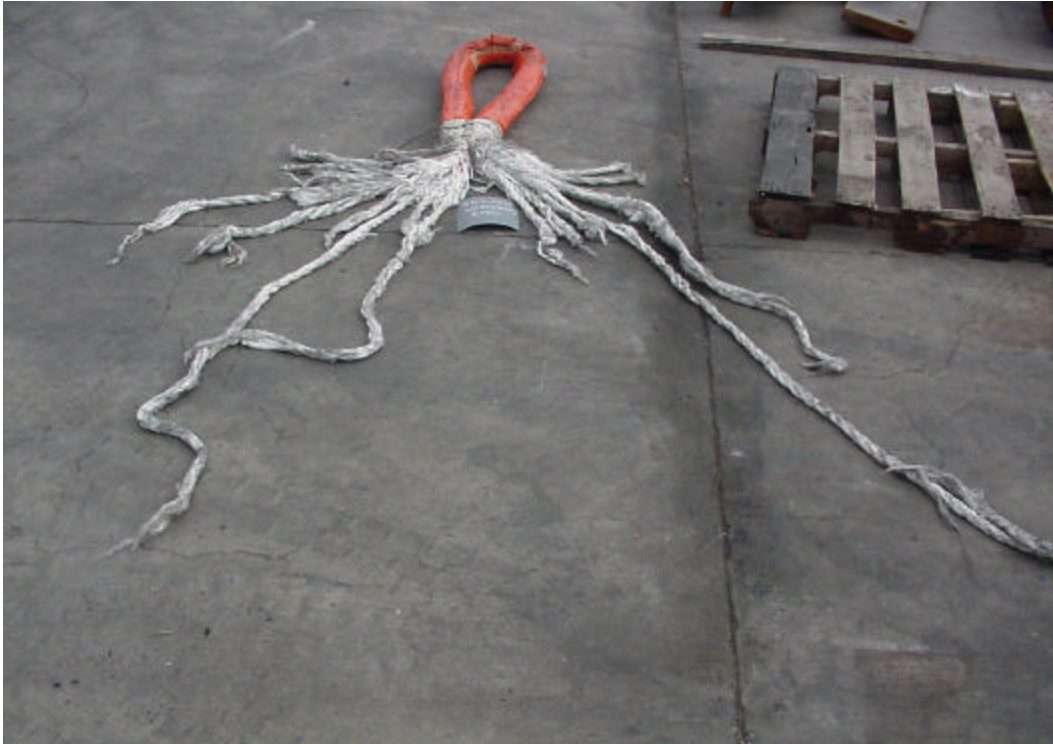
Figure B17. Damage of SES 1. First End.

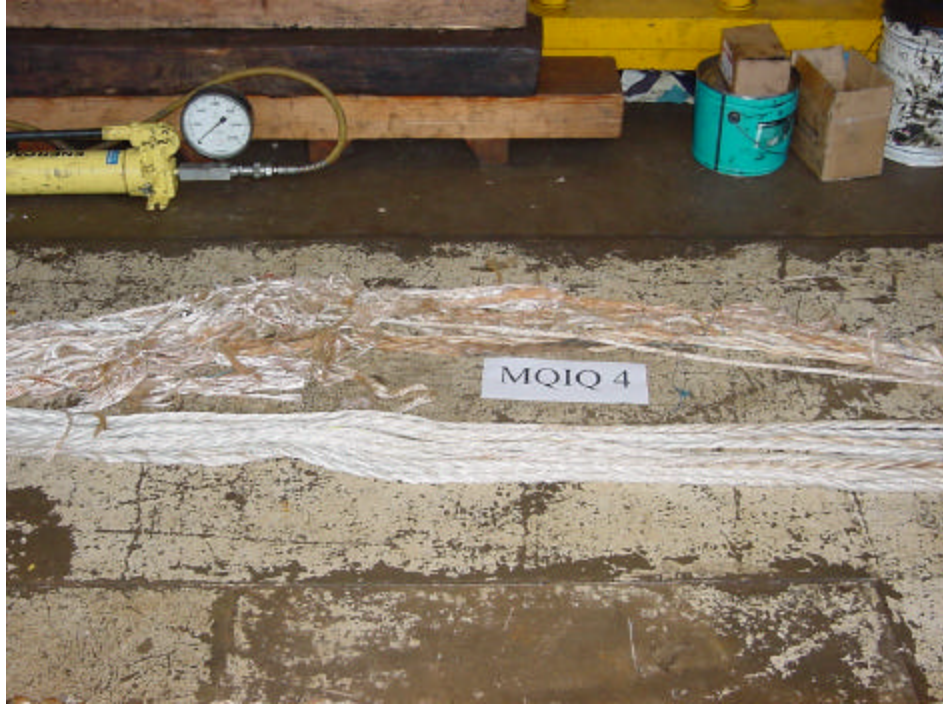
Figure B19. Failure of MQIQ 4 in the Center Section.

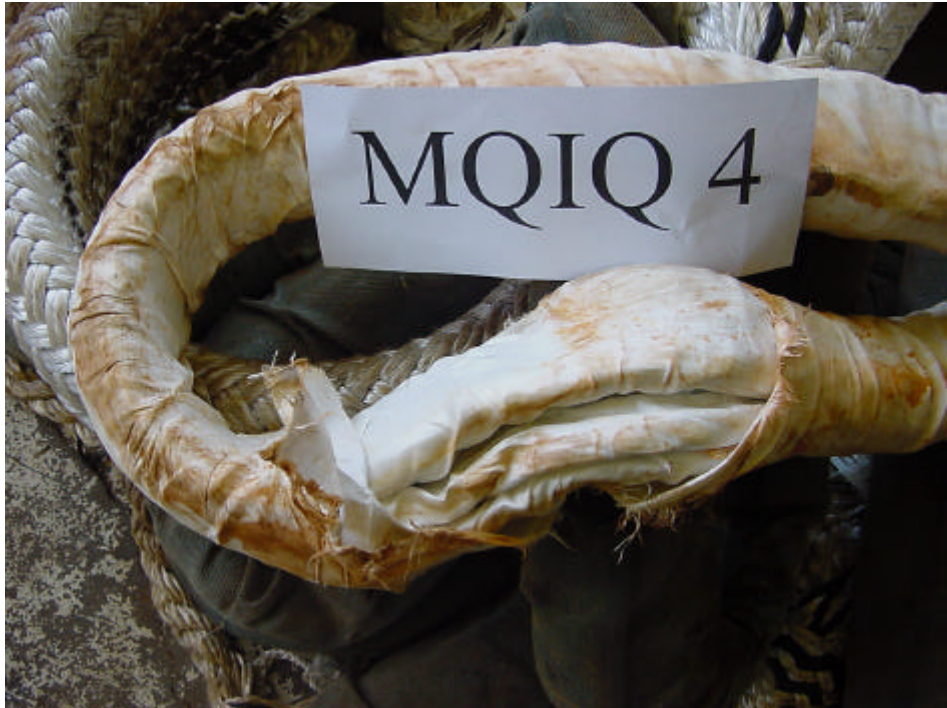
Figure B20. Wear of Outer Cover of Splice in MQIQ 4.

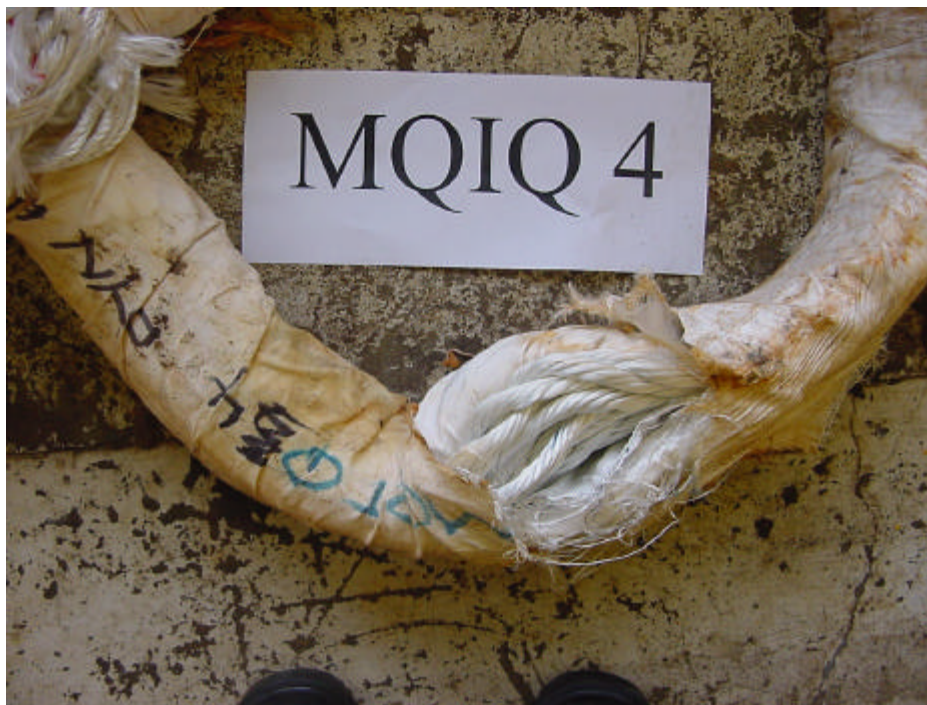
Figure B21. Eye Wear at Other End.

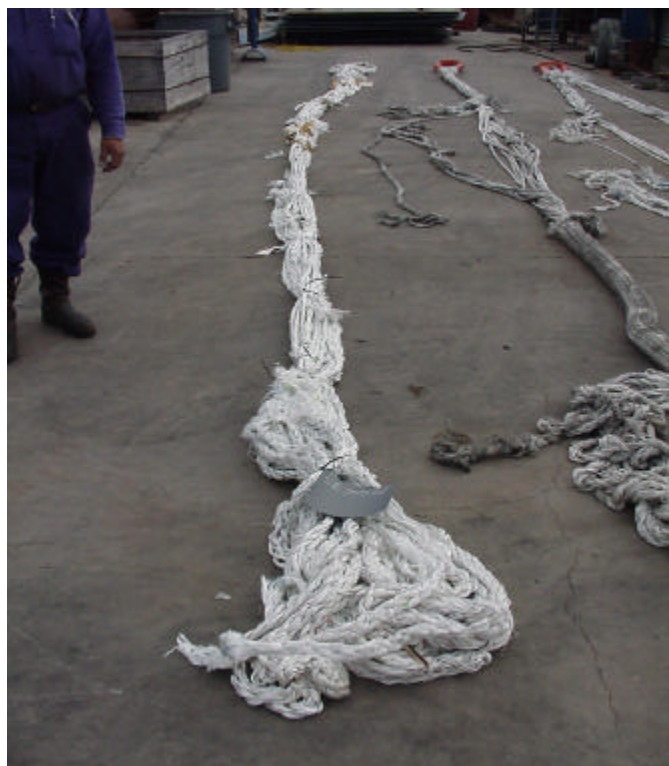
Figure B22. Failure Photo of SES 2.

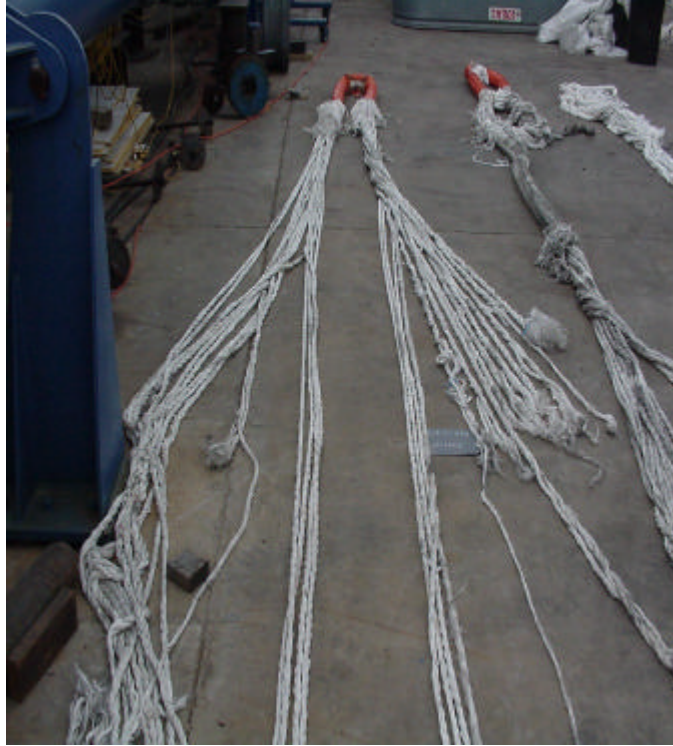
Figure B23. Failure Photo of SES 3.

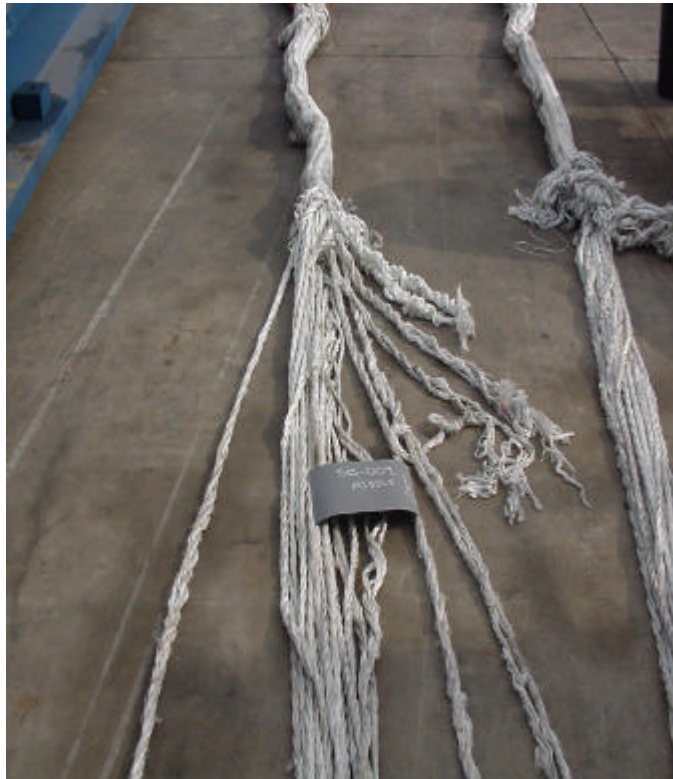
Figure B24. Failure of SES 4.

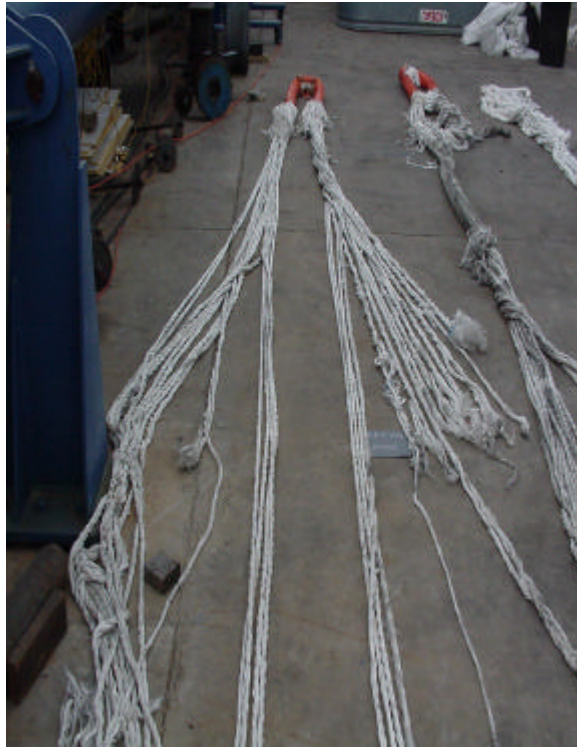
Figure B25. Failure Photo of SES 5.

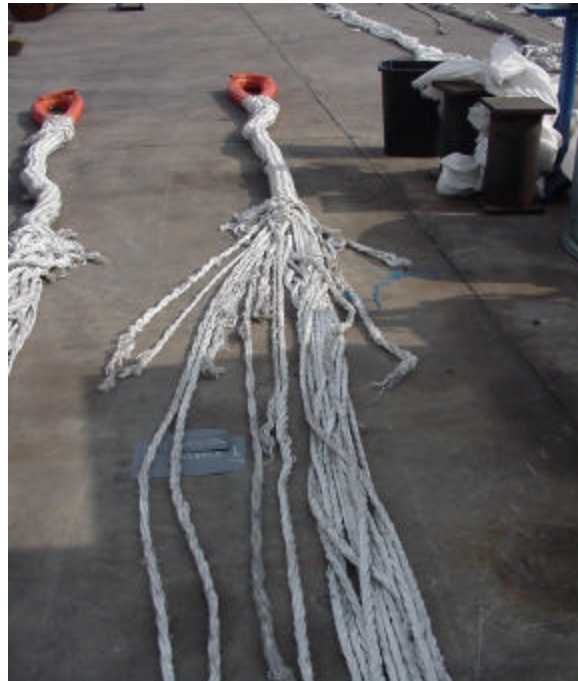
Figure B26. Failure Photo for SES 6.

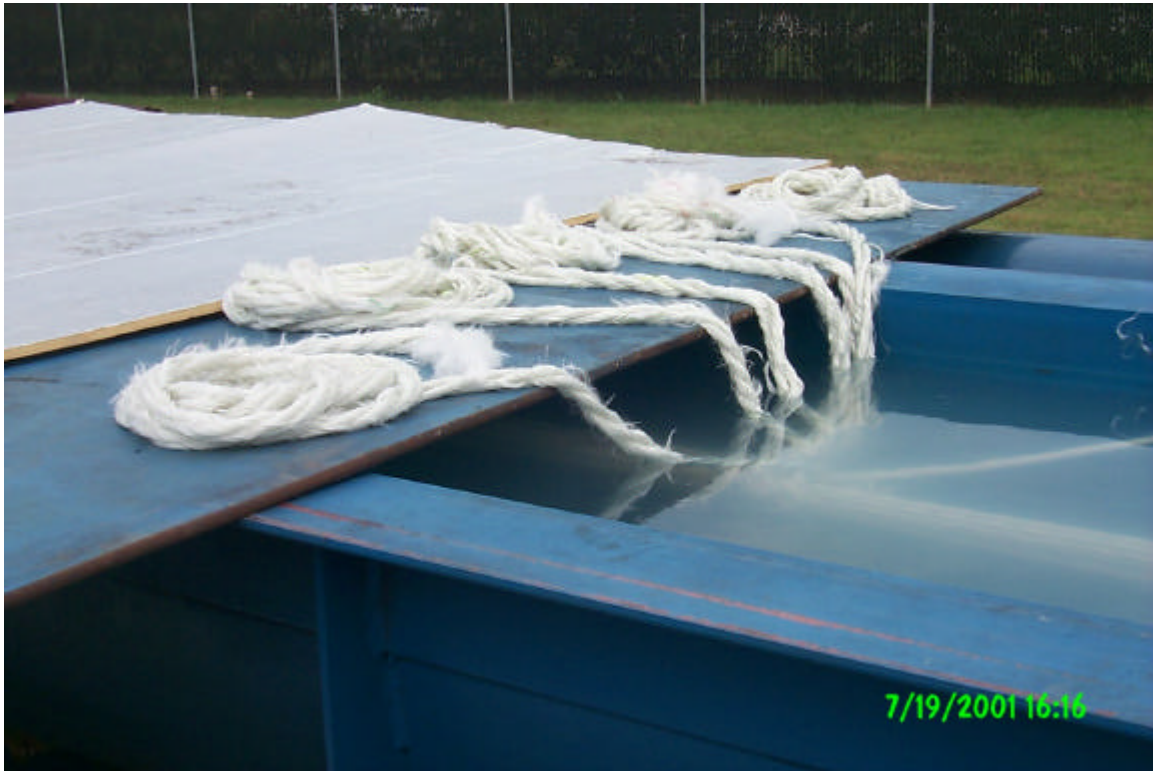
**Figure C-1. Broken/Cut Subropes Found After Test SES 2 Stopped.
Note Tensioned Ropes in the Water.**

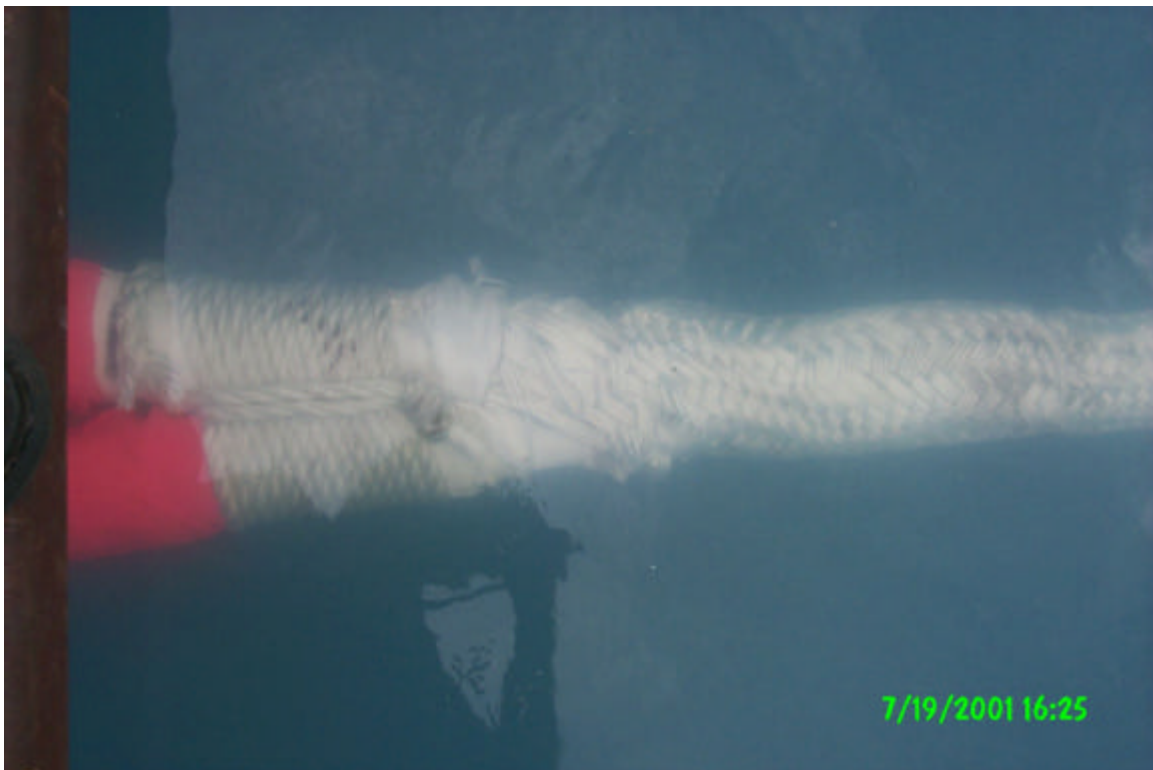
**Figure C-2. Photo of Broken/Cut “Bunching Up” Under the Cover.
Note Also the Asymmetry of the Splice.**

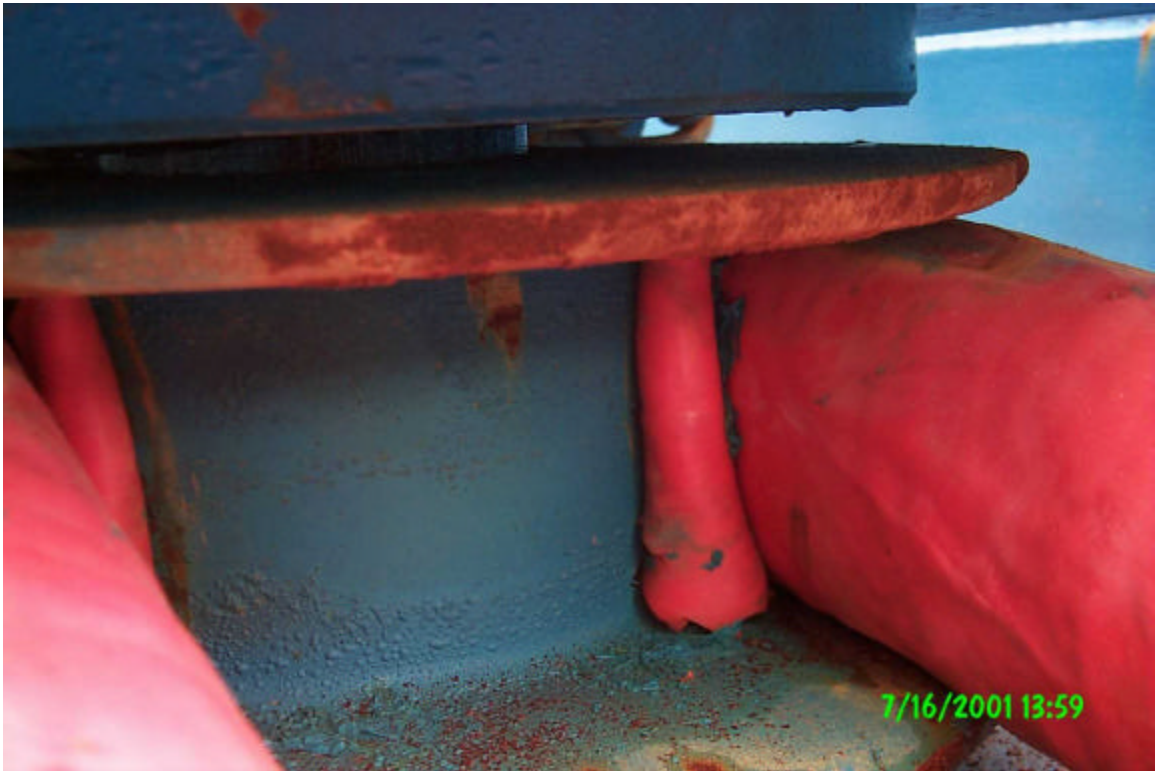
Figure C-3a. Coating Extrusion Damage Caused by Thimble Loading.

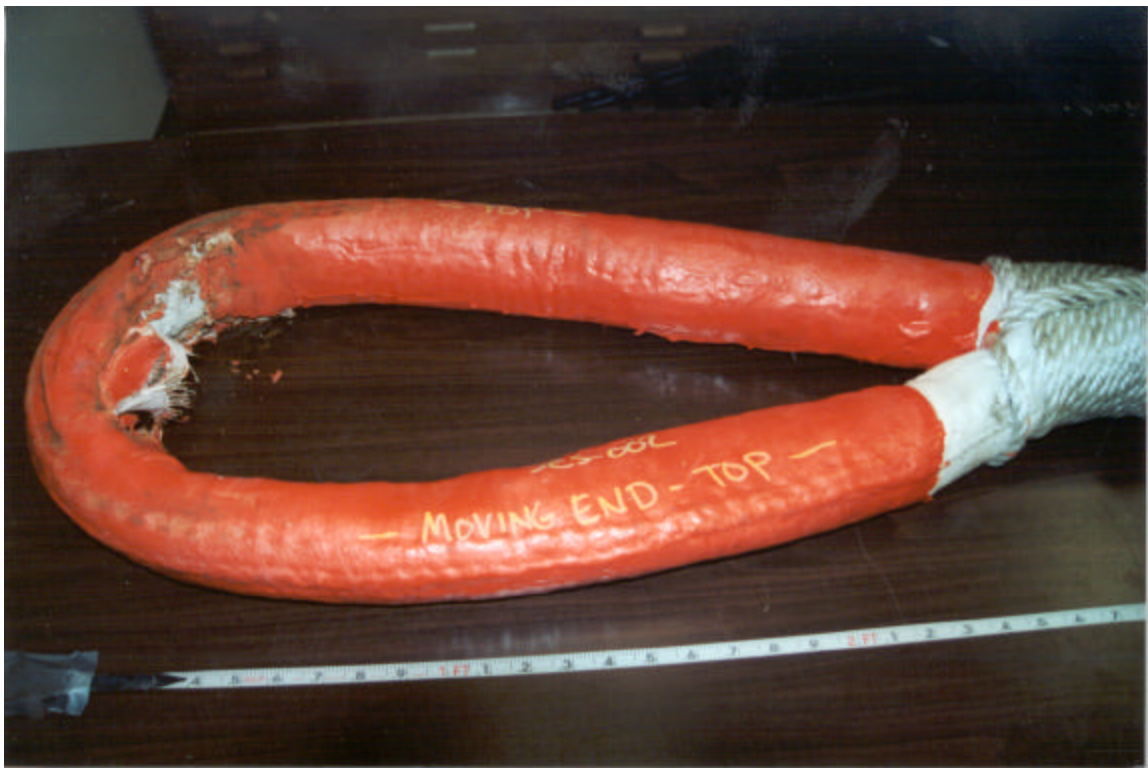
Figure C-3b. Photo Showing Rope Removed, and Splice Plastic Coating Damage.

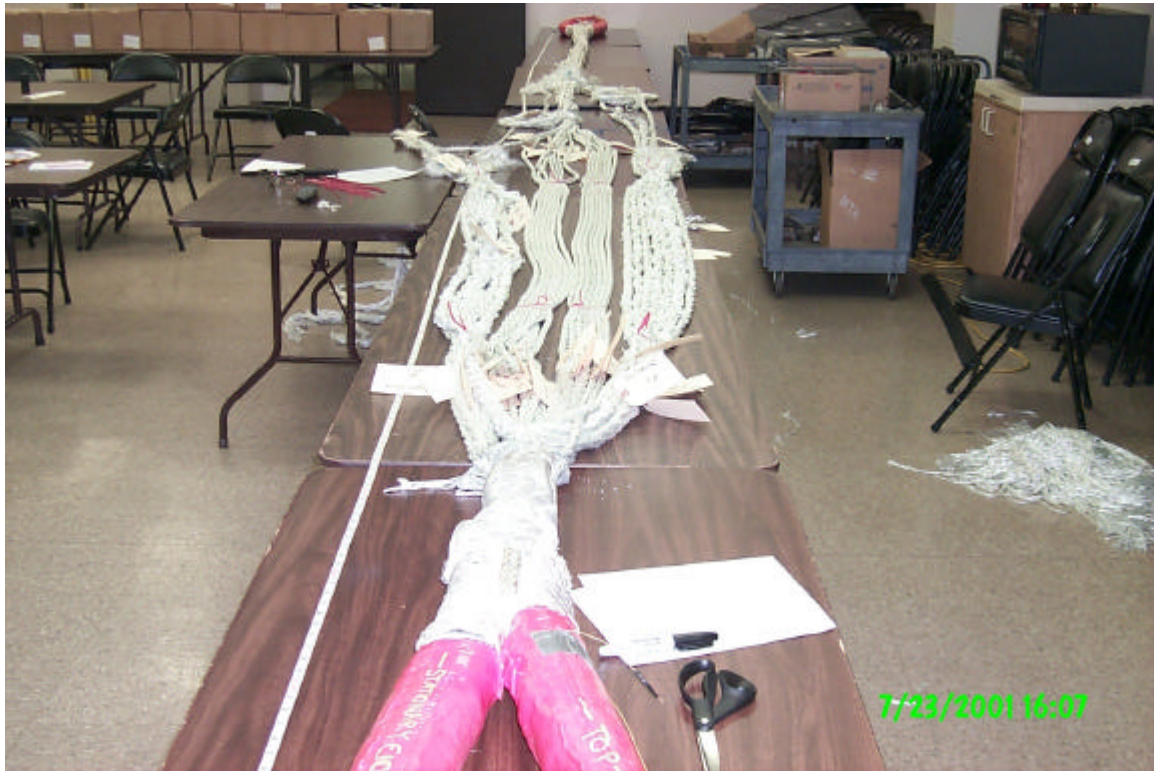
Figure C4. Sample SES 2 with Jacket Removed, Showing Inner Two Bundles of Undamaged Subrope, and Outer Two Bundles of Broken/Cut Subrope.

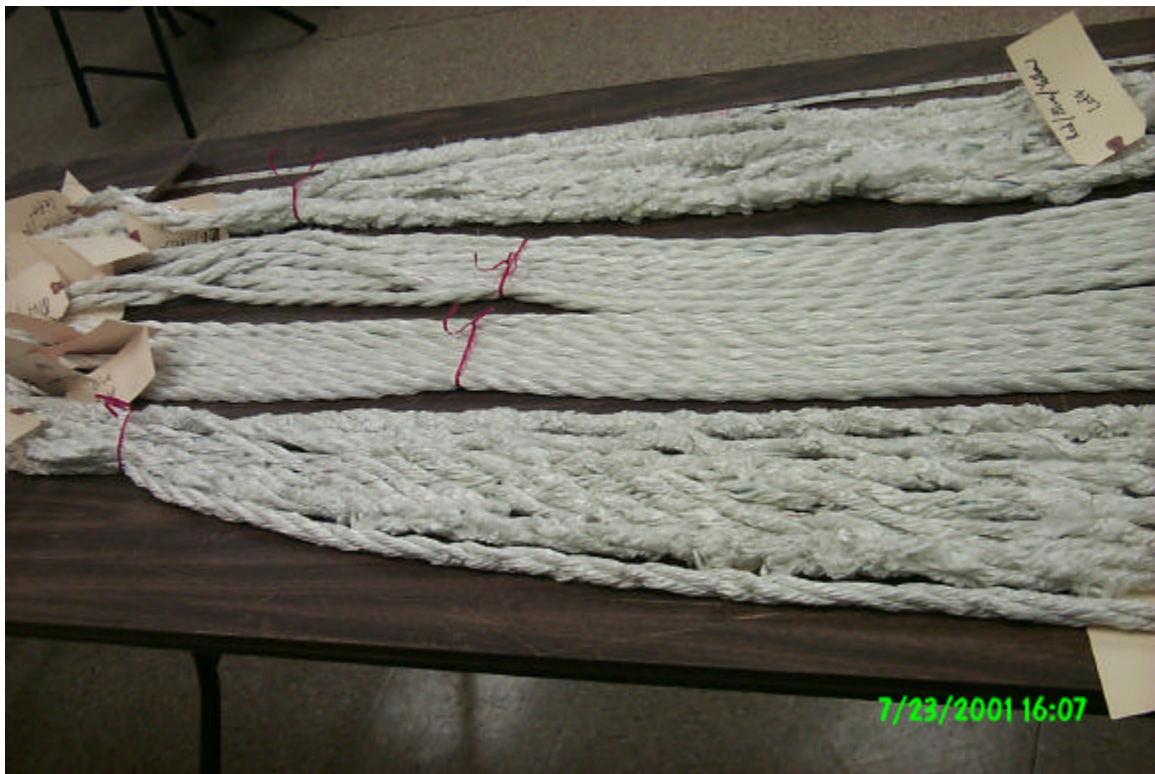
Figure C-5. Close-up of SES 2 Showing Outer Bundles Containing Subropes Affected By Bunching Up Under the Jacket.

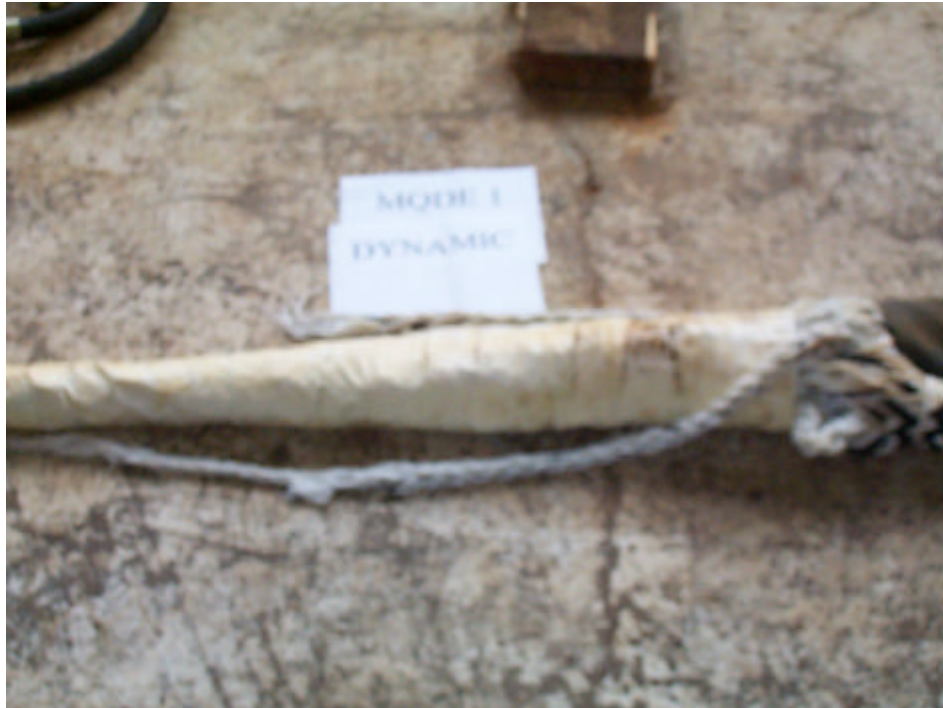
Figure 7.18 MQDE 1 – Failure Region Resulting From Break Test

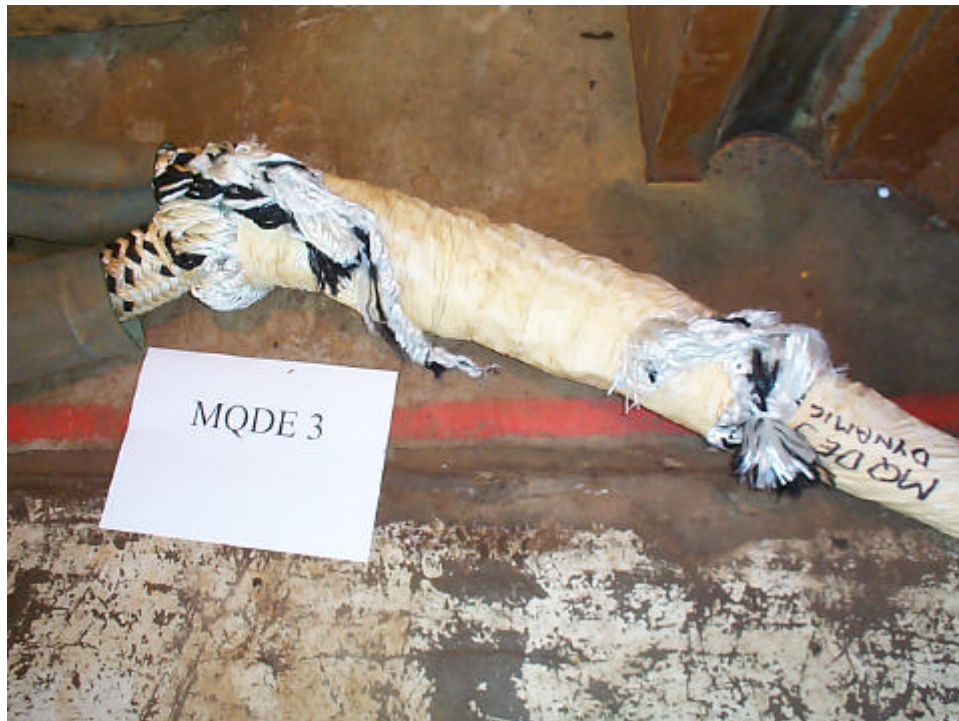
Figure 7.19 MQDE 3 – Failure Region Resulting From Break Test

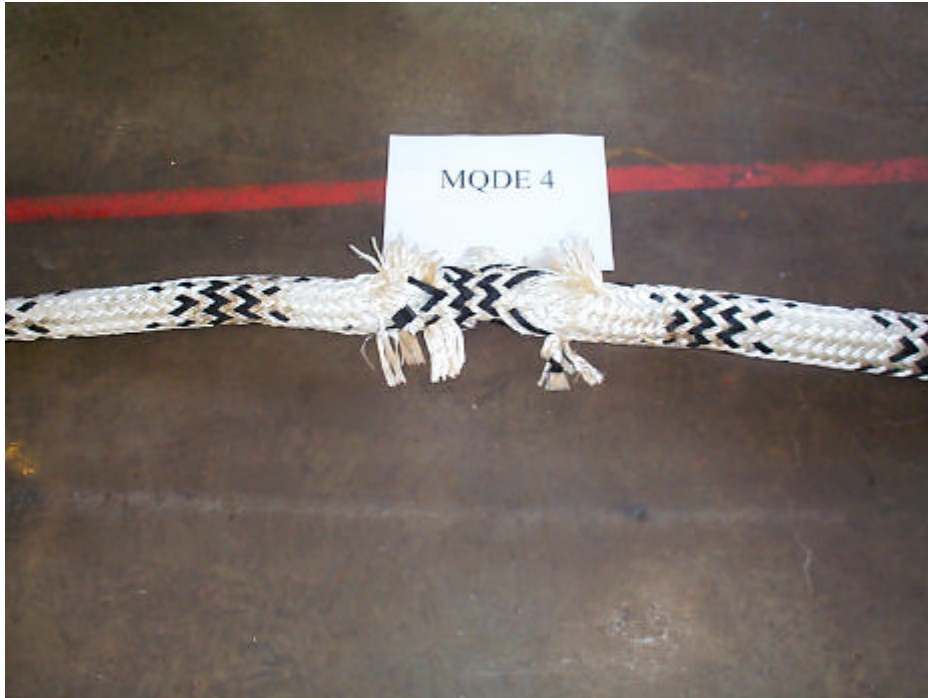
Figure 7.20 MQDE 4 – Failure Region Resulting From Break Test

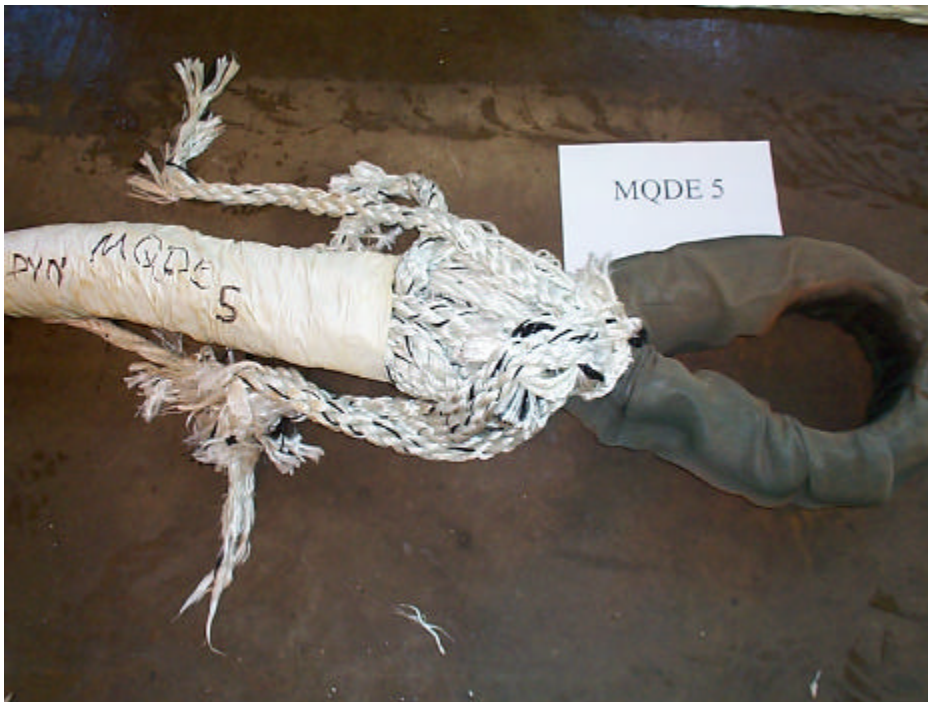
Figure 7.21 MQDE 5 – Failure Region Resulting From Break Test

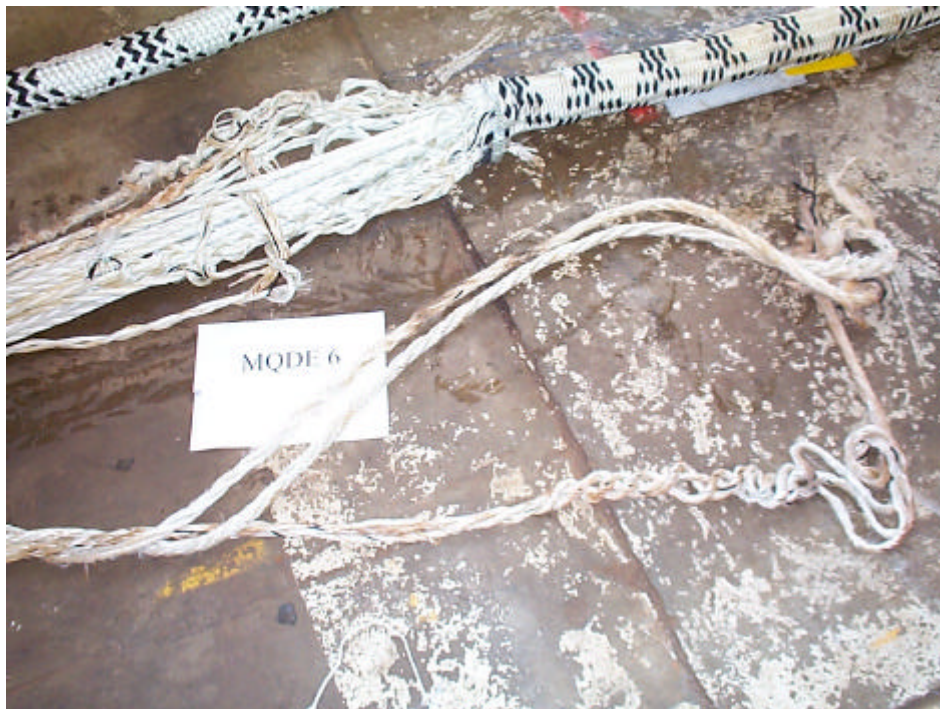
Figure 7.27 MQDE 6 – Failure Region Resulting From Break Test

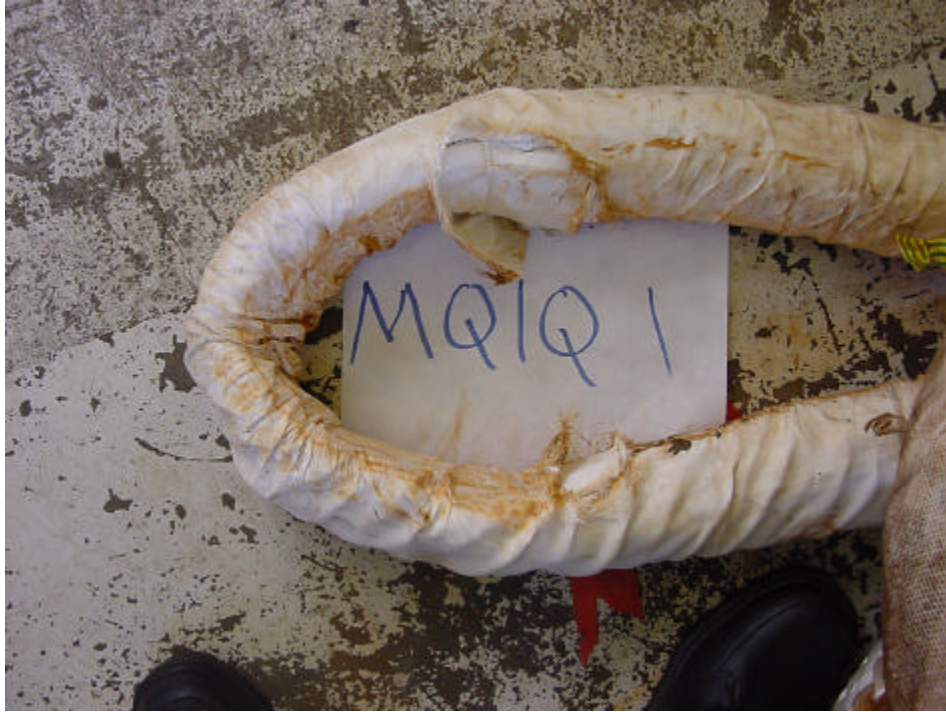
Figure 8.9 MQIQ 1 Wear of Outer Cover at Point Where Rope First Makes Contact with Spool (Tangent Point)

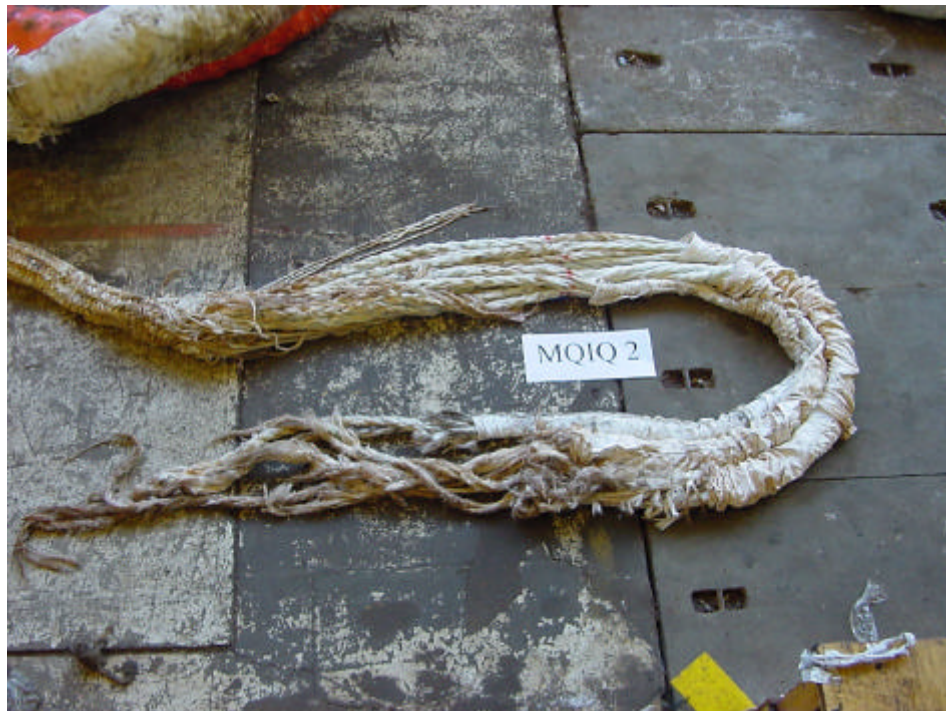
Figure 8.10 MQIQ 2 – Failure Region Resulting From Break Test

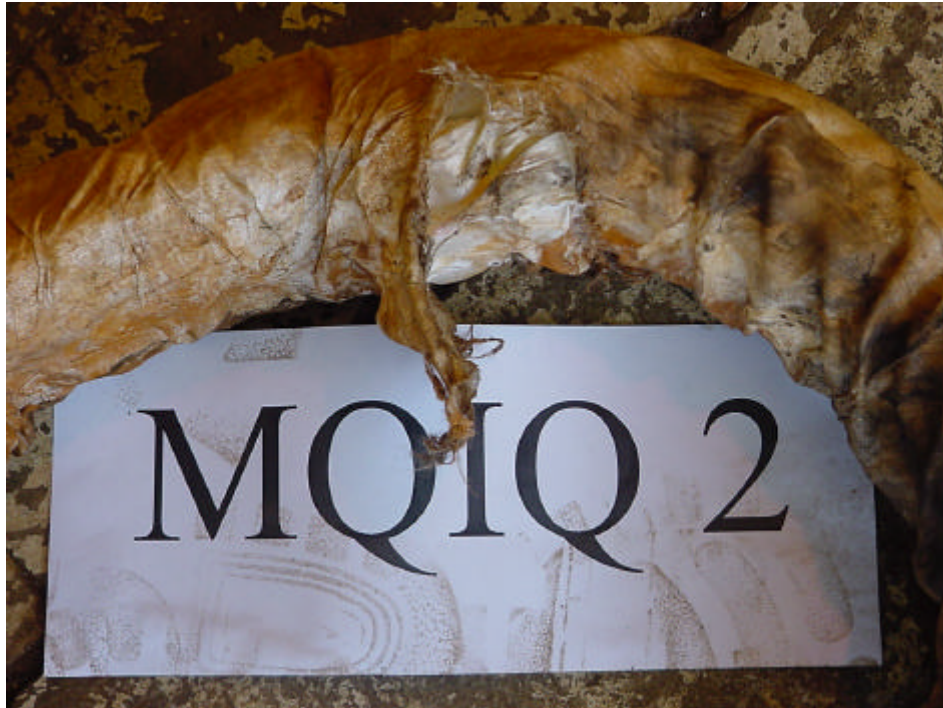
Figure 8.11 MQIQ 2 Wear of Outer Cover at Point Where Rope First Makes Contact with Spool (Tangent Point)

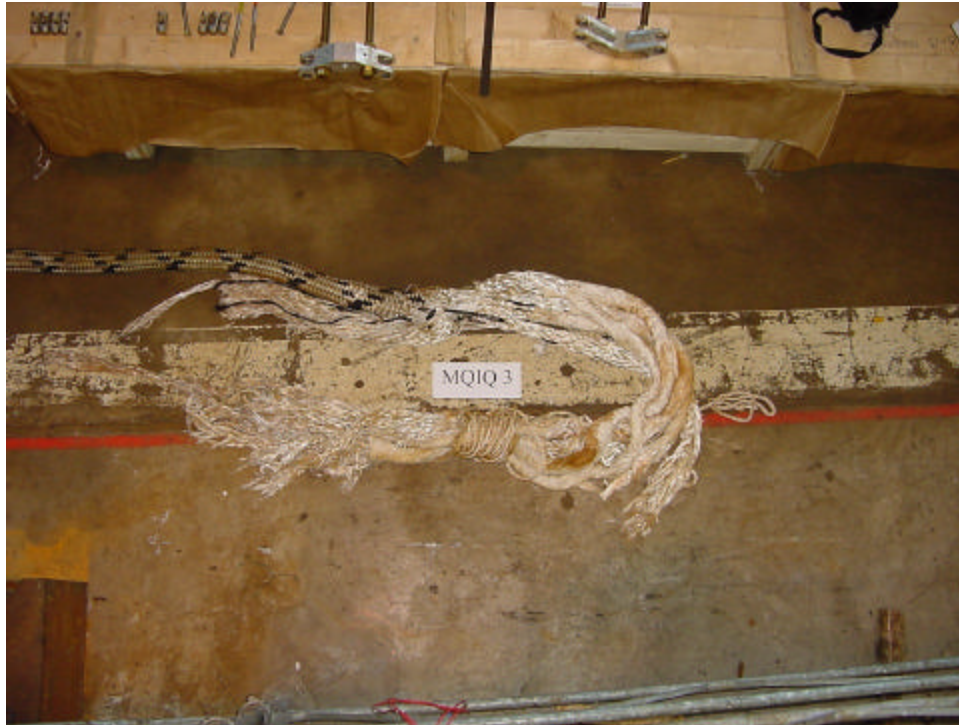
Figure 8.13 MQIQ 3 – Failure Region Resulting From Break Test (Splice Plus Tangent Point)

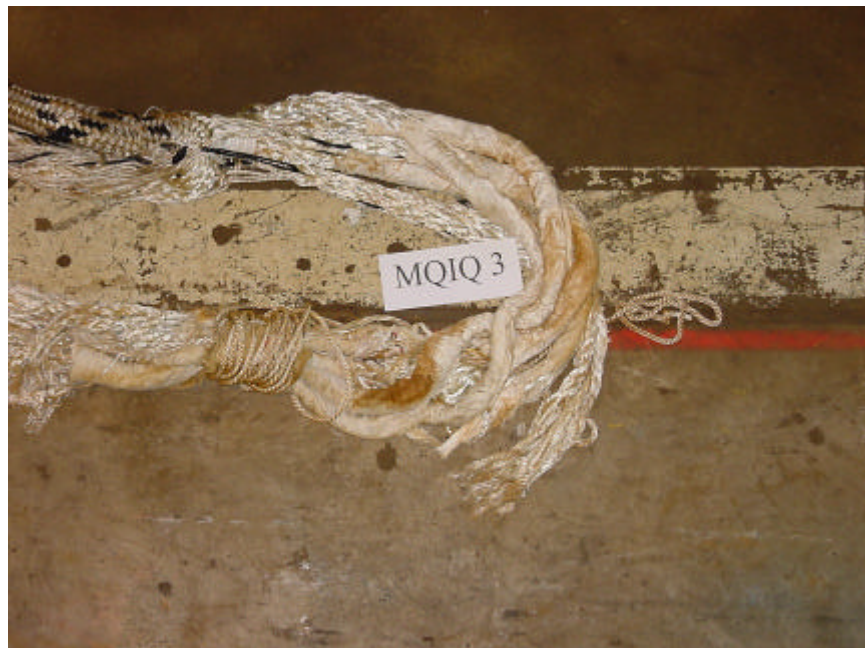
Figure 8.14 MQIQ 3 – Close-up of Tangent Point Failure

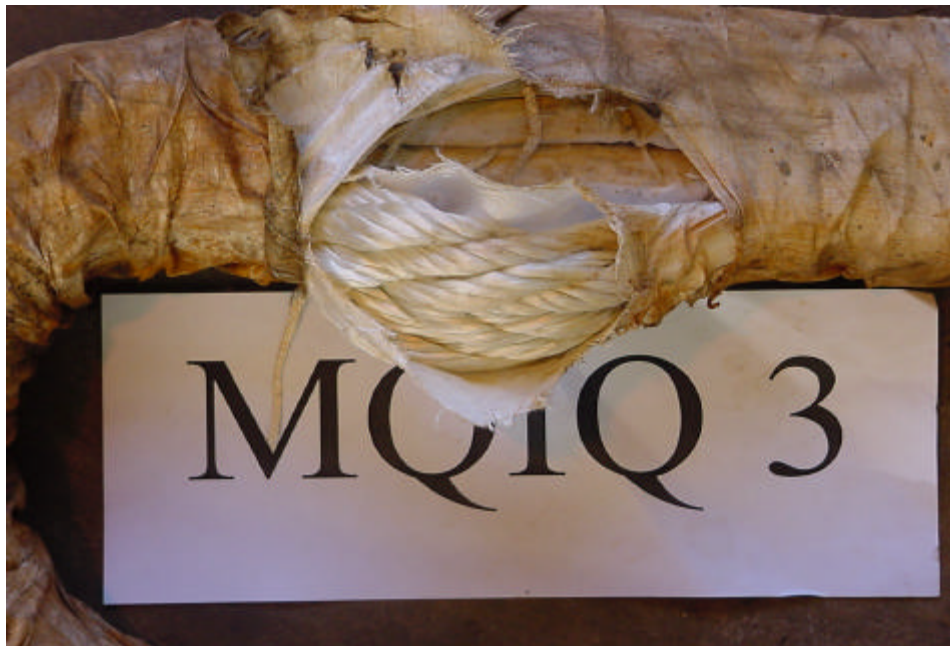
**Figure 8.16 Wear of Outer Cover Plus Cover Protection a Group of Sub-cores
(Where Rope First Makes Contact with Spool (Tangent Point))**

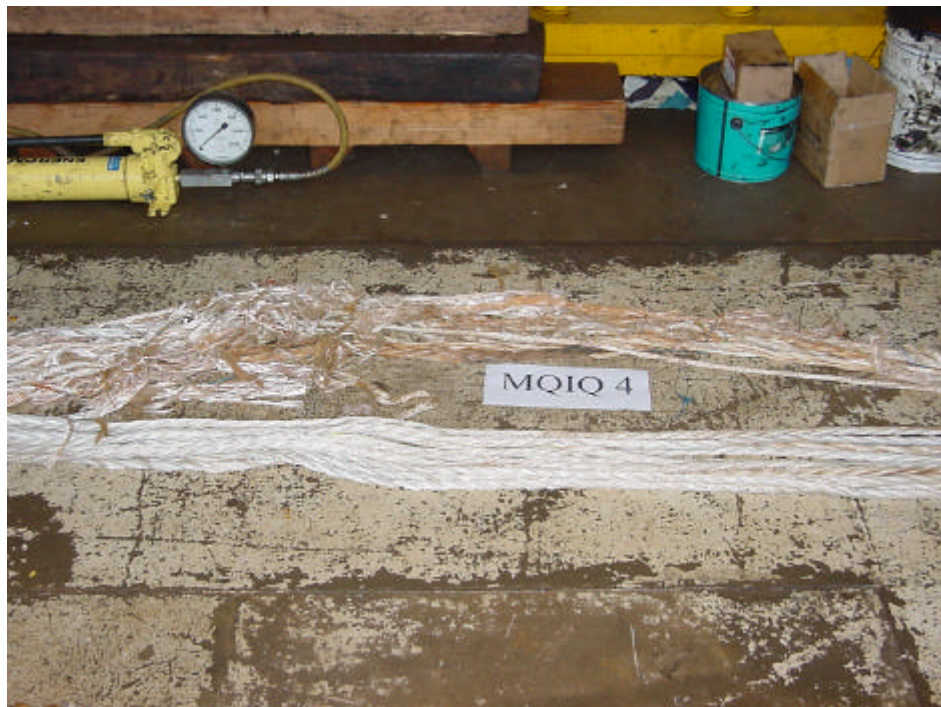
Figure 8.18 MQIQ 4 – Failure Region Resulting From Break Test

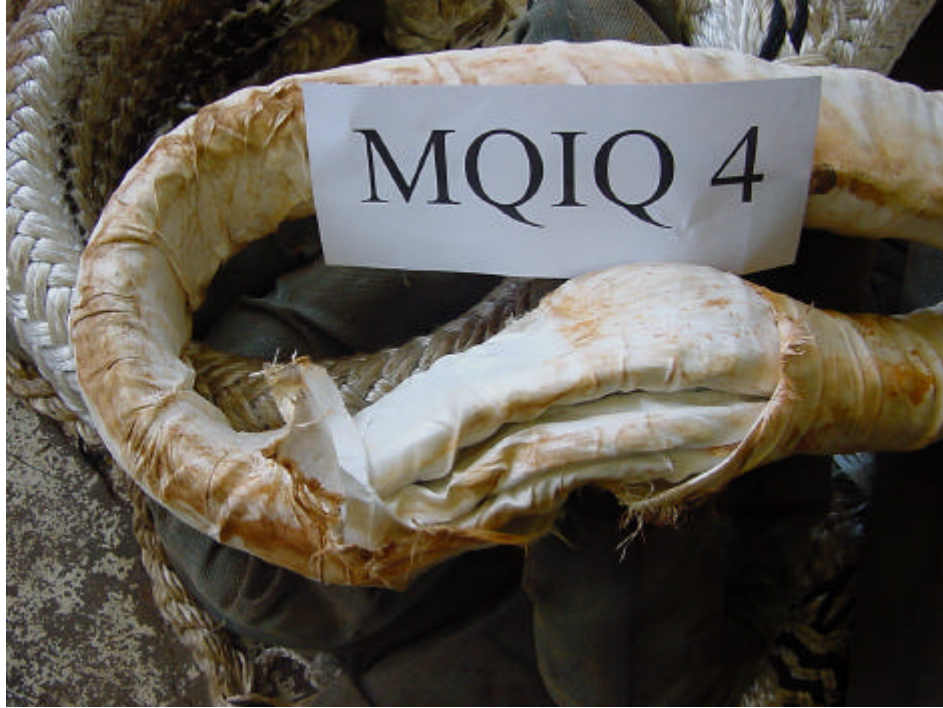
Figure 8.19 MQIQ 4 Wear of Outer Cover at Point Where Rope First Makes Contact with Spool (Tangent Point) Fixed End Eye

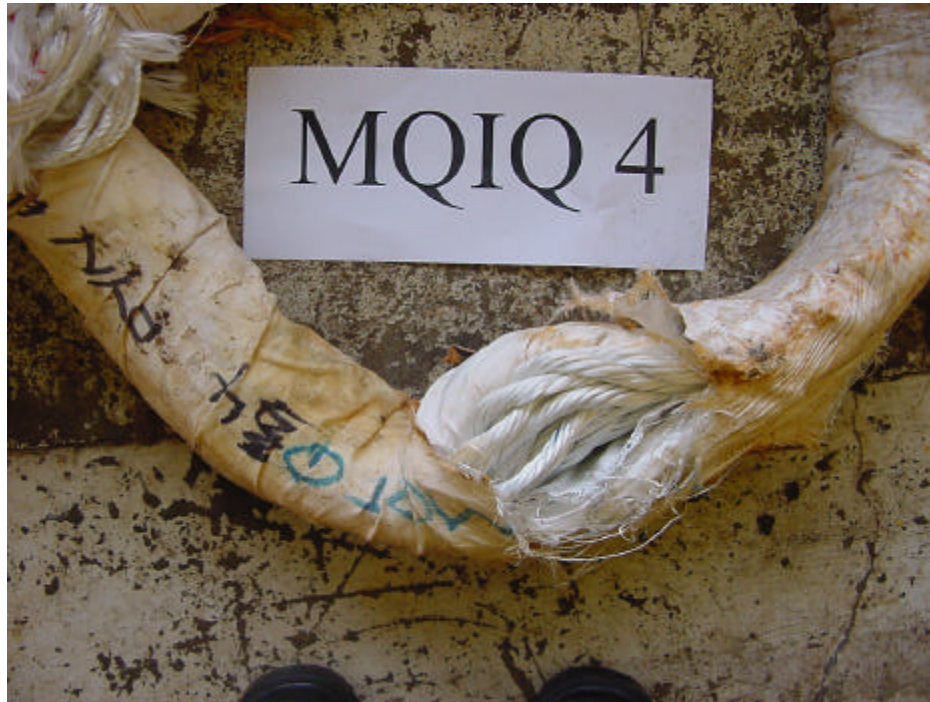
Figure 8.20 MQIQ 4 Wear of Outer Cover at Point Where Rope First Makes Contact with Spool (Tangent Point) Moving End Eye
