# MANAGEMENT OF HUMAN ERROR IN OPERATIONS OF MARINE SYSTEMS

**A GORDIAN KNOT:  
INTO WHICH SAILED  
THE *EXXON VALDEZ***

**Karlene H. Roberts  
&  
William H. Moore**

**Report No. HOE-92-1  
January, 1992**

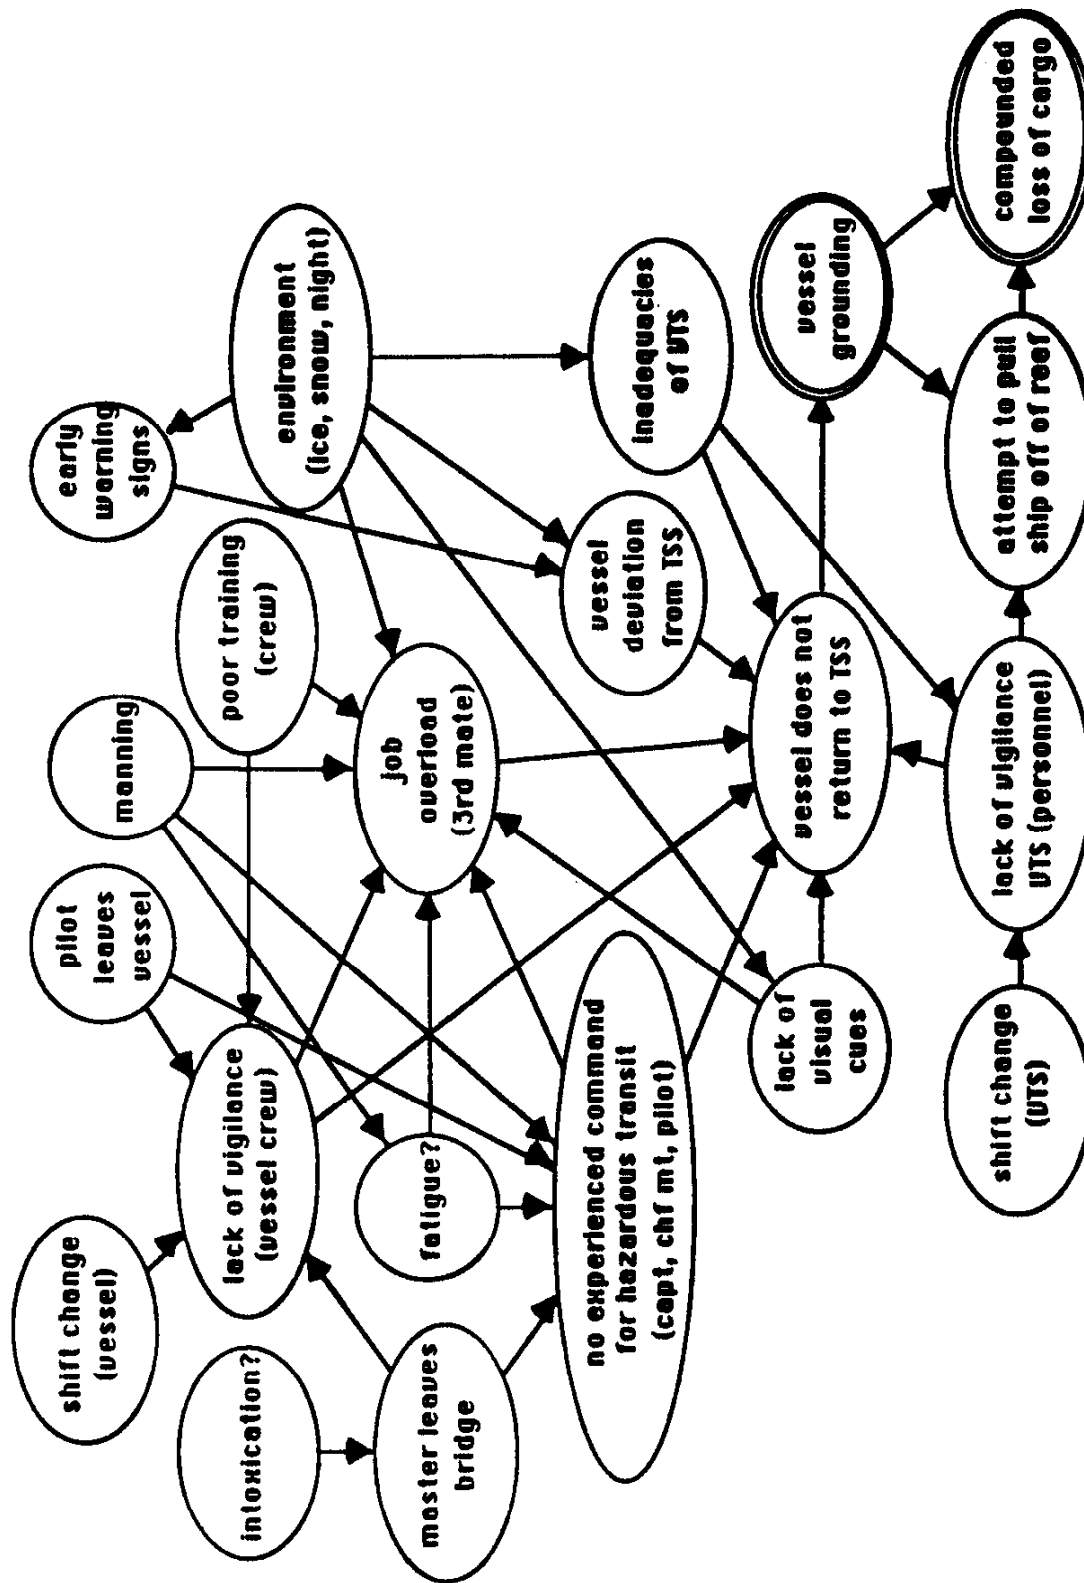
Figure 1: Events surrounding the grounding of the tankship *Valdez*

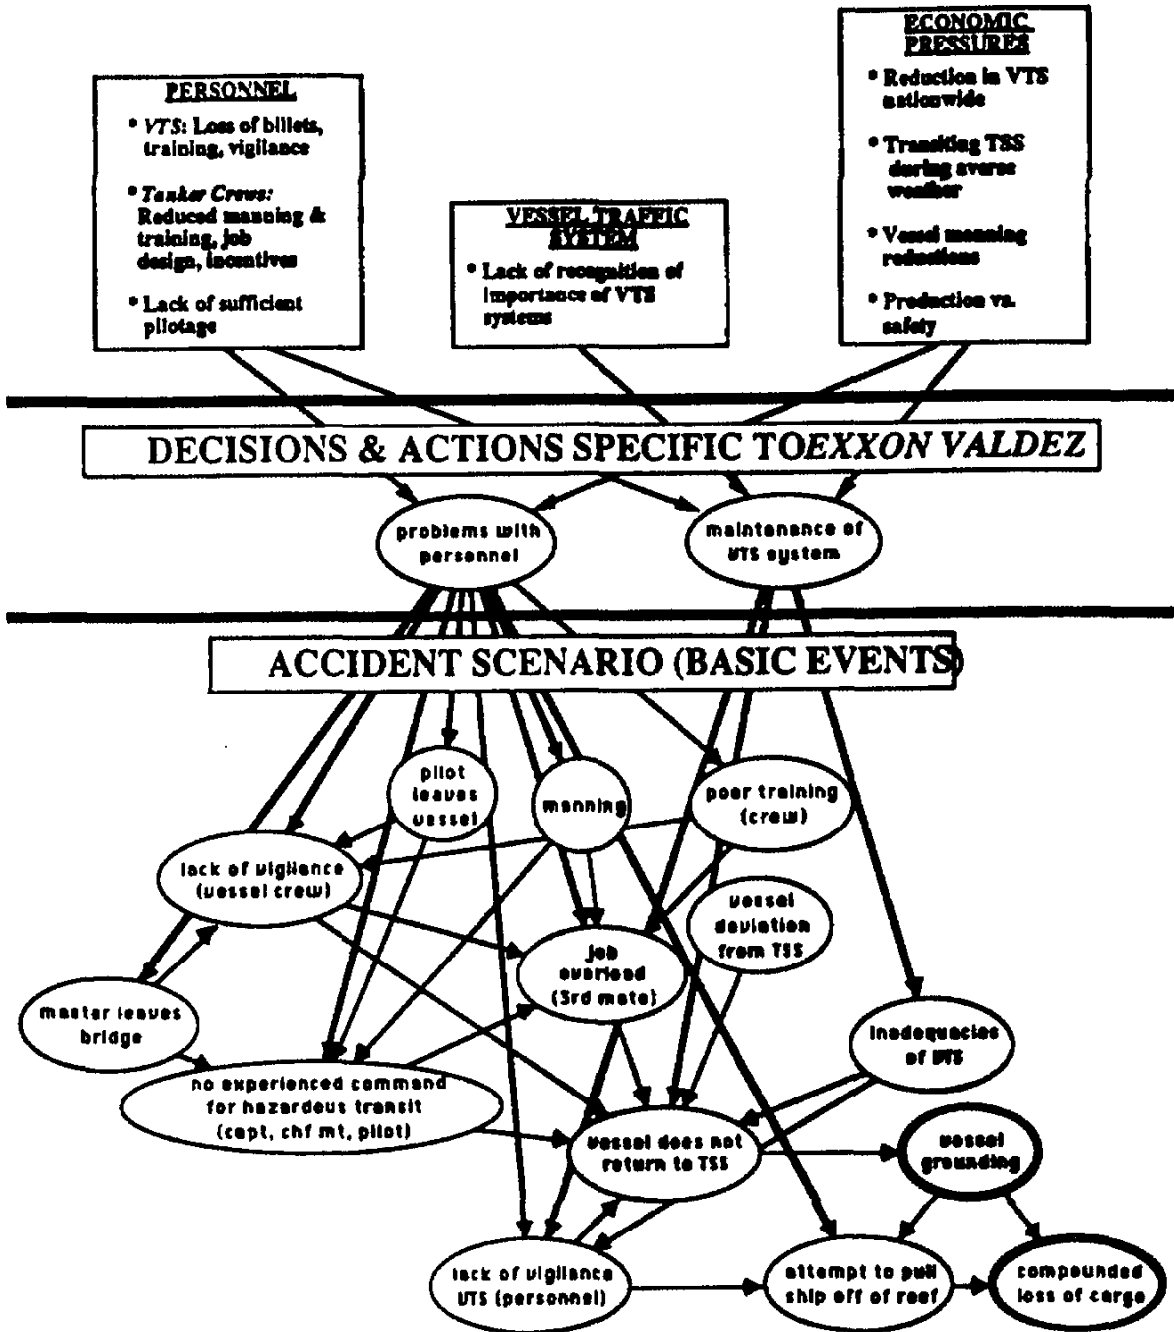
All in all the Valdez Coast Guard looks like an organization of deteriorating resources, suffering from downsizing, and lack of appropriate training. Figure 2 shows the organizational factors between both *Exxon* and the Coast Guard which led to the *Exxon Valdez* grounding. This figure demonstrates the personnel and economic pressures were observed in both organizations which were critical to the events leading to the grounding.

Figure 2: Dependencies among events of accident scenarios, decisions and actions specific to the grounding of the tankship *Exxon Valdez* and organizational factors

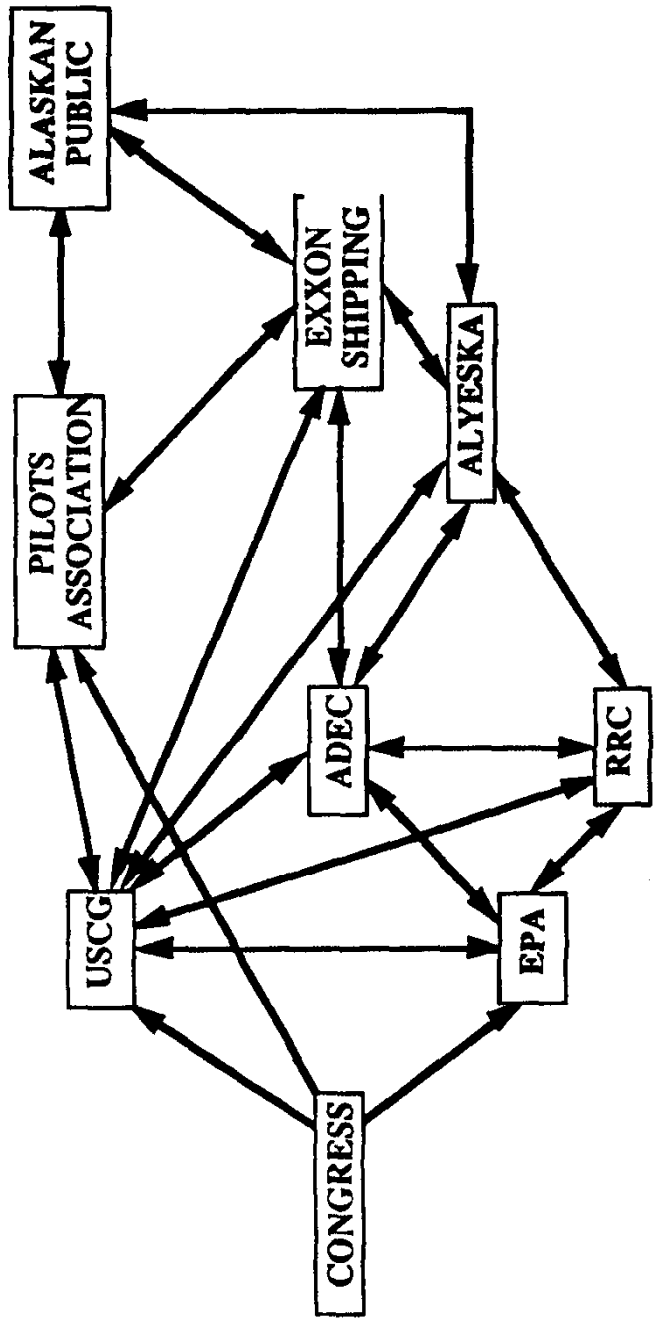
Figure 3: Organizational relationships for the Exxon Valdez incident
