# Surveys of Abandoned Vessels: Guam and CNMI

**SURVEYS OF ABANDONED VESSELS:  
GUAM AND THE COMMONWEALTH OF THE NORTHERN MARIANA ISLANDS**

Christine Lord and Colin Plank  
Research Planning, Inc.  
Columbia, South Carolina 29202

October 2003

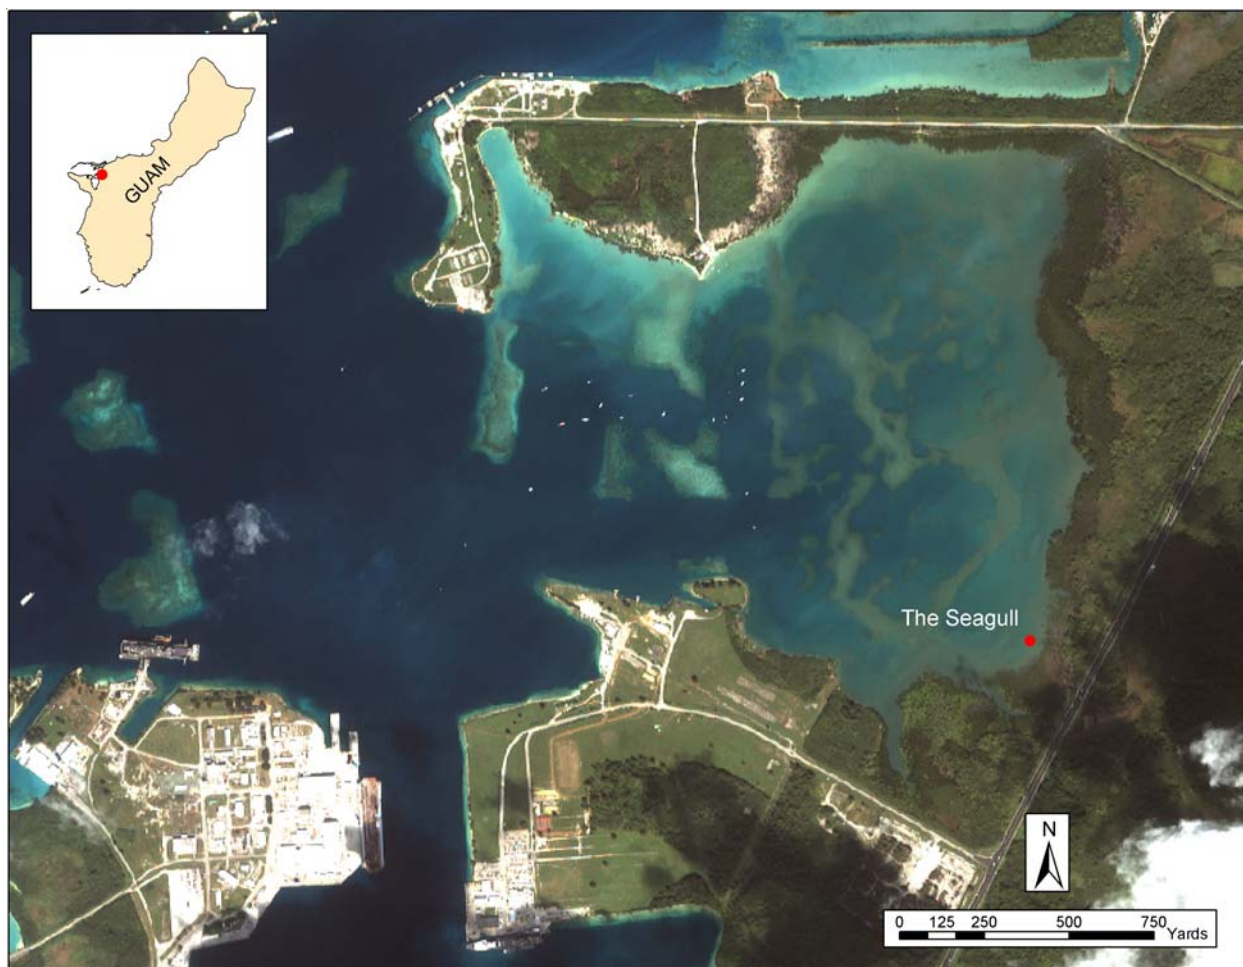
**PLATE 1.** *The Seagull*, Sasa Bay, Guam.

**Removal Scenario:** High priority for removal.

**Vessel Information:** The *Seagull* (Incident ID: 2537) is a 70 ft recreational fiberglass sailboat that has been hard ashore since the 2002 Supertyphoon Pongsona. The vessel is in fair condition though the keel is damaged. Large mooring lines, gear, coolers, etc. remain onboard as does 128 gallons of fuel. The vessel is jointly owned by five Japanese citizens, and a local salvage firm is currently applying for removal permits.

**Comparison to Other Vessels/Removal Considerations:** The *Seagull* is in good condition and may be usable if salvaged, as opposed to the majority of recreational vessels surveyed, which were more severely damaged. Of the vessels surveyed, this boat has the highest potential to impact mangroves. Most other vessels in mangrove habitats were WWII era steel barges that are unlikely to move or be removed.

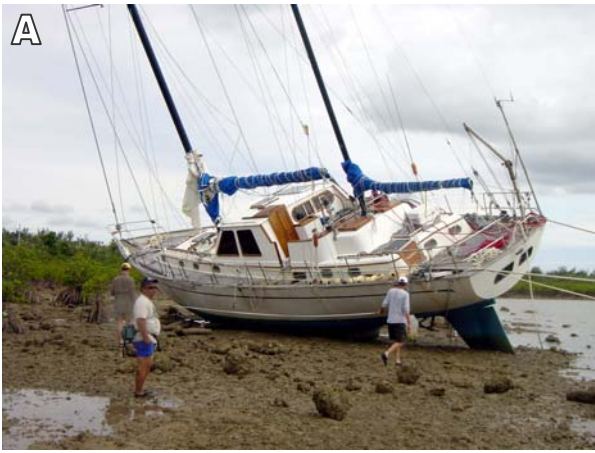
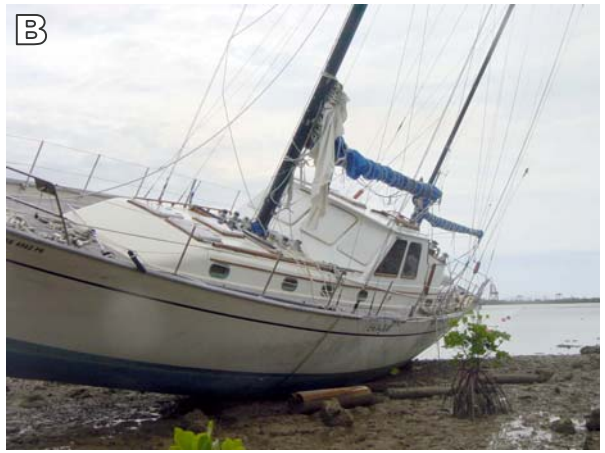
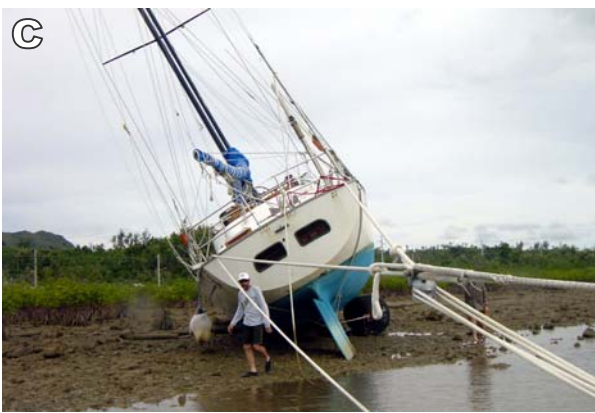
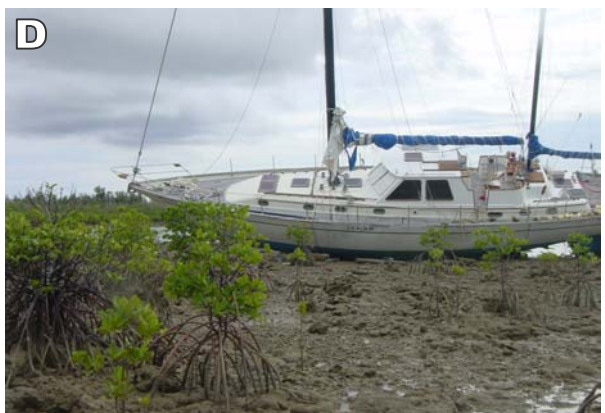
**Photographs of *Seagull* (3 June 03):**

- A. View of vessel hard aground on mud-draped cobble and pebble tidal flat.
- B. View of vessel condition.
- C. View of stern.
- D. View of vessel aground in mangrove and tidal flat habitats.
- E. View of vessel from point of access at road.

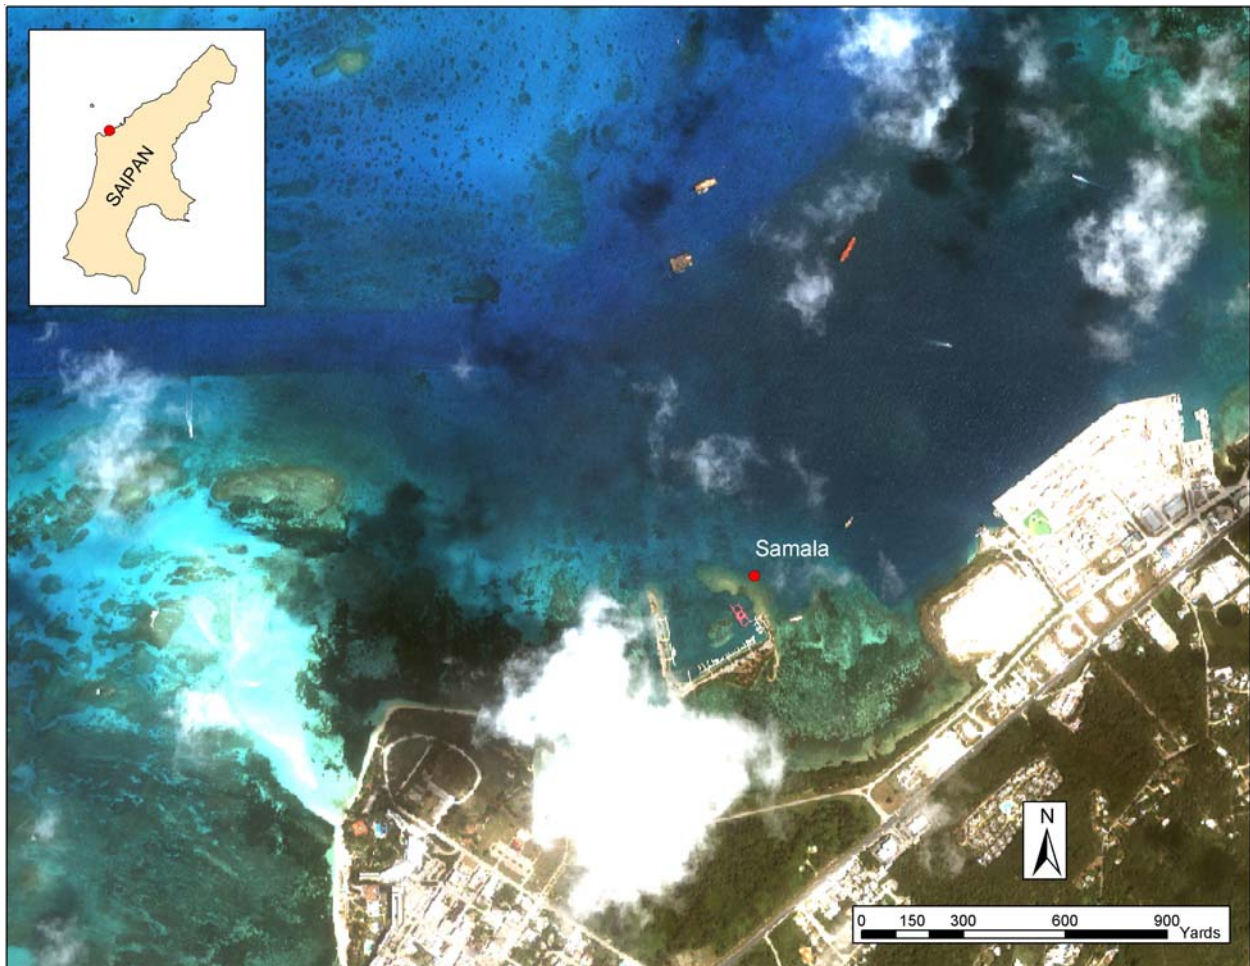
**PLATE 2.** *Samala*, Outer Cove Marina, Saipan.

**Comparison to Other Vessels/Removal Considerations:** This was the only vessel surveyed that was constructed largely of wood and is deteriorating at a great rate. Of the vessels characterized as “high priority for removal”, the *Samala* appears to be having the most noticeable impact on surrounding coral reef habitats.

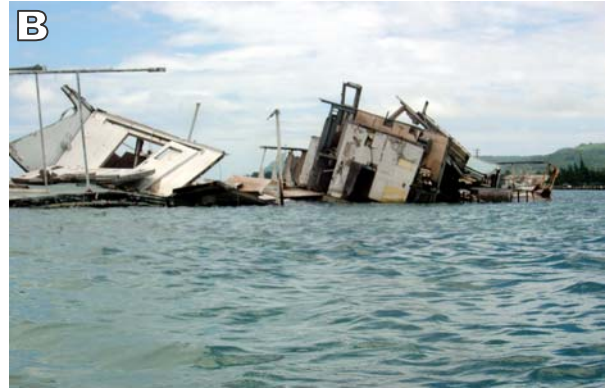
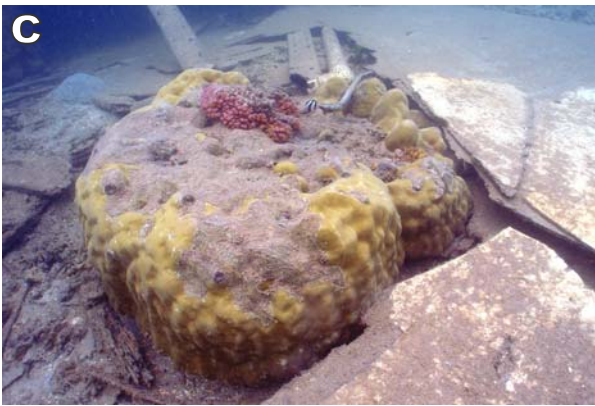
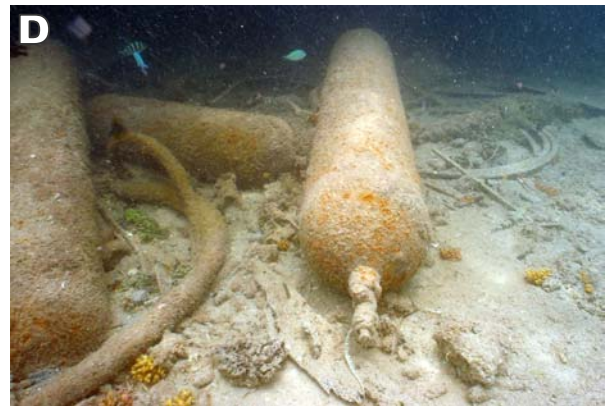
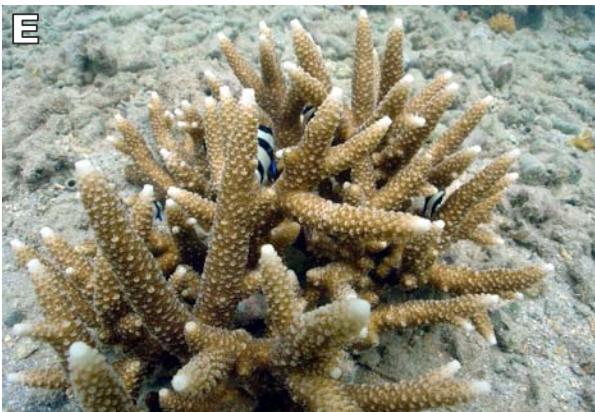
**Photographs of *Samala* (5 June 03):**

- A. View from access point at Outer Cove Marina.
- B. View of wooden cabin deterioration.
- C. View of debris on *Porites* coral head immediately adjacent to vessel.
- D. Compressed gas tanks observed in debris.
- E. View of *Acropora* and damselfish near vessel.

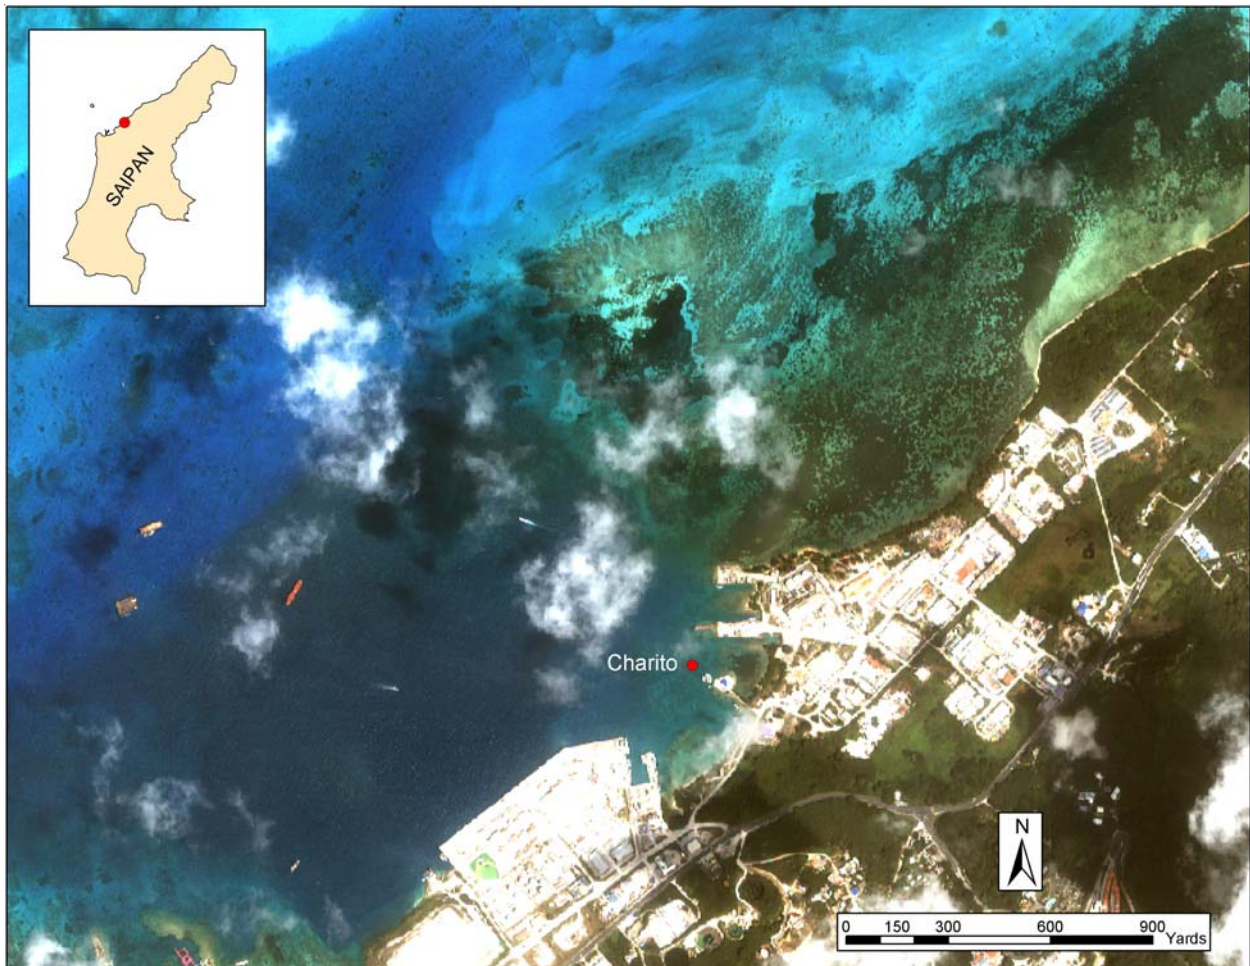
**PLATE 3.** *Charito*, Lower Base, Saipan.

**Comparison to Other Vessels/Removal Considerations:** The vessel is located in a high use recreational fishing, boating, and birding area. A small boat launch and anchorage are located 500 ft from the vessel. Local officials view the vessel as an eyesore and potential threat to other boats/facilities if it were to move during a storm. They are very interested in removing it.

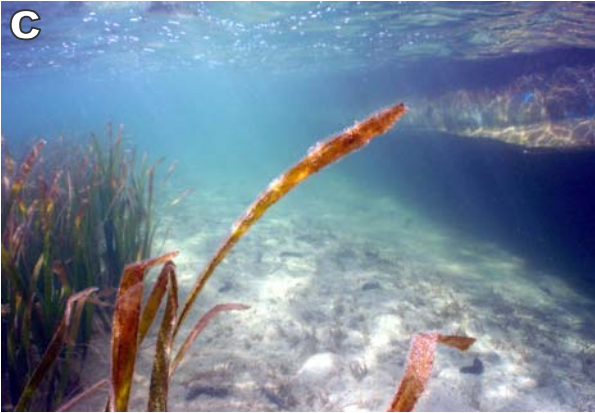
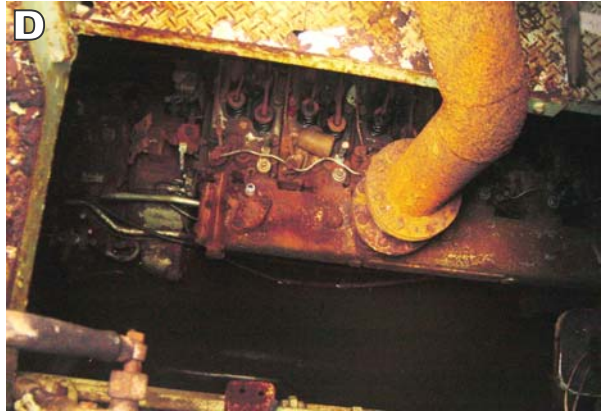
**Photographs of *Nago No. 15* (6 June 03):**

**Comparison to Other Vessels/Removal Considerations:** Seagrass coverage surrounding the vessel was denser and covered a more extensive area than in all other areas surveyed in Guam and CNMI. Previous attempts to remove the vessel failed, but our survey assessment indicated that removal would probably be feasible if performed by experienced personnel.

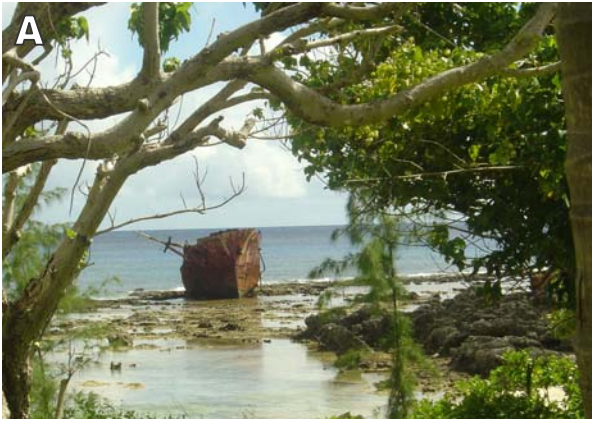
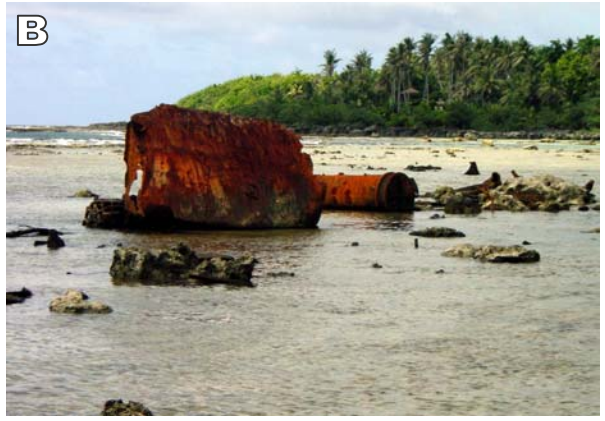
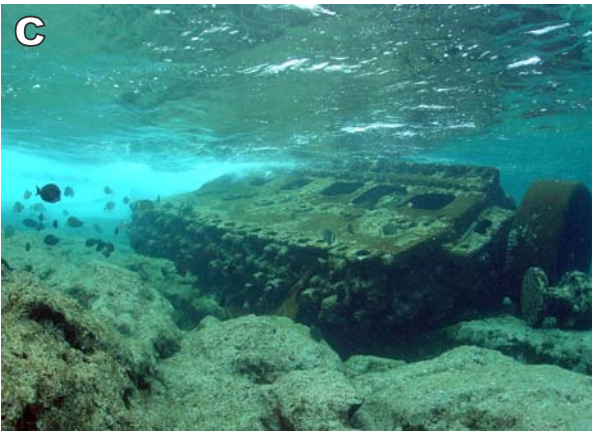
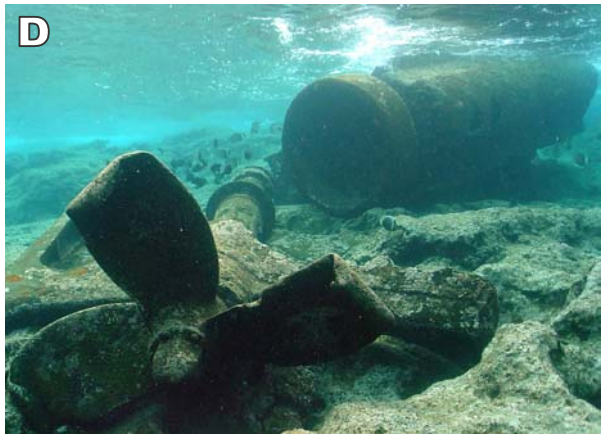
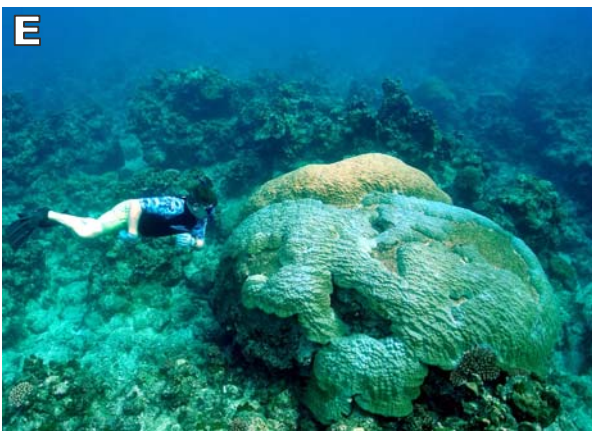
**Photographs of *Nam Sung* (10 June 03):**

**Comparison to Other Vessels/Removal Considerations:** One of two sites that had extensive debris fields, this site has debris spread over the greatest area. Heavy surf in shallow area may impede removal. This area had the highest coral species diversity of all areas surveyed in the Pacific region.

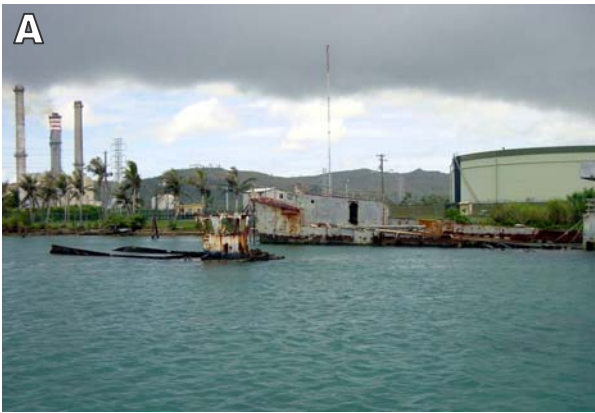
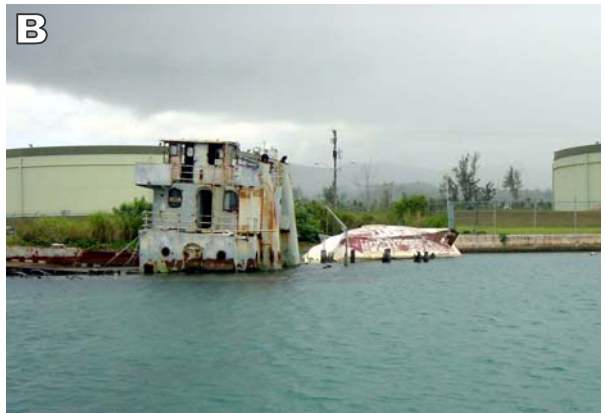
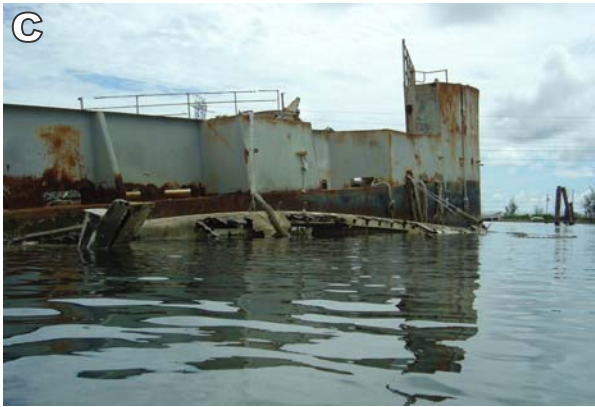
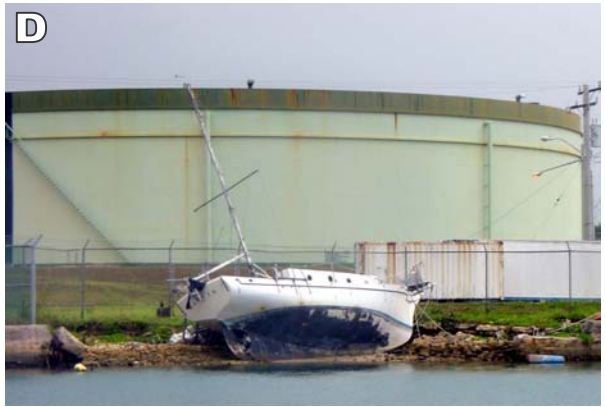
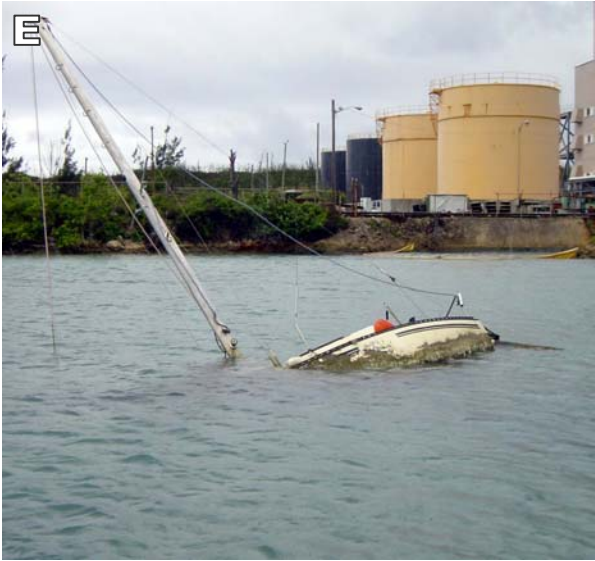
**Photographs of Apra Harbor vessel cluster (2 June 03):**

**Comparison to Other Vessels/Removal Considerations:** These vessels are in one of the tighter “clusters” found in the survey. These types of areas often become dumps for abandoned vessels, and several similar areas were surveyed in the U.S. Caribbean. None of these vessels are a pollution threat but all are threats to navigation.

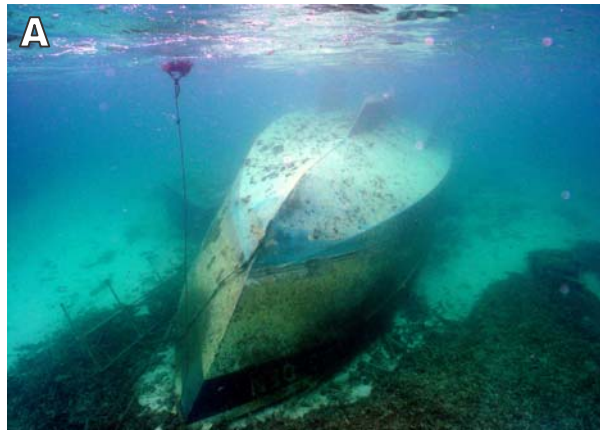
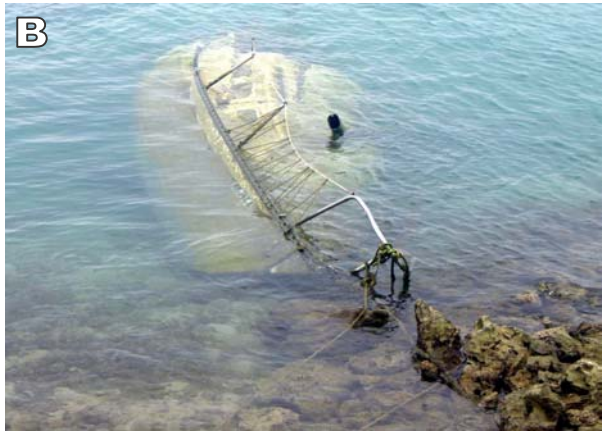
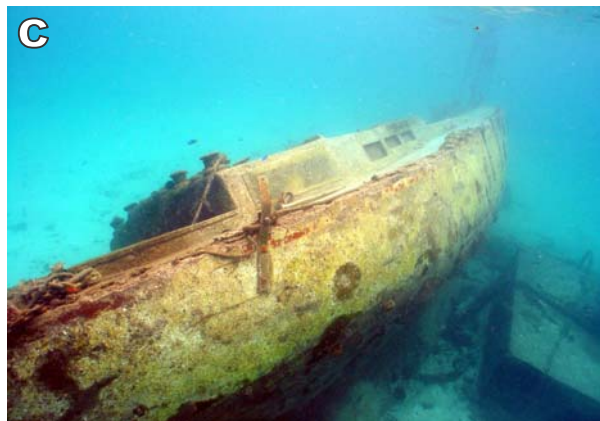
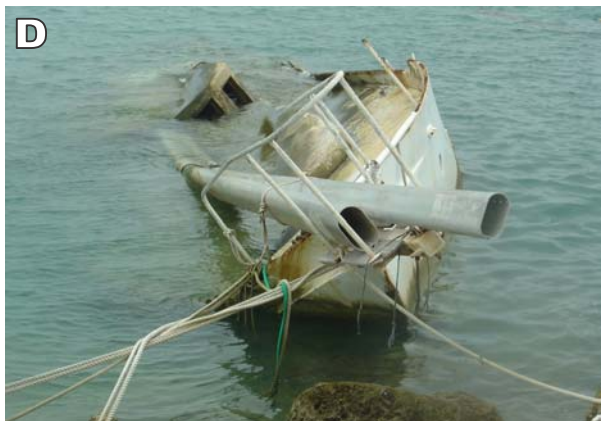
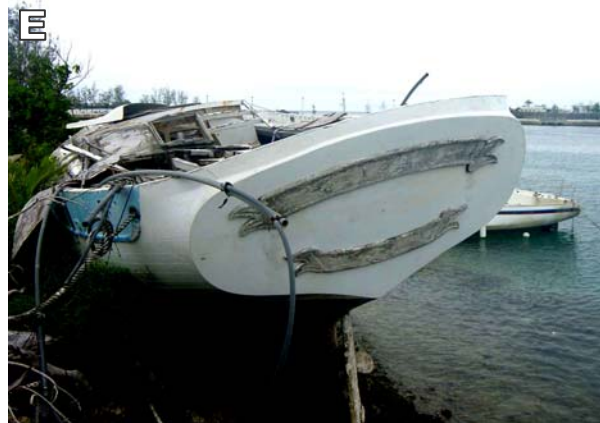
**Photographs of Agana Boat Basin vessel cluster (4 June 03):**

**Comparison to Other Vessels:** These vessels are in one of the tighter “clusters” found in the survey. One of these vessels (*Lion’s Den*, Incident ID: 1901) is a pollution threat and one (Unk1900) is a threat to navigation. These vessels could also threaten other vessels moored in the area if they were to move in a storm. Vessels clustered in mooring areas following hurricanes were also common in the U.S. Caribbean.

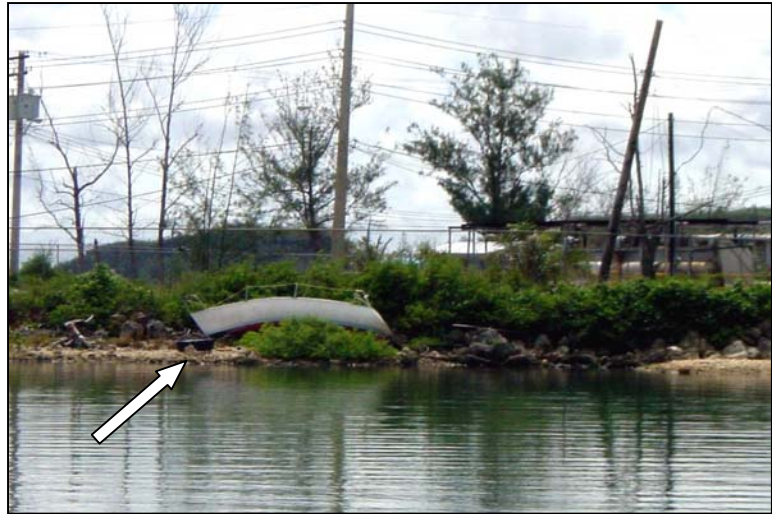
- a) **Date and location:** 2 June 2003. Piti Channel, Guam.
- b) **Weather and tide conditions at time of survey:** High tide. Overcast and some rain showers.
- c) **Team members:** Lord, Plank (RPI); Helton, Zelo (NOAA); Davis (DAWR), Aranza (EPA).
- d) **GPS location:**  
Lat: 13.46382  
Lon: 144.68768

- e) **Inspection narrative:** Condition of vessel was inspected on foot. Due to location on shore, no snorkel survey was conducted nor was videotaping of benthic habitats undertaken.

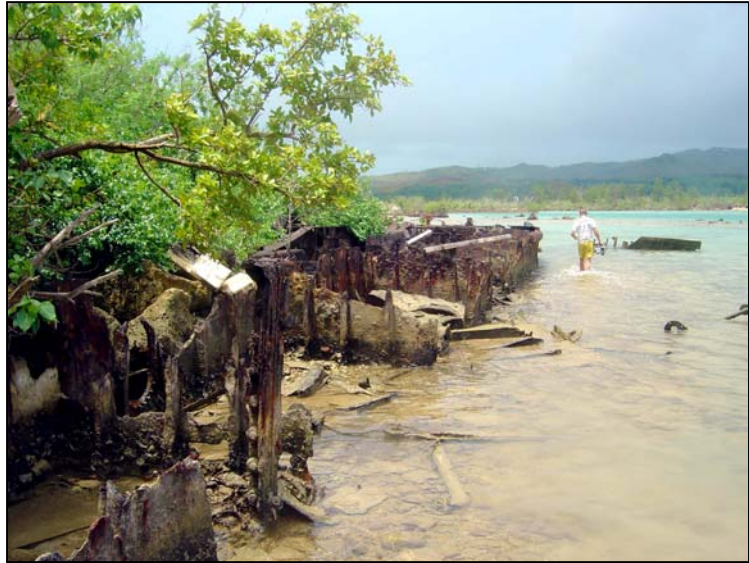
- a) **Date and location:** 2 June 2003. Outer Piti Channel, Guam.
- b) **GPS location:**  
Lat: 13.46040  
Lon: 144.67334

**2) Grounding Site Logistics:** Port Authority/Gov. Guam land. Unclear whether submerged land is territorial or federal. Channel mostly used for navigation and fishing.
