INVESTIGATION REPORT

COMBUSTIBLE DUST FIRE AND EXPLOSIONS

CTA ACOUSTICS, INC.

REPORT NO. 2003-09-I-KY

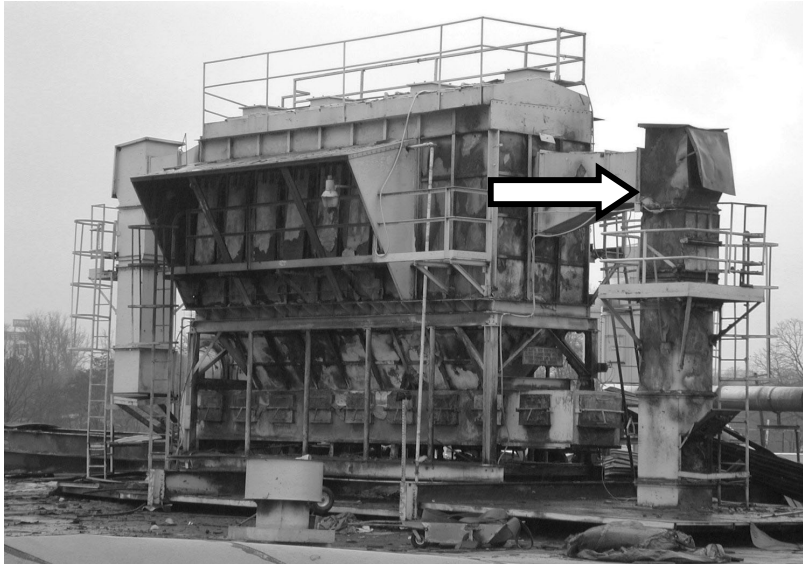
Two operators on the roof stated that moments after the baghouse was turned back on at 7:30 am, flames shot up through the inlet ducts, into and out of the baghouse (Figure 4). Both operators were burned—one received minor facial burns; the other received second-degree burns to his hands and face, which required a lengthy hospital stay. Inside the plant, personnel located about 80 feet northwest of line 405 observed smoke coming from the line prior to the initial explosion. Once the explosion occurred, personnel both heard it, and saw a fireball emerge from the south end of the oven.

Figure 4. Fire damage to inlet duct of line 405 baghouse.

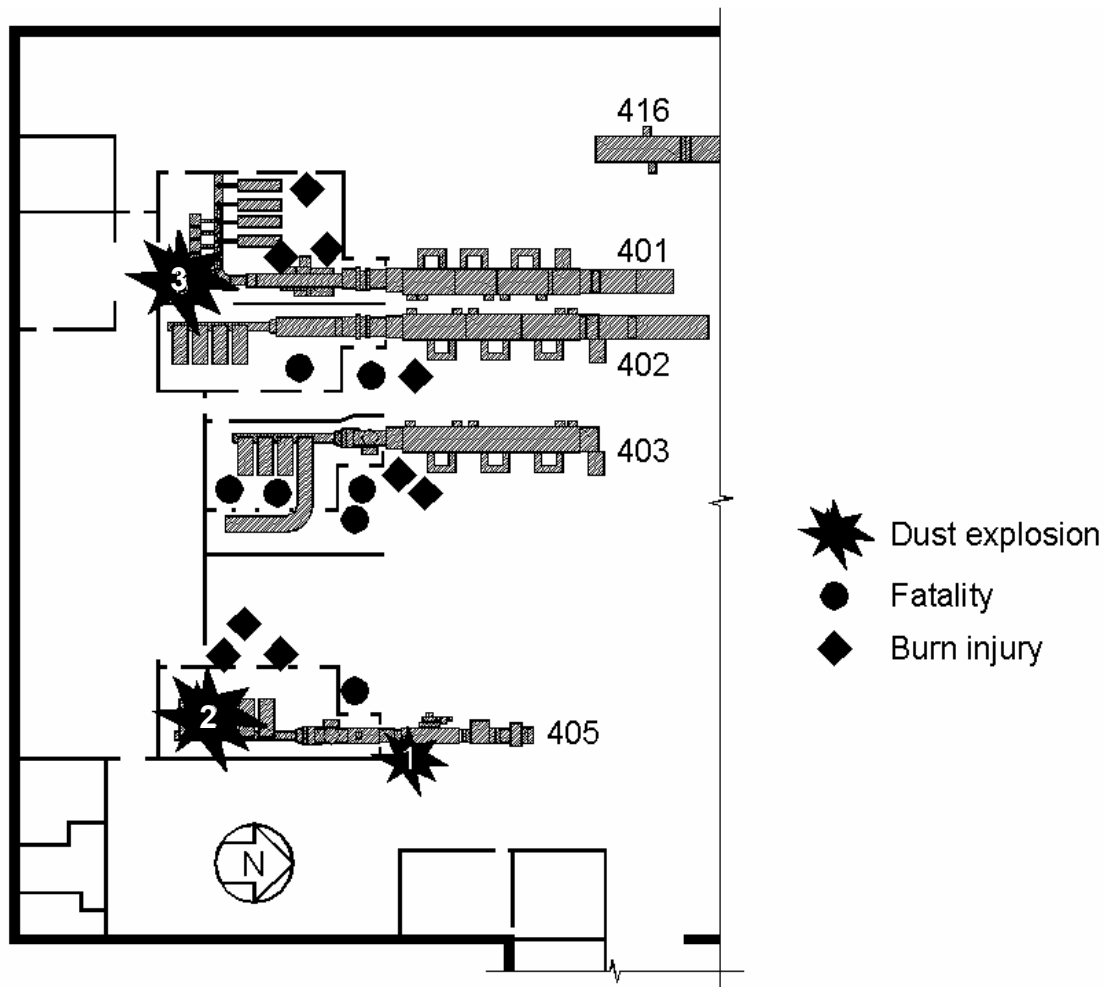
Eyewitnesses standing northwest of line 405 felt a pressure wave blow dust and other material in their direction. The force shook loose accumulated dust from the overhead roof joists and blew out roof panels. Employees also saw a fireball coming toward them from the south side of the line 405 oven; the fireball dissipated when it reached the molding department. Employees reported that dust fell from above, the lights went out, and the building fire sprinkler system activated.

Figure 5. Sequence of dust explosions and likely locations of those killed and burned in the production area (Note: All employee injuries not shown in figure).

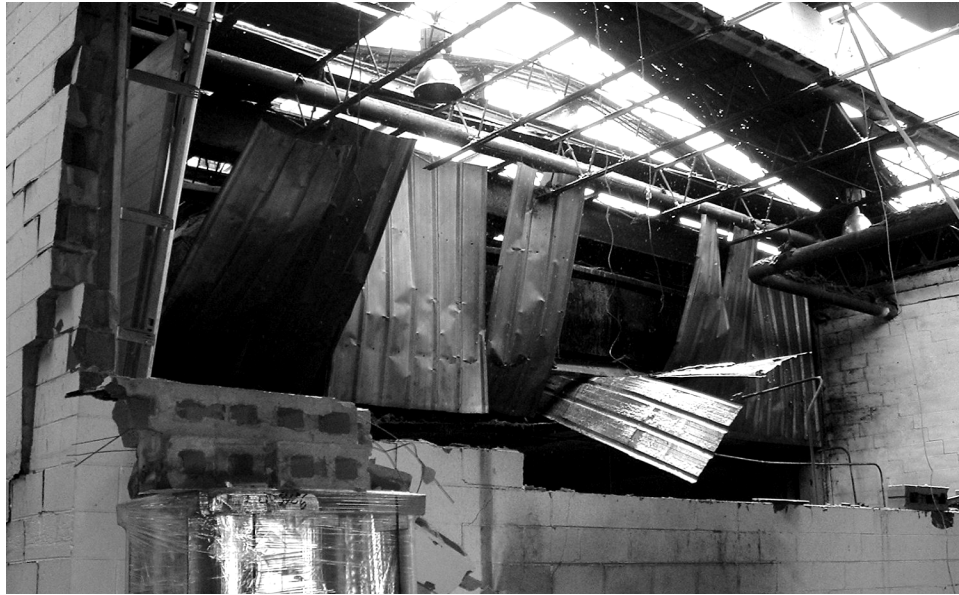
The fireball generated by the initial explosion near the line 405 oven ignited dispersed combustible dust, which caused a secondary explosion in the relatively confined area above the line 405 blend room. The force of this explosion damaged the firewalls to the east and south and pushed metal wall panels above the blend room roof on the south side out to the south (Figure 6). The explosion also pushed ceiling

panels and lights down inside the blend room. The pressure wave vented out of the building, damaging metal wall panels on both the south and east outer walls.

Figure 6. Collapsed firewall and metal panels at south end of line 405 blend room.

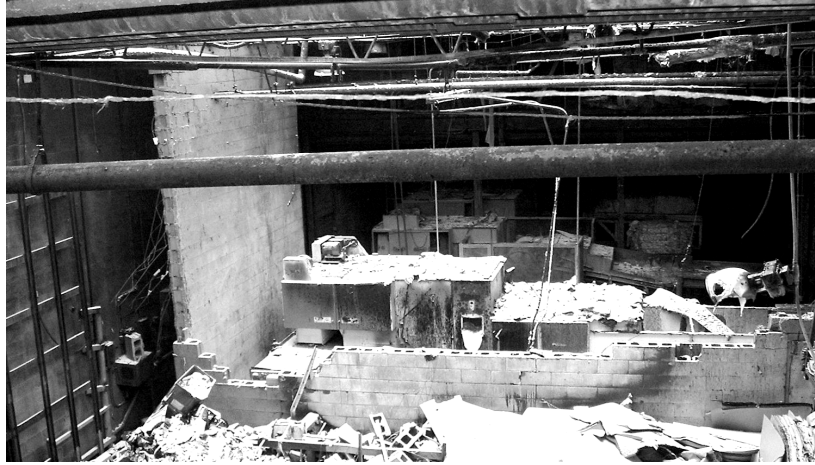
- A collapsed firewall between lines 403 and 405 (Figure 7).
- Metal wall panels above the line 403 blend room on the east side that were blown to the west.
- Burnt residue on the building's roof trusses.

Figure 7. Collapsed firewall between lines 403 and 405.

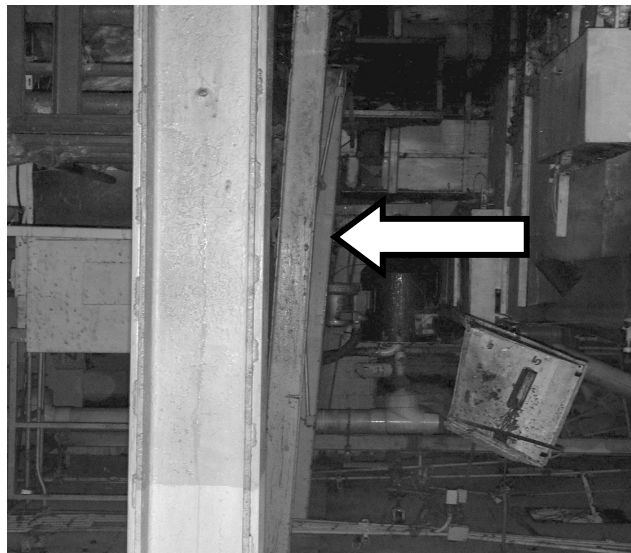
The fireball continued to move west over the top of the line 402 blend room and into line 401. CSB investigators noted extensive explosion damage at line 401, nearly 300 feet from the initial explosion's point of origin at line 405. Physical evidence revealed that an additional secondary dust explosion

occurred in the southeast corner of the line 401 blend room, another confined area. The firewall south of line 401 was partially collapsed, and concrete blocks dislodged from this wall fell to the south. The force of the dust explosion pressure wave likely bent a steel column on the west side of the blend room (Figure 8). Metal panels of the north and west walls were deformed outward. A large hole was blown in the building roof above the southeast corner of the blend room.

Figure 8. Bent support column in line 401 blend room.

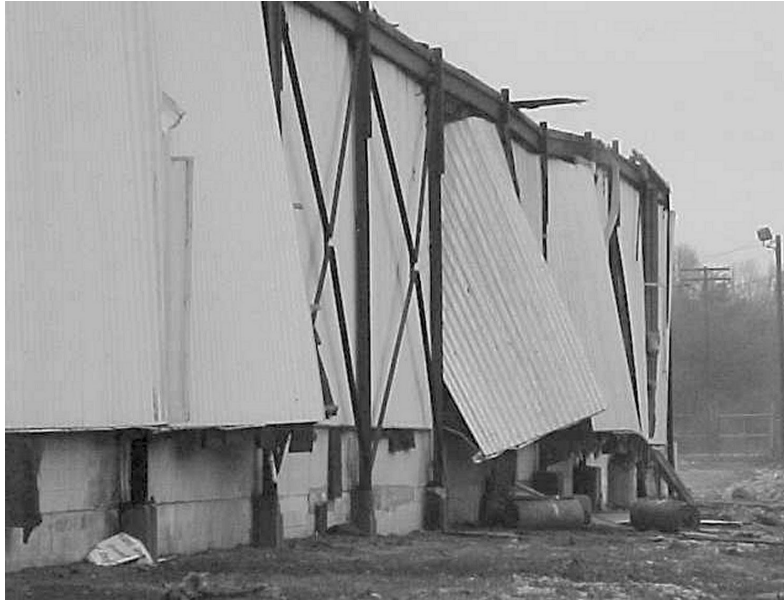
Figure 9. Explosion damage to exterior plant wall at southwest corner of building.

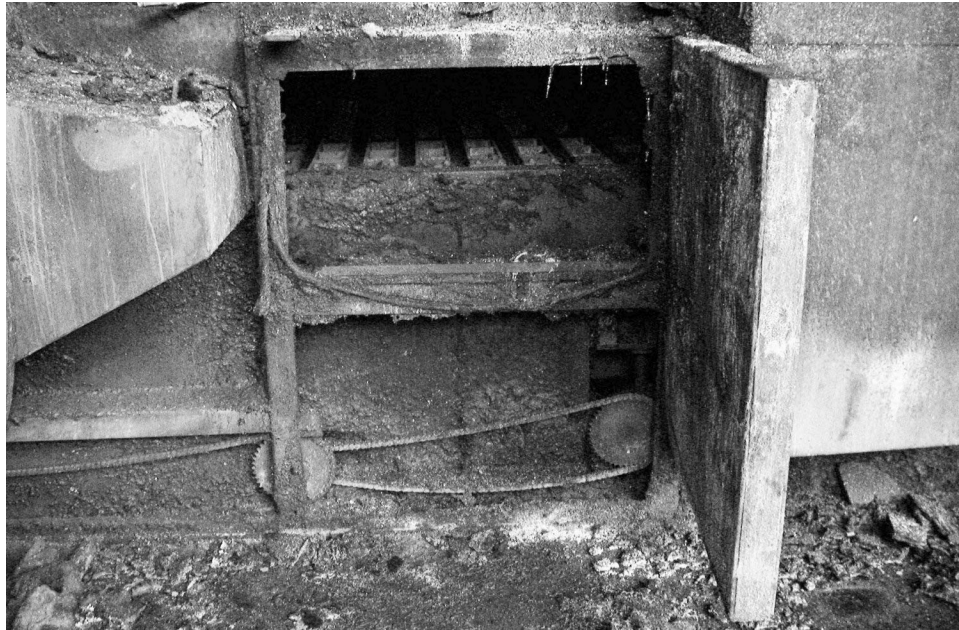
CSB also examined the interior of the oven; virtually all the combustible material that likely had been inside was burned away (Figure 13). In contrast, the interior of the ovens on lines 401, 402, and 403 contained accumulations of resin powder/fiberglass debris. The chain-driven oven flights for 405 were

burned clean but otherwise intact and undamaged. Metal discoloration was noted on the interior of the line 405 oven; however, CSB found no evidence of explosion damage inside the oven.

Figure 13. Interior of line 405 oven.
