**Investigation of July 20, 1983,
Blowout Matagorda Island Block 657,
Lease OCS-G-4139 Gulf of Mexico**

by

William Martin

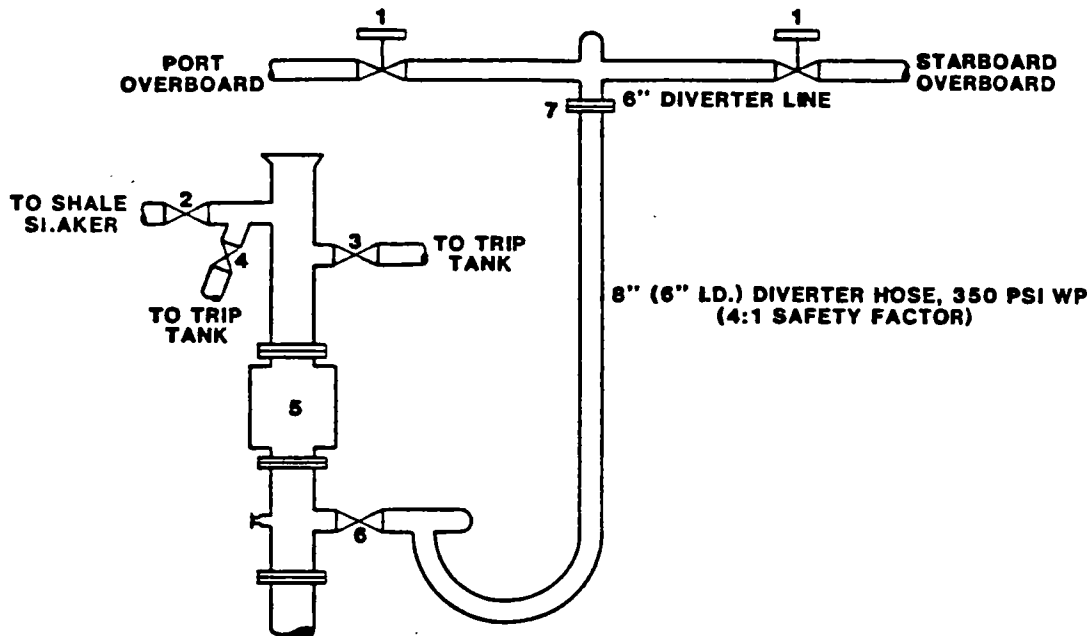
**OCS - G 4139 WELL #1
MATAGORDA ISLAND BLOCK 657
DIVERTER SYSTEM - PENROD 52 JACKUP RIG**

The portion of the diverter system on top of the 30" drive pipe was installed and connected to the rigs 6" diverter system hose as shown in Attachment No. 5. The diverter system on the drive pipe was 21 1/4", 2000 psi msp hydril and a diverter spool with an 8" TK ball valve. The diverter system pressure tested to 150 psi.

1. The panel was unable to determine the cause of the diverter equipment failure. The diverter line apparently plugged but we do not know why. The Corps of Engineers allowed the drilling rig to remain on the bottom of the Gulf of Mexico.
2. The 6" diverter piping is probably too small but meets the current MMS regulatory requirements.
3. The diverter system was flow through tested as recommended by MMS and diversion through the system was successful for 25 minutes.

1. The cause of the annular preventer failure cannot be determined as it is on the bottom of the Gulf.
2. Diverter annulars which are part of the diverter system can be exposed to maximum rated working pressure.
3. Testimony indicated that Penrod was not sure when the rubber element in the annular preventer on the rig had been changed.

- C. The panel recommends, and the MMS is funding, research to develop technology for improving diverter systems. The problem of diverter plugging will be studied.

- E. The panel recommends that larger diverter lines be required. This requirement has been proposed in the Regulatory Reform Document. Louisiana State University is conducting studies on the diverters for MMS.

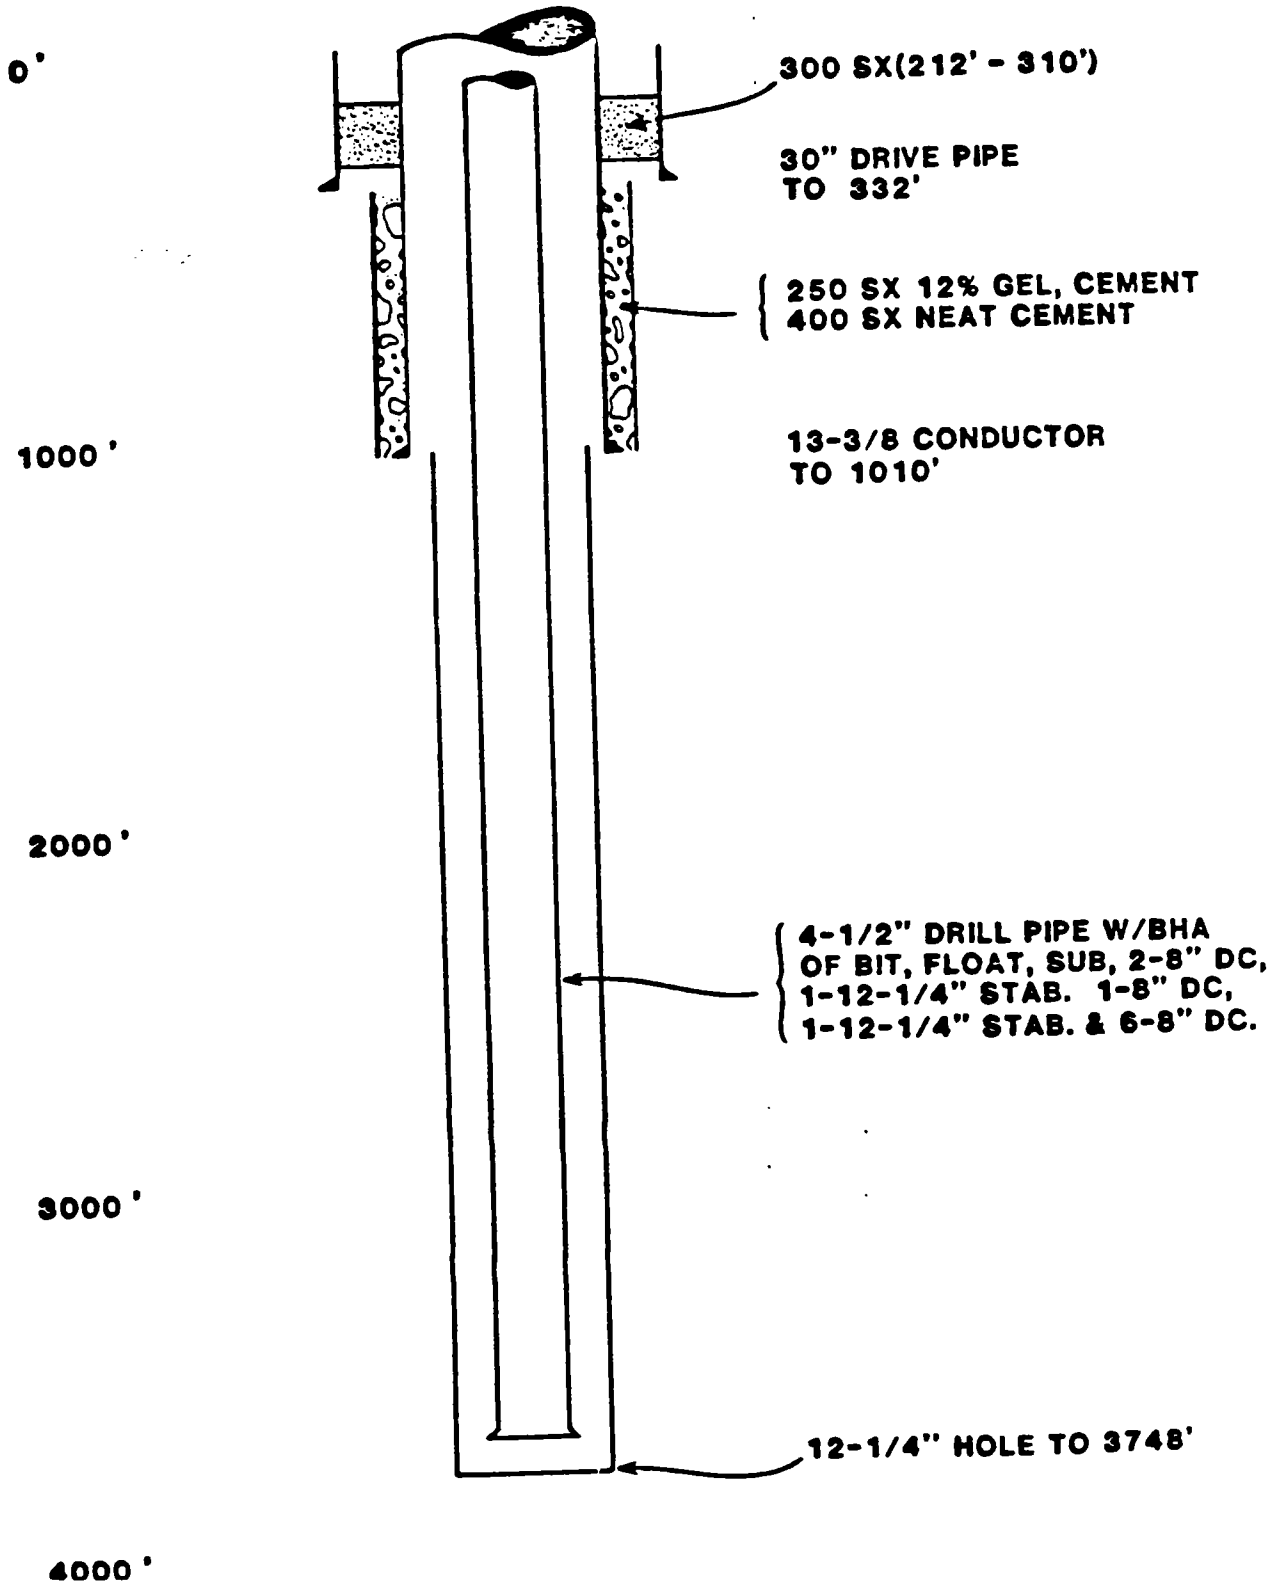
OCS-G 4139 WELL # 1 MATAGORDA ISLAND BLOCK 657 WELLBORE SKETCH

3. **Loss Of Mud Return.** Drilling proceeded to 3748' by Geolograph (3765' mud logger) when the driller noticed loss of mud returns on the flo-sho (drilling mud return monitor) at 1910 hours. (The well schematic is shown in Attachment No. 6.) The pumps were immediately shut down and the kelly picked up. Exxon supervisors were notified, and proceeded to the rig floor.

- A. The panel recommended to Exxon that they consider revising their subsequent casing programs to allow greater well control. Exxon's casing program to 4000' for a well on the same lease included: drive pipe at the same depth as well No. 1; conductor casing 200' deeper, at 1200'; surface pipe at 1800'; protective pipe at 3200'; and protective liner at 3850'. On the first well, where the blowout occurred, the conductor pipe was set at 1010'; the surface pipe was approved for 4000' but was never set.

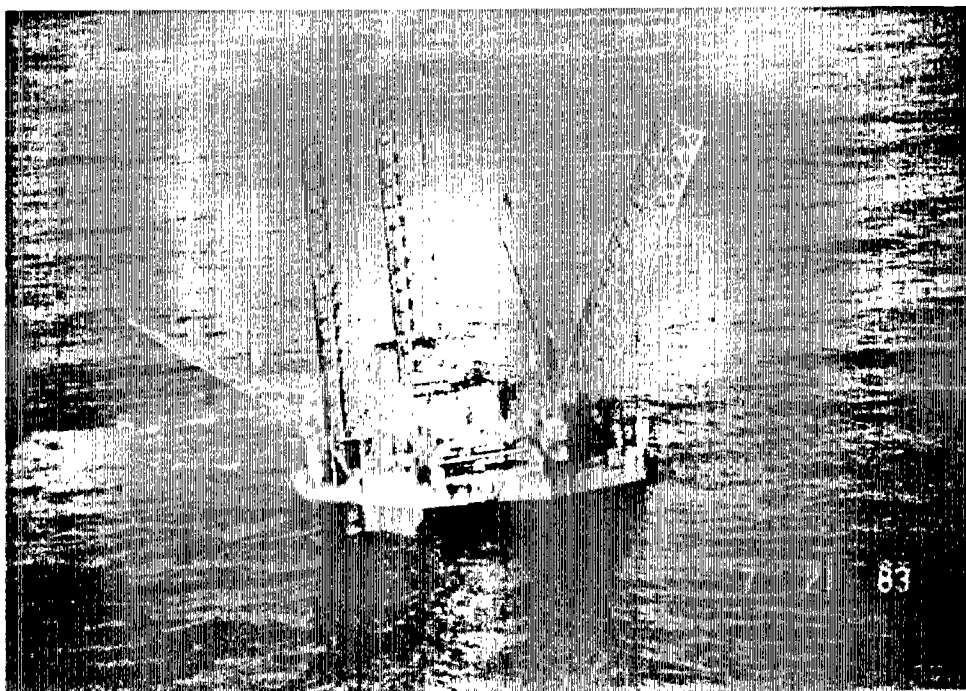
During the night of the 20th, the well apparently bridged and broached, resulting in a flow around the outside of the conductor casing. During the surveillance flights on the morning of the 21st, the well was observed to be flowing, causing a 15' to 20' boil in the water, and the rig was slowly sinking. By the morning of the 22nd the well flow ceased and the rig sank with only parts of two legs exposed. The photographs attached show this clearly.

Rig began to sink, July 21, 1983

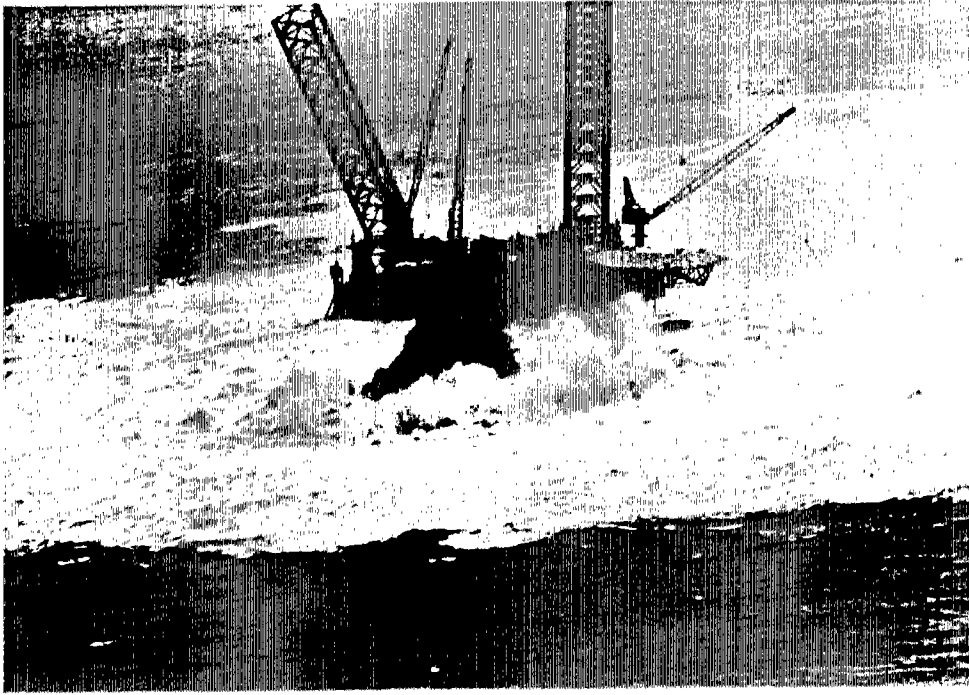
Boil in water caused by well flow, July 21, 1983

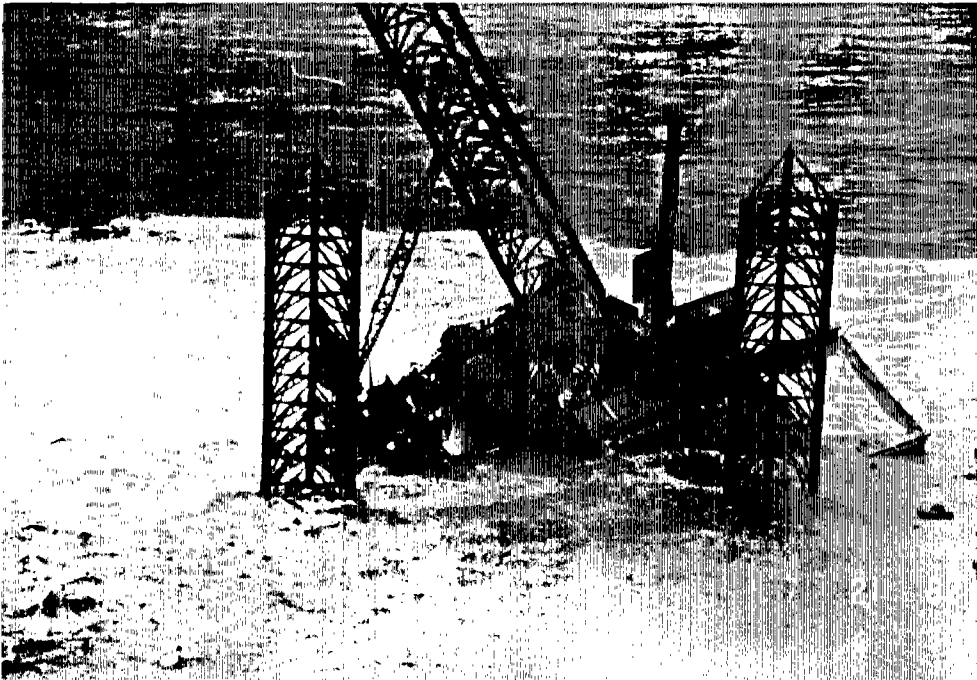
Rig tipped to side with view of boil caused by well flow, July 21, 1983

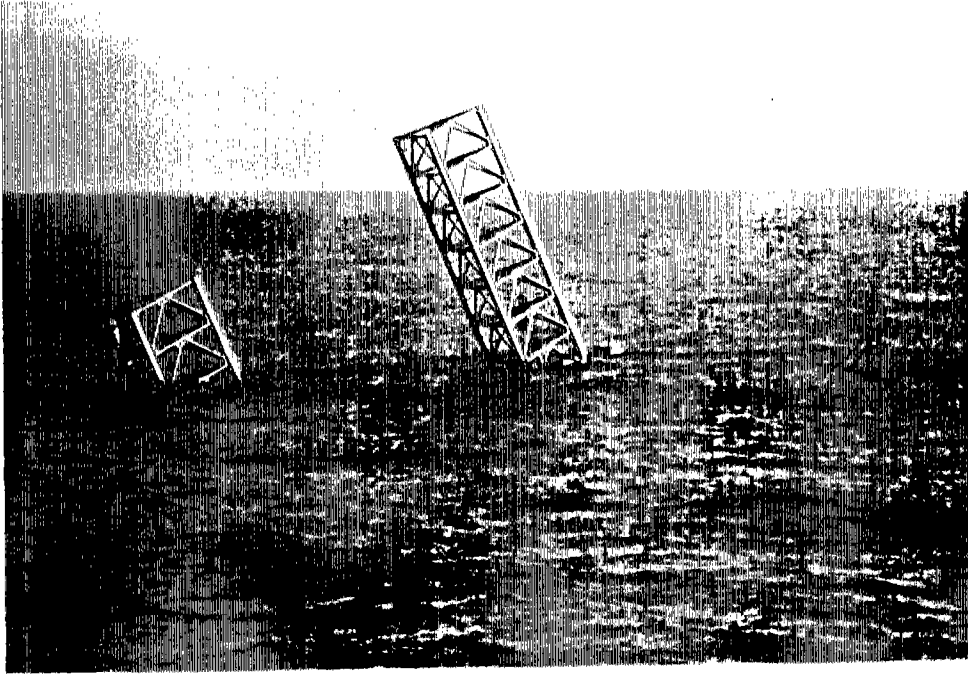
A seismic survey of the rig site was conducted on July 24-25, 1983. The top portion of two legs and a crane boom were the only parts of the rig visible above the sea surface during the time of the survey. The third leg was twisted and bent; the top of it appeared to be 40' below the sea surface.

Parts of two legs exposed, July 24, 1983
