OCS Report
MMS 86-0100

**Investigation of the December 1985 Blowout and Fire,
Lease OCS-G 4268,
West Cameron Block 648,
Gulf of Mexico,
Off the Louisiana Coast**

October 1986

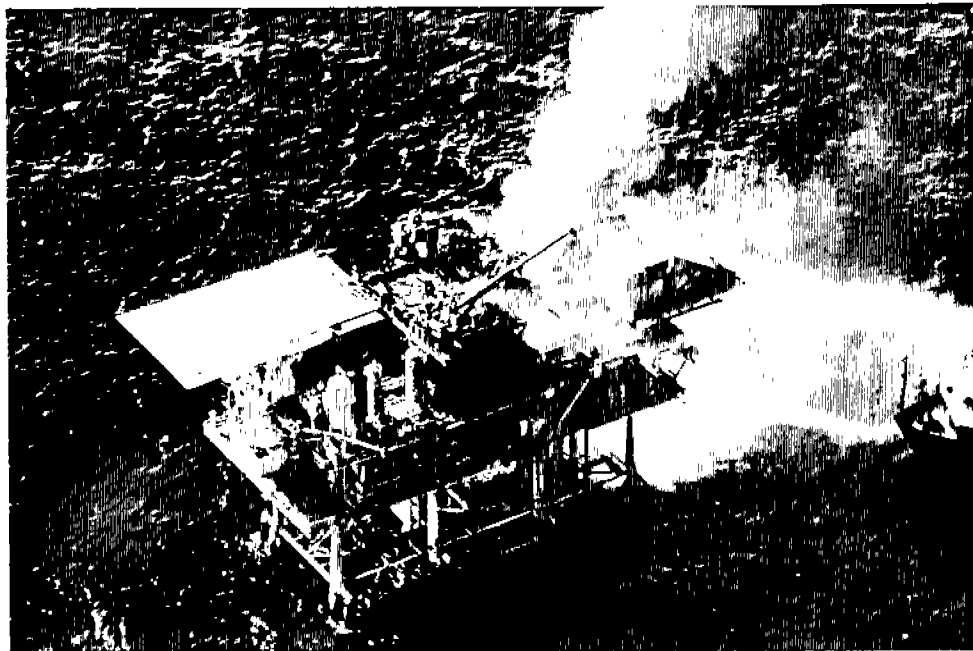
Photographs of Fire

On December 7, 1985, at approximately noon, the traveling block fell to the drill floor, igniting the gas. Within minutes the drill floor was engulfed in flames, with the derrick collapsing by 12:30 p.m.

At approximately 12:00 noon, December 7, 1985, the traveling block in the derrick fell, immediately igniting the gas. By 12:30 p.m. the derrick had collapsed, and by 6:30 p.m. the quarters for the drilling rig had toppled overboard and sunk.

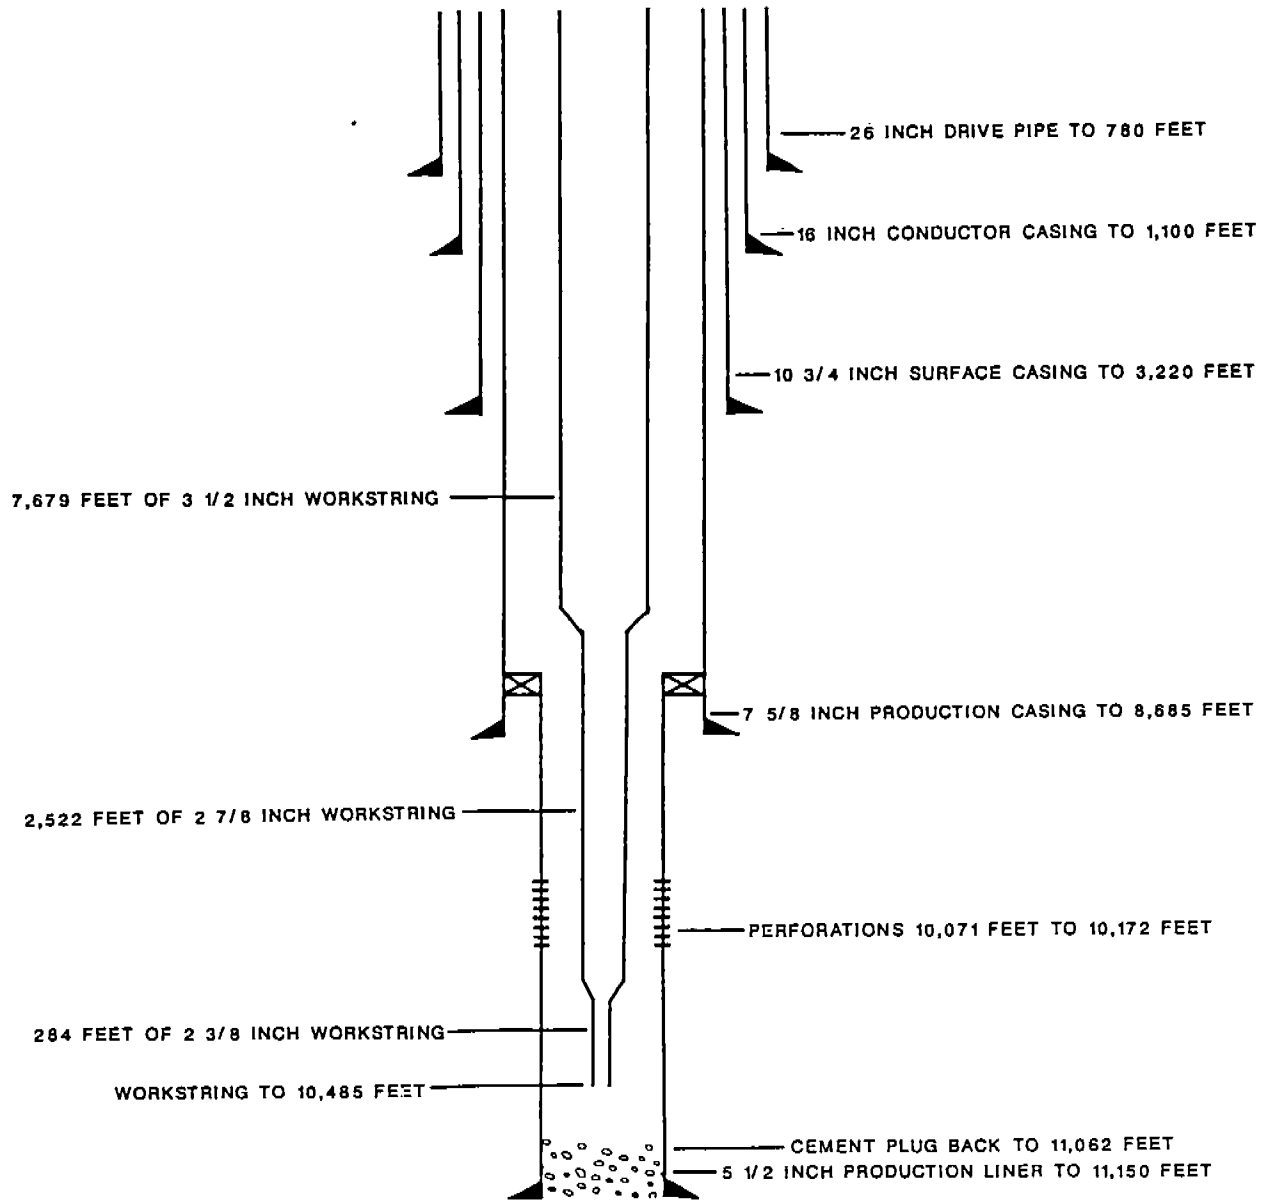
SCHEMATIC OF WELL A-1

On December 3, 1985, the S.E.E. Rig No. 14, a platform-type rig, was being used to perform workover operations on Well A-1, Lease OCS-G 4268, West Cameron Block 648. (For schematic of Well A-1, see appendix, attachment 4.)

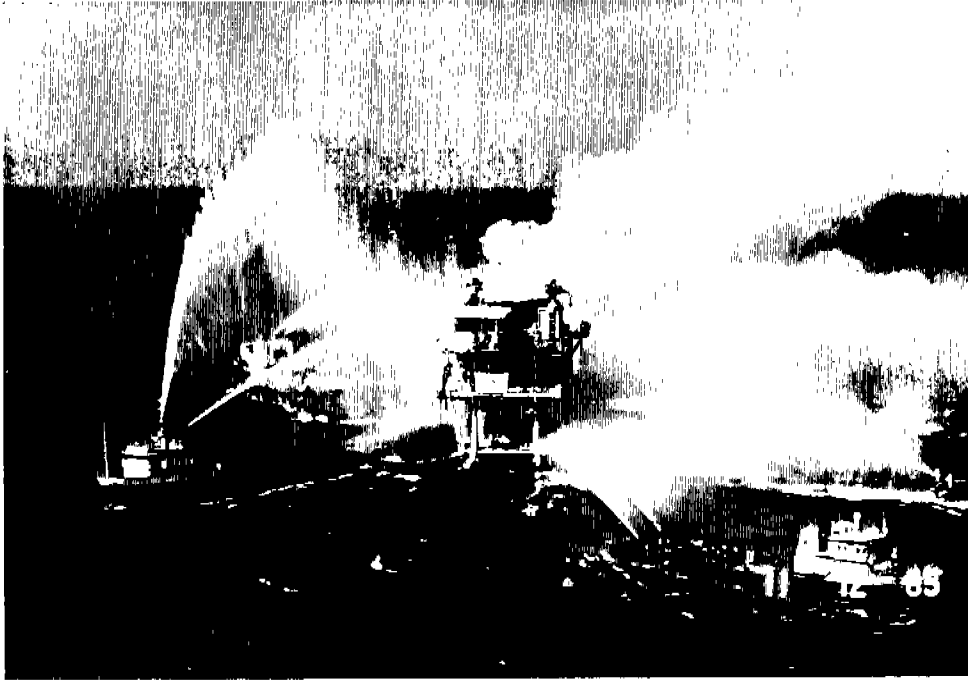
Fireboats

In an attempt to extinguish the blaze, additional boats equipped with fire monitors arrived on location. At one time 58,000 gallons of water were being sprayed on the fire per minute. The fire was extinguished several times on December 9, 1985, and thereafter, but it continued to reignite.

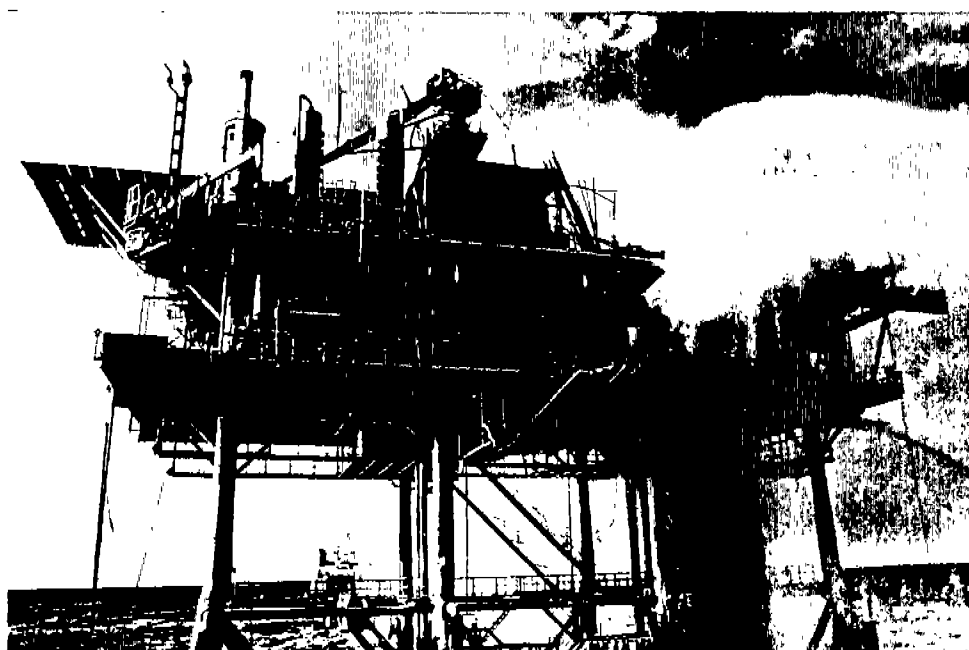
The wellbay area of the West Cameron Block 648 Platform A was completely destroyed. All wellheads and flowlines in the area were replaced. The firewall separating the wellbay area from the rest of the platform prevented the fire from spreading to and destroying the production equipment, living quarters, and heliport. (For photograph of production side of platform, see appendix, attachment 6.) The platform was restored to production on August 20, 1986. The S.E.E. Rig No. 14 was completely destroyed.

Right: Workstring valve with crossover subs.
Below: Production side of platform.
