**Investigation of Rig Accident and Fatality
Grand Isle Block 19
Gulf of Mexico
Off the Louisiana Coast
September 24, 1996**

Frank Pausina
Mike Conner
Thomas Machado

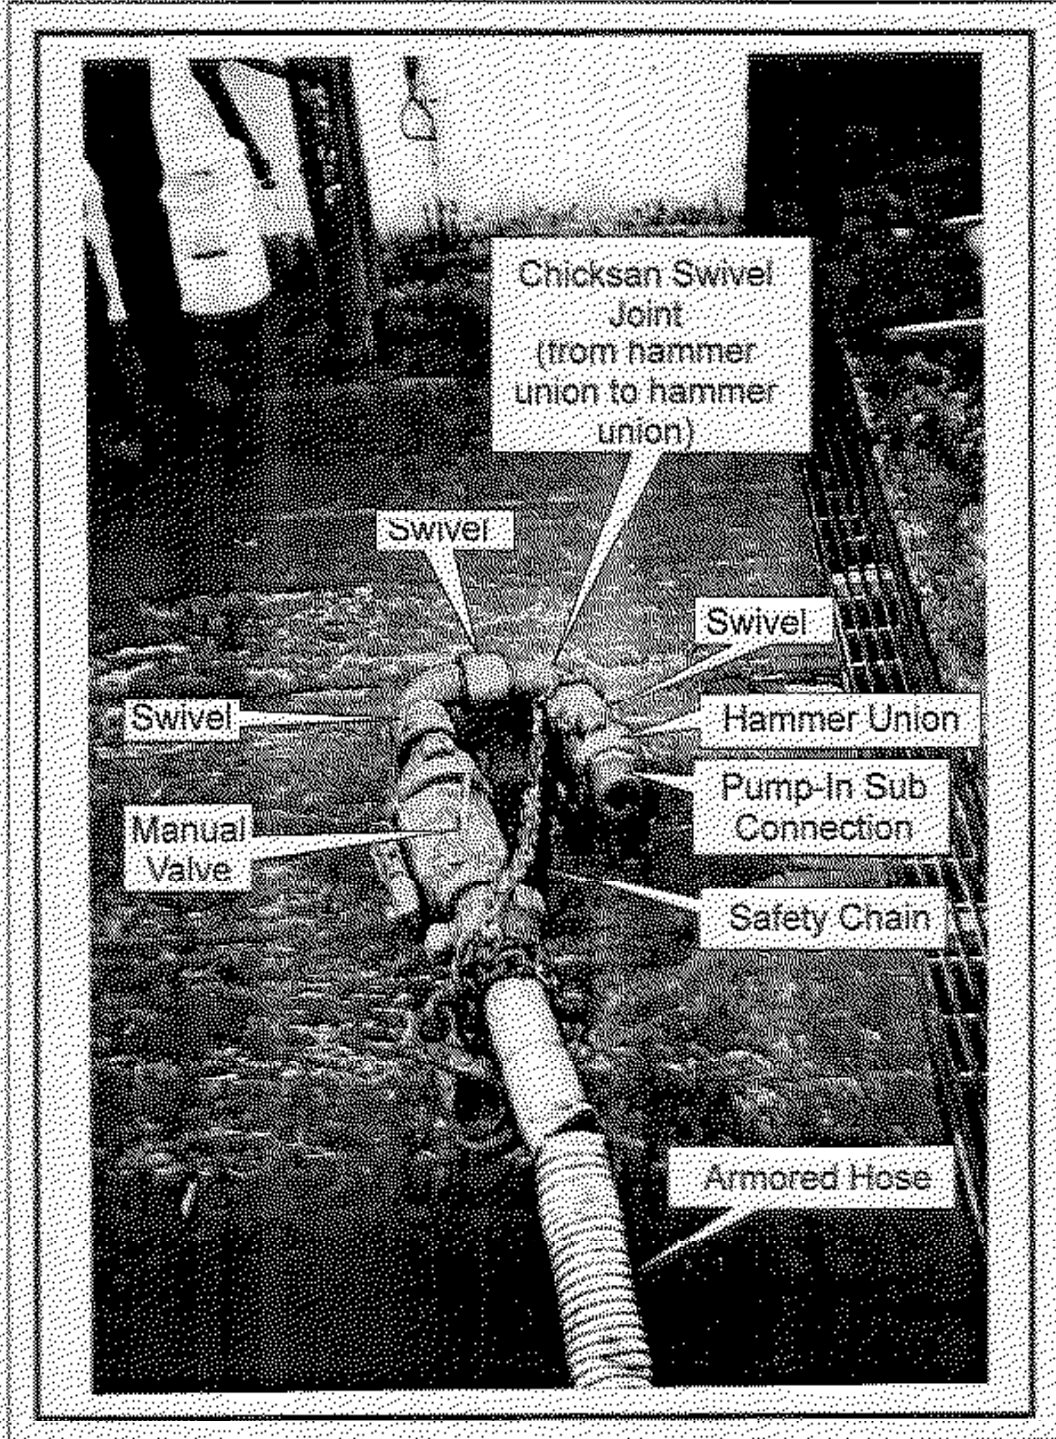
The safety chain as seen in Attachment 3 usually connected the armored hose to the elevators for the purpose of preventing the chocks swivel joint from falling should it break out of the pump-in sub assembly. However, on the morning of the accident the safety chain connected the chocks swivel joint to the armored hose. The chain was in that configuration when the morning crew began their shift at 0600 hours. One of the crew members stated that the chain was attached in that configuration by a previous drilling crew and was simply overlooked.

Photograph of the pump-in sub connection, chicksan swivel joint, manual valve, armored hose, and safety chain as the unit lay on the rig floor following the accident

Photograph of the pump-in sub connection, chicksan swivel joint, manual valve, armored hose, and safety chain as the unit lay on the rig floor following the accident.

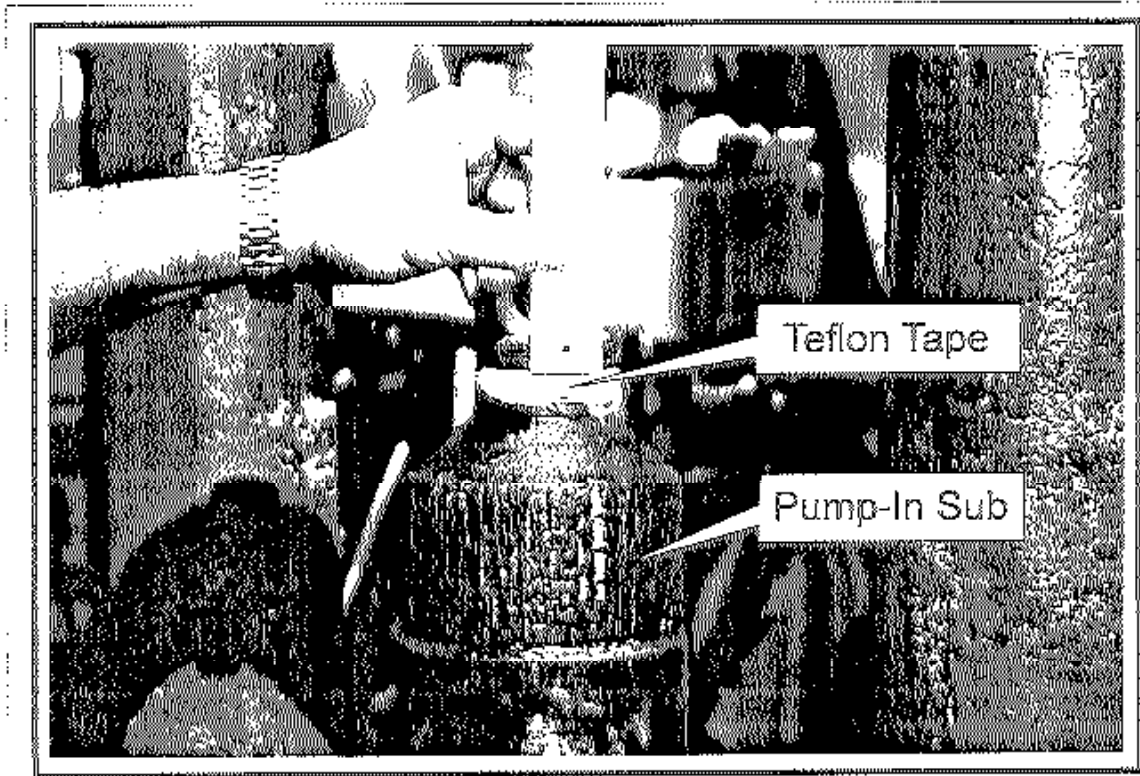
An examination of the threads of the male end of the pump-in sub revealed that it had been made up to a depth of approximately five threads to the female end of the pump-in sub connection with approximately that many threads left unused. This was determined by an inspection of the thread's Teflon coating. For a photograph of the male end of the pump-in sub, see Attachment 7. A visual inspection of the male and female threads of the connection did not reveal any significant damage to the threads. One interviewed crew member stated that more threads should have been used.

4. The unused threads of the male end of the pump-in sub at the very least did not add to the integrity of the connection and at worst compromised that integrity. The degree to which the connection would have held had all threads been used is not known. However, when considered in conjunction with the possible interference of the swivel by the safety chain, not using all the threads available can be considered a possible cause of the accident.

Photograph of male end of pump-in sub
