**Investigation of Fatal Rental Crane Support Brace Failure
Main Pass Block 255 “A” Platform
OCS-G 07825
May 5, 2002**

**Gulf of Mexico
Off the Louisiana Coast**

**U.S. Department of the Interior
Minerals Management Service
Gulf of Mexico OCS Regional Office**

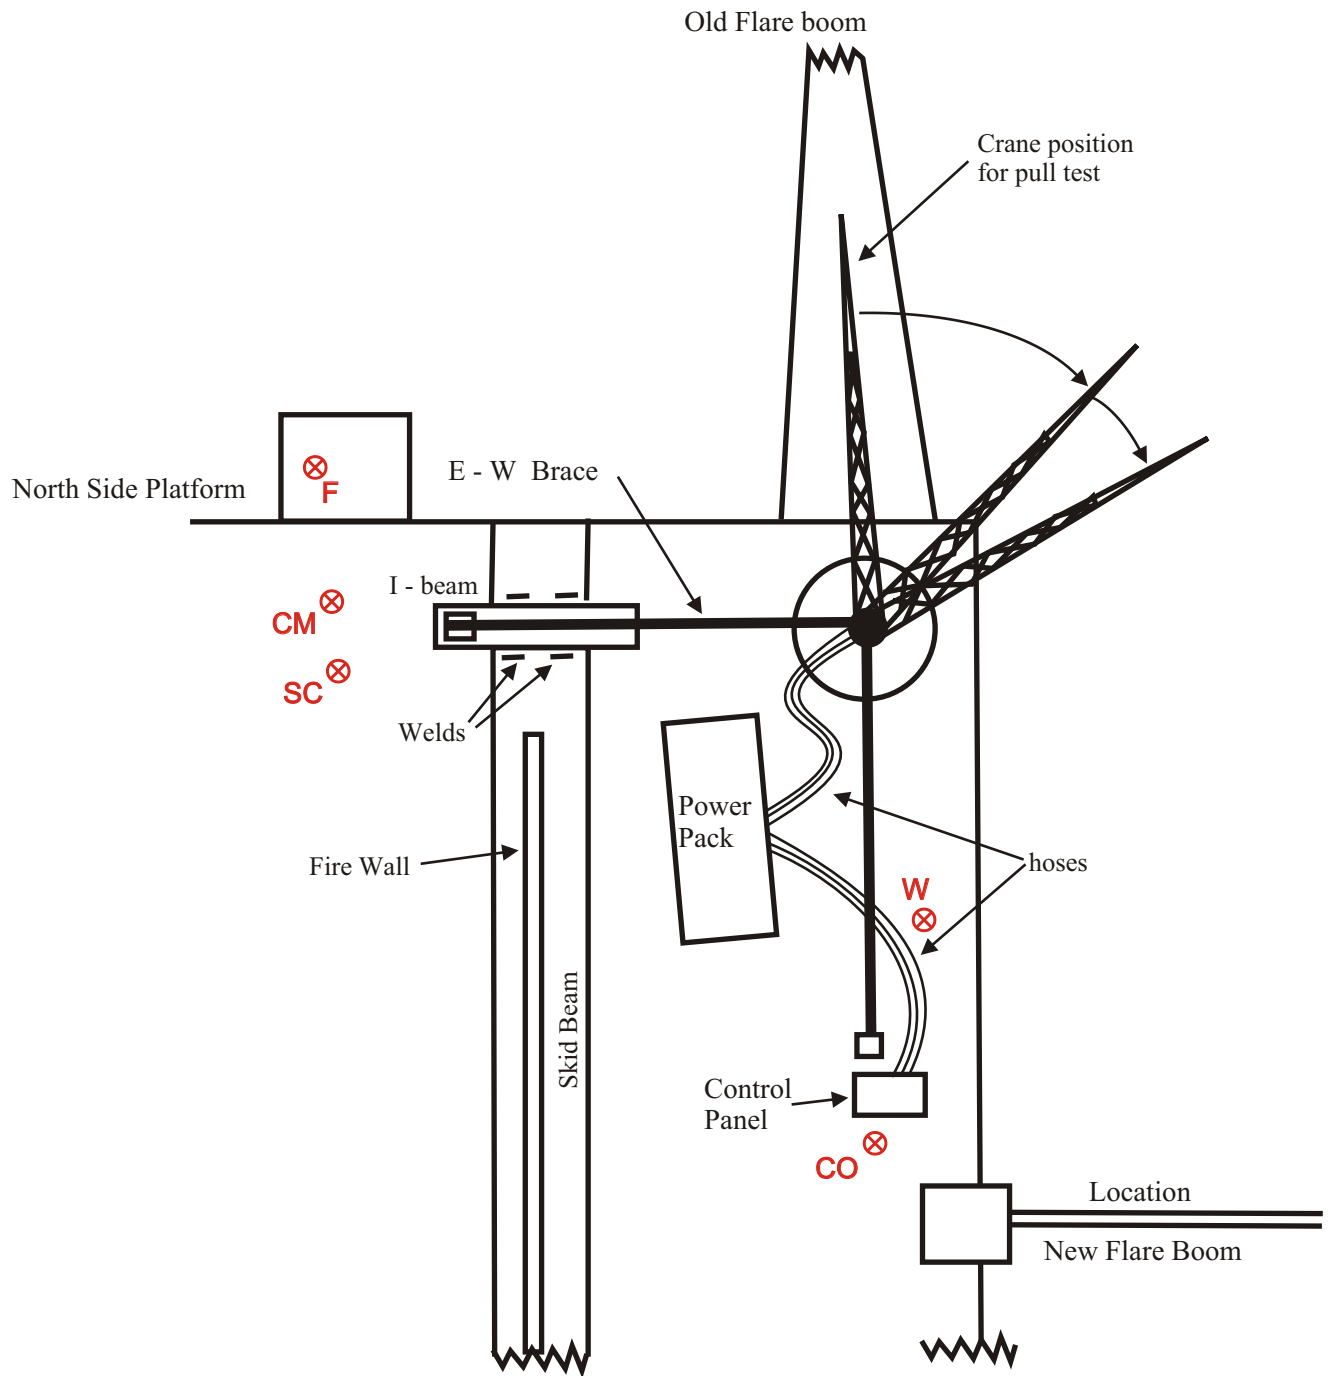
13. At approximately 0800 hrs, as the rental crane boom holding the old flare swung around from roughly a heading of 0° (north) to approximately 50° (east-northeast) (*see Attachment 3*), the E-W crane brace pulled up from the deck.

However, he was positioned in such a manner that he was inside the potential danger zone should the crane fall. No written JSA or JHA addressed the danger of standing in that position and no supervisors corrected the position of W.

Diagram: Personnel Locations and Rental Crane Swing Path with/Load.

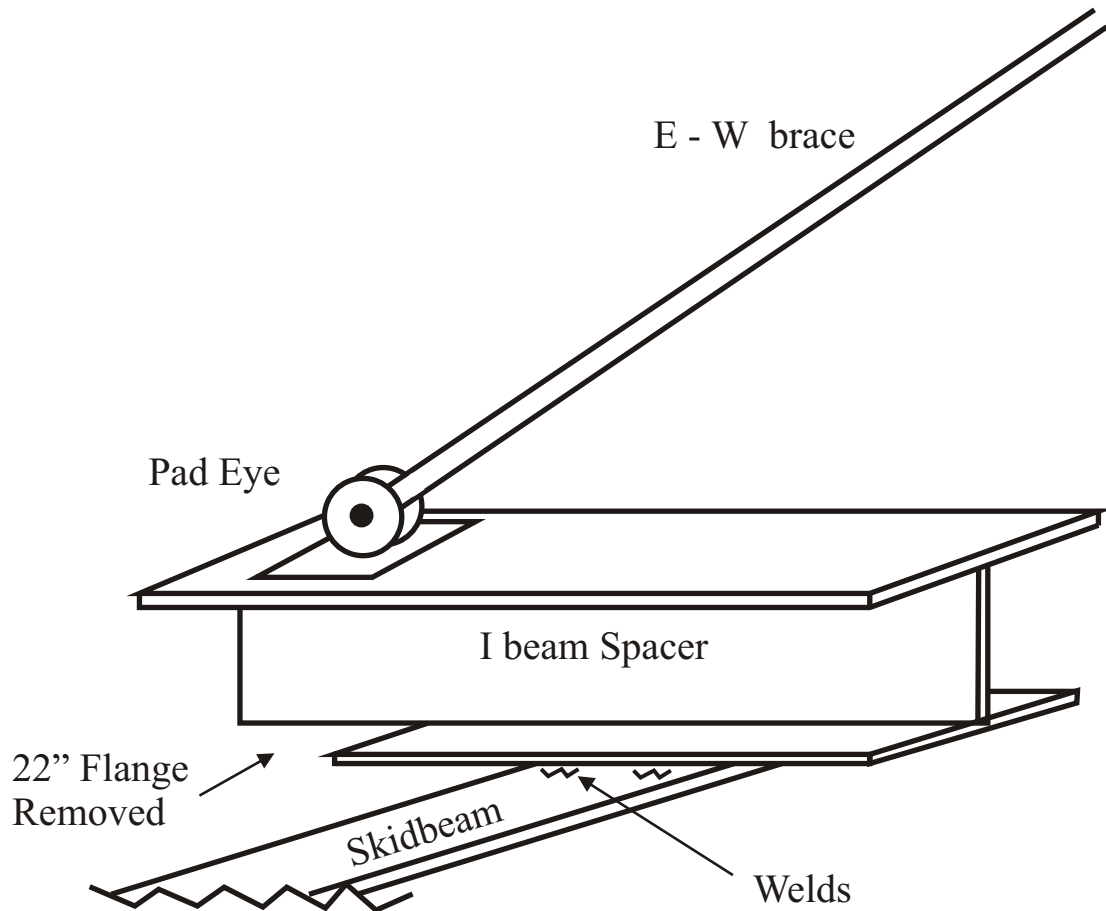
After the new procedure was agreed upon by all parties, the construction crew, supervised by CS-1, set up the crane (*see Attachment 4*). The dimensions and spacing needed to allow the pad-eye base of the two crane support braces (N-S and E-W) to be welded directly onto the platform support beams were measured to determine the location for the king post. The king post was then welded down to the deck and the N-S brace was welded, its pad-eye base being set directly on a support beam as planned. It was then discovered the E-W brace pad-eye overlapped the main skid beam, which was supposed to be its weld point, by about 6 inches (*see Attachment 5*).

When it was discovered that the E-W brace pad-eye could not be directly welded to the main skid beam, the CS-1 opted to install the crane in a different manner. Instead of taking up the king-post and N-S brace pad-eye and resetting them so that the E-W brace pad-eye would fall on the skid beam, the crane supervisor used a ? x 10-inch I-beam (taken from the tool basket) to create a base for the E-W brace. This I-beam was first attached to the skid beam by four 8-inch fillet welds, and then the pad-eye of the E-W brace was welded to the I-beam. The ends of the I-beam were unsupported (*see diagram, Attachment 5; picture Attachment 6*). In a conversation between the CS-1 and the OM that day, no mention of this method of setting up the crane was made, that conversation being

Diagram: Connection of Rental Crane E - W Brace to MP - 255 "A" Platform Skid Beam

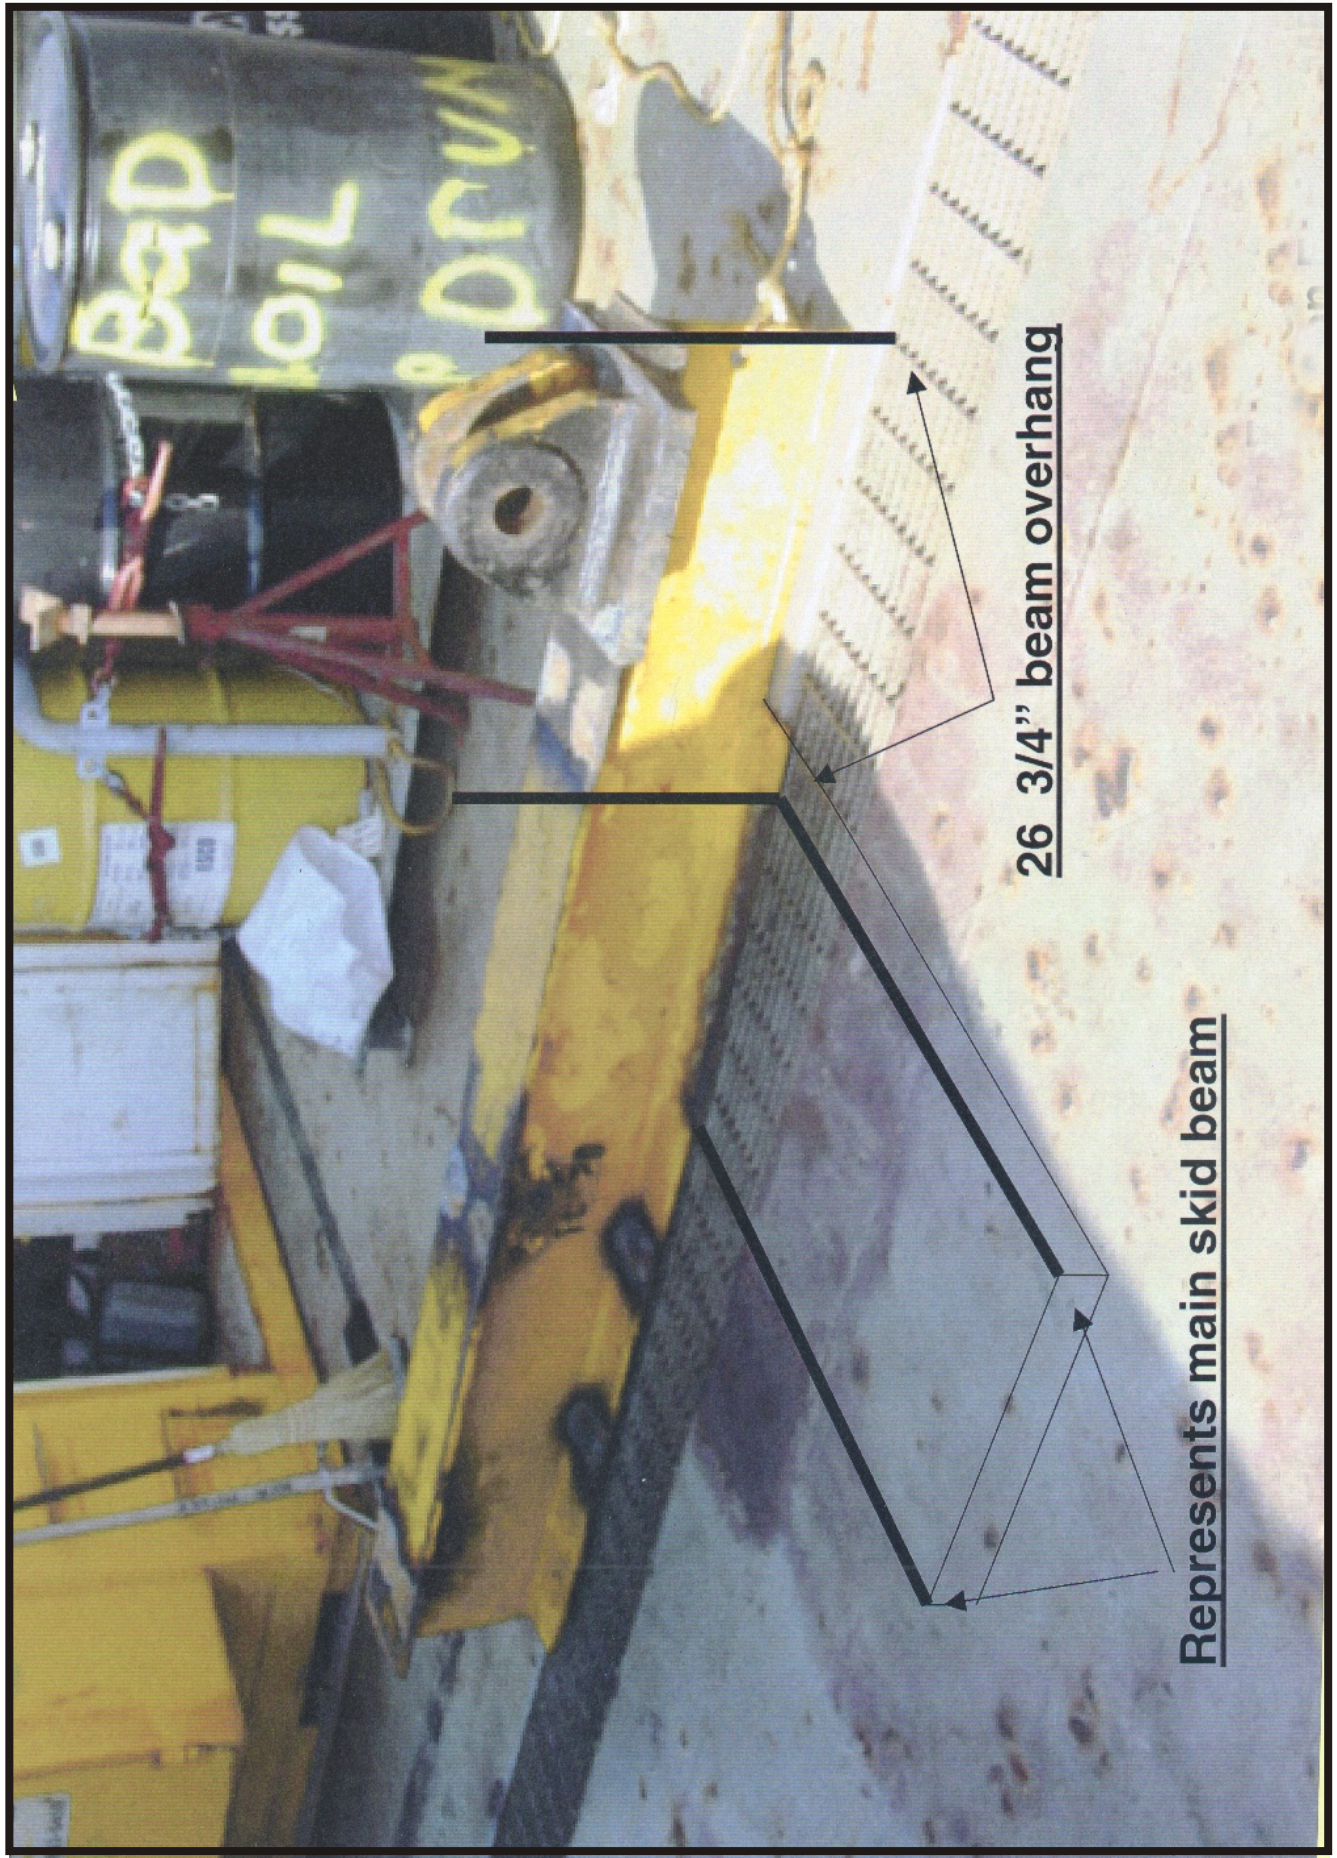
This method of setting the crane brace created a cantilever, with the I-beam/E-W brace pad-eye connection being outboard of the I-beam/skid beam welds. This situation allowed a force moment, multiplying the force applied to the I-beam/pad eye connection onto the I-beam/skid beam connection. The I-beam itself had been used as a base for a crane brace several times and was previously modified by the removal of about 22 inches of the bottom flange (*see Attachment 7*). The method previously used was to weld the I-beam onto two or three support beams, thus providing a more stable base than the cantilever employed in this application.

Represents main skid beam

26 3/4" beam overhang

I-Beam, Pad Eye w/Representation of Attachment to Skid Beam

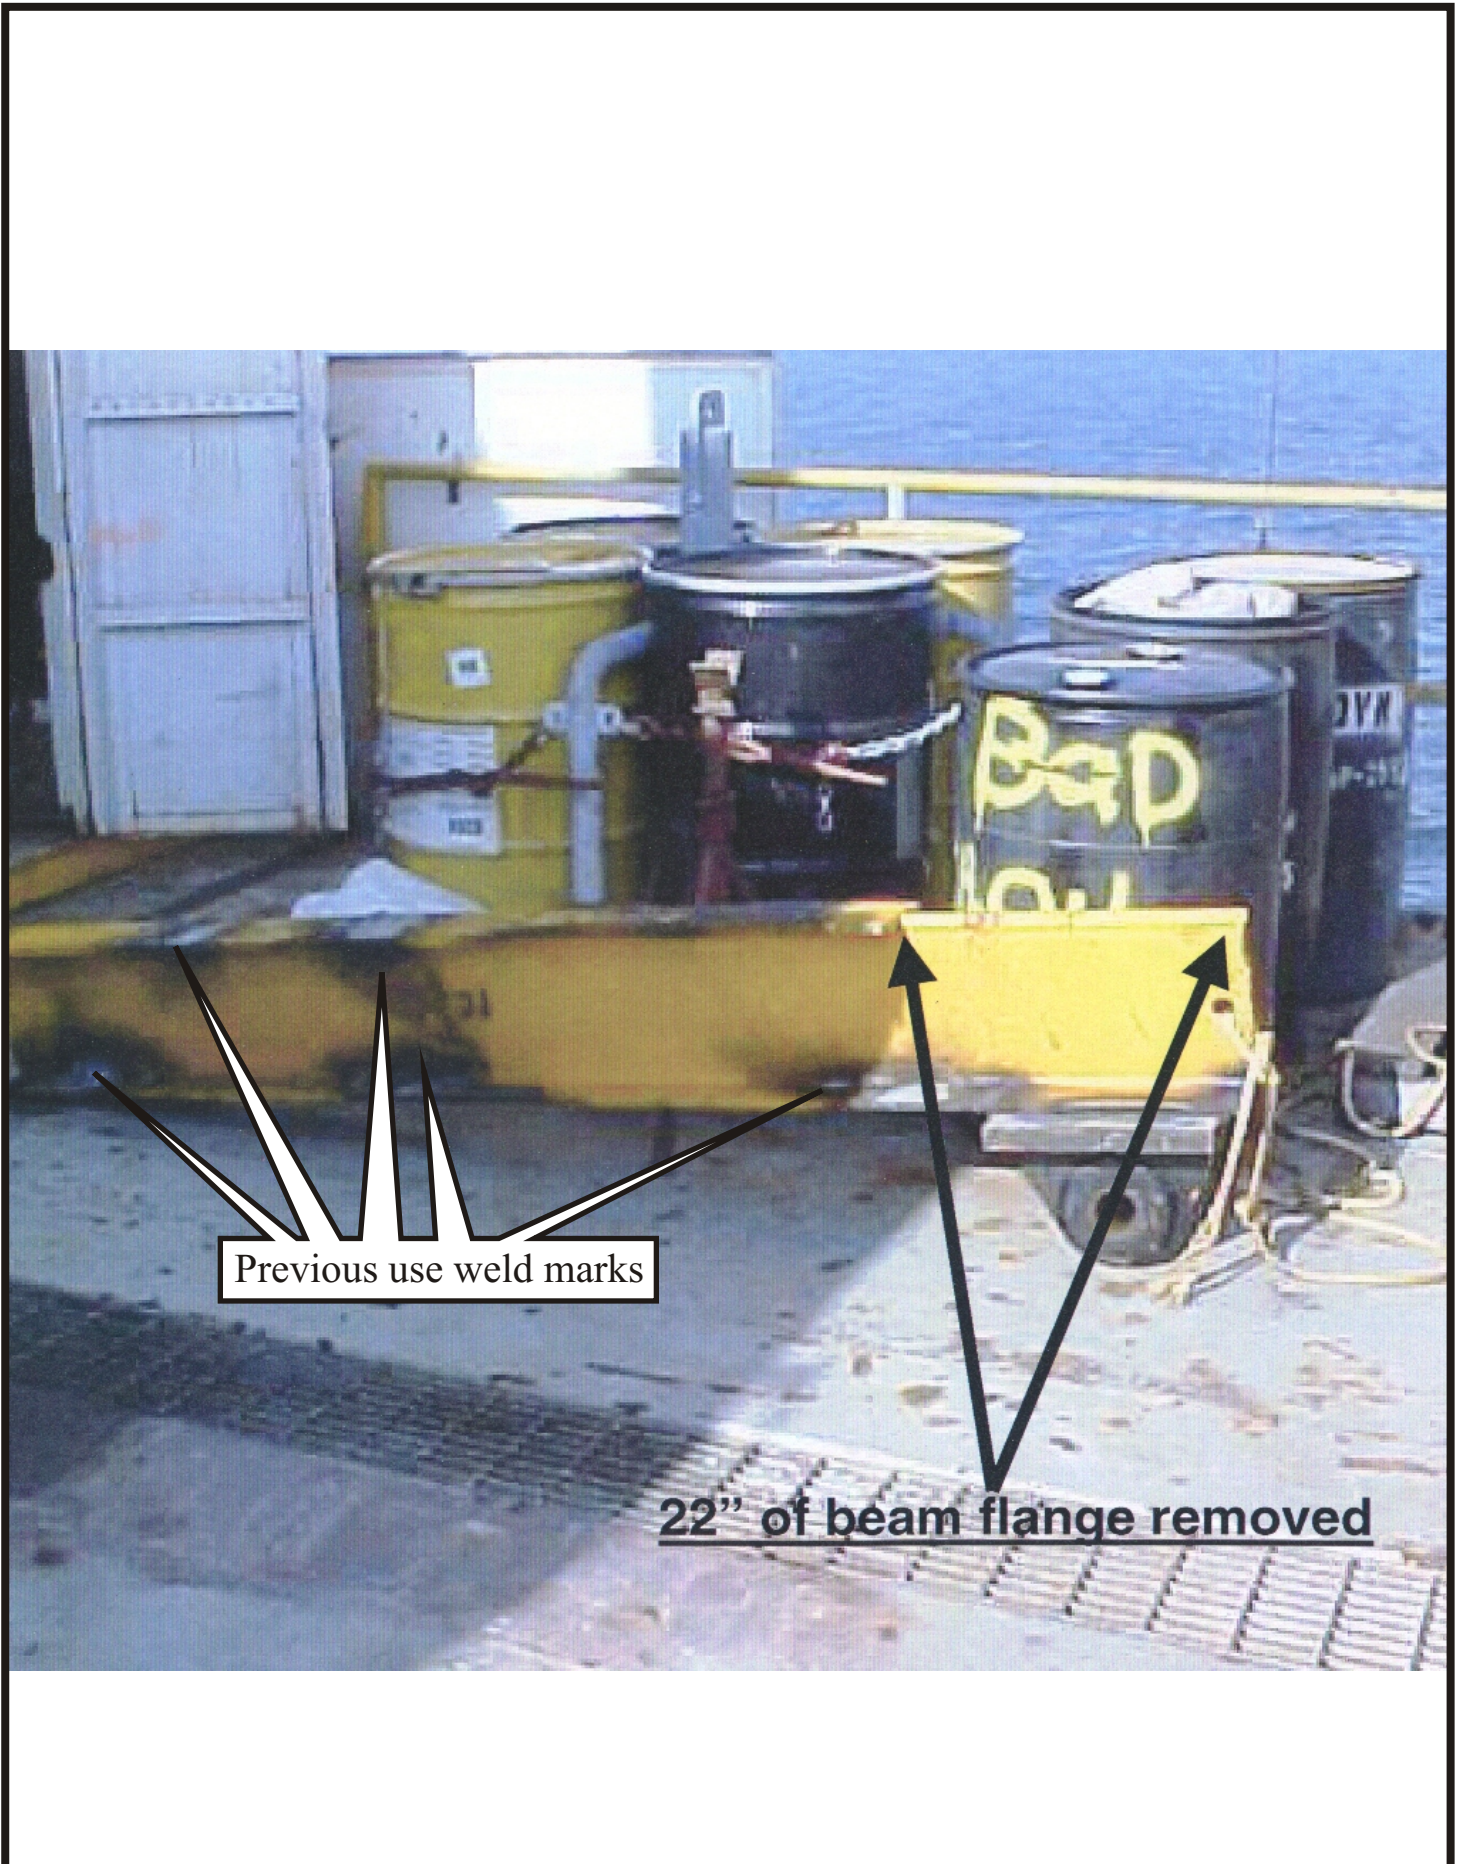
Previous use weld marks

22" of beam flange removed

I-Beam with Missing Flange and Previous Use Weld Marks

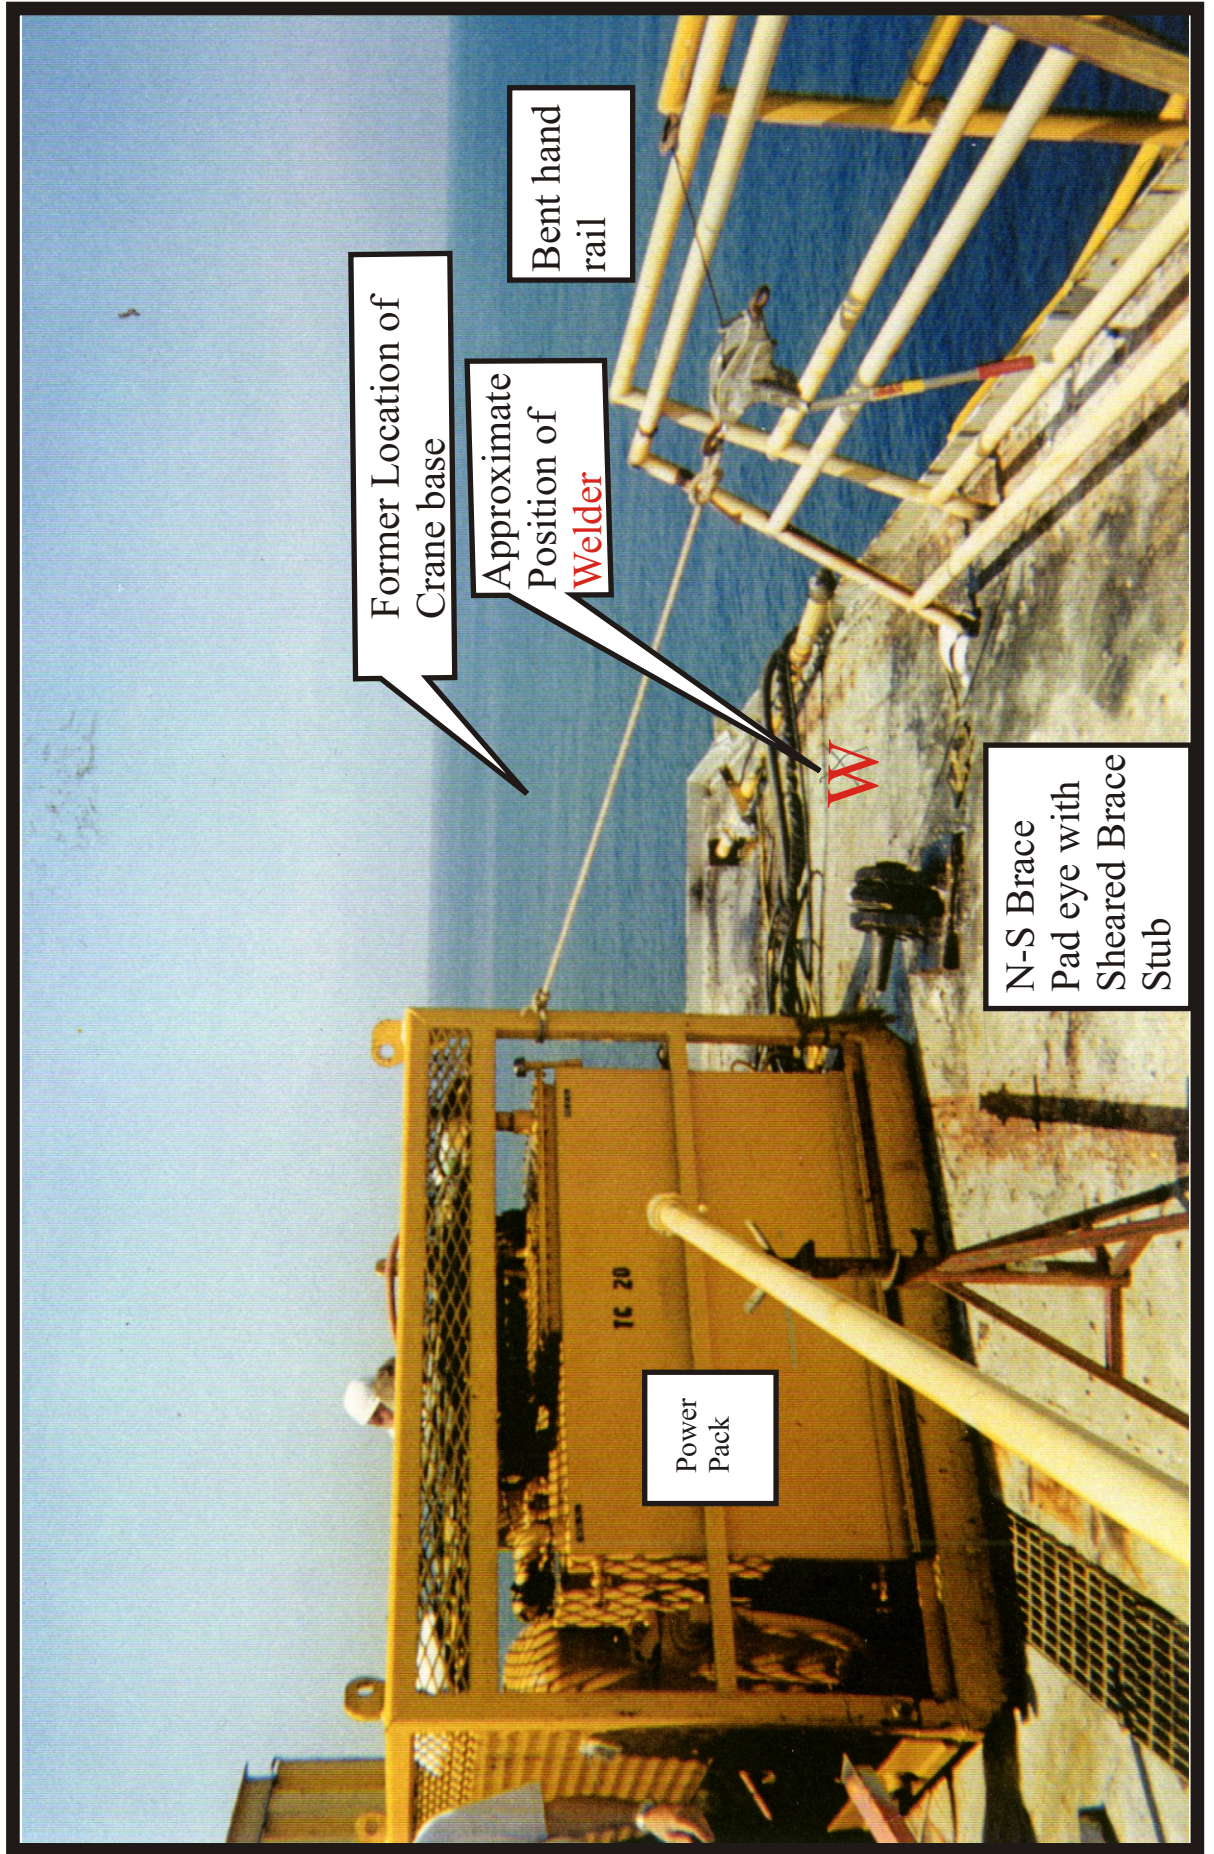
The inspection revealed that the I-beam that formed the base for the E-W brace had deformed considerably where the beam was welded to the skid beam of the platform. Portions of the beam flange had deformed and chunks of the flange metal were apparently missing where it had been welded. (See Attachment 10, fillet welds, and Attachment 11, picture of beam and deformation.) The N-S brace had been broken above the pad eye connection to the platform structure,

with the pad eye connection remaining welded to the platform (*see Attachment 9*). The E-W brace had been bent but was intact. With the concurrence of the investigation team, the I-beam and the portion of the skid beam to which the I-beam had been welded, and all pad eye elements, were sent to Anderson & Associates, Consulting Metallurgical Engineers and Testing Laboratory, in Houston, to determine the failure mechanism.

Platform Location of Crane after Failure

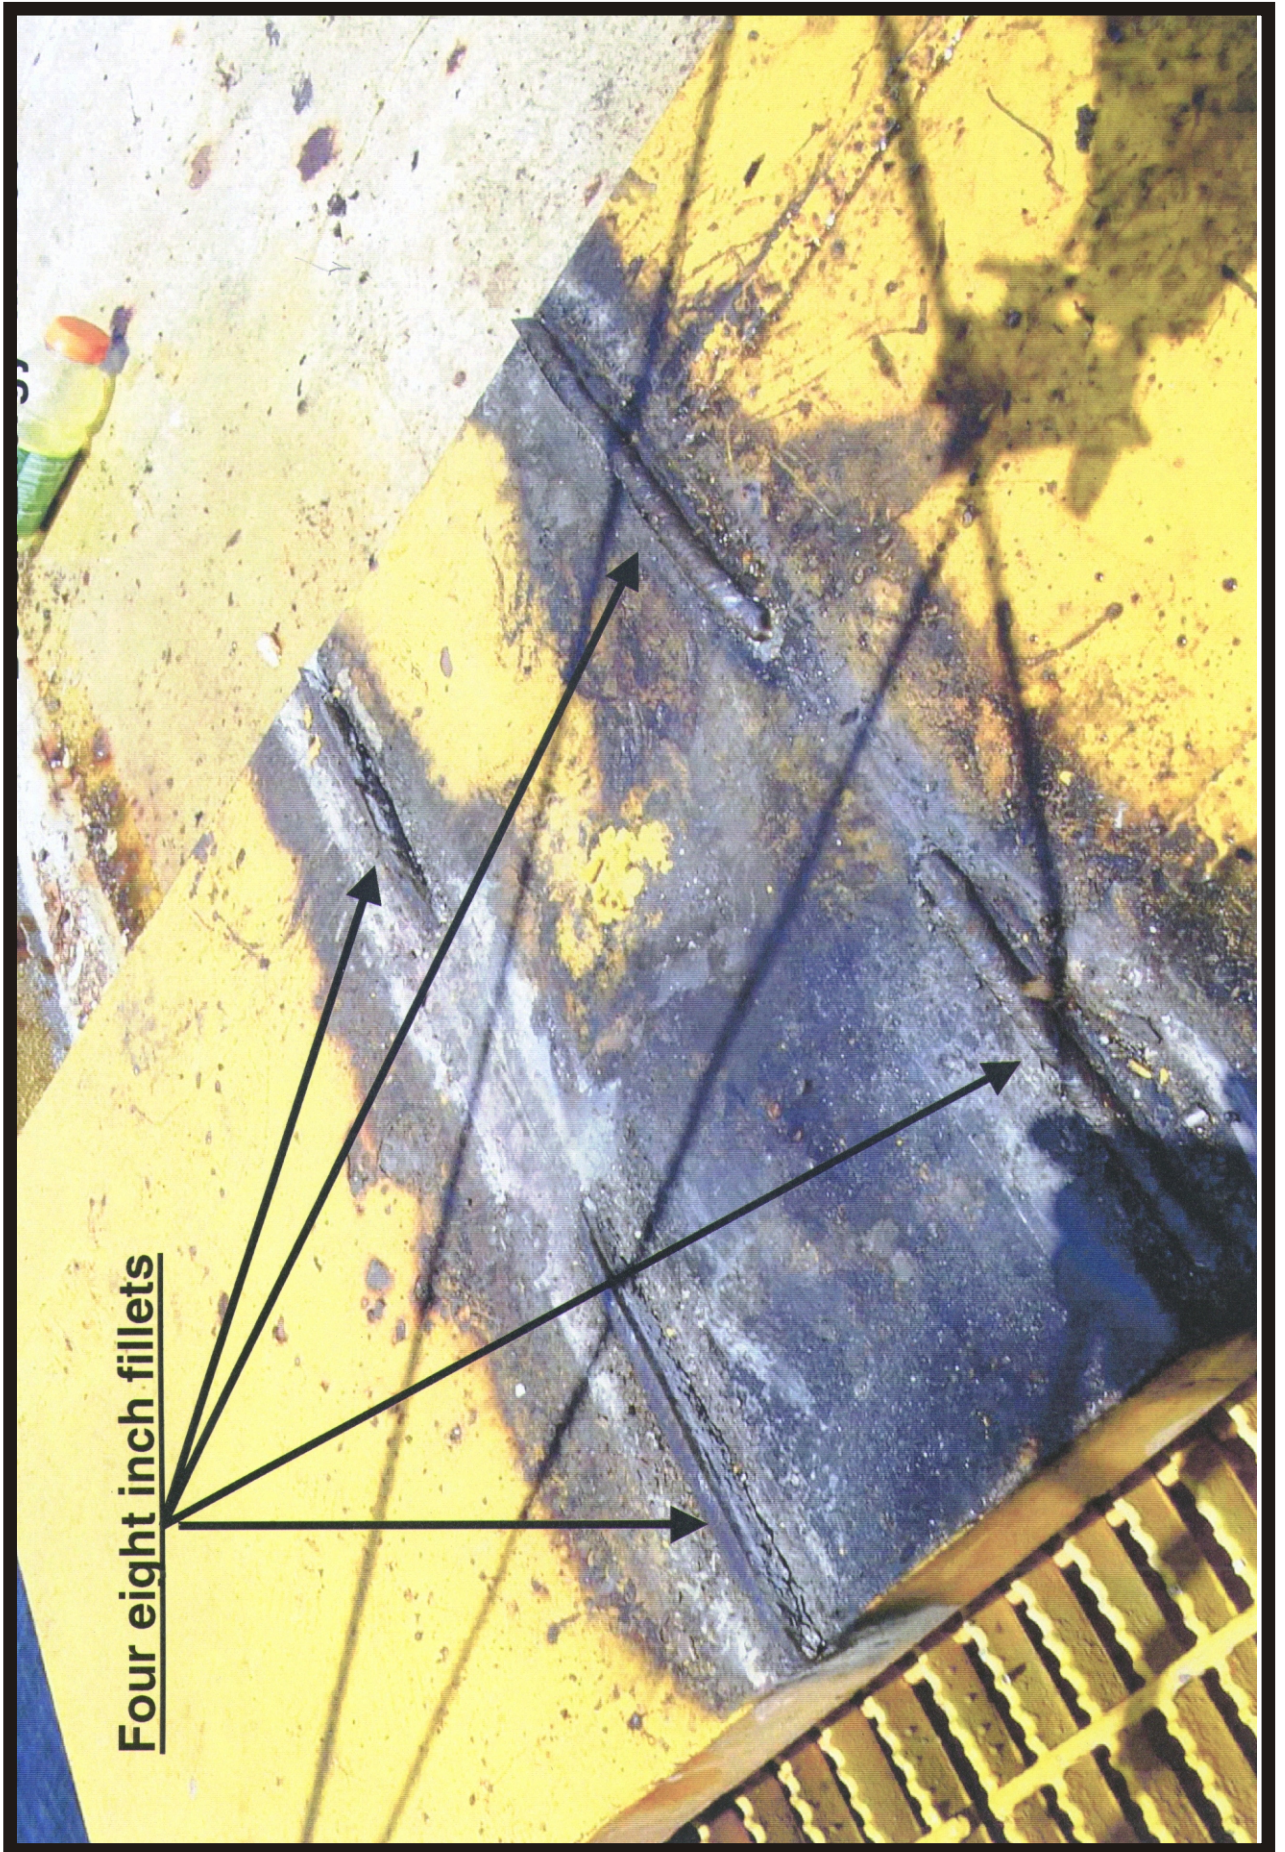
The report noted the I-beam that formed the connection between the E-W brace pad-eye and the platform was placed across the skid beam with the ends of the I-beam hovering in the air, unsupported, forming a cantilever. The bottom flange of the I-beam was attached to the skid beam using four fillet welds. The four

fillet welds failed (*see Attachment 10*). The report noted there was significant deformation of the bottom flange of the I-beam and all such deformation was precisely oriented around the welds (*see Attachments 11, 12, and 13*).

The report stated that it was discovered the materials involved in the failure were basically sound. The I-beam and skid beam were proper structural grade steels and the welds were properly made. The weld fusion was good, the weld was stronger than the metals it attached, and the weld size could not have been any larger because it was limited by the thickness of the I-beam flange. The report concluded the failure of the brace support was completely caused by an overload on the I-beam. The degree of bending of the I-beam flange was such that the fillet welds became loaded more in tension than in shear and the beam itself then failed. The report noted that the failure of the crane brace that led to the accident was caused by the incorrect fundamental design of the attachment of the crane to the platform.

Four eight inch fillets

Fillet weld on skid beam after failure

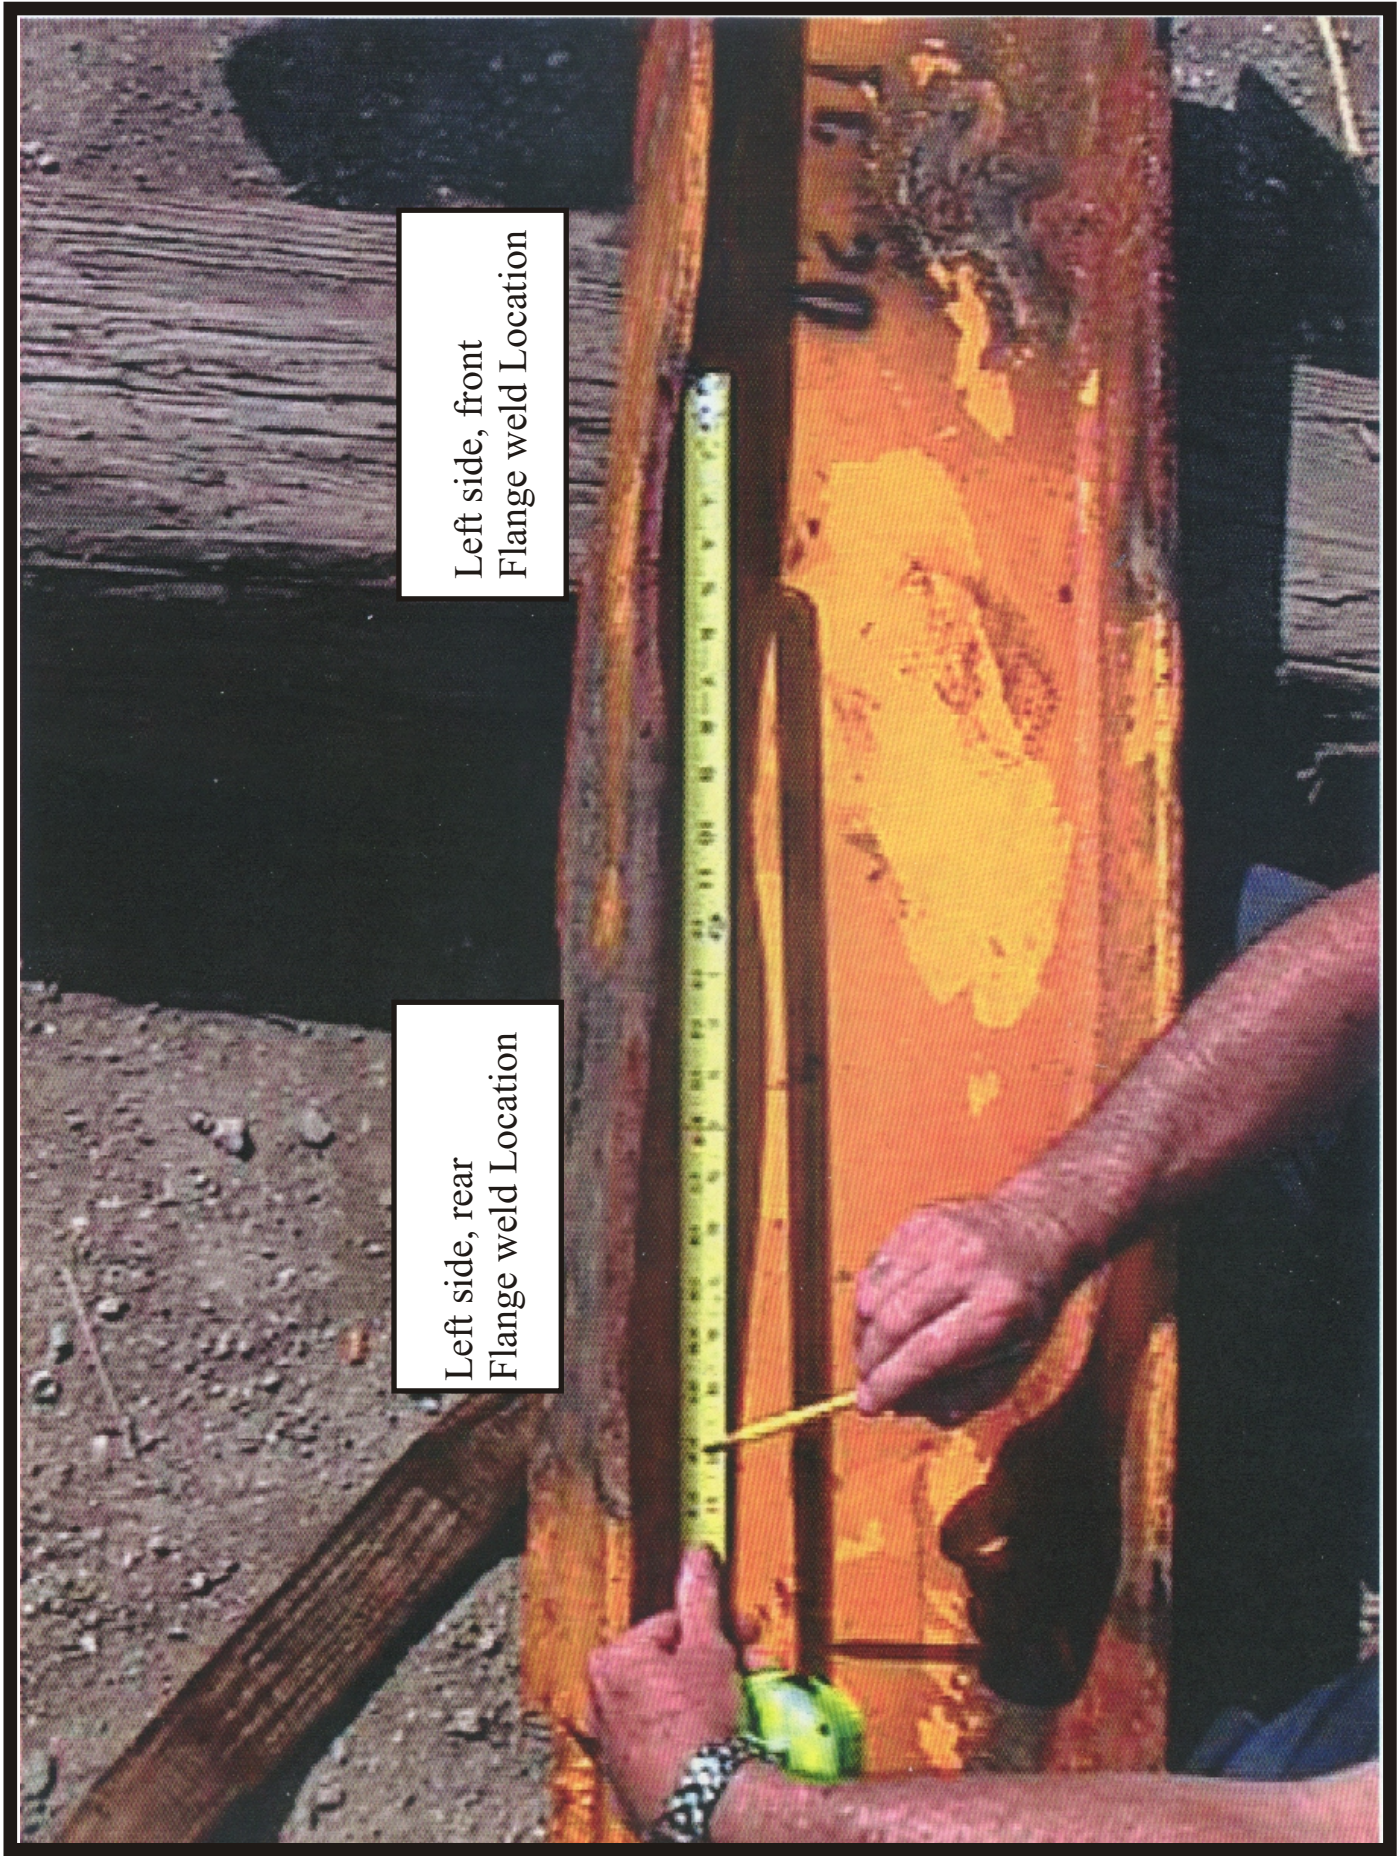
Left side, front
Flange weld Location

Left side, rear
Flange weld Location

Deformation of I-Beam Flange

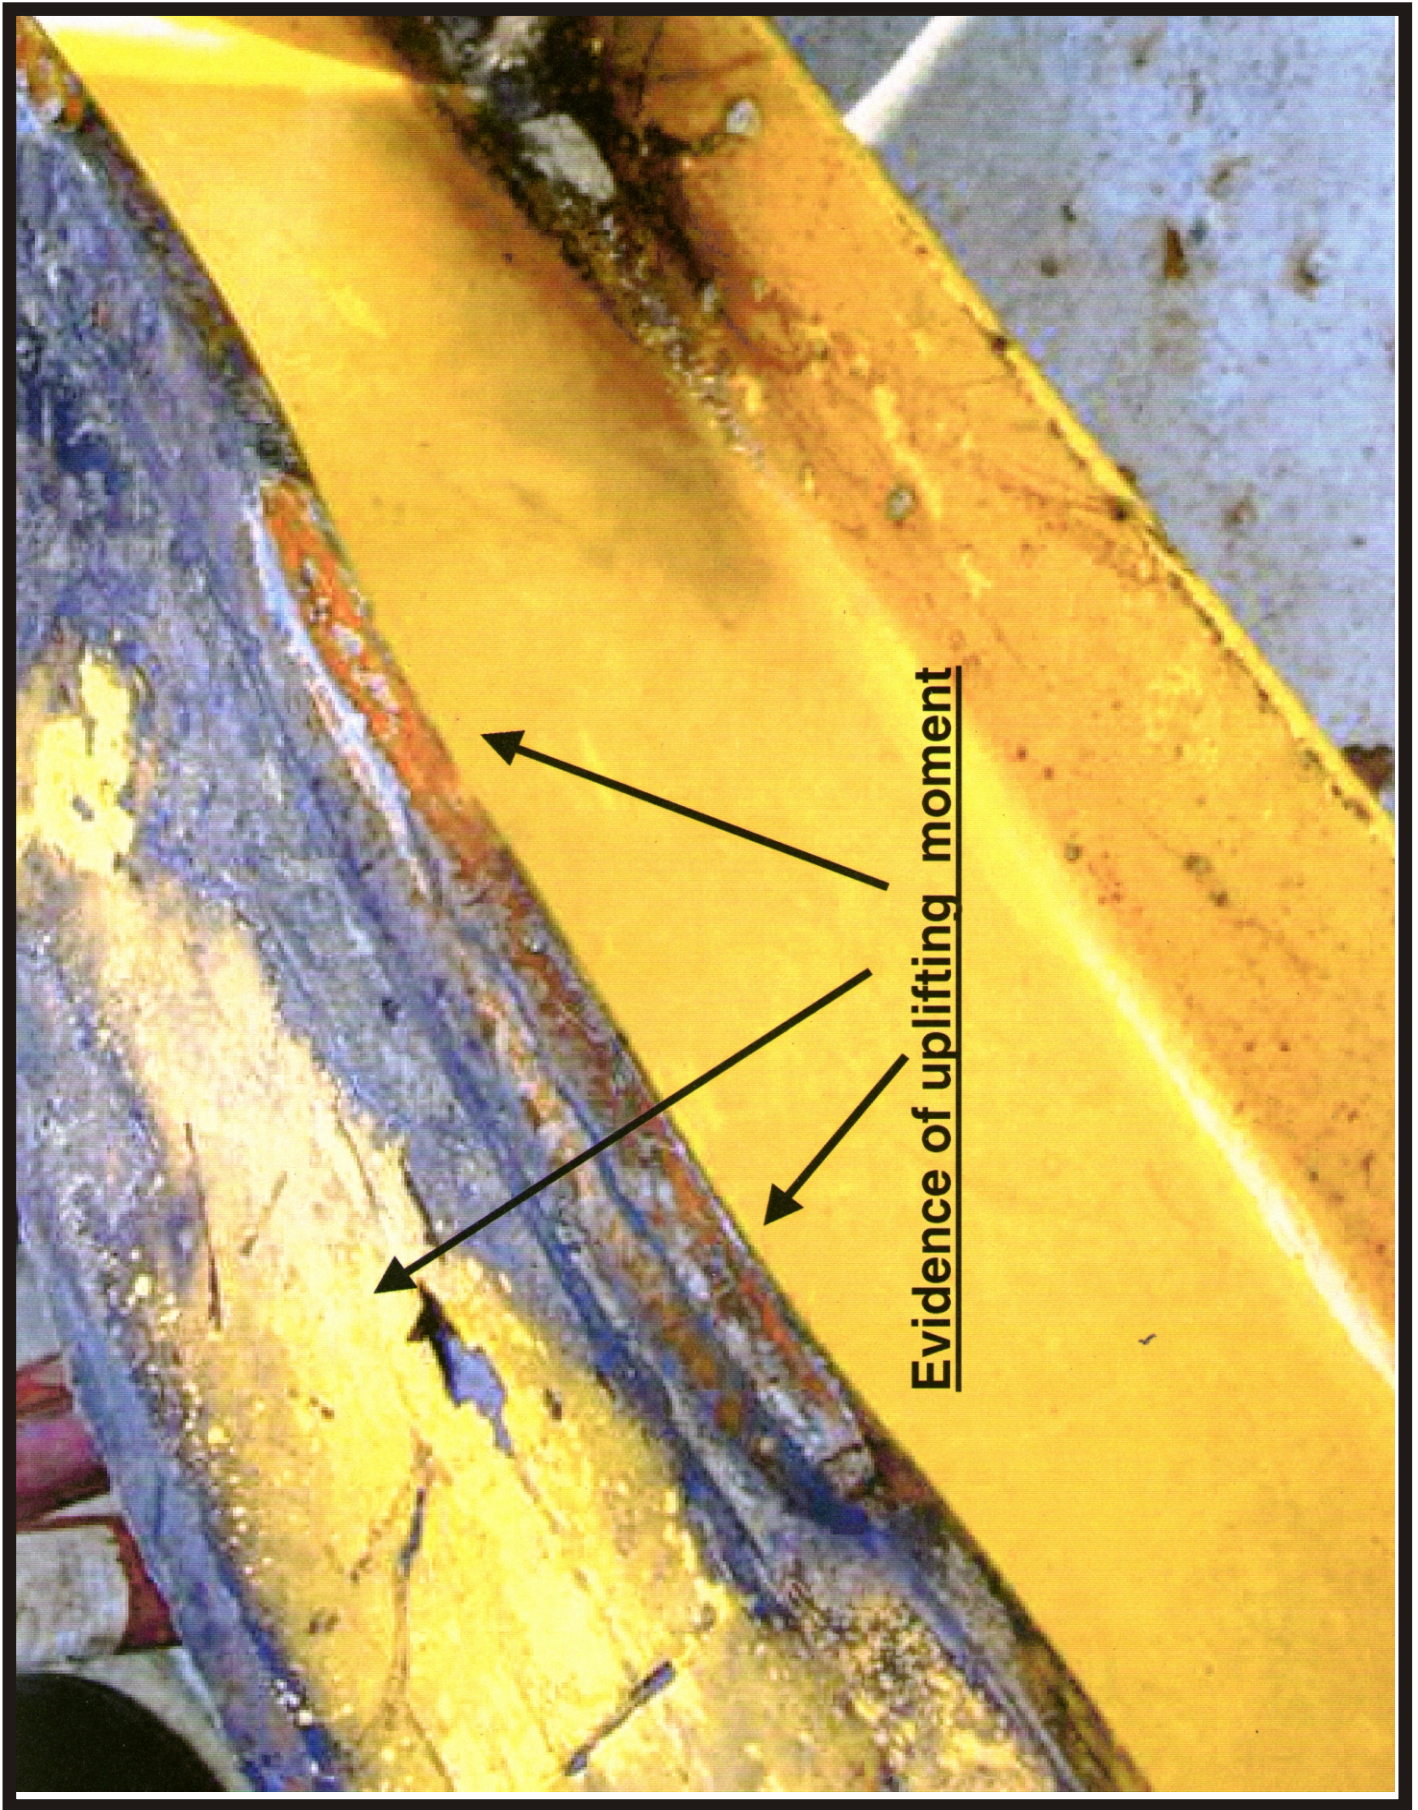
I-Beam Evidence of uplifting moment

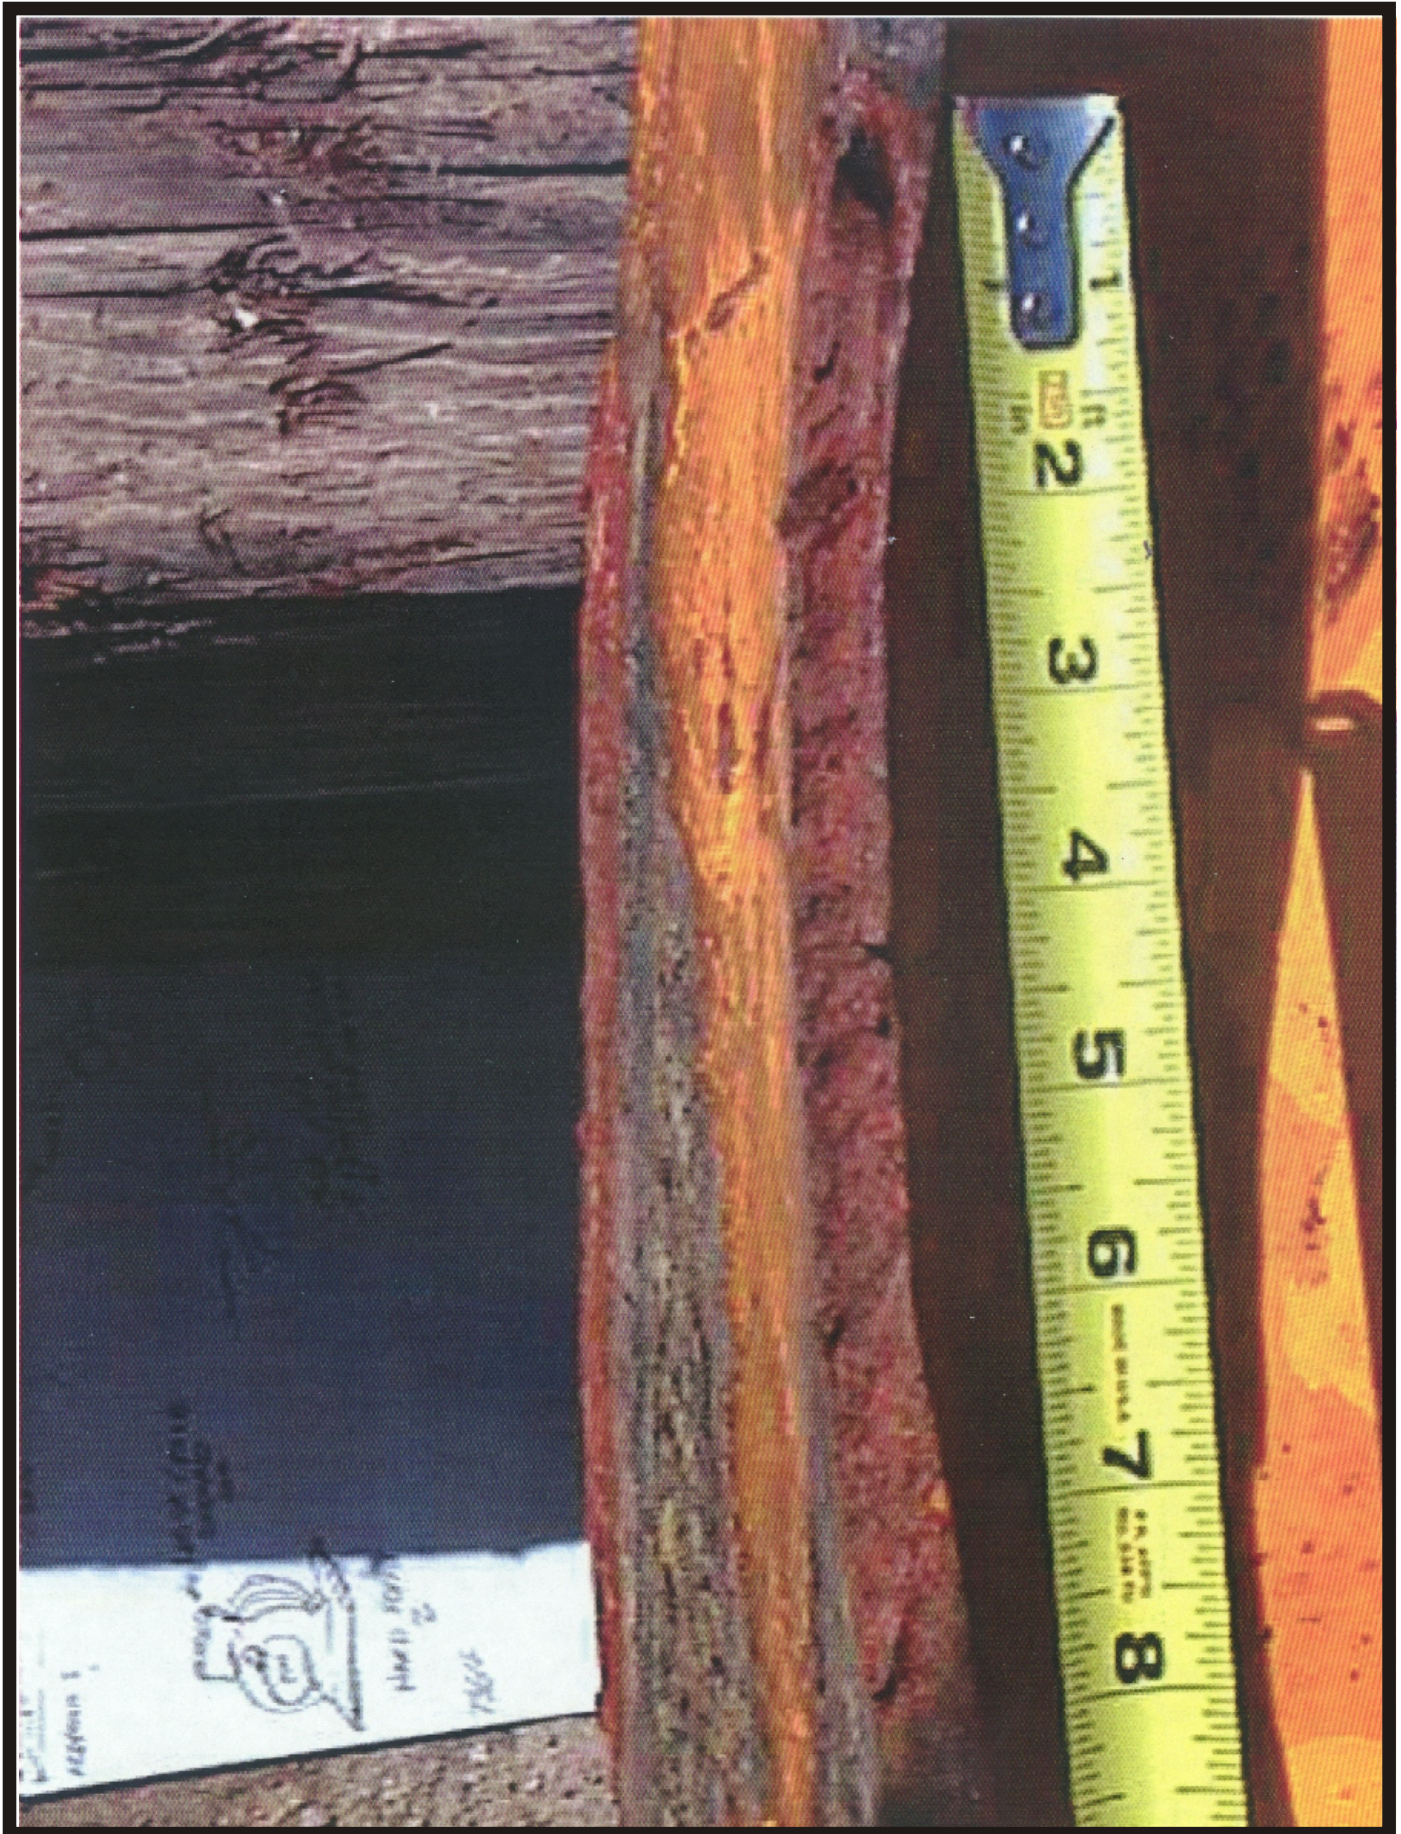
I-Beam Flange Deformation after Failure
