**Investigation of Loss of Well Control  
South Timbalier Block 188, Well CA-3  
OCS-G 1899  
22 April 2003**

**Gulf of Mexico  
Off the Louisiana Coast**

**U.S. Department of the Interior  
Minerals Management Service  
Gulf of Mexico OCS Regional Office**

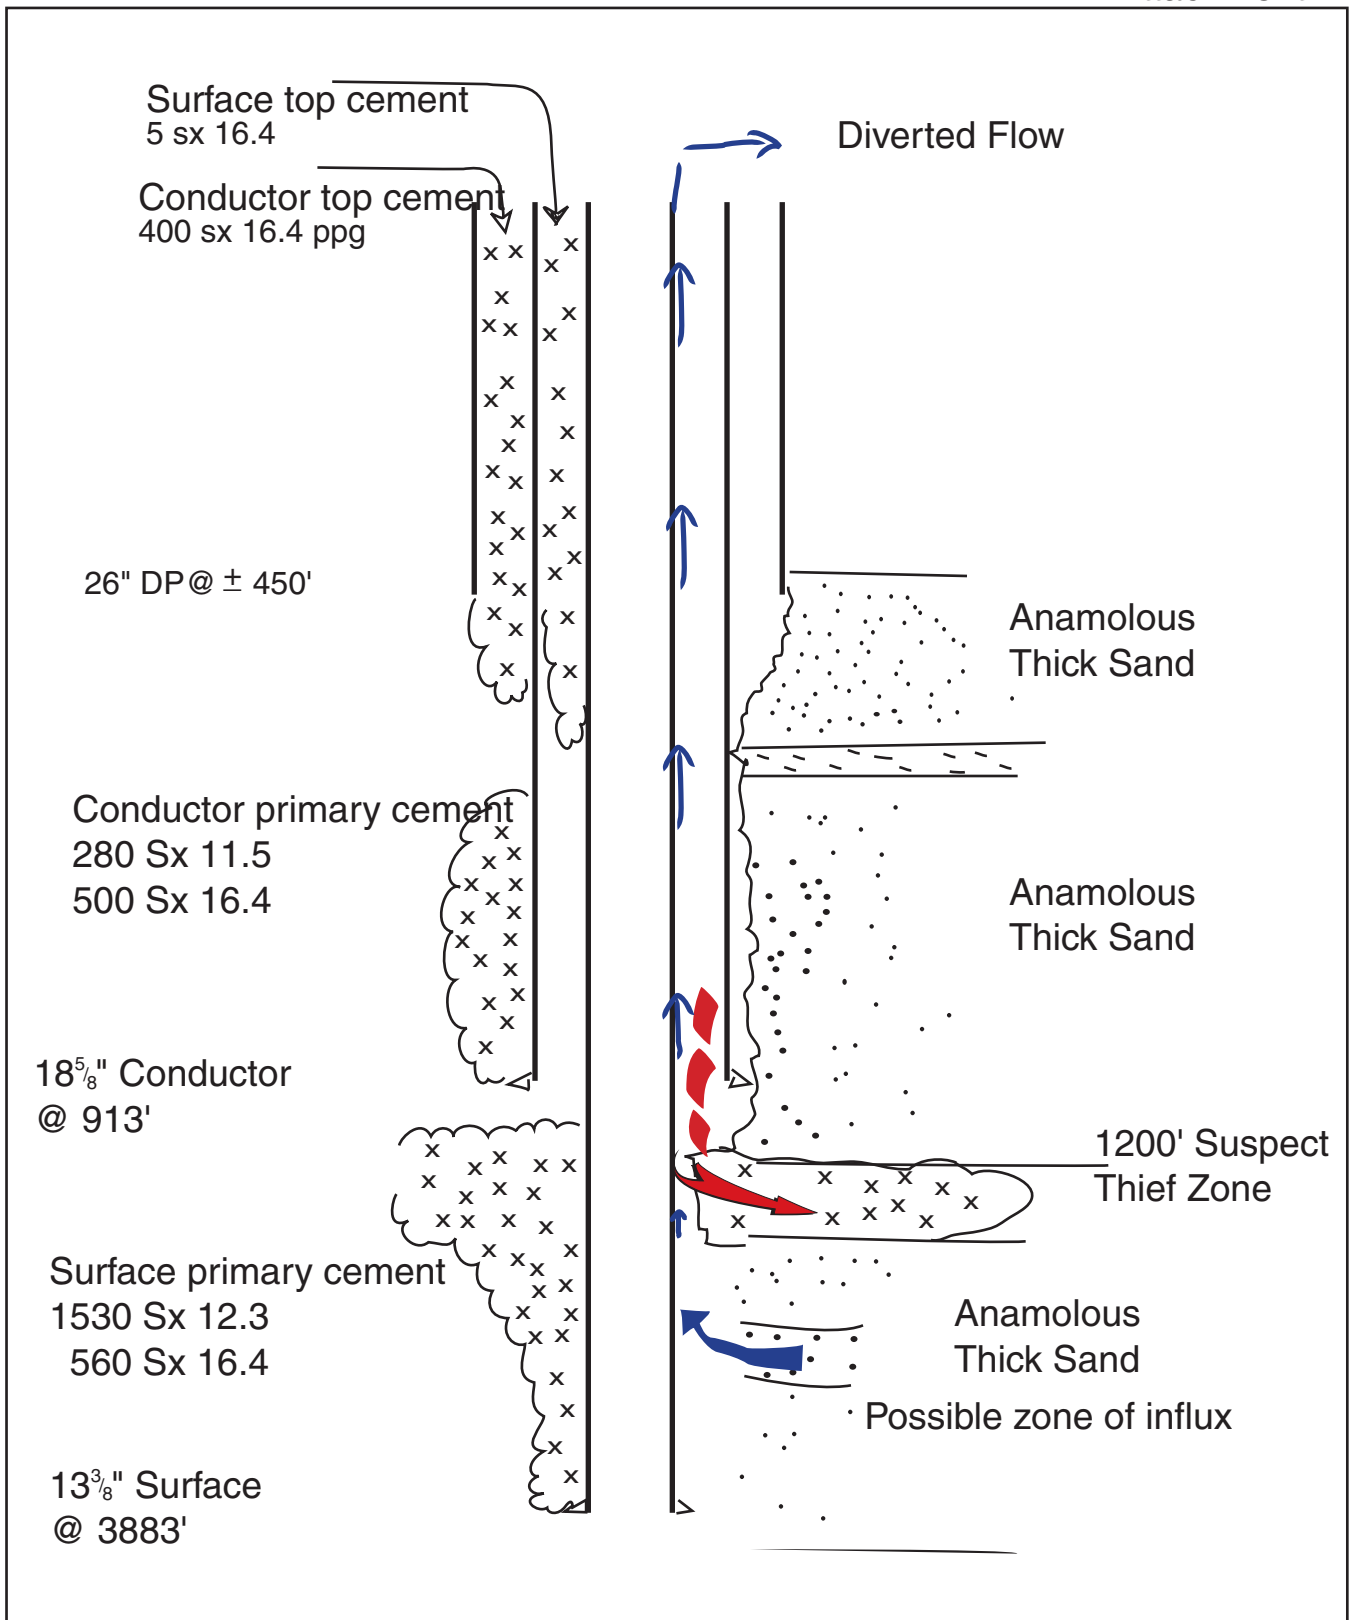
South Timbalier Block 188 CA-3: to surface casing installation

However, once the CA-3 drive pipe was drilled out, an anomalous, thick sand deposit was immediately encountered that initially caused large seepage losses and finally complete loss of drilling fluid returns. The drilling plan was subsequently modified and a string of conductor casing was run to 913 ft and cemented. Because no cement returns were received at the surface, a top cement job was performed. When the conductor casing was subsequently drilled out, the anomalous sand deposit continued to be encountered to a depth of 4,800 ft where surface casing was to be set, with significant seepage losses continuing (*see Attachment 2 for casing and cement schematic of Well CA-3*).

During the drilling of the CA-3, however, severe fluid losses were encountered immediately upon spudding the well. The losses and associated control problems were of such a nature that the Operator opted to install the waived conductor pipe at the first opportunity, at 993 ft. However, cementing the conductor was accomplished with little or no returns and a top cement job was finally required. According to testimony, because of the severe circulation problems, the conductor pipe was run unexpectedly and the conductor shoe was set in an unknown geologic layer. The bottom of the conductor casing was later found to be within the anomalous sand deposit, thus reducing the integrity of the conductor shoe.

The Operator's engineering and geosciences personnel reported the through-casing logs of the CA-3 indicated a section of hole at approximately 1,200 ft had suffered deep invasion during drilling and cementing operations. According to the Operator, this highly permeable sand section is suspected of being the primary thief zone that caused the hydrostatic loss preceding the well kick, as well as the location of formation breakdown, which limited returns during cementing operations. The Operator was unable to determine if the zone of influx was also the 1,200 ft permeable sand streak, or if other permeable zones also contributed to the inflow.

The primary zone responsible for the loss of drilling fluid was probably the highly permeable sand encountered at approximately 1,200 ft as logged in the CA-3. The log showed that this zone was not only deeply invaded by drilling fluids, but was also the zone that likely broke down during cementing the conductor and surface casing strings.

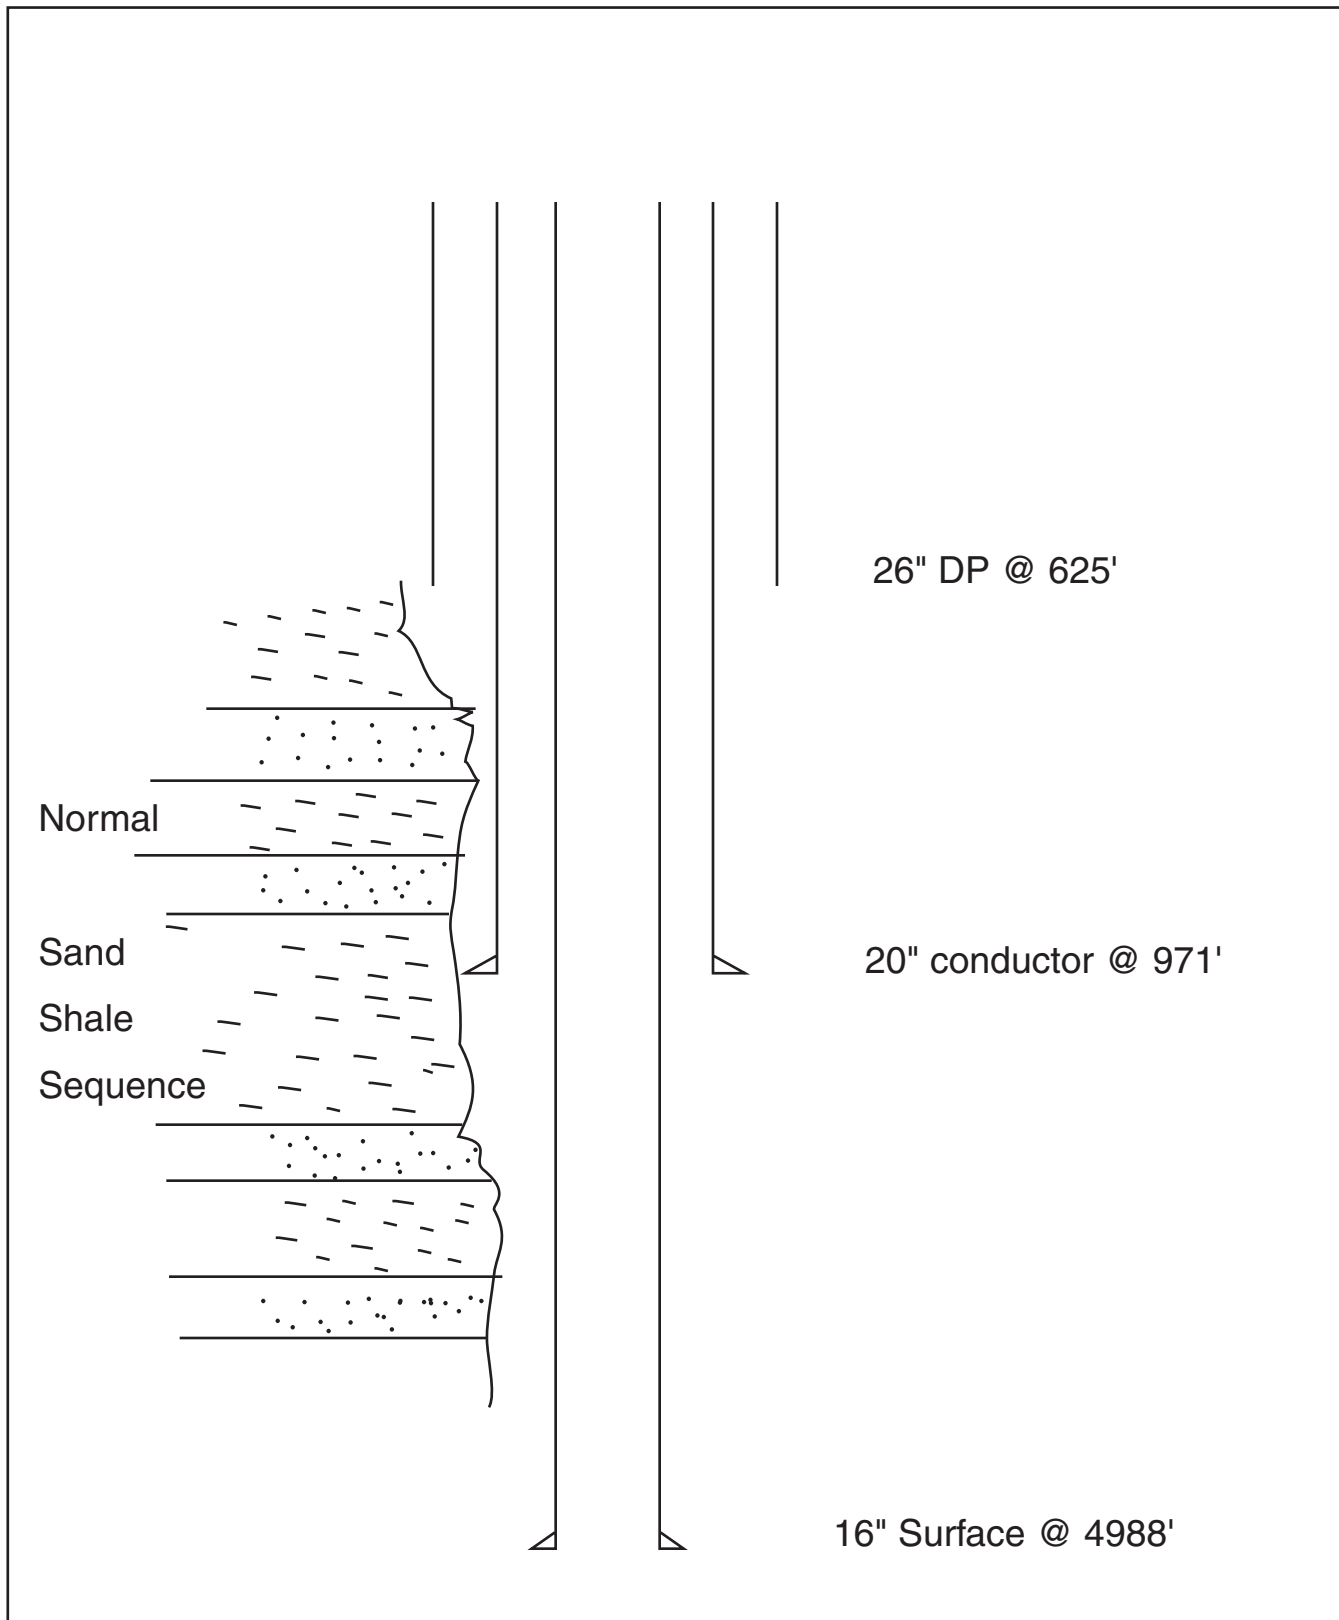
South Timbalier Block 189 CA-7: to surface casing installation

The 2002 well program scheduled the C-7 well first. This well was permitted to be drilled from the Platform to a bottomhole location (BHL) within adjacent Lease OCS-G 1572. The CA-7 was spudded on 3 November 2002 and completed as planned with no abnormal drilling incidents. The casing program for the CA-7 utilized new drive-pipe (the CA-7 was drilled from a pre-existing slot with no previously installed drive-pipe) driven to 626 ft, conductor casing set at about 971 ft, and surface casing set at 4,988 ft (*see attachment 3 for casing plan of CA-7*).

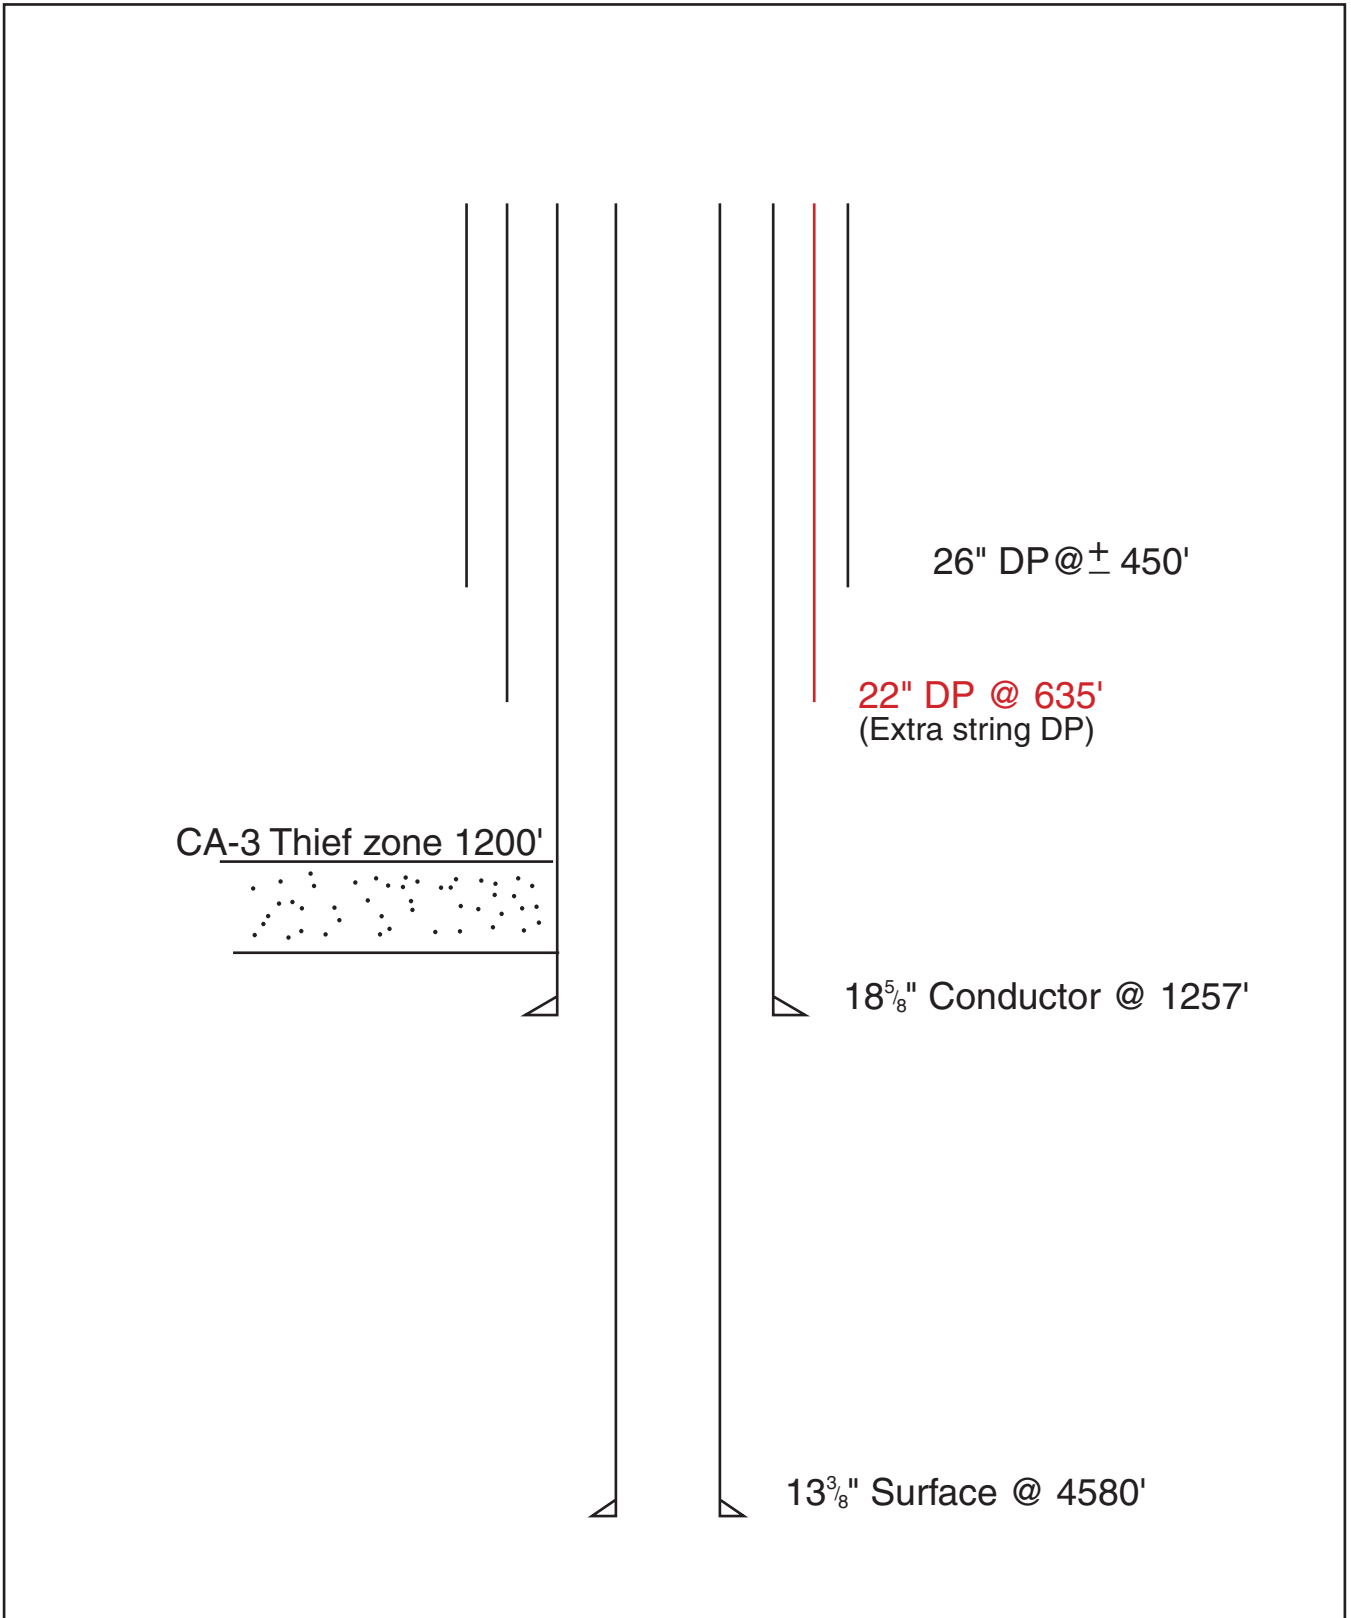
South Timbalier Block 189 CA-4: to surface casing installation

The chronology of events during the drilling of the CA-4, after the completion of the CA-3, indicates that the well did not experience the drilling problems to the extent encountered in the CA-3, though the CA-4 did encounter lost circulation and no returns during cementing of the conductor pipe. However, the design of the CA-4 was significantly different than that of the CA-3. In the CA-4, the Operator drove new drive-pipe 188 ft deeper than that which had been installed for the CA-3. According to testimony, the deeper drive-pipe enabled the Operator to set the conductor casing at 1,331 ft rather than the 931 ft in the CA-3. In the CA-4, after the setting of the conductor casing at 1,331 ft, presumably isolating the primary thief zone encountered at approximately 1,200 ft in the CA-3, the surface hole for the CA-4 was drilled with normal fluid loss and the surface casing was cemented with full returns.
