**Investigation of Loss of Well Control
Eugene Island Block 205, Well No. D-5
OCS 0805
28 May 2005**

Gulf of Mexico
Off the Louisiana Coast

David Dykes – Chair
Jack Williams
Frank Pausina

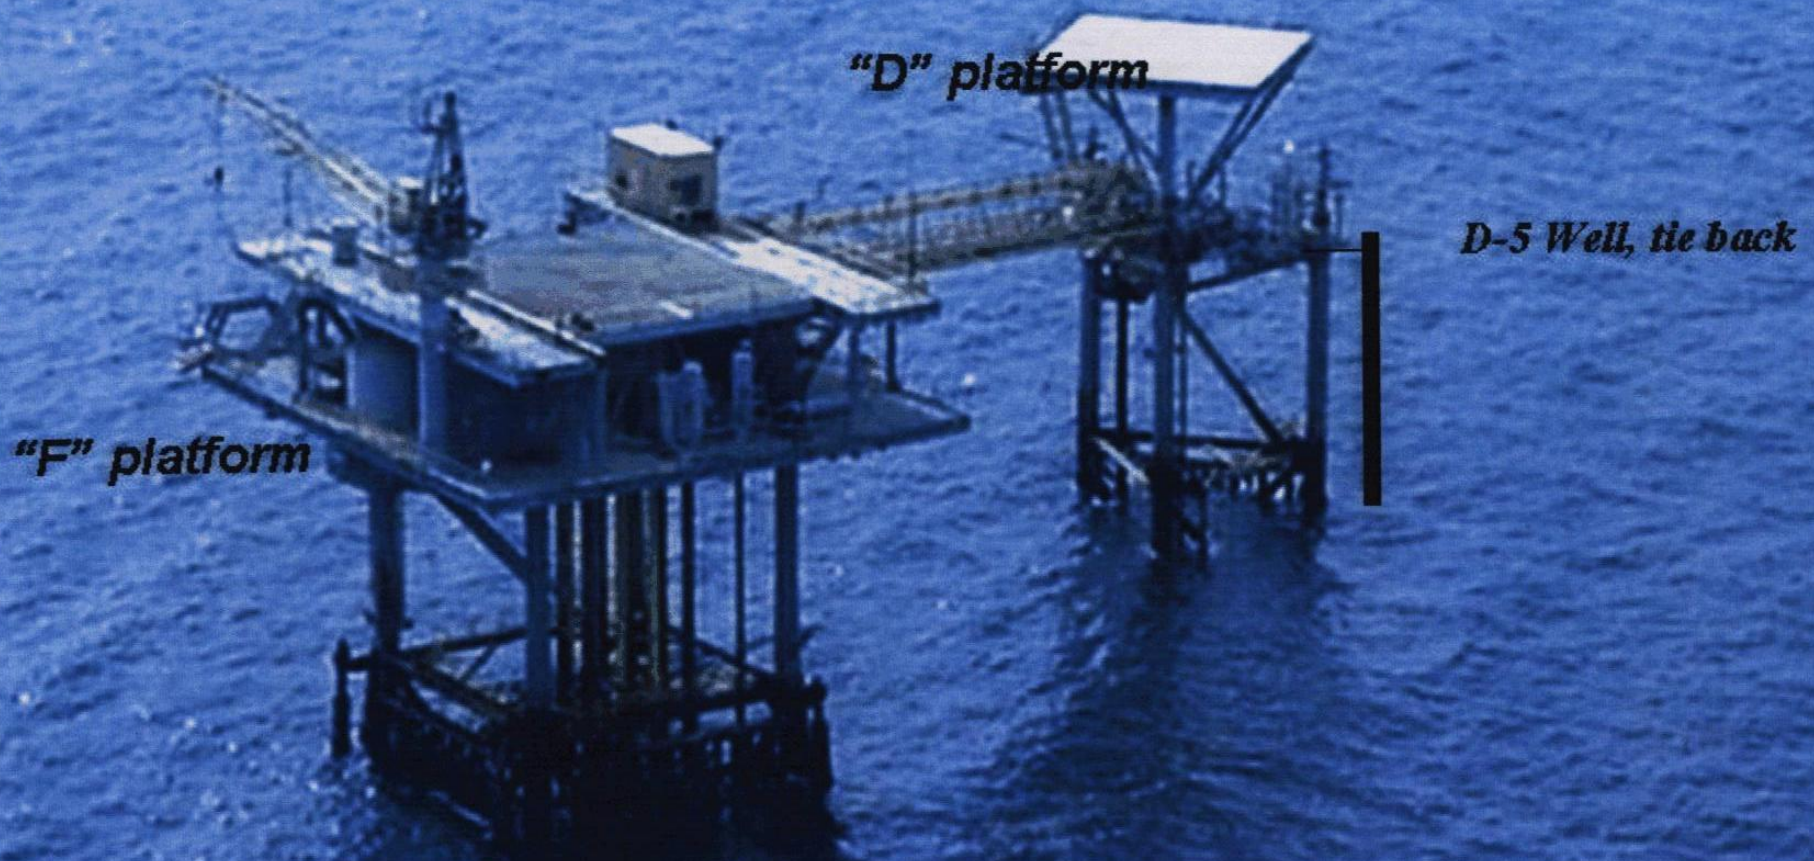
Attachment 2

Within Block 205, two platforms, the “D” and “F,” are set in close proximity, within 80 ft of each other, connected by a bridge (*see Attachment 2*). A total of 13 wells have been drilled from these two platforms to date.

EI-205 "D" and "F" Platforms and Location of Well D-5
