**Investigation of Fatal Accident
V-Door Guide Post Failure
Chandeleur Block 31, Well No. 1
OCS-G 27214
18 July 2006**

**Gulf of Mexico
Off the Louisiana Coast**

Jack Williams – Chair
Tom Perry
David Emilien
Kevin Langlinais

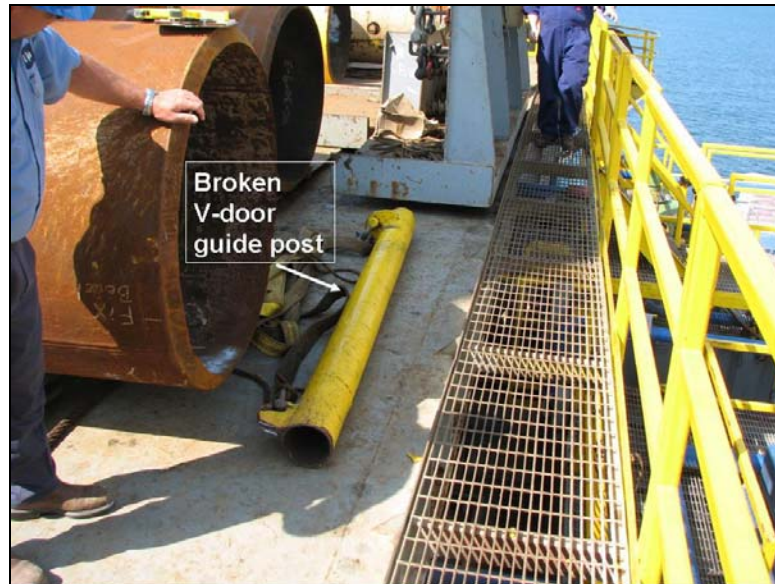
Figure 7: Broken right side V-door guide post

As he checked the tension of the cable, a sound was heard as if the Driller slacked off the brake slightly. Suddenly the V-door post which formed the anchor of the drive pipe rotating assembly broke from the Rig floor. The post (*see figure 7*) was propelled across the floor by the tension held on the rotating assembly, and struck the Floorman in the head and chest.

From examination of the post, it appeared as if the welds failed completely around the pipe circumference (where tack-welded) and around the lip of the lower pad eye. A portion of the pipe itself also seems to have failed. It appeared as if portions of the post were not welded to the Rig floor. Much of the exposed pipe wall thickness was rusted, rough-cut in appearance, and showed no sign of a recent failure. The pipe appeared to have been tack-welded so that only portions of the outside wall were connected to the deck (*see figures 15 and 16*).

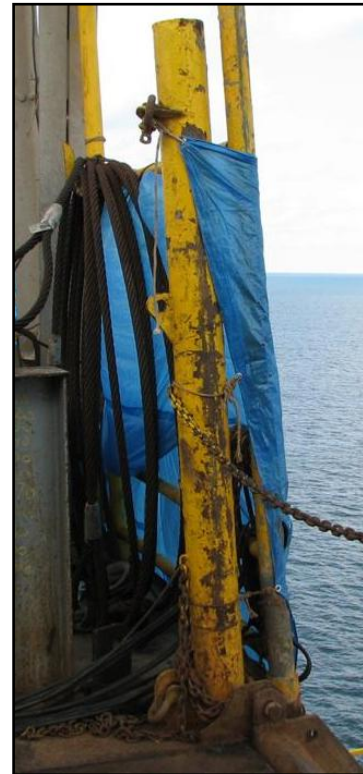
Figure 13: Left V-door guide post

The two V-door posts on the Rig were relatively thin walled 6.5-inch diameter, schedule 80 class B (or C). The posts were 7.2-ft long and were welded directly to the rig floor. Both posts had two relatively large pad eyes attached; one at the top of the post, and another large one on the

base of the posts where it was also welded to the Rig floor (*see figure 13*). The left hand V-door guide post also had additional smaller pad eyes welded in the middle of the post.

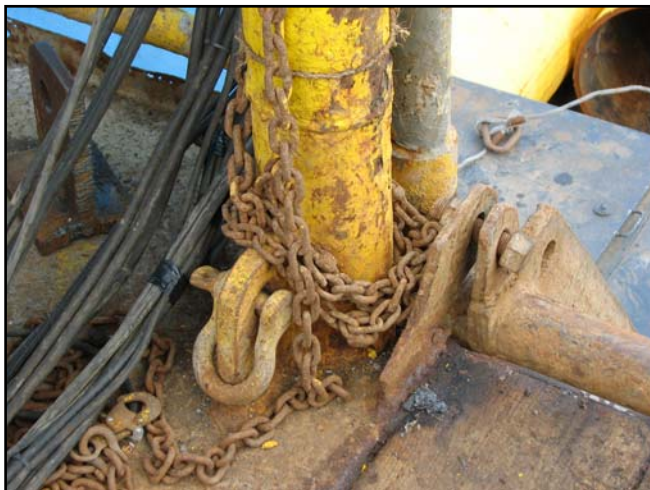
Figure 14: Base, left V-door guide post

Both of the guide posts had shackles attached to the pad eyes. The left post also had a large chain wrapped around the base of the post. The chain seemed to be stored in that manner to be available for future use. Both posts were originally painted yellow. However, both were heavily scarred from use with many dents, scrapes, and dings that revealed raw and-or heavily rusted unpainted metal. The posts also showed evidence of having been frequently cut off and re-welded into place. This was indicated by the multiple re-weld seams at the base of both posts (*see figure 14*).

Both V-door guide posts were attached to the rig floor in what appeared to be a temporary manner. They appeared to be simply “tack-welded” to the floor, and neither appeared to be welded using a bead that went completely around the circumference of the pipe and pad eye. Neither post seemed to be welded in a manner that attached the full pipe wall thickness to the Rig floor.
