M/V WAVE WALKER Coral Reef Restoration Baseline Monitoring Report – 2004 Florida Keys National Marine Sanctuary Monroe County, Florida

Erik C. Franklin J. Harold Hudson Jeff Anderson

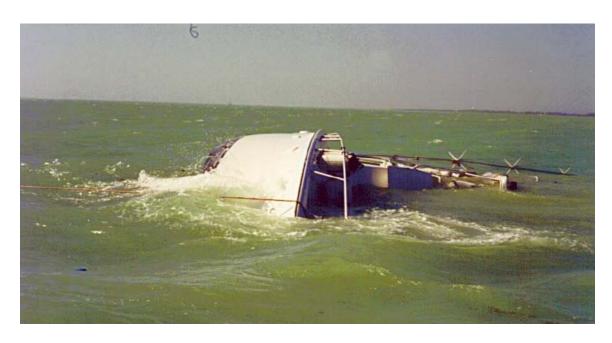
The Wave Walker, a 52-foot motor vessel, struck and damaged a large coral colony at "The Rocks," a patch reef offshore of Plantation Key, Florida, on January 19, 2001 (Figure 1). The vessel suffered significant hull damage and sunk as a result of the grounding (Figure 2). The Rocks are a cluster of sizeable Montastrea annularis colonies located 1 nautical mile inshore of the much more highly developed "Hen and Chickens" reef. Typical for large specimens of this species, the injured colony displayed a "volcanolike" shape, in which the top central area was mostly dead and sunken due to bioerosion, with a crown of living tissue encircling the rim of the depression. When the hull and running gear of the vessel struck the colony, much of the live tissue along the colony rim was broken into relatively large pieces. These pieces sheared off and landed either in the colony's central depression or on the surrounding substrate. Additionally, a large (1.5 m²) portion of the colony's sidewall was broken off, exposing the interior framework (Figure 3). In total, 10 m² of coral cover was lost as result of this grounding incident.

Figure 2. The remains of the M/V *Wave Walker* following damage suffered from grounding on a large coral colony offshore of Plantation Key.

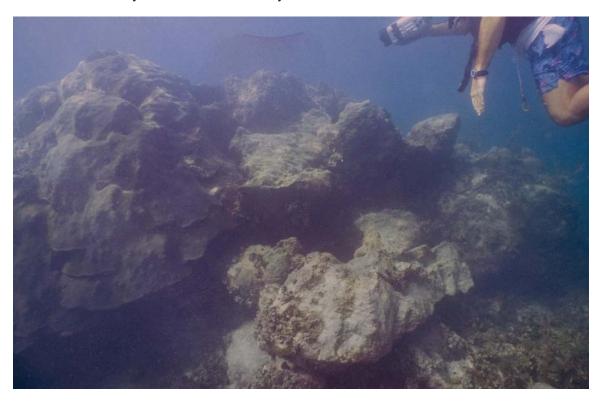
Figure 3. Dislodged portion of the colony sidewall of a *Montastrea annularis* damaged by the grounding of the M/V *Wave Walker*. Photo view is towards the northwest.

The objectives of the M/V Wave Walker site restoration were to 1) repair the sidewall and rim of the injured coral colony (Figure 3), and 2) reattach dislodged live coral fragments on the colony's skirt and in an adjacent "reef crown" restoration module. To accomplish these objectives, the damaged rim and sidewall of the colony were stabilized with a layer of 50/50 Portland cement and silica sand grout anchored to the framework with concrete nails. Three large, broken sections of coral were also reattached to the flank of the damaged colony with cement grout. Additional coral fragments were cemented into a reef crown placed on the seafloor approximately 2 meters from the restored colony. The reef crown was a 1.2 m diameter, cylindrical structure created with Portland type II cement, sand, limestone rock aggregate, and boulders and anchored to the substrate with iron reinforcing rods. Short-length (15cm) fiberglass reinforcing rods were used to ensure structural integrity of cement layers with modules. Restoration activities were completed on March 22, 2002.

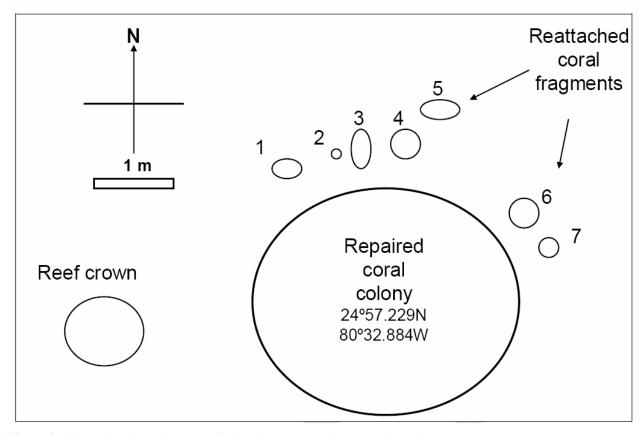
The stability and surface of the coral colony repair and restoration module were found to be visually and tactilely sound (Table 2). The colony cement grout cap and module were found in place with a stable attachment to the substrate and no visible cracks in the cement surface. There was no noticeable physical damage to the reattached coral fragments. The location of the fragments and reef crown were mapped in relation to the repaired coral colony (Figure 4).

Figure 4. Schematic planar view map of the M/V *Wave Walker* restoration site.

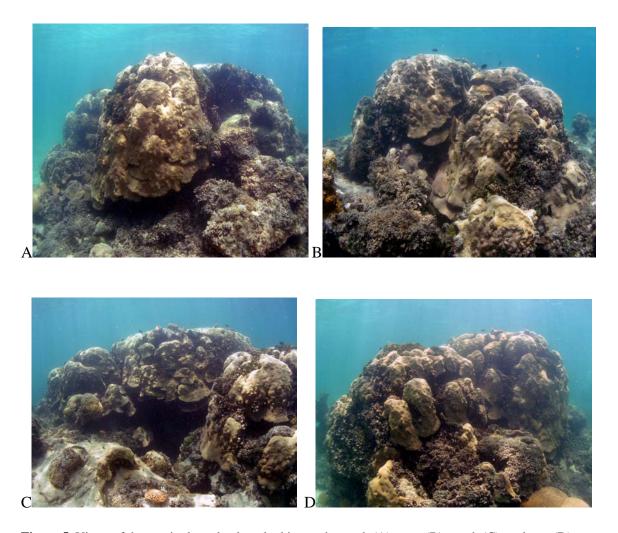
The *Wave Walker* restoration site was composed of a large (> 2 m diameter) repaired colony of *Montastrea annularis* (Figure 5) with adjacent reattached coral fragments and an installed reef crown. Reattached coral species included *Colpophyllia natans*, *Diploria labyrinthiformis*, *Montastrea annularis*, and *Porites astreoides* (Table 2). The site and surrounding habitat were defined as a cluster patch reef as described by Ginsburg and colleagues (2001). Live coral tissue was observed on the seven reattached fragments (see photos in Appendix) and five colonies within the reef crown (Figure 6). The tissues of several corals in the surrounding area and one of the reattached colonies (colony #1) were pale or bleached (Figures 7 & 8), but there was no way to determine if these observations were related to restoration activities. In general, the color of the corals appeared "pale" but it was uncertain if this was a common condition for the corals of this patch reef. An estimate of coral cover of the repaired colony was 68%. Coral cover on two nearby, similarly-sized colonies of *M. annularis* were 85% and 67%. The area of the plastic that outlined the cement colony top was 2.66 m² (Figure 9).

Figure 5. Views of the repaired coral colony looking to the north (A), west (B), south (C), and east (D).

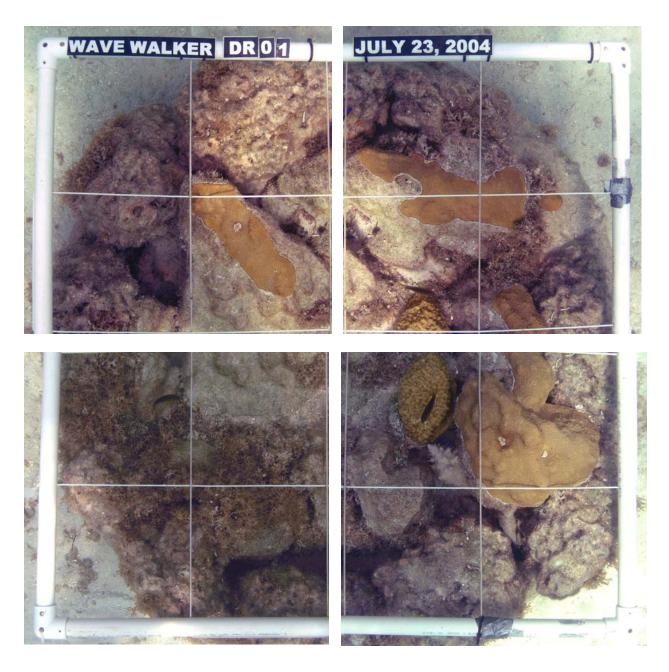
Figure 6. Photo mosaic of reattached corals in the reef crown installed adjacent to the repaired coral colony. For the photos, the reef crown was overlain with a 1 m 2 quadrat. The smaller squares are 1/16 m 2 .

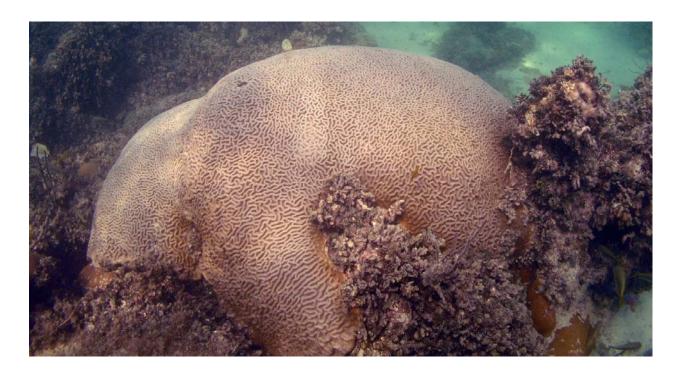
Figure 7. A large (> 1 m diameter) colony of *Colpophyllia natans* that exhibited signs of coral bleaching at "The Rocks" patch reef on July 23, 2004. This colony and several others adjacent to the restoration site were observed in various states of bleaching.

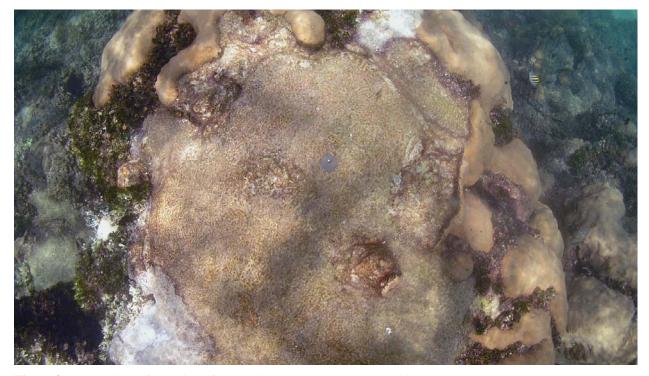
Figure 8. Planar view of a section of the repaired coral colony damaged by the Wave Walker.

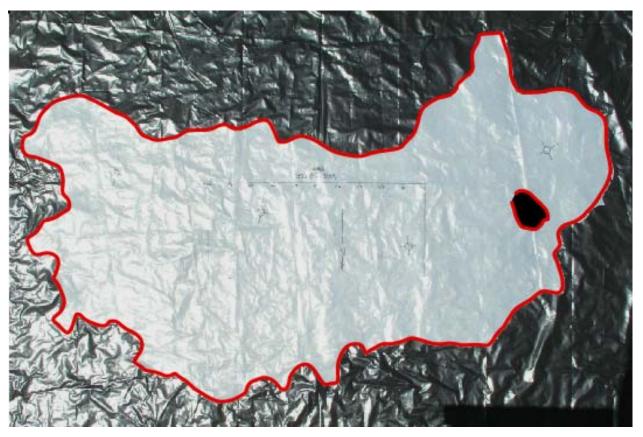
Figure 9. Outline (in red) of the plastic sheet cut to delineate the interface of the concrete surface and live coral tissue along the rim of the coral colony.

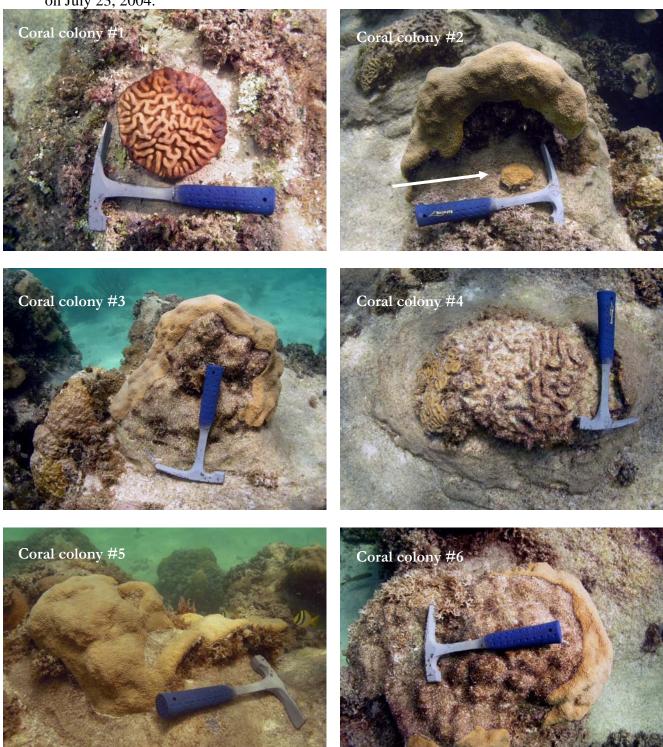
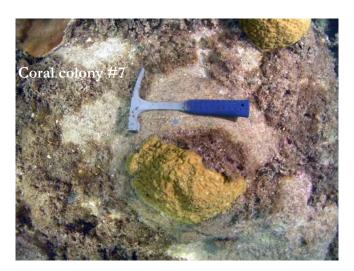
Photographs of coral fragments reattached at the M/V Wave Walker grounding site taken

on July 23, 2004.
