National Transportation Safety Board

Railroad Accident Brief

Accident No.:	DCA-05-FR-002
Location:	Pico Rivera, California
Date:	October 16, 2004
Time:	9:40 a.m. ¹
Railroad:	Union Pacific Railroad
Property Damage:	\$2.7 million
Injuries:	None
Fatalities:	None
Type of Accident:	Derailment

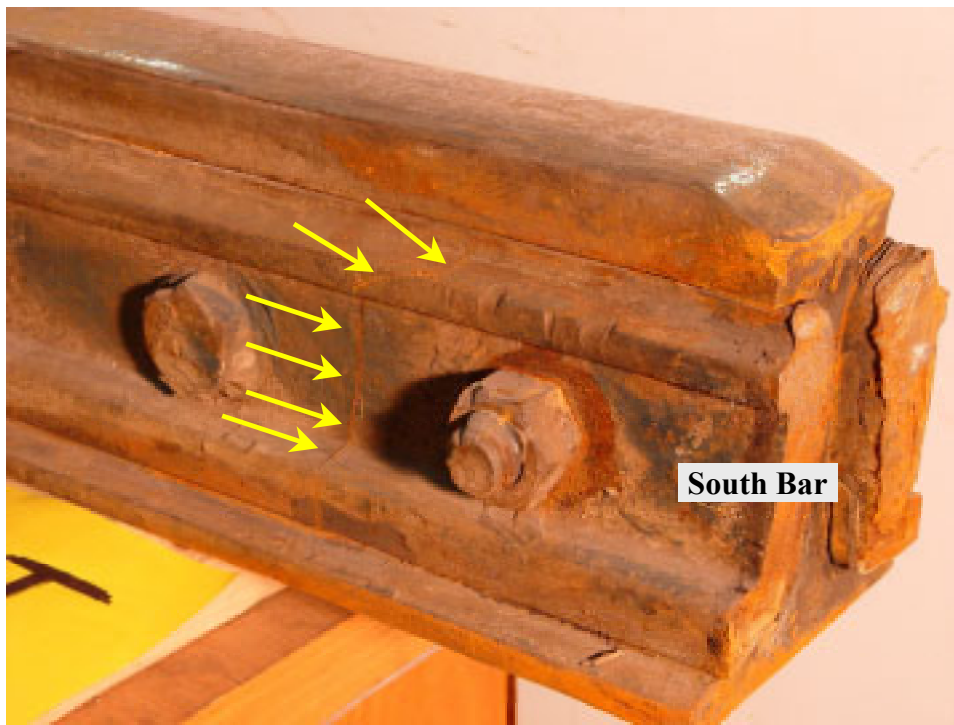
The Materials Laboratory report⁶ on the examination of the joint pieces is in the Safety Board's public docket. The evidence indicates that there were slowly growing fatigue cracks in both joint bars and that at least part of each fatigue crack had been visible on the lower outer portion of the bar for some time before failure. (See figures 1 and 2.)

Figure 1. West rail portion showing the fractured ends of the joint bars, a fracture between the first two bolt holes of the south joint bar, and rail batter.

The initial cracking in the south joint bar was between the first and second bolt holes from the center of the joint and was associated with an indentation in the bottom outside corner of the bar. The metallographic evaluation of the deformation could not determine whether the damage had occurred while the joint bar was being manufactured or at a later time.

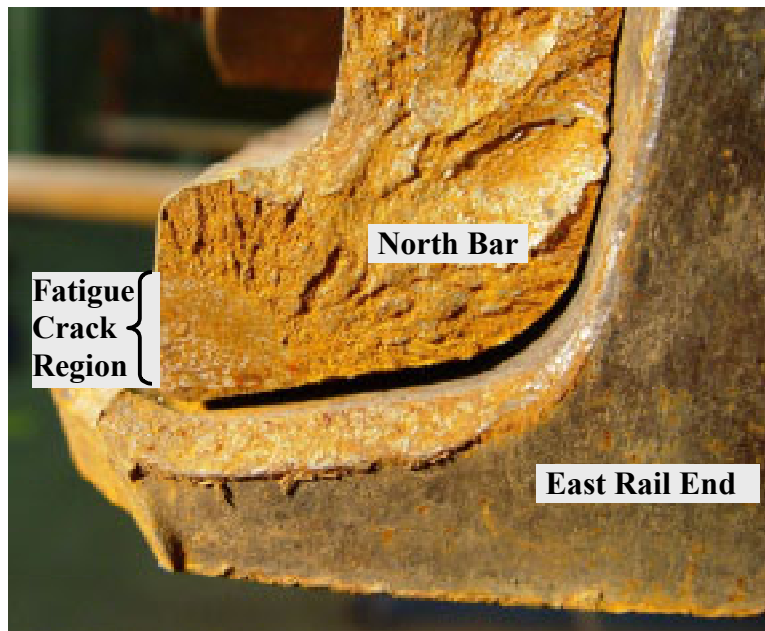
Figure 2. East rail portion showing the fractured end base of the north joint bar.

The epoxy bead along the top of the joint bars was missing from the center sections of the bars, indicating that the joint was older and was experiencing relative movement between the rail head and the bars. The joint bars were still securely bonded at the ends, indicating that the joint bars were not moving laterally, but were bending cyclically in the middle under the weight of passing trains.
