# Highway Concrete Pavement Technology Development and Testing: Volume V— Field Evaluation of Strategic Highway Research Program (SHRP) C-206 Test Sites (Bridge Deck Overlays)

PUBLICATION NO. FHWA-RD-02-086

AUGUST 2006

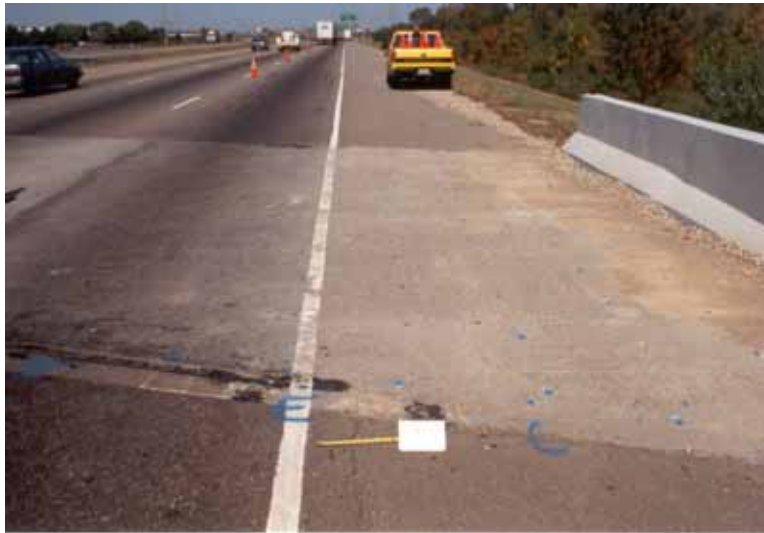
**Figure 2. Photograph showing test section on I-270 northbound (1995).**

The test sections studied on both spans include the shoulder and travel (outside) lanes. Examination of the deck overlay surface indicated several narrow longitudinal cracks in the shoulder lanes of both bridges. Cracks were more frequent in the travel lanes. The travel lane of the northbound SFC bridge had mostly single nonconnected cracks running in both the longitudinal and transverse directions with very little branching. The travel lane of the southbound LMC bridge had more and longer longitudinal cracks and also more branching of cracks.

Severe cracking and spalling was noted in the exposed travel surfaces of the abutments of the northbound SFC structure. The overlay at the approach joint was spalled away and had been patched with a soft tar-like material. The joint between the bridge and the abutment on the leave side of the bridge was irregular, with a separate one-foot wide closure pour placed between the deck and the abutment. The joint between the closure pour and the abutment was well-sealed, but the formed joint between the deck and the closure pour was open and packed with debris.

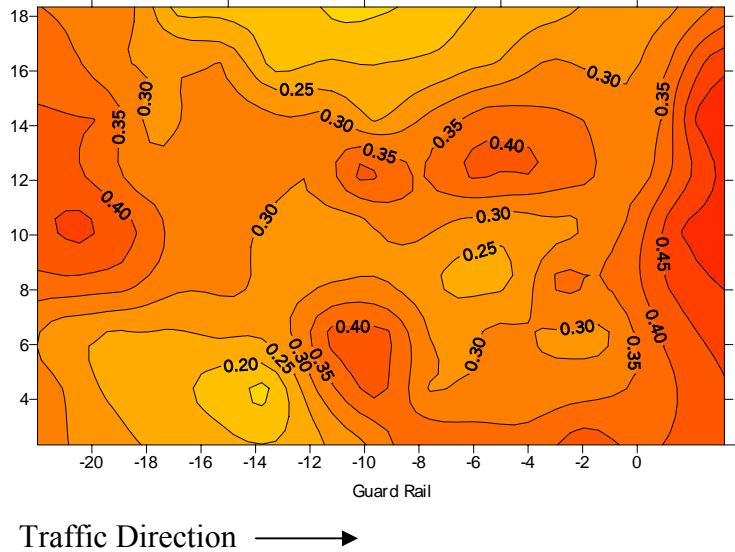
An equipotential map for the northbound SFC test section in 1997 is shown in figure 5. The most negative potentials were seen at the ends of the bridge and near the cracked delaminations. No area of more negative potentials was associated with the longitudinal construction joint. Approximately three-quarters of the readings were more negative than -250 mV, indicating that corrosion is likely occurring over most of the deck. The alignment of the areas of rapid potential changes with the edges of the bridge and the cracked delaminations indicate that the overlay is not providing sufficient protection from water and waterborne chlorides in these locations.

**Figure 5. Equipotential map of half-cell potentials for I-270 NB (silica fume-modified concrete).**

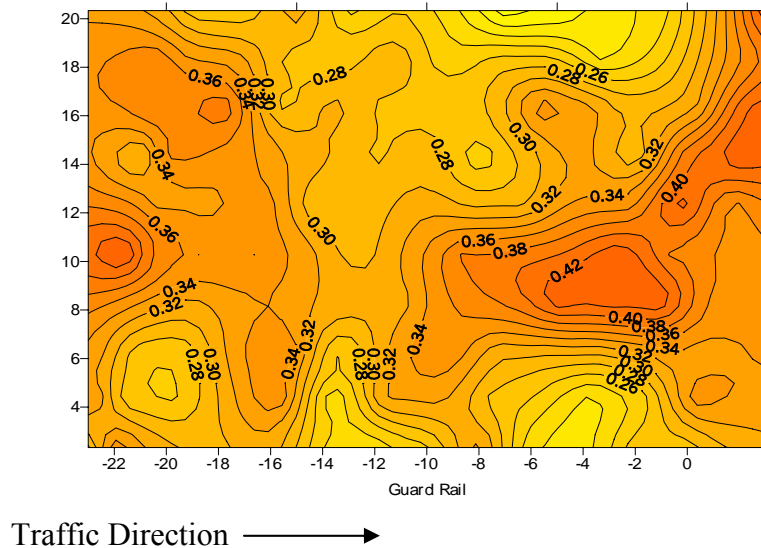
An equipotential map of the half-cell data for the I-270 southbound test section in 1997 is shown in figure 7. The most negative potentials were seen in the areas of the construction joint, the ends of the bridge, and near cracked delaminations. The majority of the readings were more negative than -250 mV. Also, indicative of corrosion in the structure are the relatively large differences in potential across the area surveyed, as indicated by the closely spaced lines on the contour plot. The most negative potentials along the edges of the bridge, the construction joint, and the cracked delamination indicate that the overlay is not providing sufficient protection from water and waterborne chlorides in these locations.

**Figure 7. Equipotential map of half-cell potentials for I-270 southbound (latex-modified concrete).**

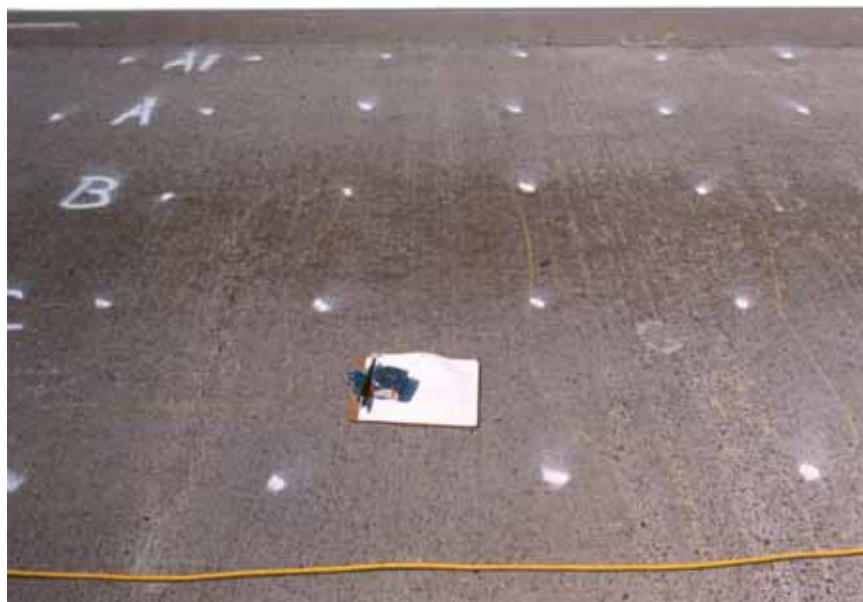
Inspection of the deck surface of the northbound LMC structure indicated the performance of the three spans was quite different, with Spans 1 and 3 exhibiting heavy transverse and longitudinal cracking and Span 2 exhibiting hardly any cracking. Figure 25 shows typical cracking on the northbound deck. Over the last two years of the study the cracking became worse. Several cracks had lengthened or were becoming interconnected with other cracks. The surface of all three spans in the driving lane was heavily abraded compared to that of the passing lane.

**Figure 25. Photograph showing typical cracking found in the northbound deck of the U.S. 41 test section LMC.**

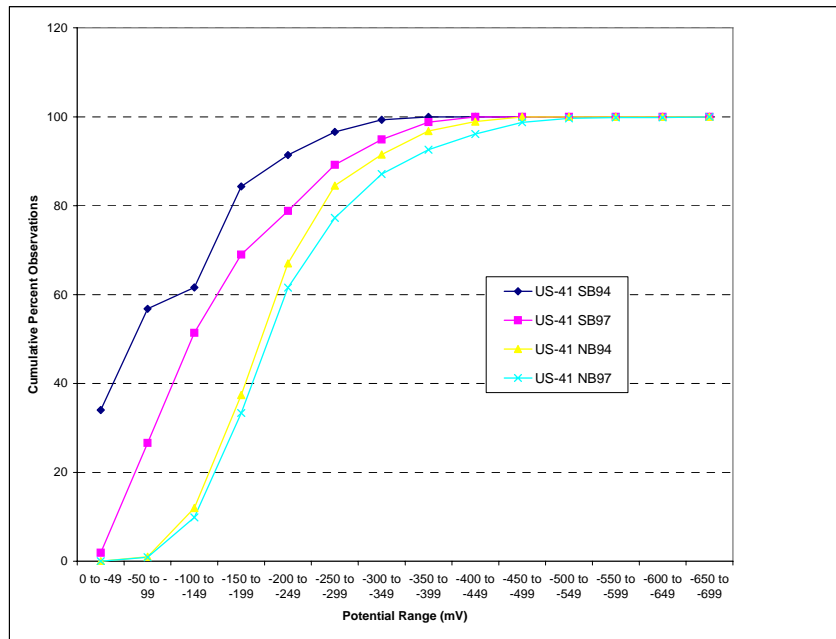
A cumulative frequency diagram for both test sections of U.S. 41 is shown in figure 33. The figure shows the shift to the right for both test sections. The shift in the curve for the southbound SFC spans is much greater than that for the northbound spans LMC. However, the northbound spans LMC had more negative values both initially and at the end of the study than the southbound SFC spans. An equipotential map of the half-cell readings for the southbound spans SFC of U.S. 41 is shown in figure 34. The figure for Span 1 indicates there is corrosion occurring along the edge between the travel and passing lane and at the two ends of the span. The figures for Span 2 and Span 3 indicate corrosion is occurring in isolated areas and also at the ends of the spans. An equipotential map for the half-cell readings for the northbound spans LMC is shown in figure 35. The maps for Span 1 and Span 3 indicate corrosion occurring over much of both spans and especially along the edge between the travel and passing lanes. The map for Span 2 indicates isolated areas of corrosion but most areas are at the ends of the span.

**Figure 33. Cumulative frequency diagram for U.S. 41 (NB and SB) for years 1994 and 1997.**
