The October 17, 1989, Loma Prieta, California, Earthquake—Selected Photographs

by By J.K. Nakata, C.E. Meyer, H.G. Wilshire, J.C. Tinsley, W.S. Updegrove,
D.M. Peterson, S.D. Ellen, R.A. Haugerud, R.J. McLaughlin, G.R. Fisher, *and*
M.F. Diggles

Photographs and descriptions to accompany
Digital Data Series DDS-29
Version 1.2
1999

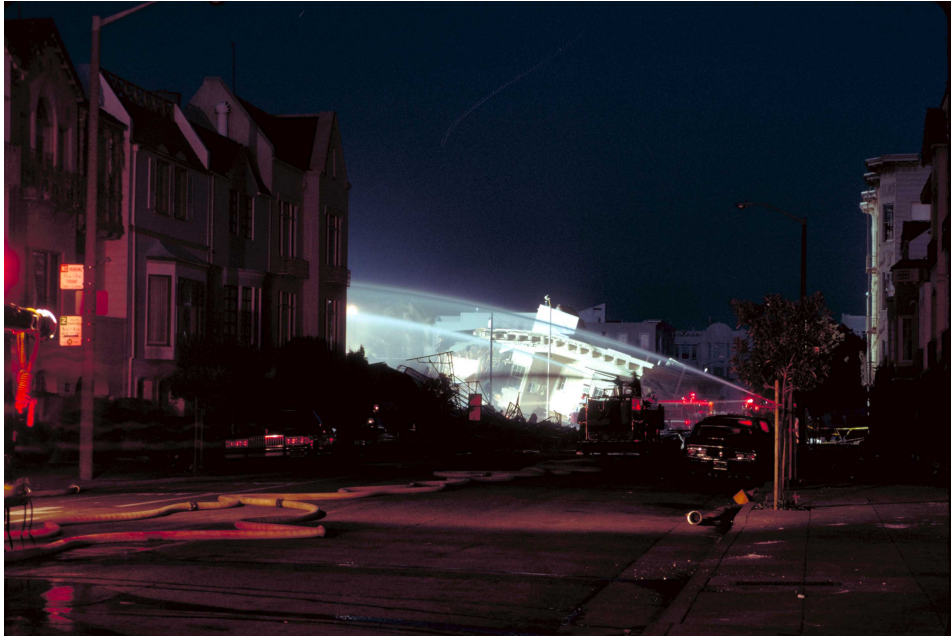
5. Demolition of collapsed building and watering down of burned area, October 18, 1989, Beach and Divisadero Streets, *Marina District*. [C.E. Meyer, U.S. Geological Survey]

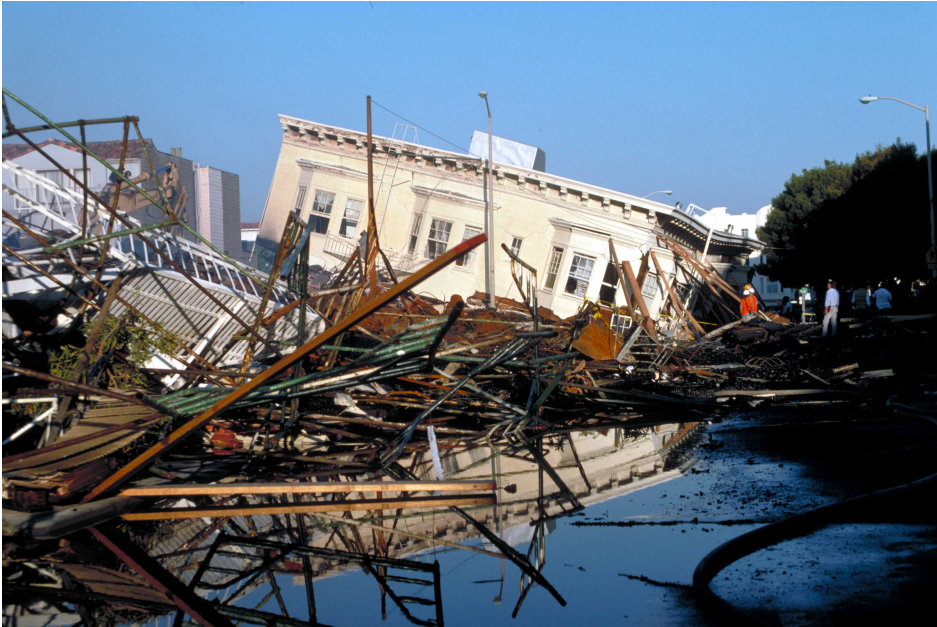
6. Ground view of collapsed building and burned area shown in photot 3, Beach and Divisadero Streets, *Marina District*. [C.E. Meyer, U.S. Geological Survey]

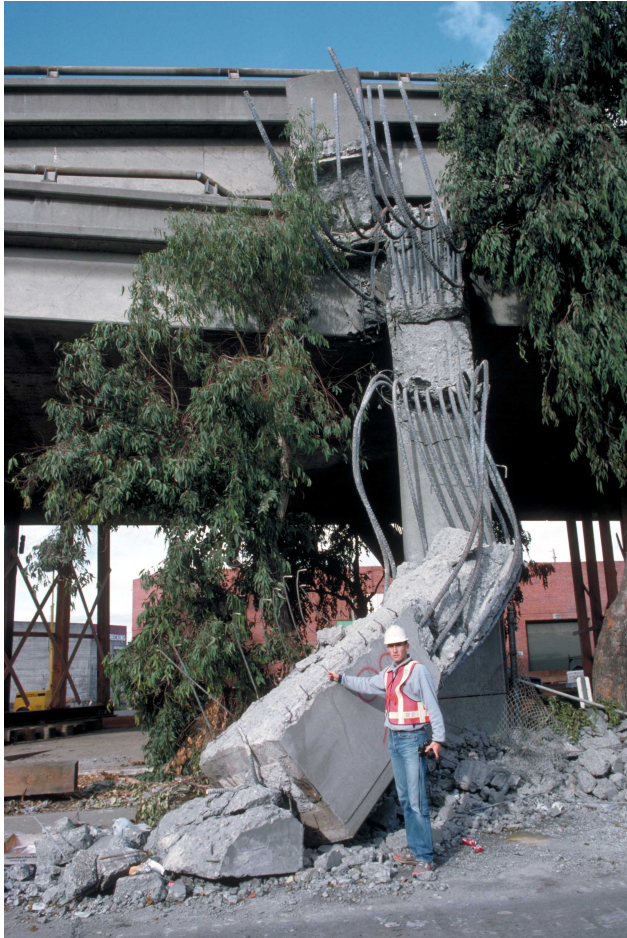
23. Support-column failure and collapsed upper deck, Cypress viaduct. [H.G. Wilshire, U.S. Geological Survey]

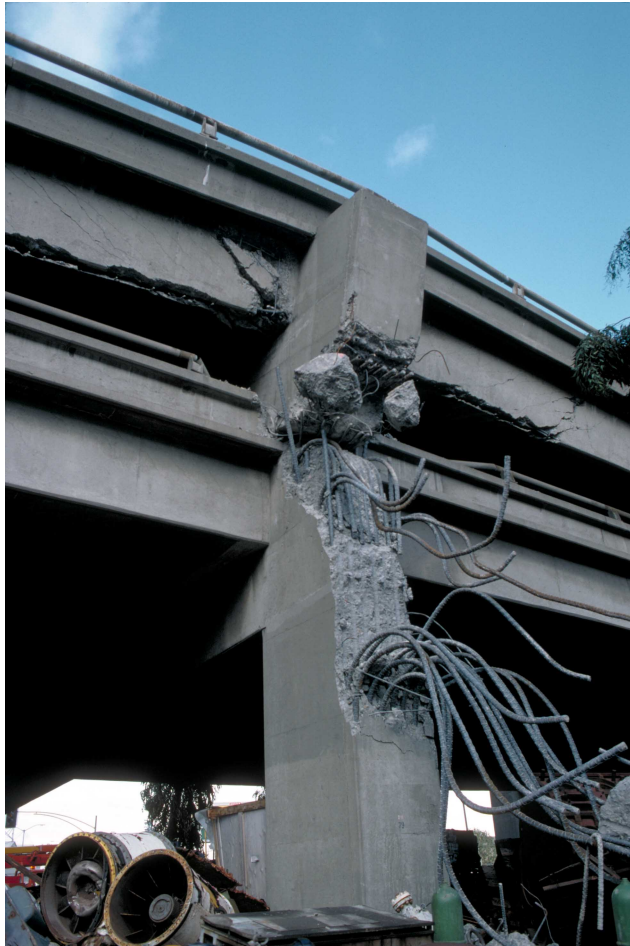
24. Bent reinforcement bars in failed support column, Cypress viaduct. [H.G. Wilshire, U.S. Geological Survey]

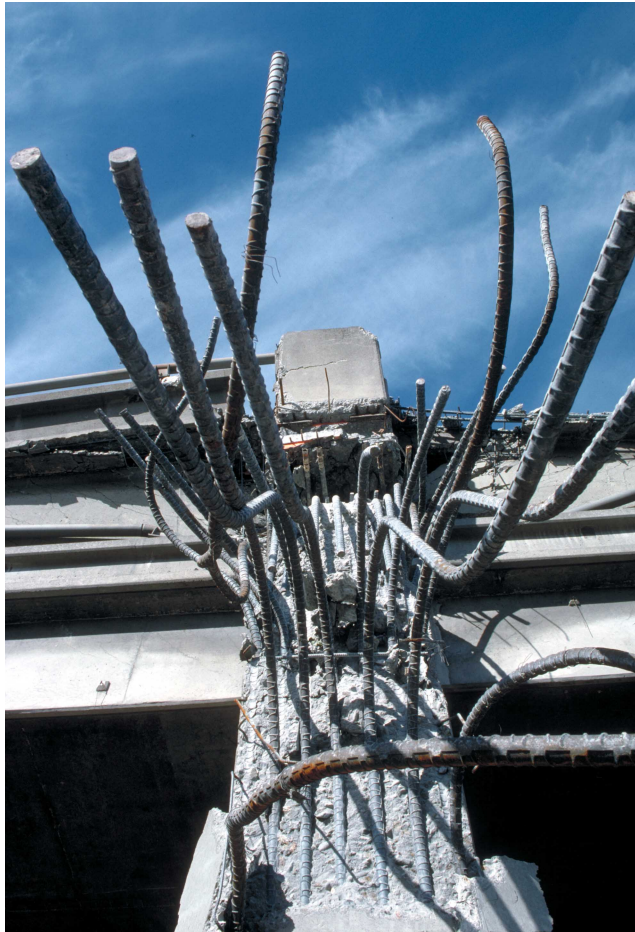
25. Closeup of damaged reinforcement bars from a Cypress viaduct support column.
[H.G. Wilshire, U.S. Geological Survey]

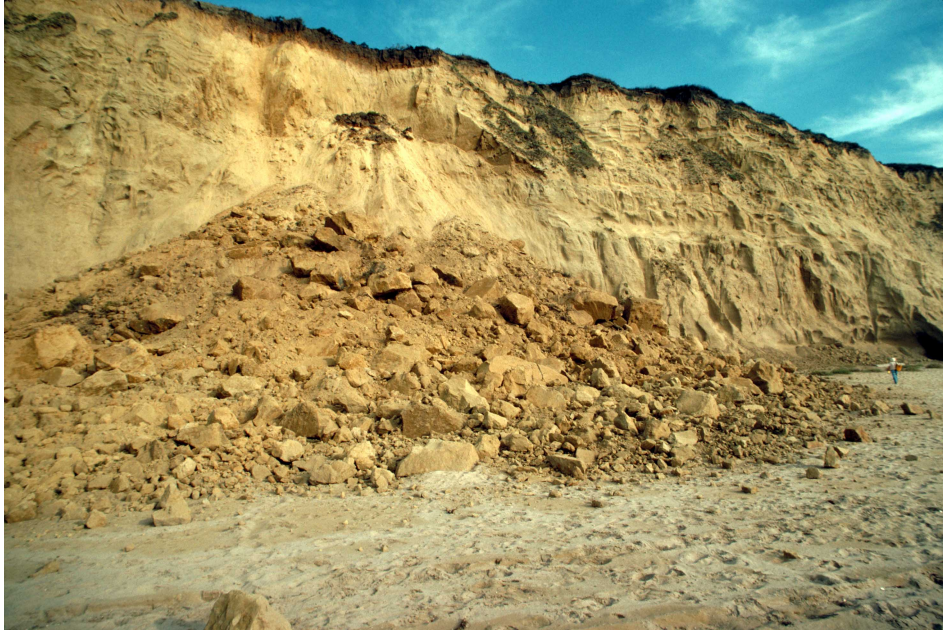
31. Cliff failure just south of San Gregorio Beach. Slide is 18.3 meters (60 ft) high and displaces approximately 6881 cubic meters (9,000 cubic yards) of material. Large boulders are 1 m (3 ft) across. [D.M. Peterson, U.S. Geological Survey]

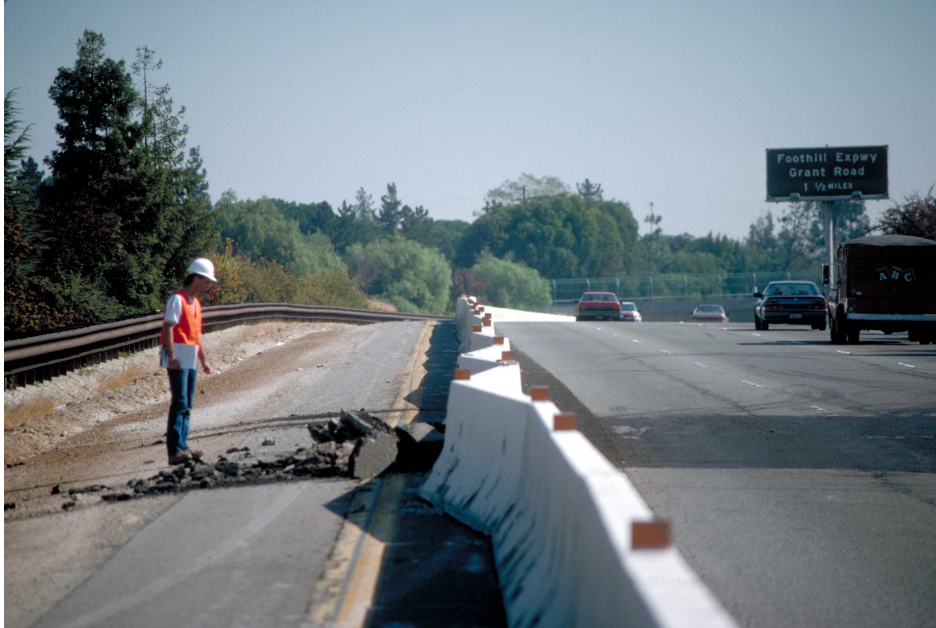
45. The cement retaining walls along Highway 280 deformed in accordion-like pattern as a result of lateral compression. [J.K. Nakata, U.S. Geological Survey]

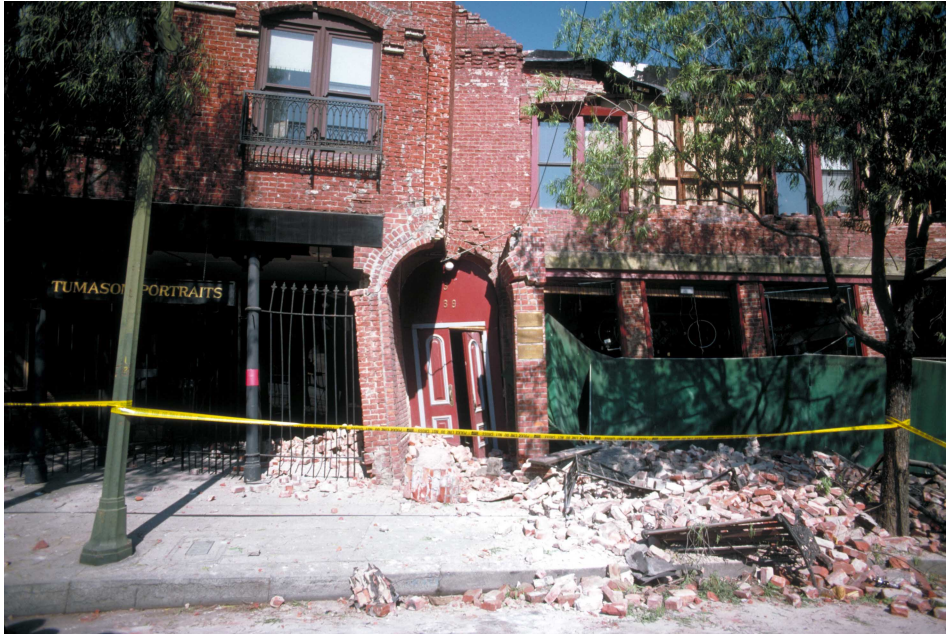
46. Failure of unreinforced brick masonry caused collapse of the upper floor in downtown Los Gatos. [J.K. Nakata, U.S. Geological Survey]

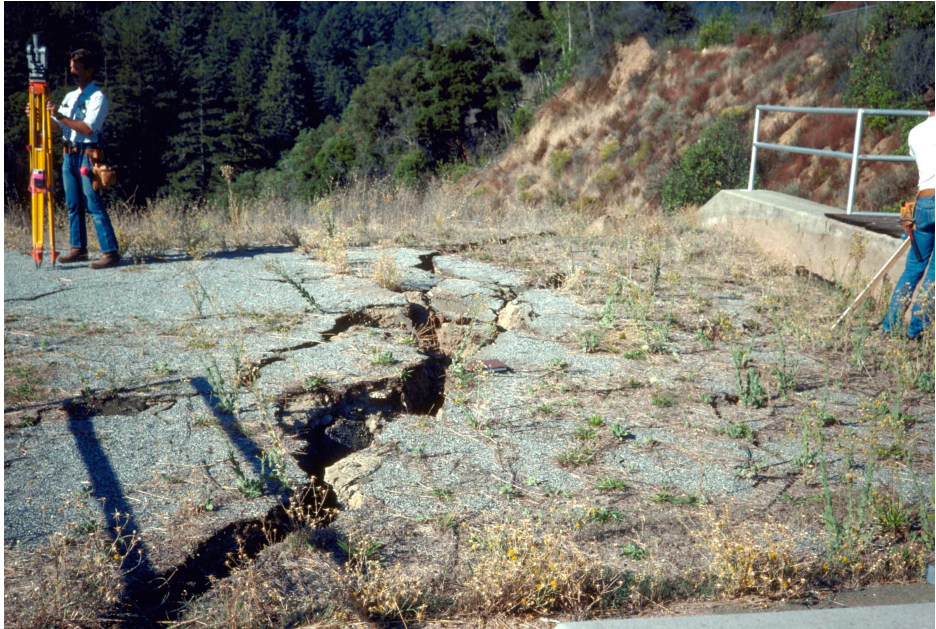
58. Northwest-trending extensional crack where dam fill settled about 0.6 m (2 ft) and pulled away from concrete spillway and north abutment of Austrian Dam. [R.J. McLaughlin, U.S. Geological Survey]

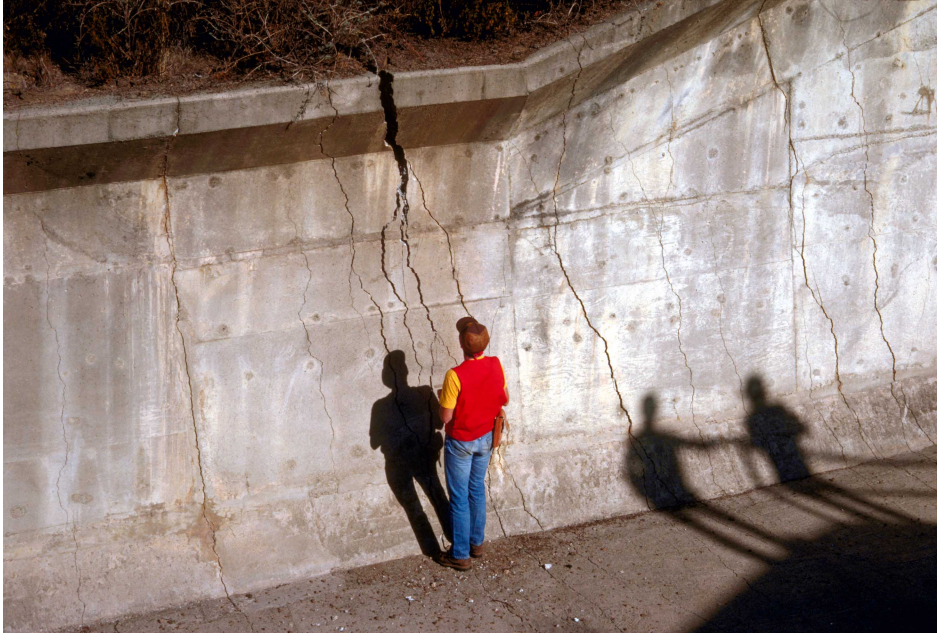
59. Prominent N. 15^o W.-trending extensional cracks up to 12 cm (4.7 in.) wide in concrete spillway to Austrian Dam, north abutment. [G.R. Fisher, U.S. Geological Survey]

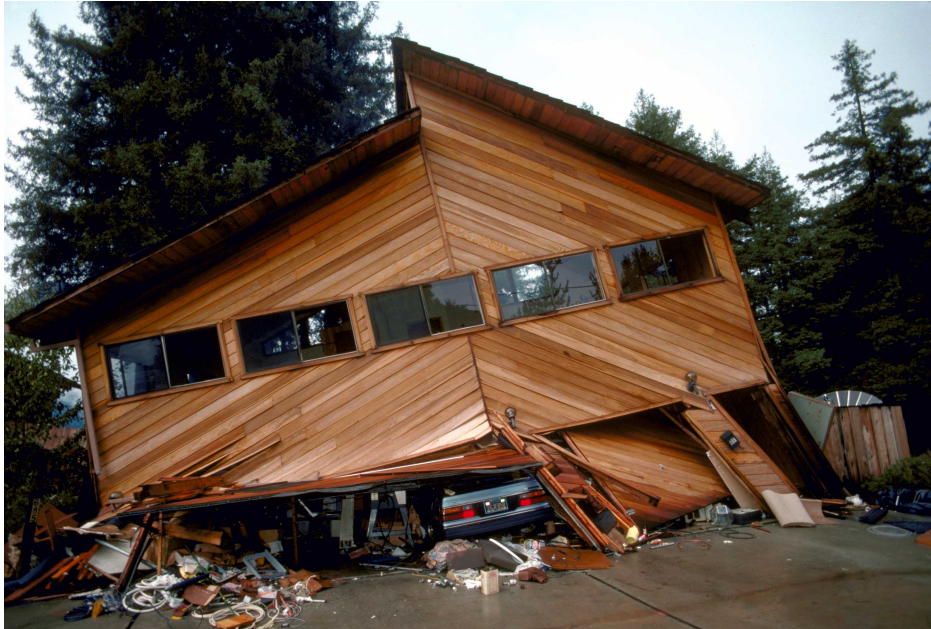
65. Construction on fill and the absence of adequate shear walls contributed to the failure of this structure. [J.K. Nakata, U.S. Geological Survey]

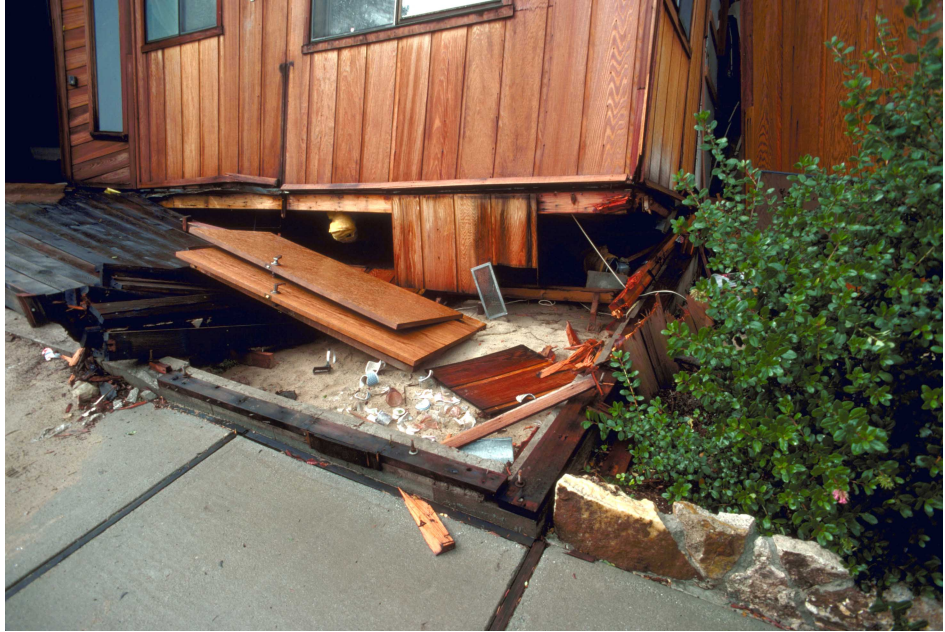
66. House torn off its foundation by the main shock. [J.K. Nakata, U.S. Geological Survey]

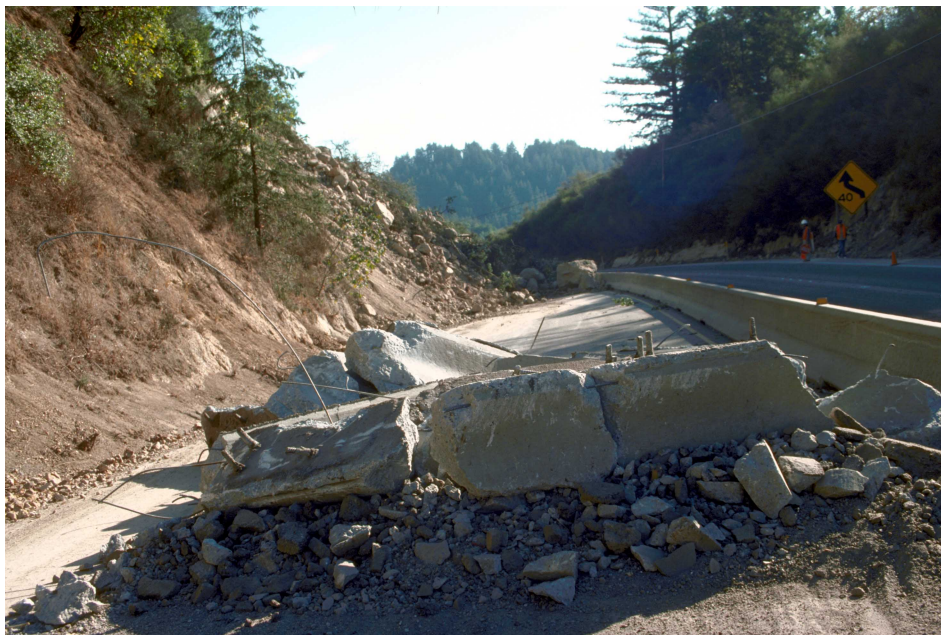
68. Landslide debris blocks both eastbound lanes of Highway 17 near Summit Road. Foreground material is damaged lane separators. [C.E. Meyer, U.S. Geological Survey]

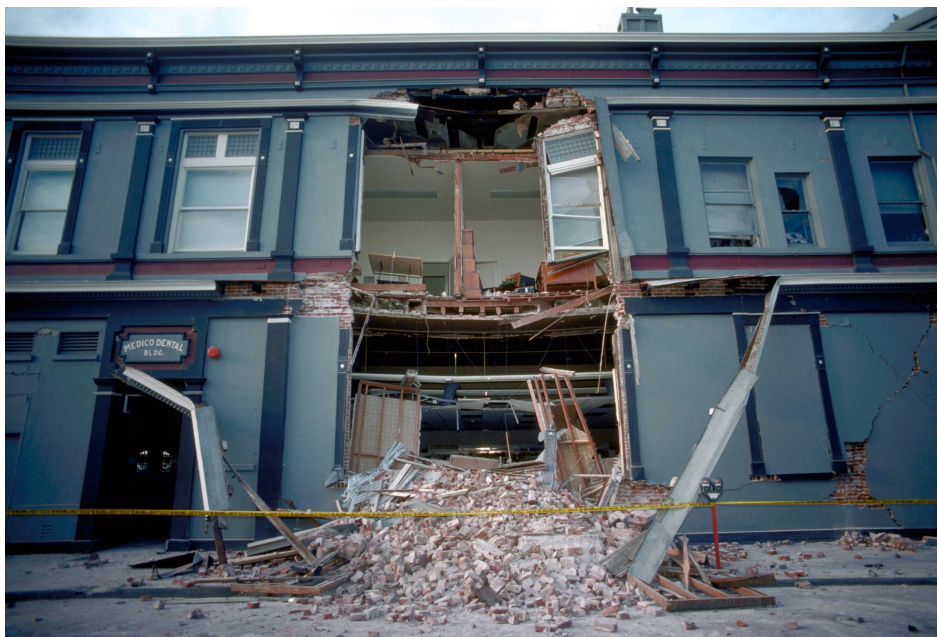
80. Collapsed outer wall of the *Medico Dental Building*, Pacific Garden Mall. [J.K. Nakata, U.S. Geological Survey]

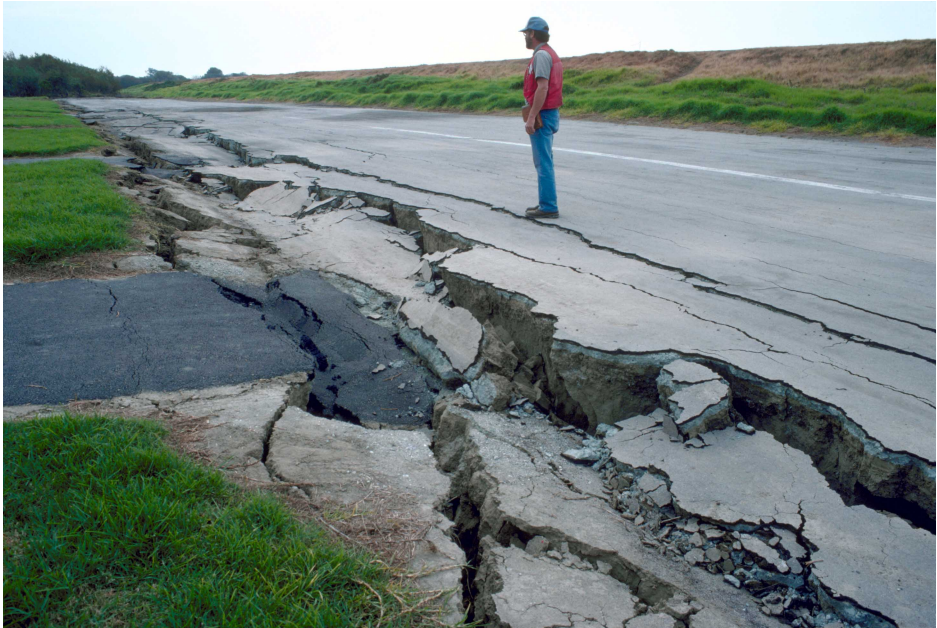
87. Ground shaking triggered liquefaction in a subsurface layer of sand, producing differential lateral and vertical movement in a overlying carapace of unliquified sand and silt, which moved from right to left toward the Pajaro River. This mode of ground failure, termed “lateral spreading,” is a principal cause of liquefaction-related earthquake damage. [S.D. Ellen, U.S. Geological Survey]

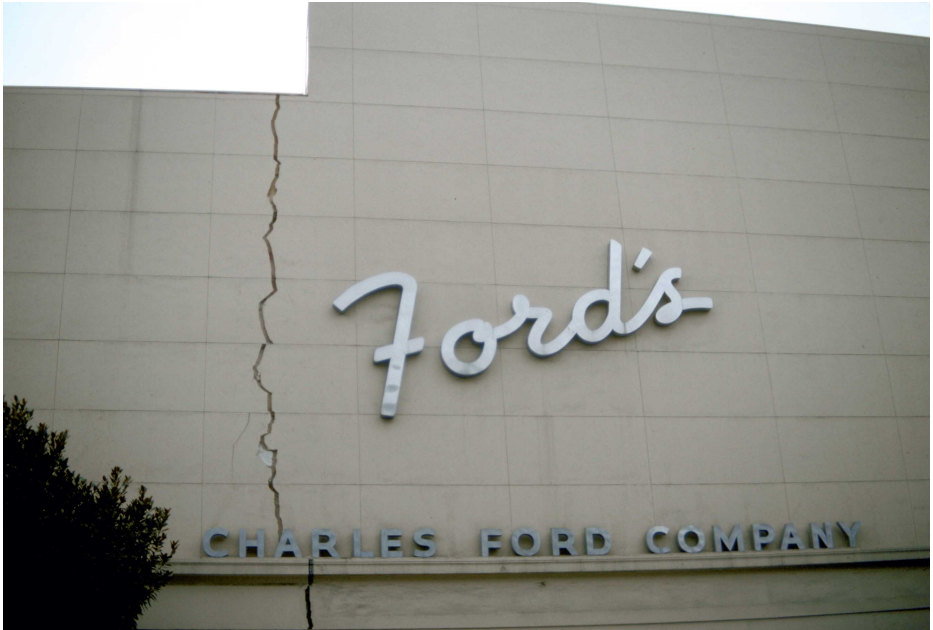
88. Crack down front of Ford's Department Store, downtown Watsonville. Although this fracture appears minor, the building was significantly damaged. [H.G. Wilshire, U.S. Geological Survey]

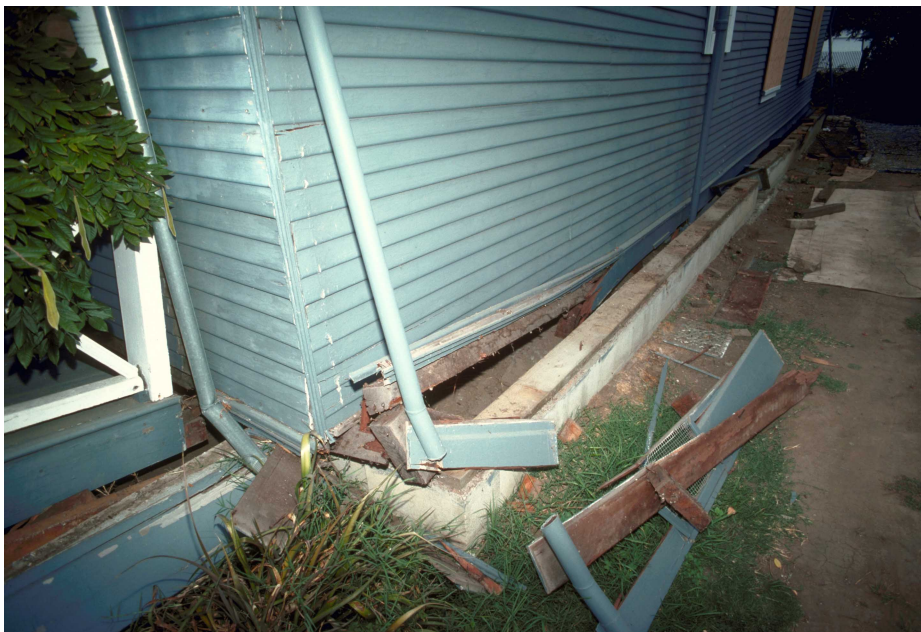
89. Houses not bolted down securely were easily dislodged from their foundations in downtown Watsonville. [J.K. Nakata, U.S. Geological Survey]

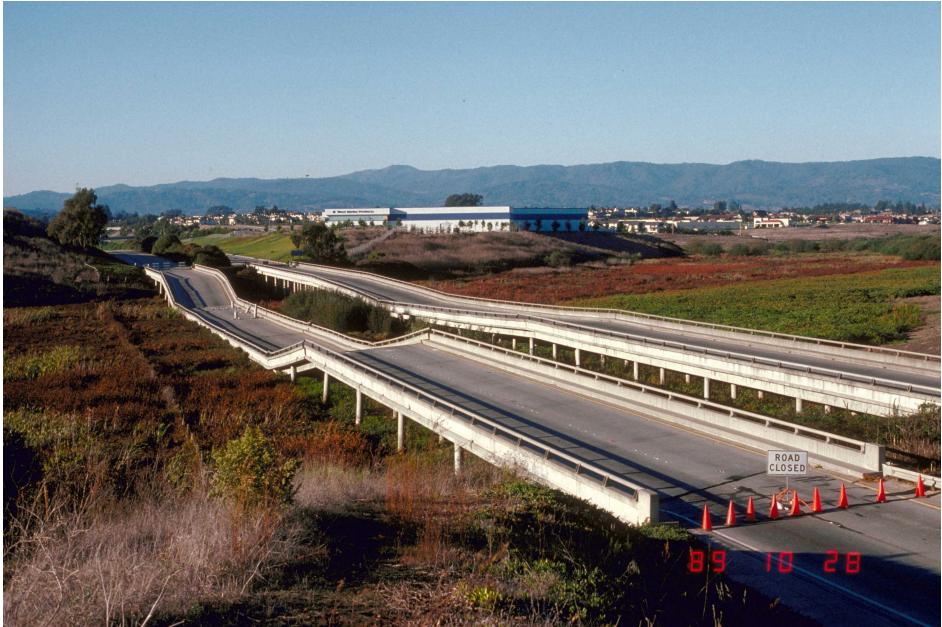
94. Structural failure of twin bridges carrying Highway 1 across Struve Slough near Watsonville. [J.C. Tinsley, U.S. Geological Survey]

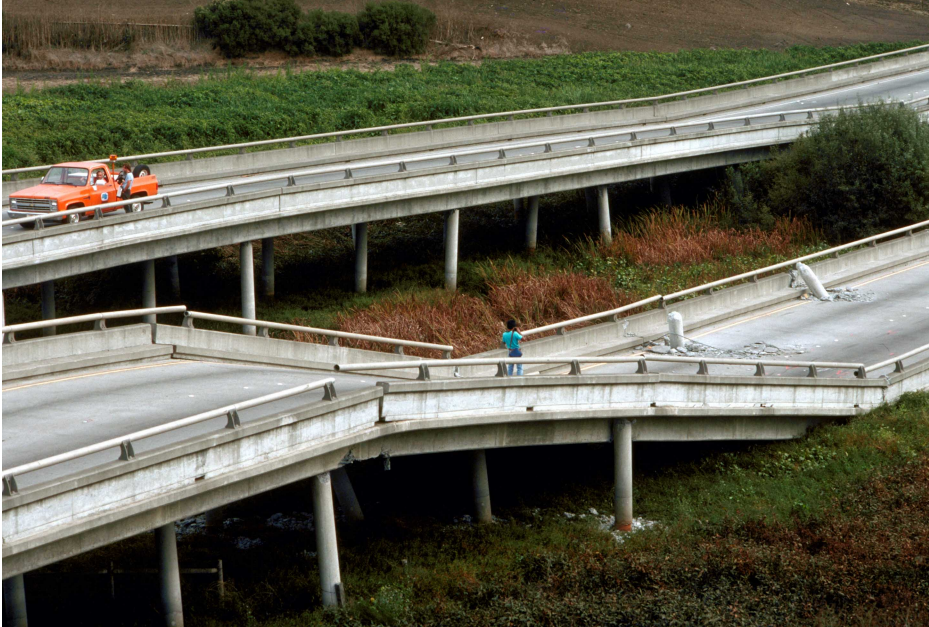
95. Closeup of collapsed bridge section on Highway 1 at Struve Slough. [J.K. Nakata, U.S. Geological Survey]

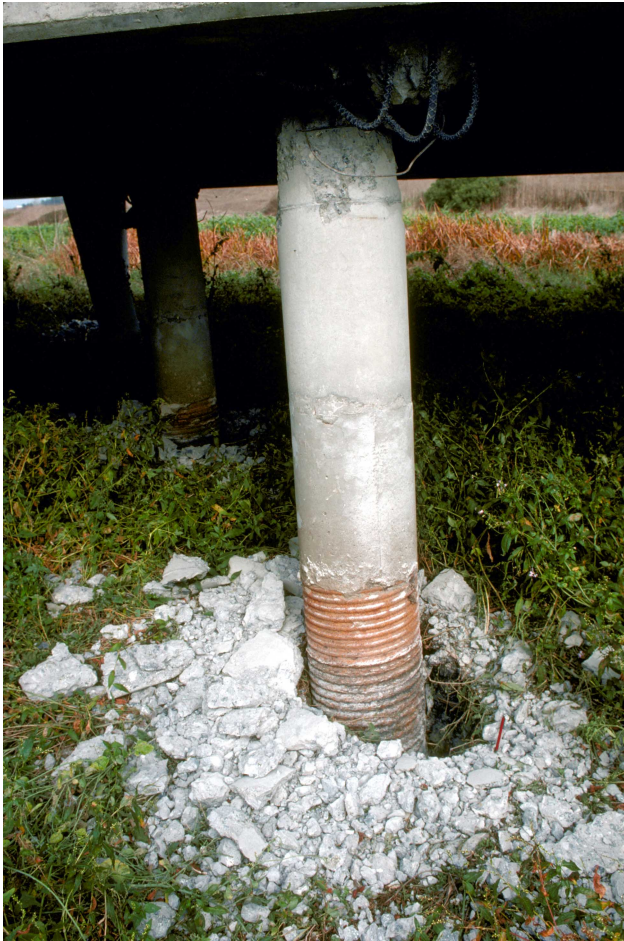
98. Support column of bridge across Struve Slough, Highway 1. Enlargement of hole where support enters the ground is an effect of lateral shaking, which caused the concrete to break up where the column joined the bridge and was instrumental in the roadbed collapse. [H.G. Wilshire, U.S. Geological Survey]

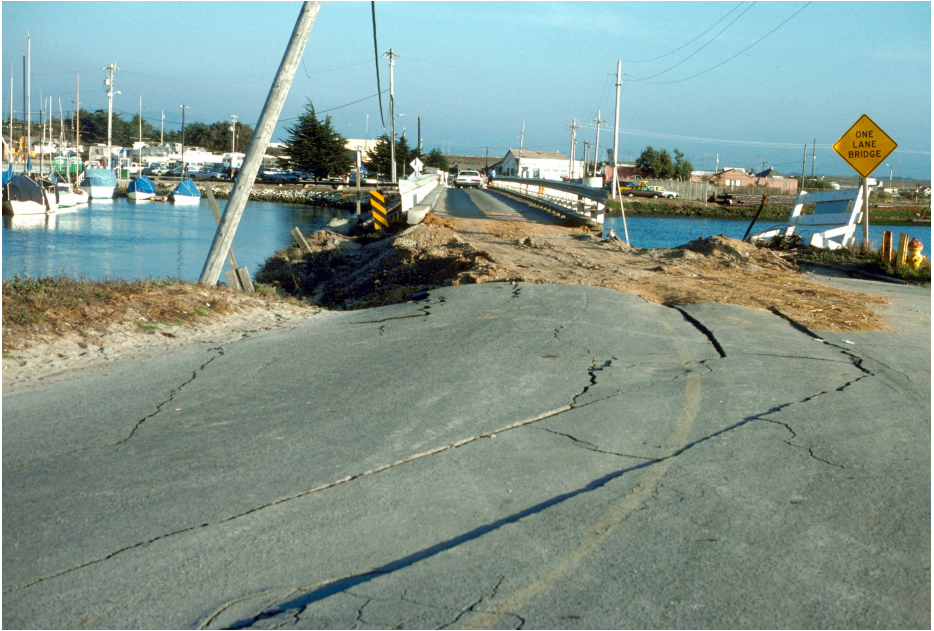
101. Ground cracking and differential settlement due to liquefaction of beach and Salinas River deposits damaged approach and abutment of bridge linking Moss Landing spit to the mainland, near Moss Landing Marine Laboratory. [J.C. Tinsley, U.S. Geological Survey]
