The Danvers Butchery Meat Market and Cold Storage

Danvers, Massachusetts

USFA-TR-151/January 2004

Investigated by: John R. Anderson

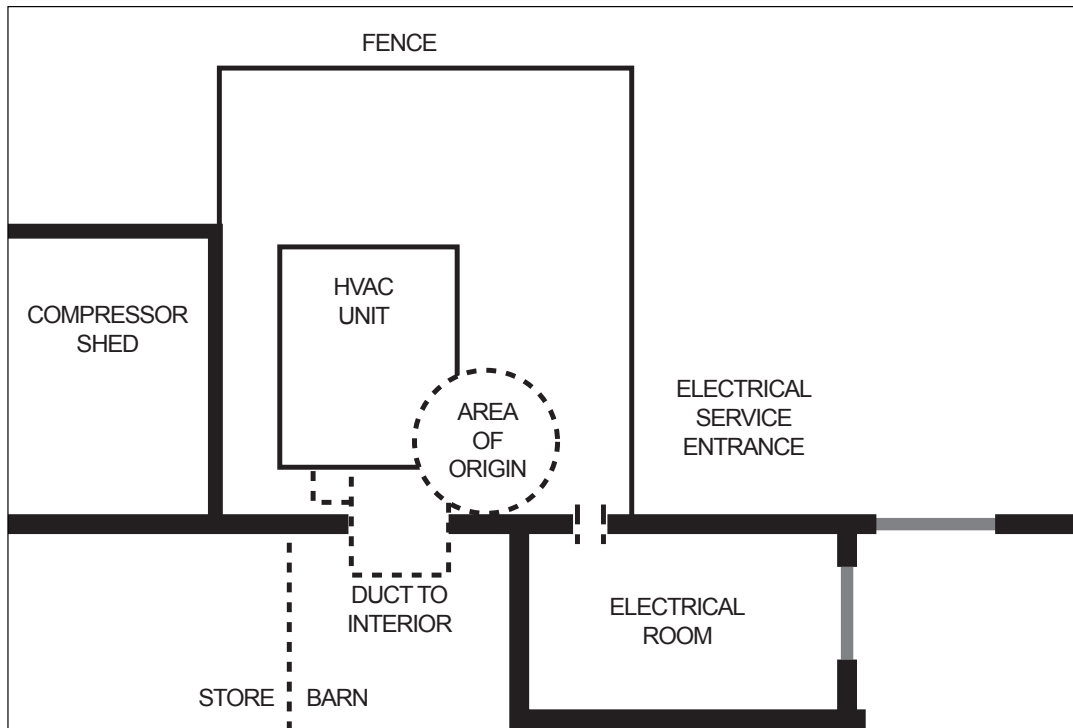
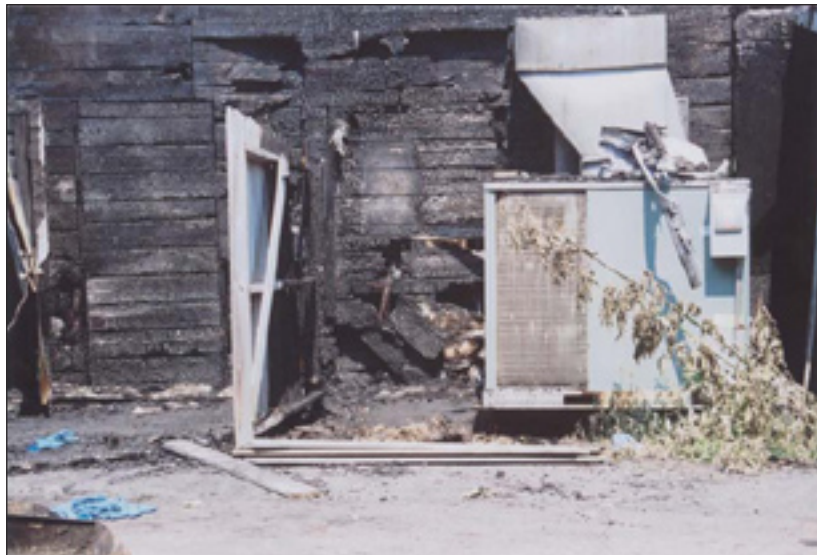
Map: Complex - First Floor

At approximately 03:00 hours, a fire started on the exterior of The Danvers Butchery. The area of origin was in a fenced enclosure next to a large air conditioning unit on the B/C corner of the Barn. (See Appendix C for details) The material first ignited is believed to have been a plastic bag filled with garbage. Sufficient combustibles were present to allow the fire to grow. Flames ignited the vinyl siding, tar paper, and sheathing. In several places flames ate through the sheathing and entered joist spaces. As flames impinged on the second floor window above, the glass failed. The fire entered the second floor and traveled through the open attic rafters once the suspended ceiling collapsed. It became visible to an awakened neighbor when the wood sheathing and vinyl siding on the C side were free burning. The property was shielded by a tree line which may have blocked earlier observations if any neighbors had, in fact, heard anything.

The area of origin viewed from the south on the morning of the fire. Note the penetrated sheathing and protruding wires from the electrical service.

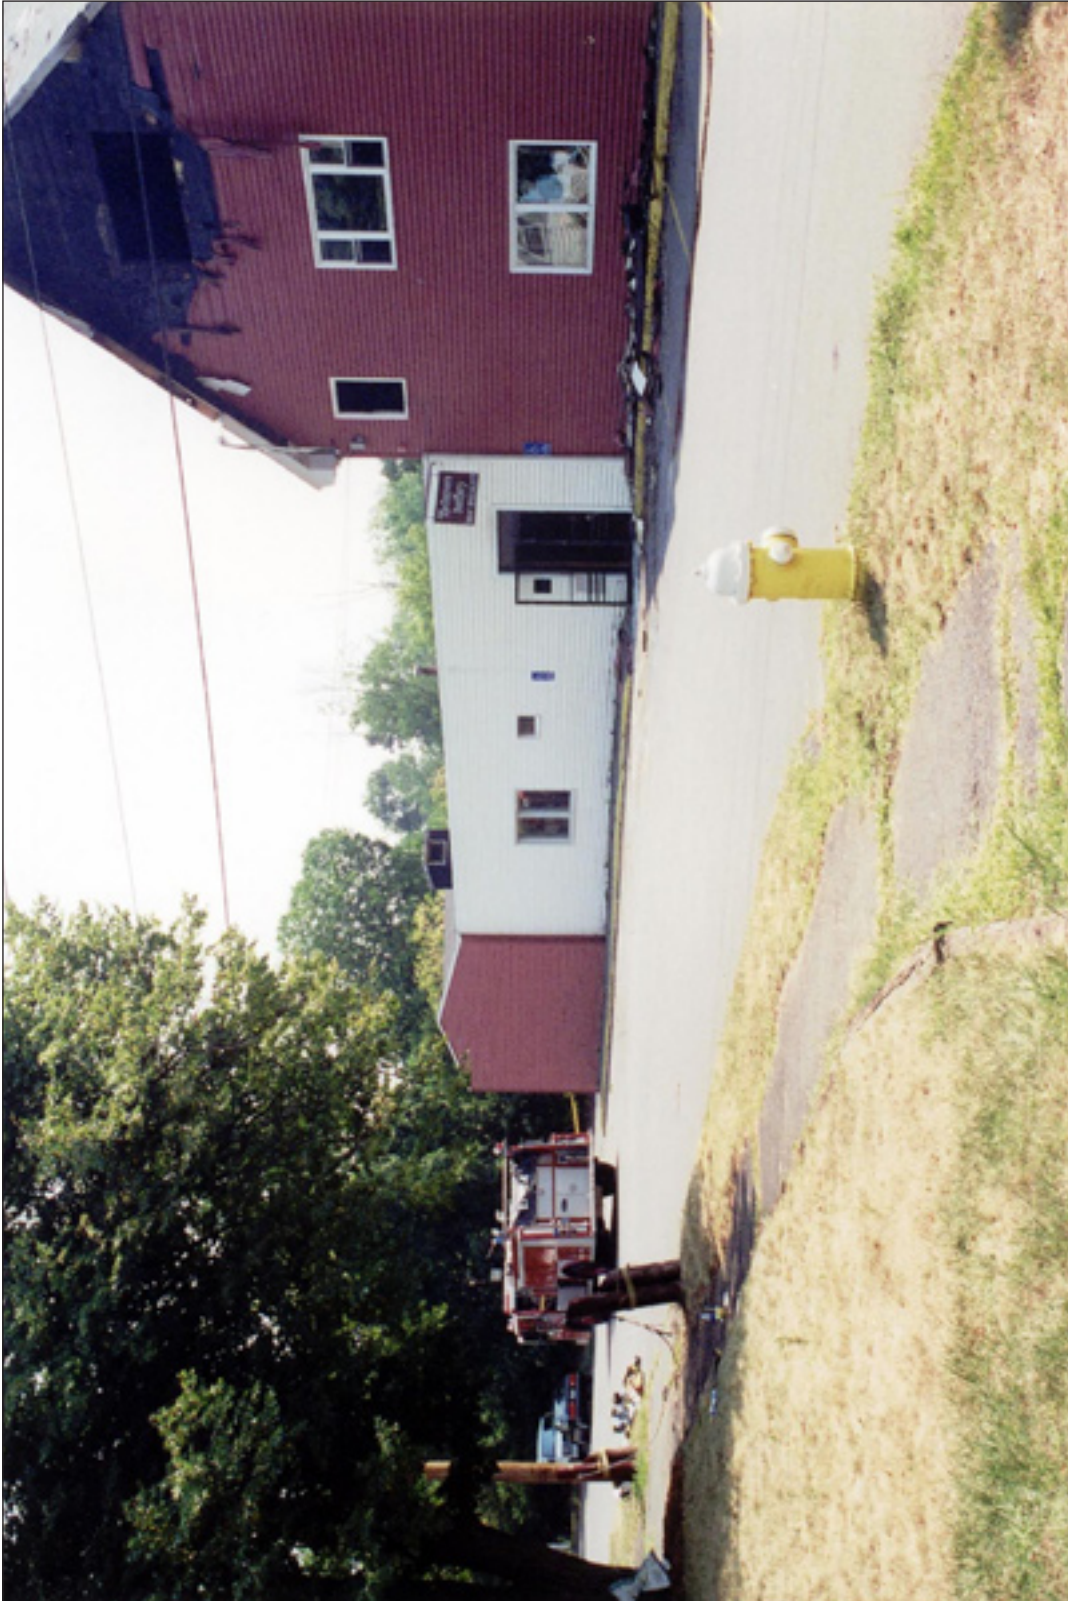
1. The eastern portion of The Danvers Butchery's Front, A side. Danvers's Engine 4, the reserve, is still on the scene. The hydrant tagged by Engine 3 is in the foreground. The interior attack was through D1, the door in the center white section. Note that the glass is still present in many windows.

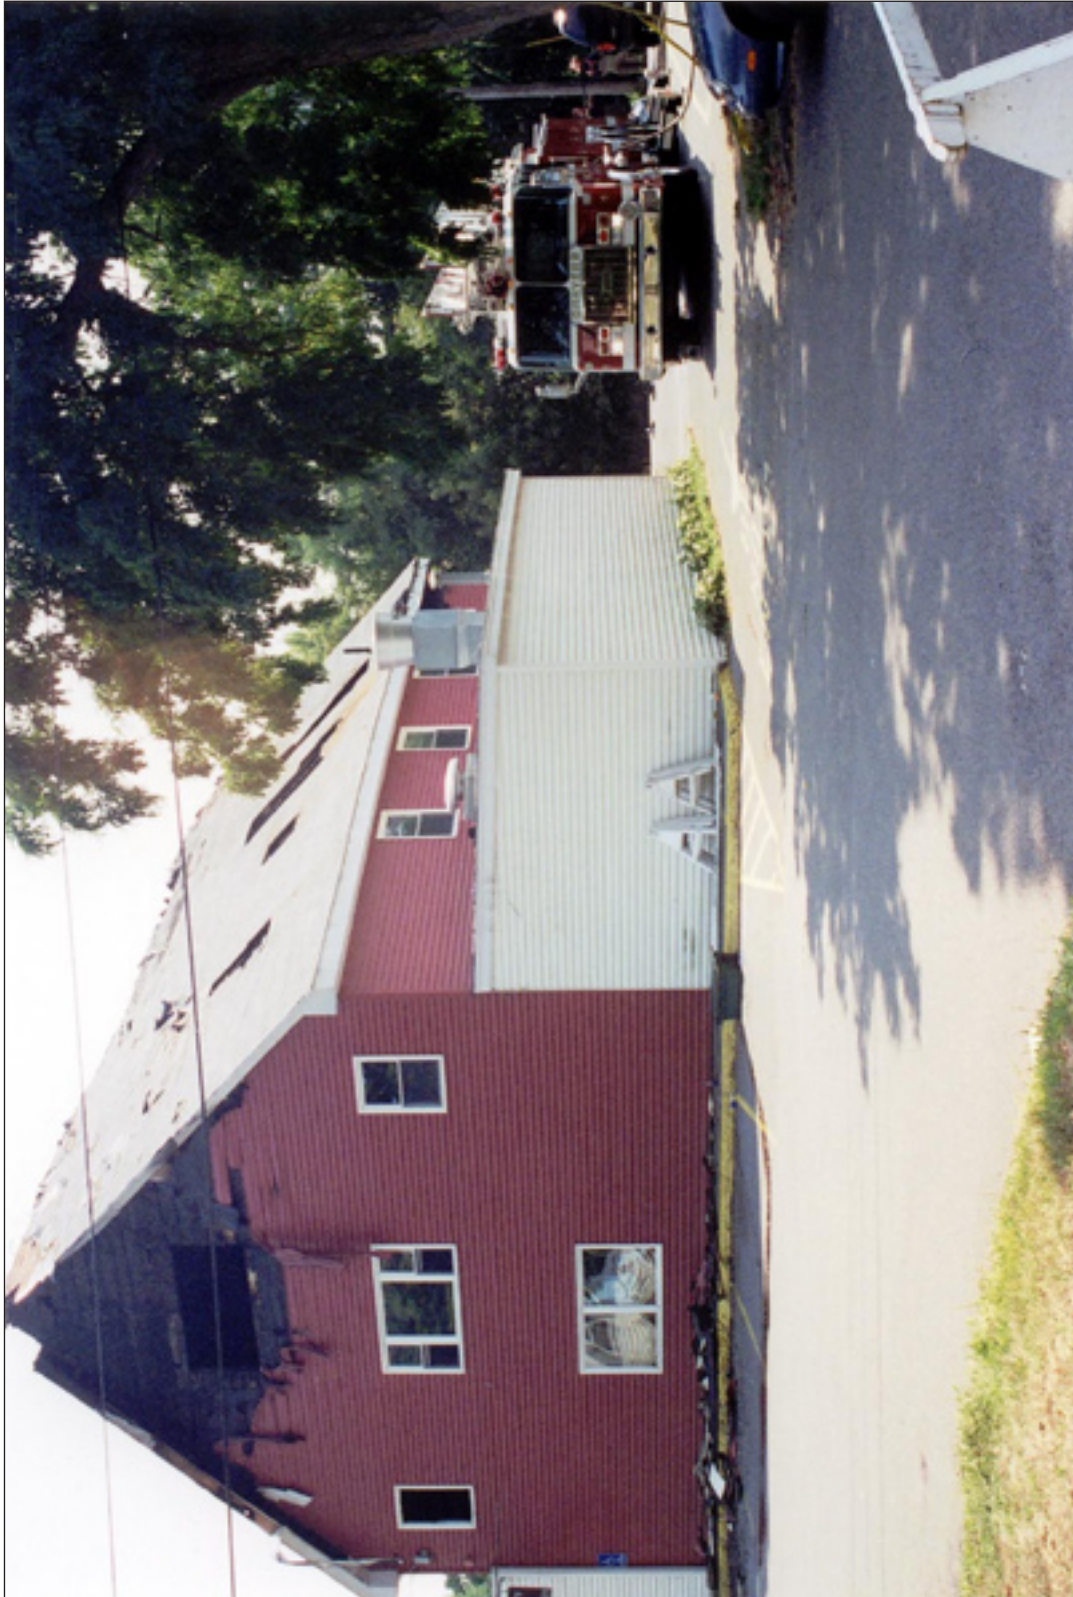
2. The western portion of the A side and the D side. Arriving firefighters observed flames from the front attic window and along the ridge. Danvers's Engine 1, a quint, is shown. (Photo courtesy Danvers Fire Department)

2. The western portion of the A side and the D side. Arriving firefighters observed flames from the front attic window and along the ridge. Danvers's Engine 1, a quint, is shown.

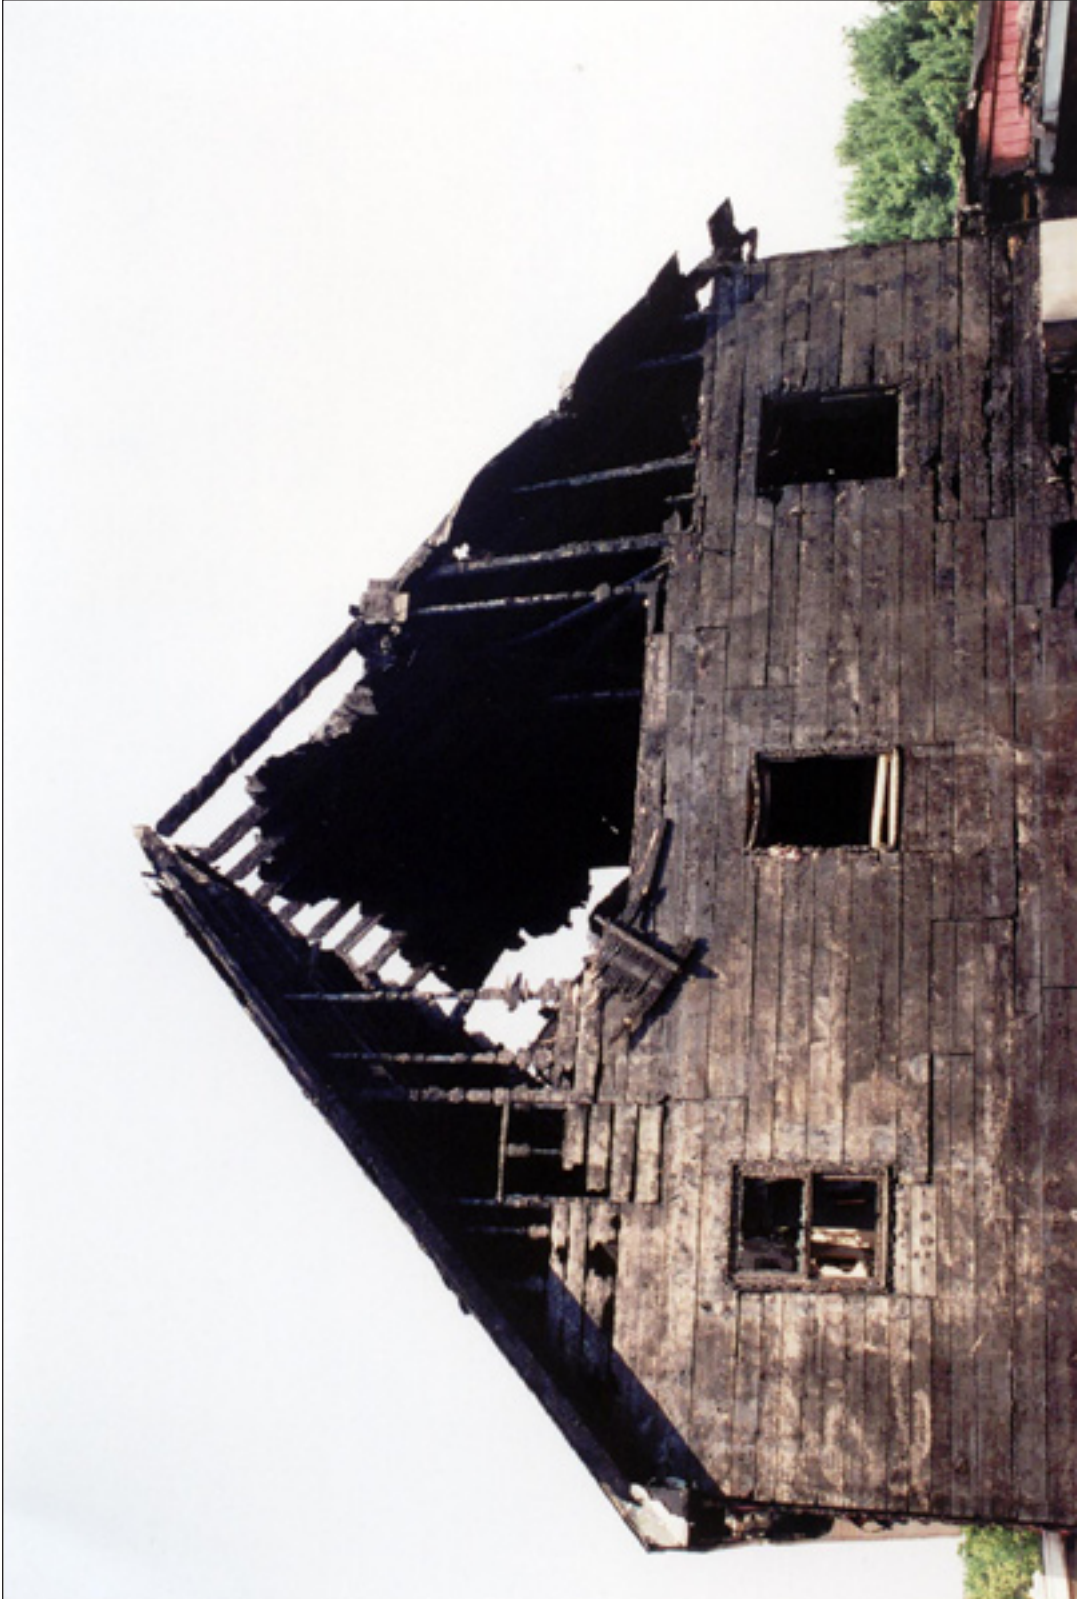
3. The upper part of the Barn's C side. The gable had burned through before firefighters arrived. The unstable roof was removed after suppression was completed. (Photo courtesy Danvers Fire Department)

3. The upper part of the Barn's C side. The gable had burned through before firefighters arrived. The unstable roof was removed after suppression was completed.

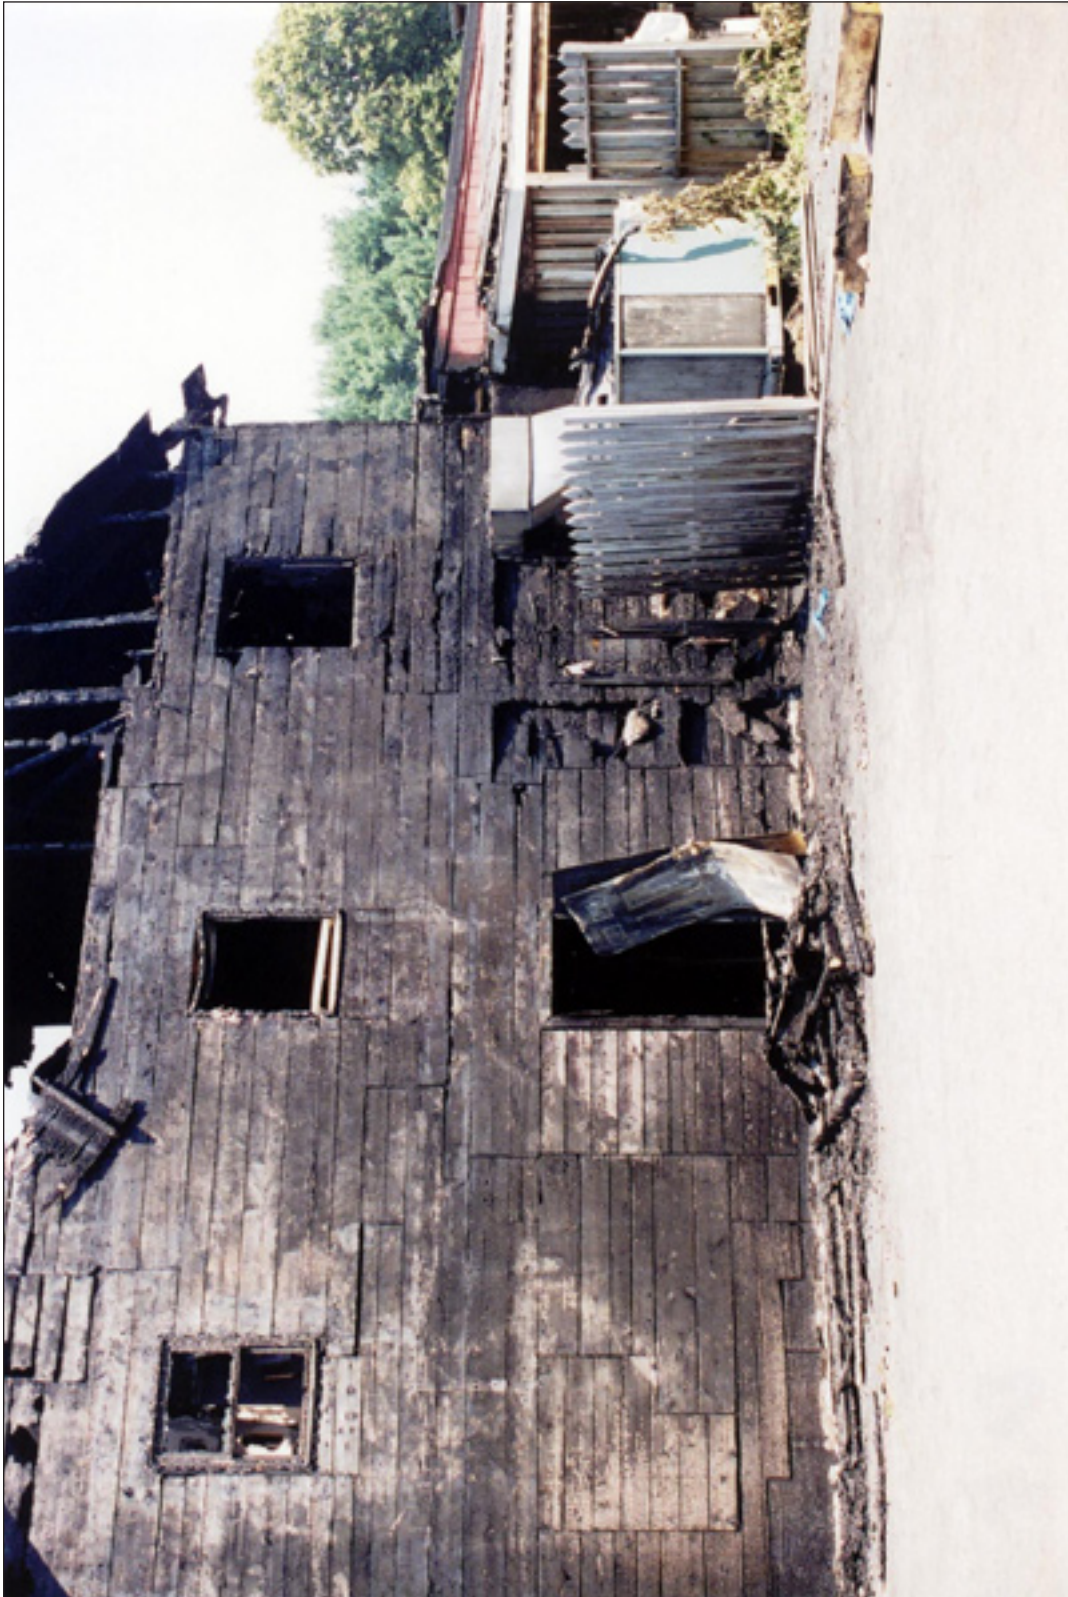
4. The lower portion of the Barn's C side. This surface, finished with vinyl siding, was engulfed when firefighters arrived. The area of origin is at the lower right.

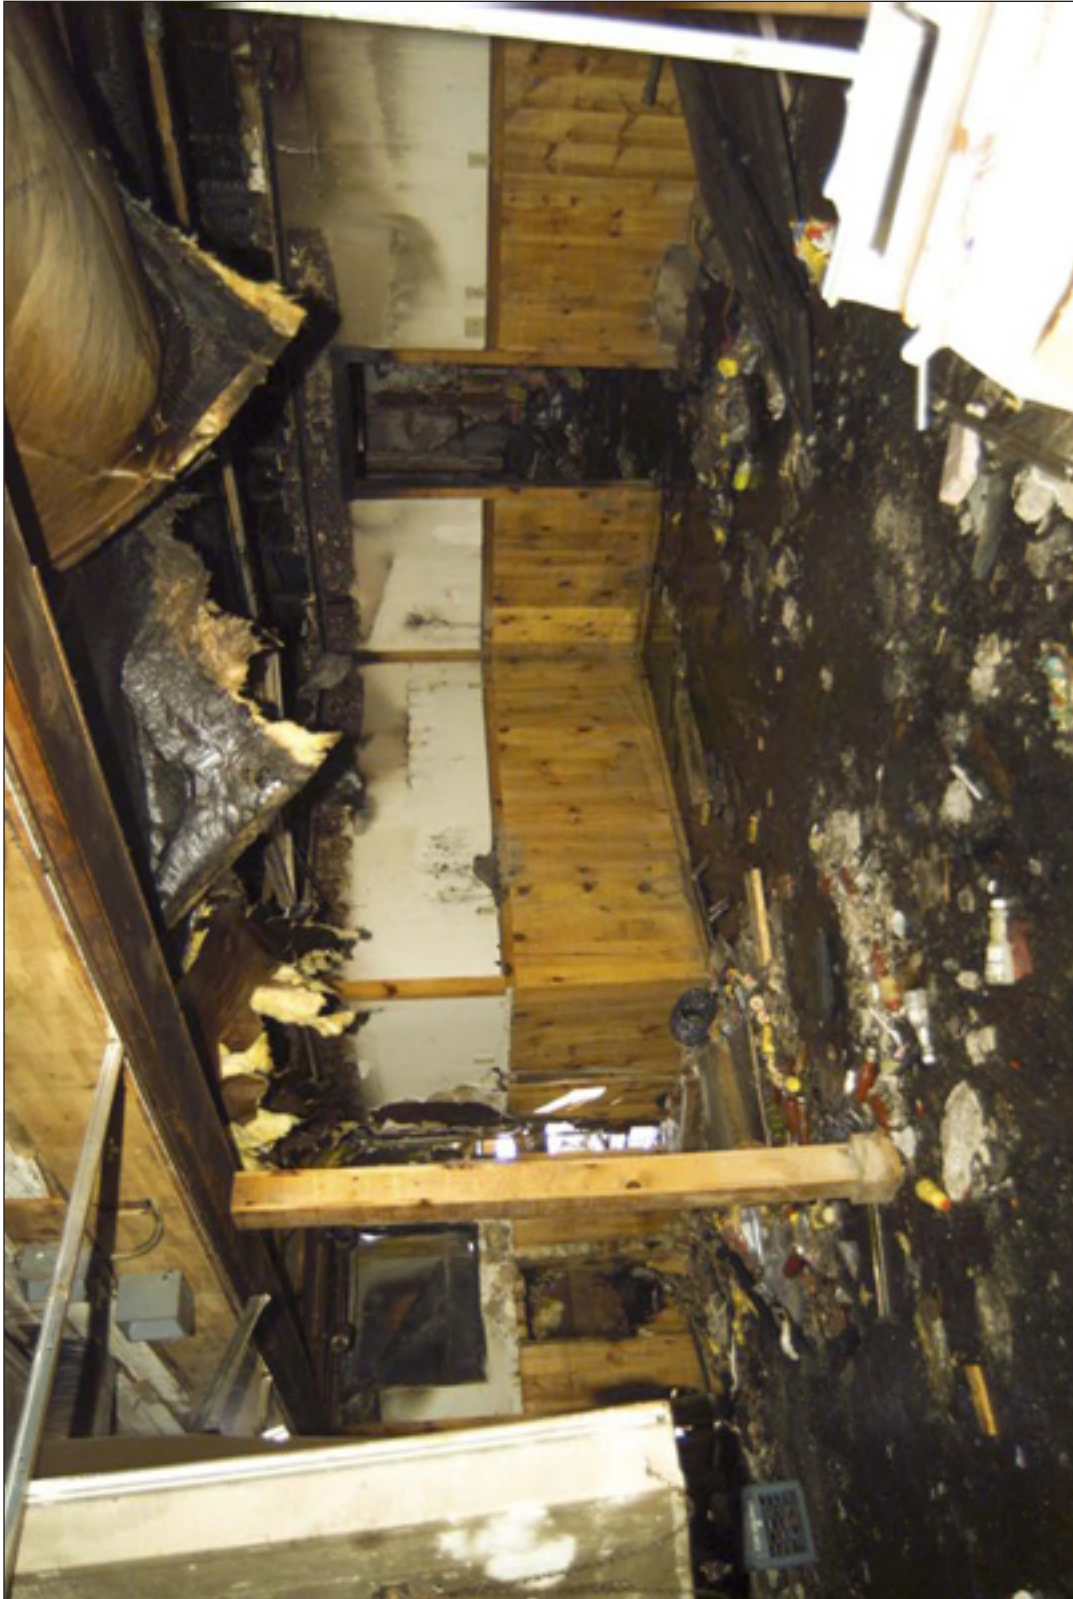
5. The rear of the Barn, 1st floor looking southwest. The protruding wall sections in the center are the outside of the electrical room. The duct from the outside HVAC unit is at the left and the entrance to the employee area is through the door right of center. The beam at the top is holding up the Barn's east wall.

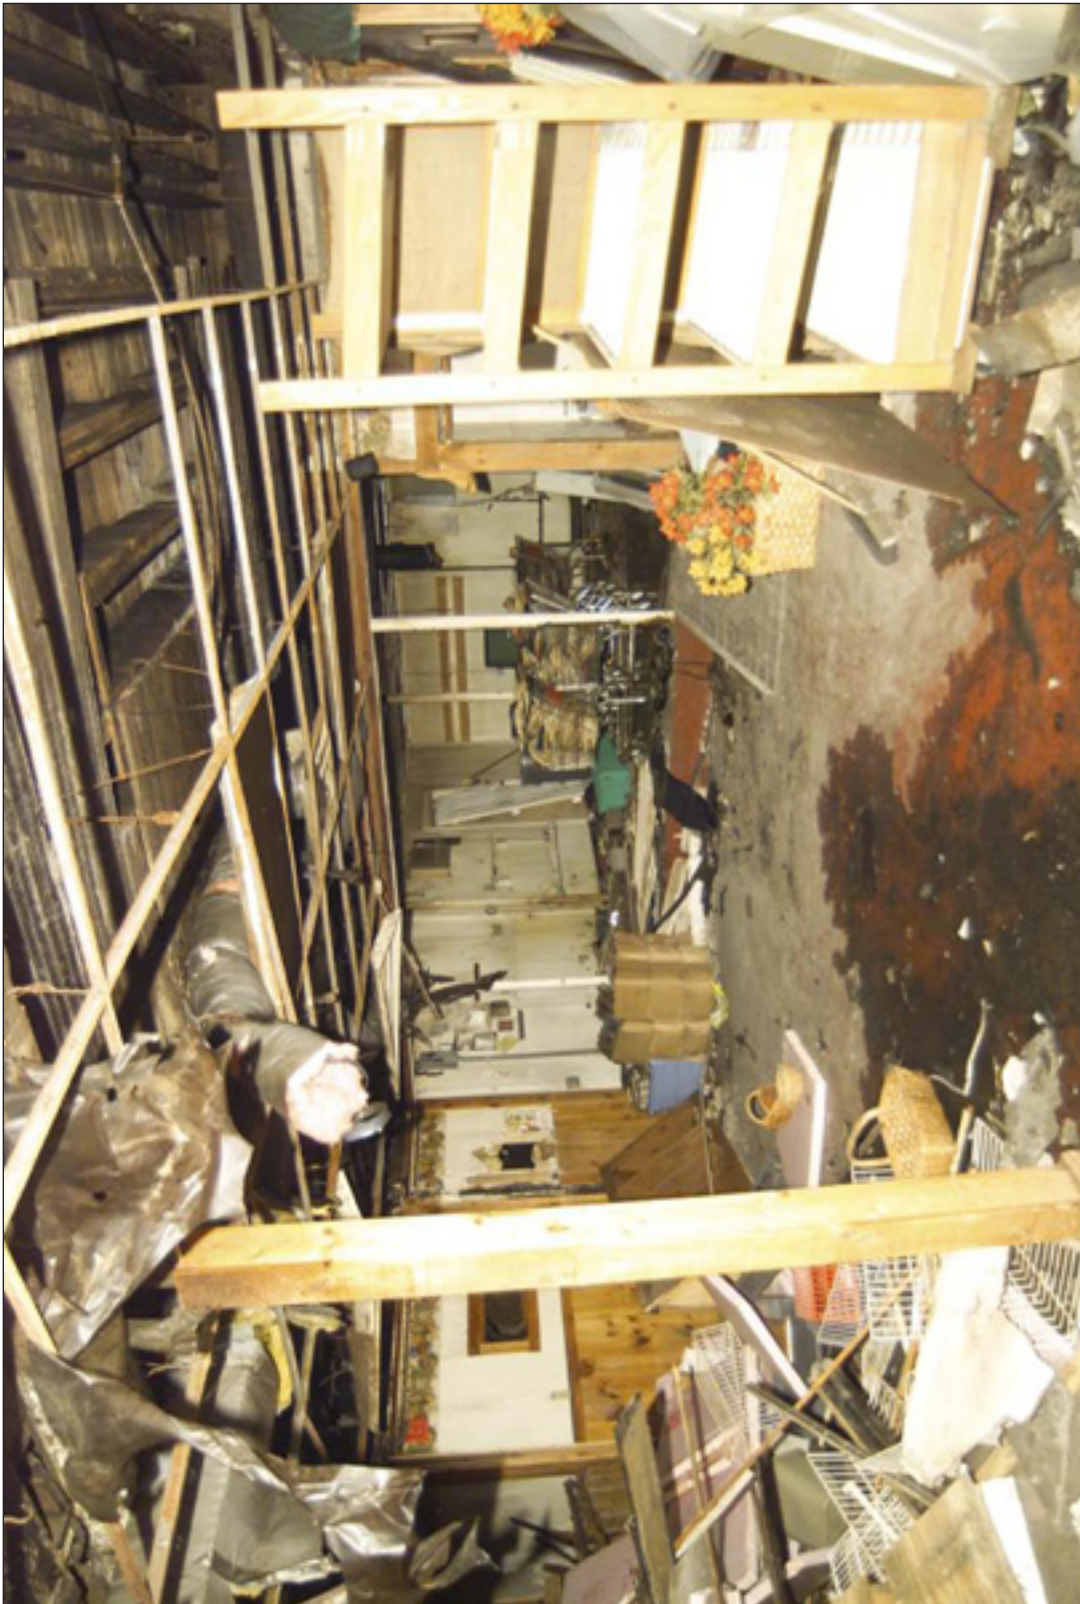
6. The north part of the Barn, 1st floor looking west into the kitchen. The fire did not penetrate the interior wall shown on the left. This photo was taken about six months after the fire, and a lot of salvage work has been done.

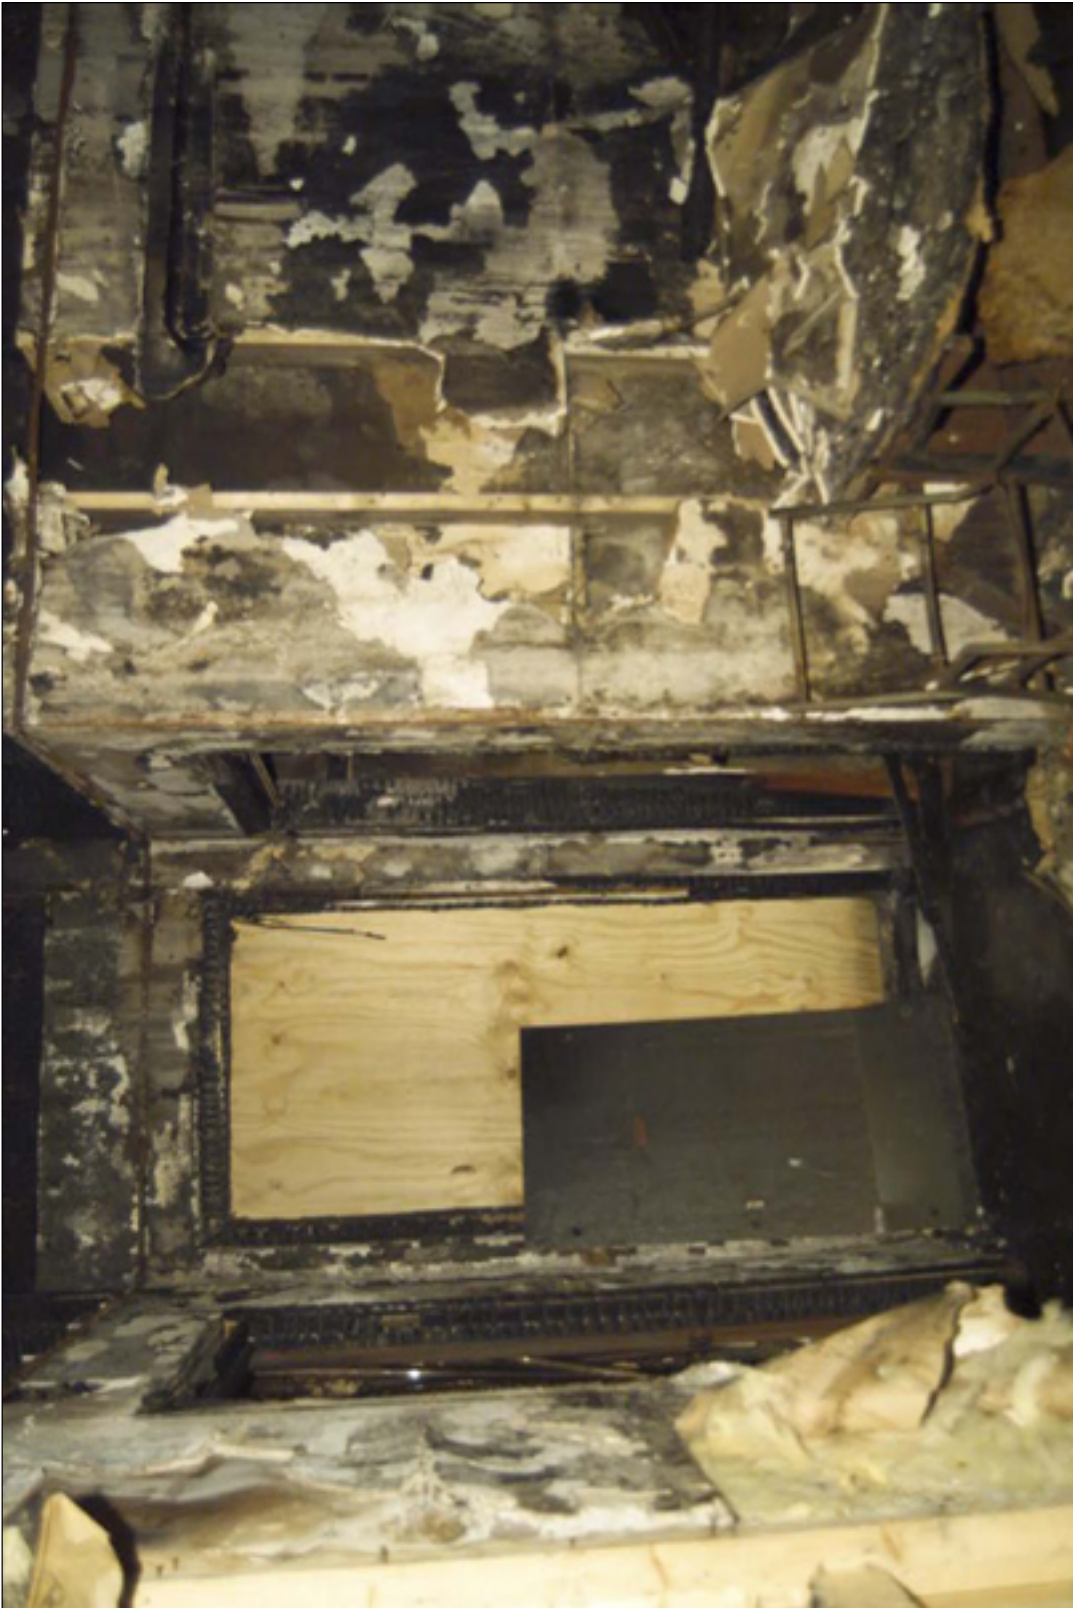
7. The employee area on the Barn's 1st floor, looking south at the D6. The electrical room is through the door on the left, and the door on the right accesses a closet under the rear stairway to the second floor.

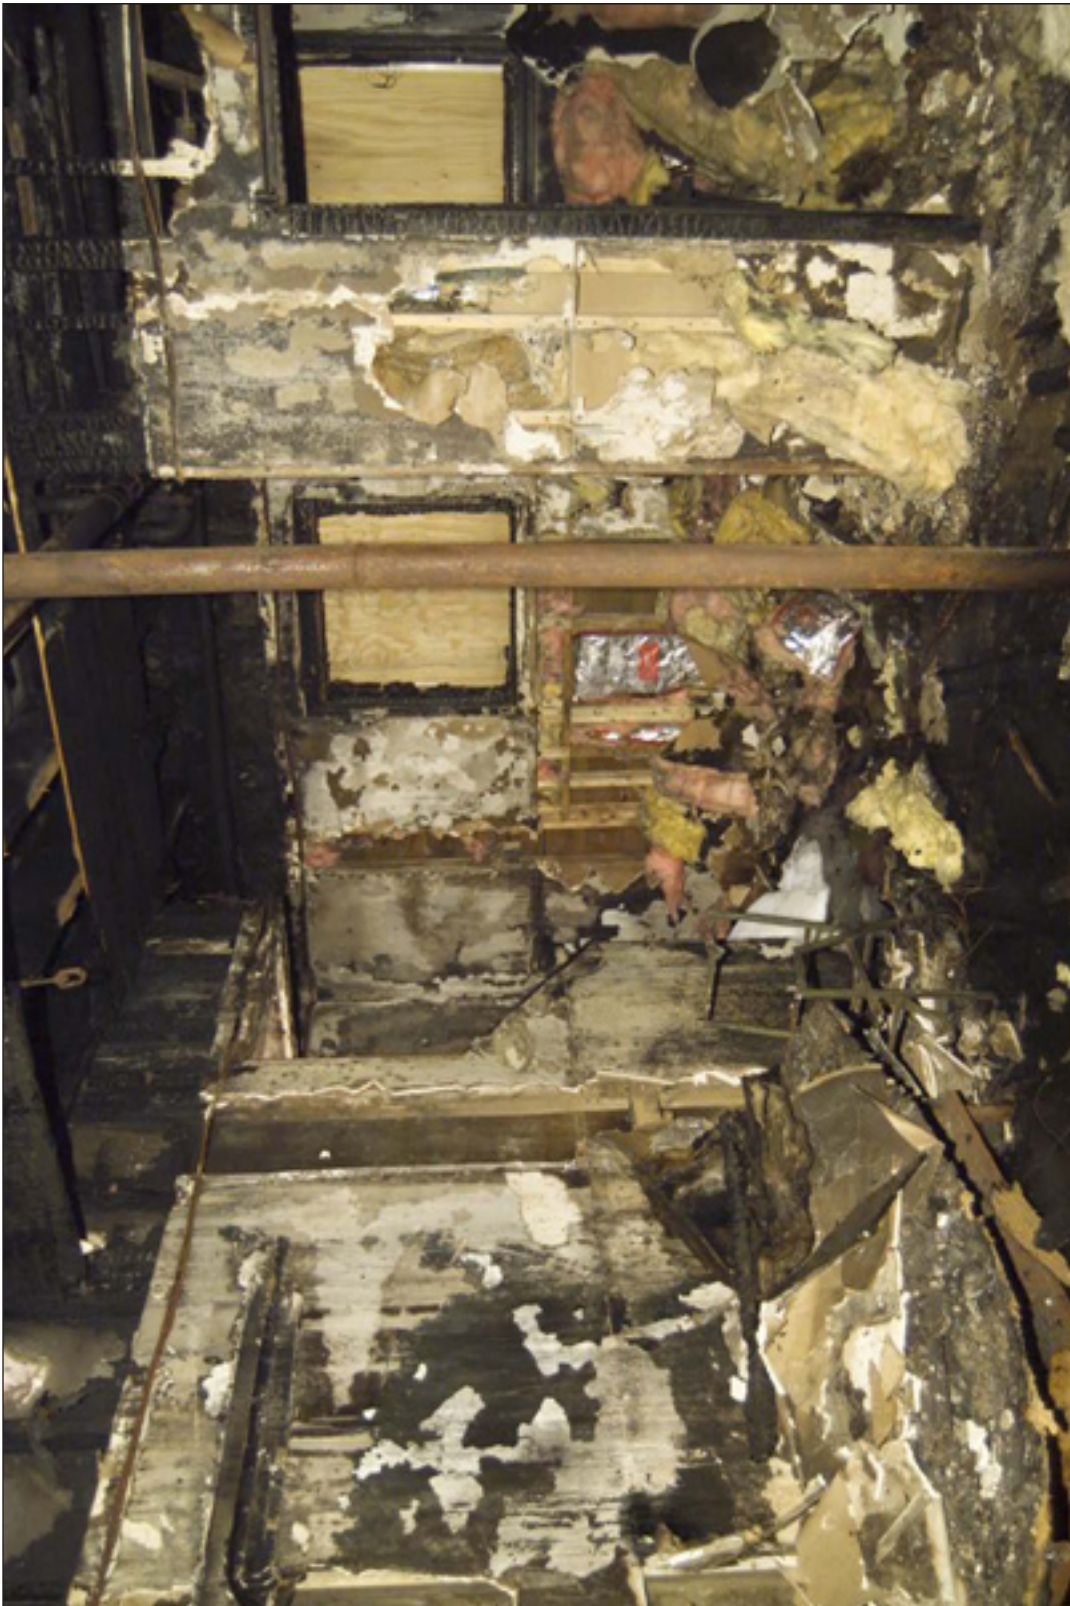
8. Another view of the employee area, looking southwest. The entrance to the staircase is at the end of the left wall where it intersects with the west wall, the C/D corner of the Barn. Fire damage in this area was caused by debris dropping down from above. The interior attack extinguished the fire in the room. (Photo is by the investigator)

8. Another view of the employee area, looking southwest. The entrance to the staircase is at the end of the left wall where it intersects with the west wall, the C/D corner of the Barn. Fire damage in this area was caused by debris dropping down from above. The interior attack extinguished the fire in the room.

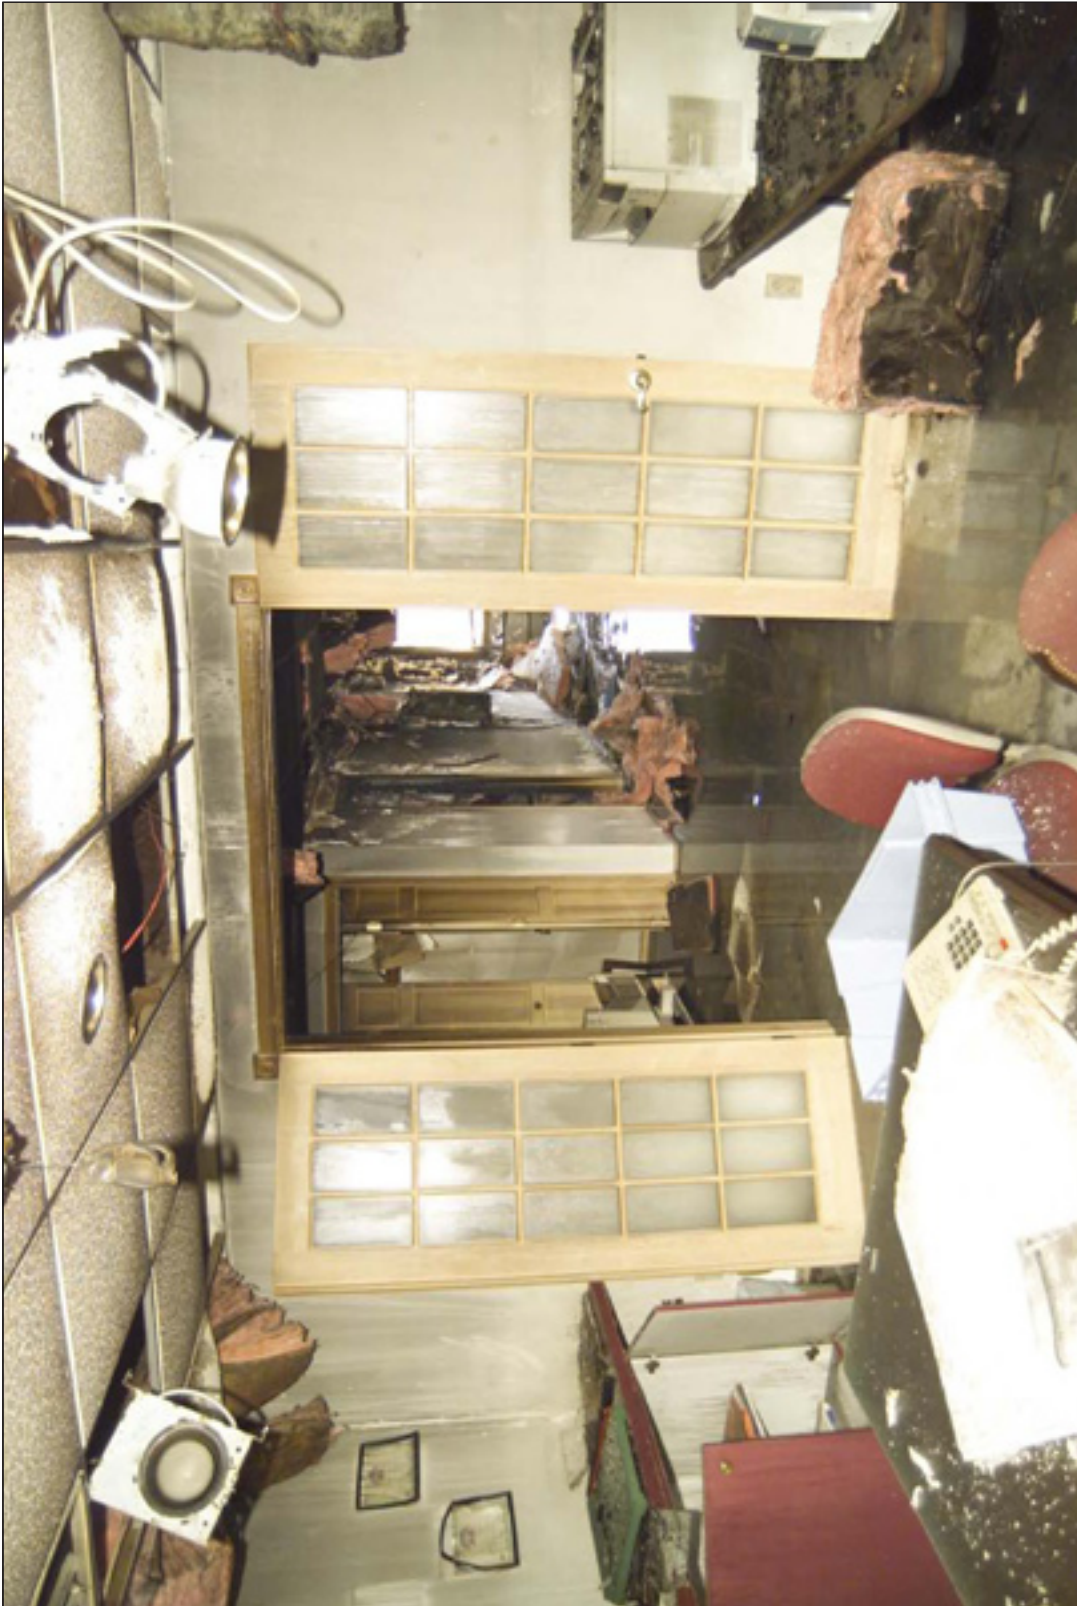
9. The Barn's second floor, looking south from the conference room. This room sustained only heat and water damage due to the presence of a wood floor in the attic. Office G can be seen through the French doors. It was devastated. (Photo is by the investigator)

9. The Barn's second floor, looking south from the conference room. This room sustained only heat and water damage due to the presence of a wood floor in the attic. Office G can be seen through the French doors. It was devastated.

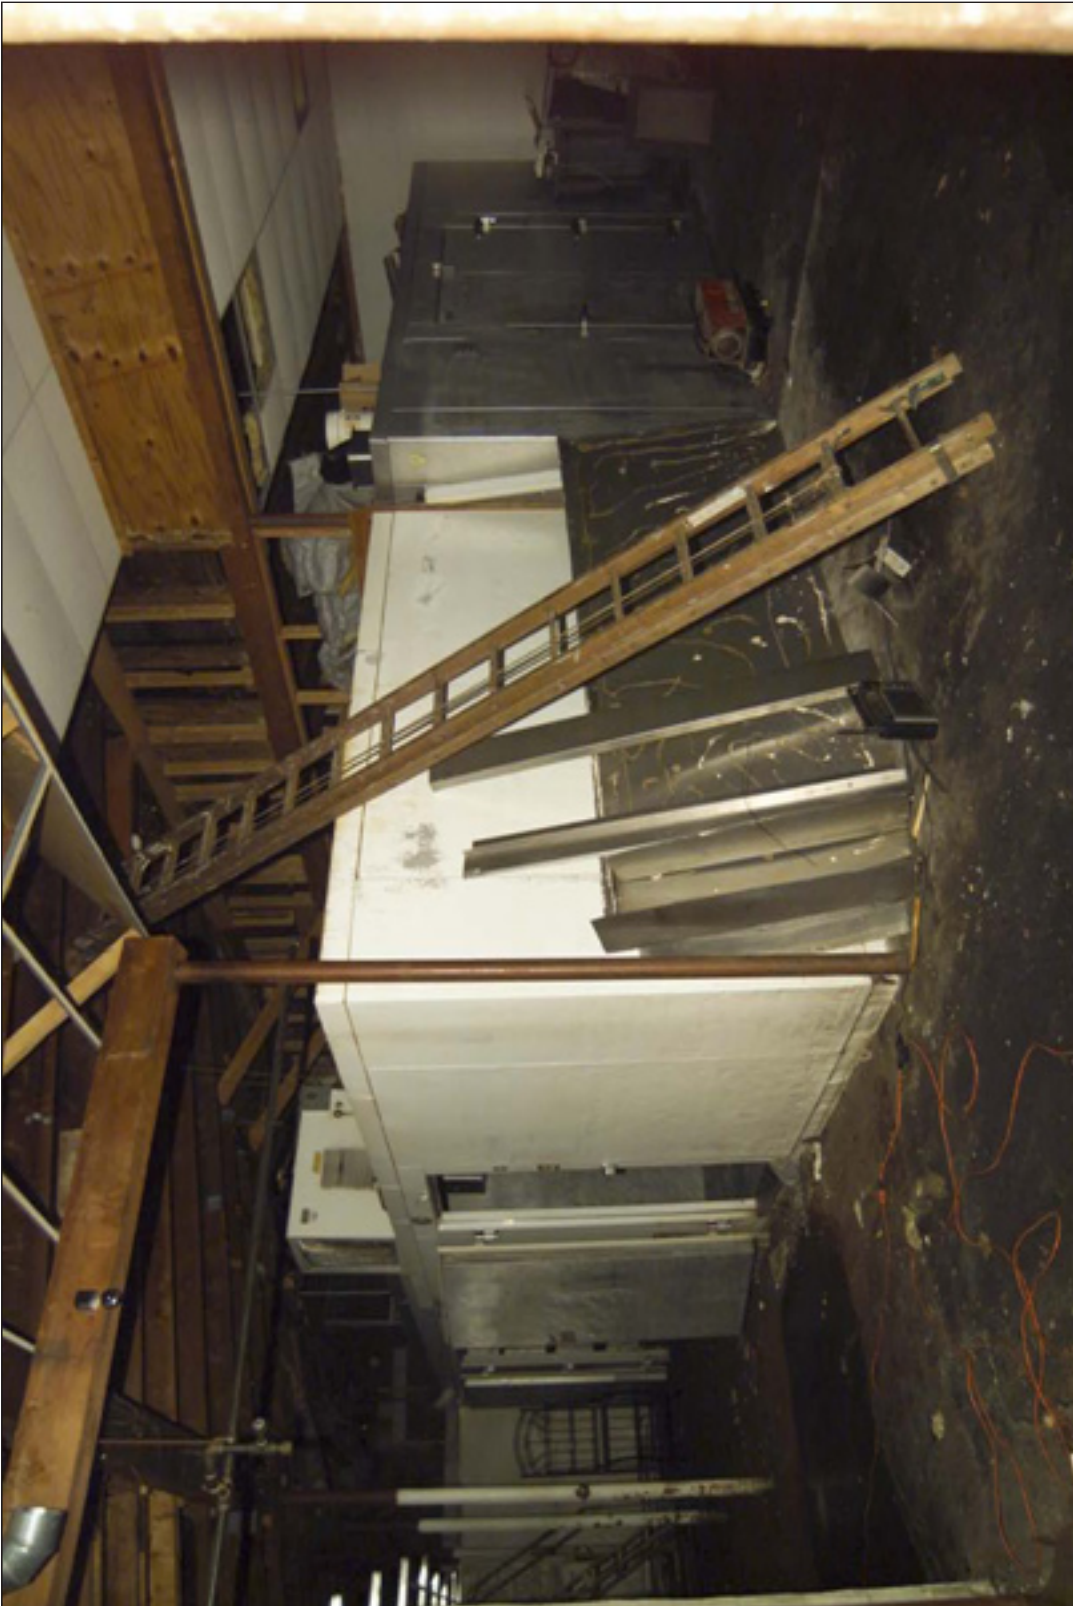
10. These are the walk-in coolers at the east end of the complex. The smoke damage was minimal, and \$40,000 worth of inventory was saved. (Photo is by the investigator)

10. These are the walk-in coolers at the east end of the complex. The smoke damage was minimal, and \$40,000 worth of inventory was saved.
