Fire at Watts Bar Hydroelectric Plant

Rhea County, Tennessee

USFA-TR-147/September 2002

Authored by: Jennifer L. Roberson
Hollis Stambaugh

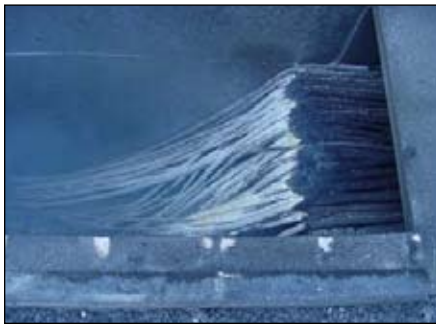
Burned cables, running from the cable tunnel to the switchyard

fire, it continued several feet down the cable channels into the switchyard and damaged cables as far as one hundred feet from the control building. In addition, the fire spread into the terminal level, igniting the fire load in the terminal room, with the result that firefighters initially considered it to be the room of origin and therefore the primary target of their attack. The smoke and the heat further penetrated the control room level, damaging everything on that level and causing further fires. Effects below the fire consisted of severe heat and smoke damage.

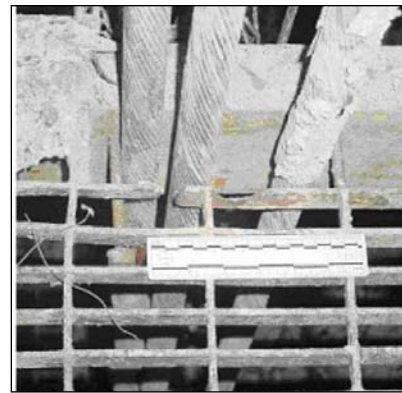
Based on damage to the cables and the steel decking, investigators concluded that prolonged rubbing of the steel decking against the butyl rubber insulation on the cable had resulted in a breaching of the cable insulation at the number five level (roughly 60 feet above ground) in the cable shaft. This resulted in an arc from the cables to the decking, and back to the cable. The extreme temperature generated by this arc was enough to cause a small amount of the insulation to deteriorate into a flammable substance, thereby resulting in ignition. The large quantity of flammable materials in the shaft, coupled with a continuous chimney effect, provided the small fire with enough fuel to self-sustain and free burn. Within a matter of seconds, the fire started to spread rapidly. The high flammability of the insulation surrounding the cabling magnified the speed of propagation. Those cables which were covered with PVC released polyvinylchloride gas as they burned.

Point of fire origin

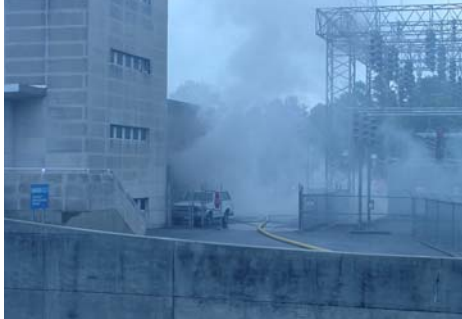
The cable spreading room above the shaft sustained significant spalling and smoke damage. The control building sustained significant damage, both from the effects of the fire and the effort associated with its extinguishment.

Control Building, approximately two hours into the fire

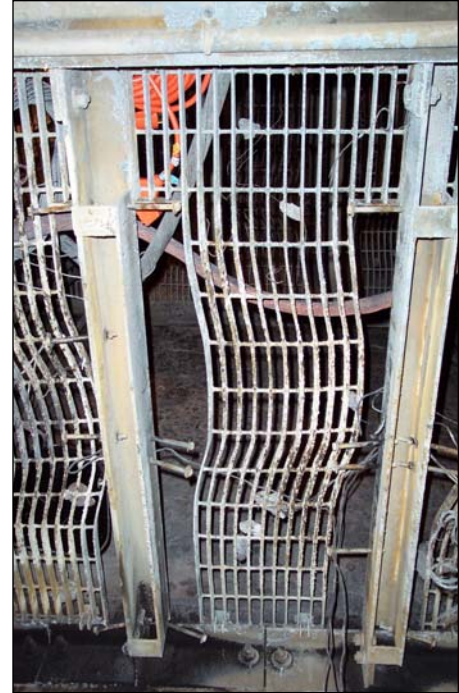
Although the fire occurred in a vertical shaft, there was a significant amount of damage to all parts of the hydroelectric plant. All cables running through the shaft were destroyed and severed as a result of the fire, resulting in a loss of communications, fire annunciation systems, and most importantly, power transmission. Additionally, the ladders and steel decking in the vertical shaft were warped.

Warped decking below the area of origin

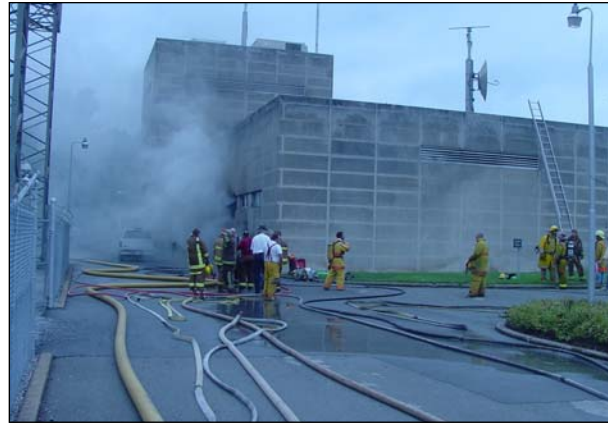
**View of the control building from the South.
Note the solid concrete construction
and lack of windows.**

The construction of the hydroelectric plant contributed to heat build-up and distribution. The concrete walls, floors, and ceilings acted as an oven, intensifying the heat and trapping it in the building. These conditions made firefighter entry and fire suppression extremely difficult. During fire suppression activities, firefighters reported that the water they were using to fight the fire was turning to steam or boiling upon contact with the floor. The level of heat in the building was further evident during the post-incident investigation. Investigators found heavy spalling in the cable spreading room.

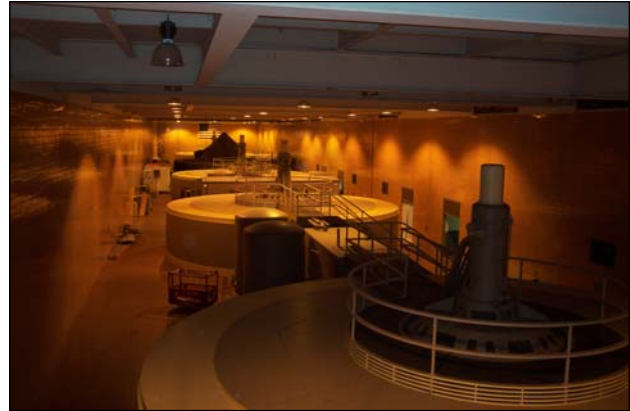
The design of the powerhouse also contributed to existing problems. The building is a large windowless structure, with heavy machinery and other dangers located throughout. It, too, has very limited means of egress, with exits to ground level on the west end and an exit to the top of the dam on the east end. The powerhouse has several levels, both above and below the waterline, with exits located on only one level. When power to the building was lost, workers were plunged into complete darkness. Personnel would have had to rely on their knowledge of the building and their sense of touch and hearing to exit the building. Luckily, a supervisor on the floor had a flashlight, and was able to find people and lead them safely from the building. TVA's review of life safety issues will likely include increased exit lighting per NFPA 101 7.8.1.

Powerhouse floor

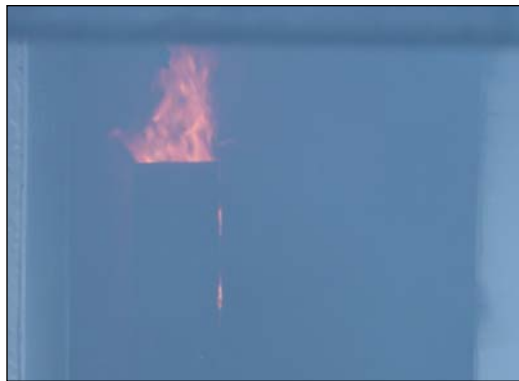
Fire in the breaker panels; looking from outside the Control Building, three hours into the fire.

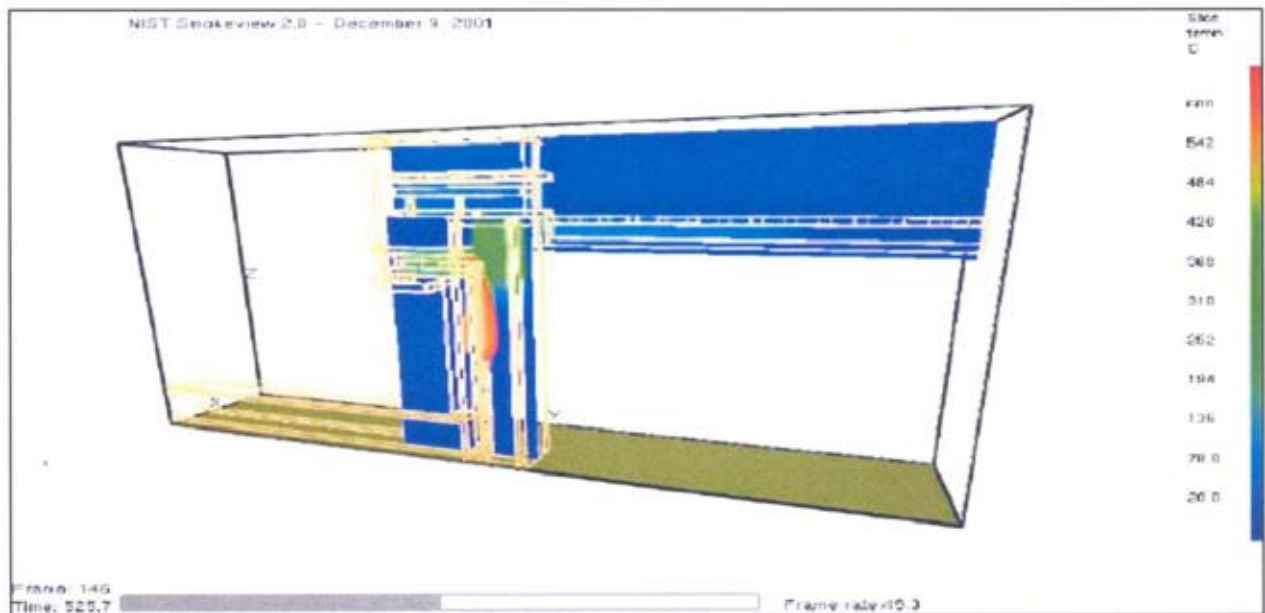
Three-dimensional computer model of WBH fire

TVA investigators utilized NIST's Fire Dynamics Simulator Version 2.9, inputting not only their own data but also information provided by USFA, NIST and NRC. The simulator modeled smoke and fire development and distribution over a period of time using a three-dimensional computer image to provide a second-by-second breakdown of the fire. The results were telling. According to the record of investigation, "The model of the WBH (Watts Bar Hydroelectric) Plant after 527 second (8.78 minutes)... shows a fire plume extending up the cable shaft to the entrance to the ante room, which leads up a staircase to the cable spreading room."
