Entrapment in Garage Kills One Firefighter

San Francisco, California

USFA-TR-084/March 1995

**75 Everson Street
San Francisco, California**

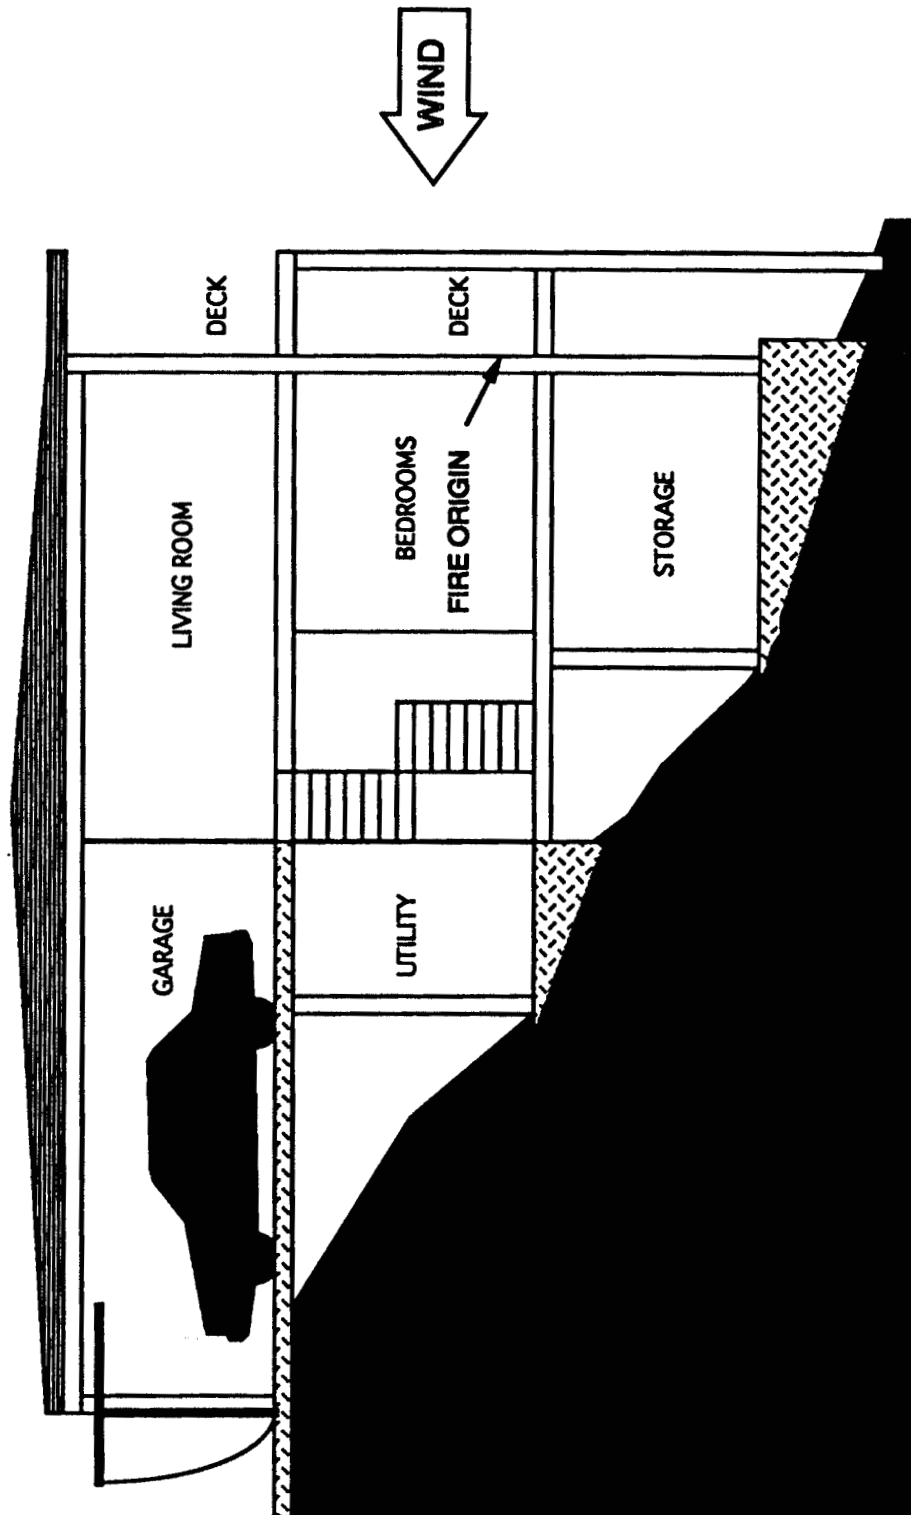
Figure 1a

The house had three levels (see Figures 1a and b). The lower level was only accessible from the back yard and was used exclusively for storage. The middle level had three bedrooms, each with a view to the south. A utility room ran the width of the house on the north side. Two full bathrooms flanked the open center stairway (Figure 3).

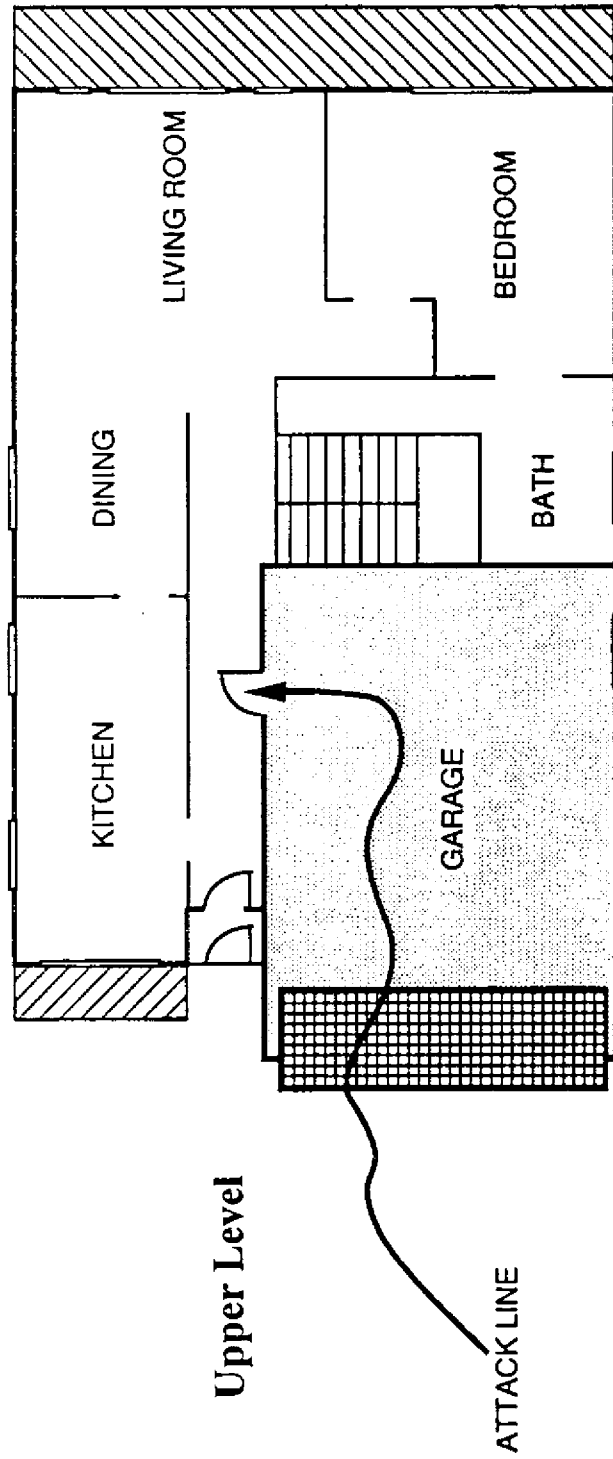
Figure 2

The upper floor was the only level visible from the street (Figure 2). On this level, the living room and the master bedroom faced to the south. The garage was north of the master bedroom, while the dining room and kitchen were north of the living room. Between the kitchen and the garage was an entry hall leading to the front door of the residence. The two upper levels contained about 2,050 square feet of living space.

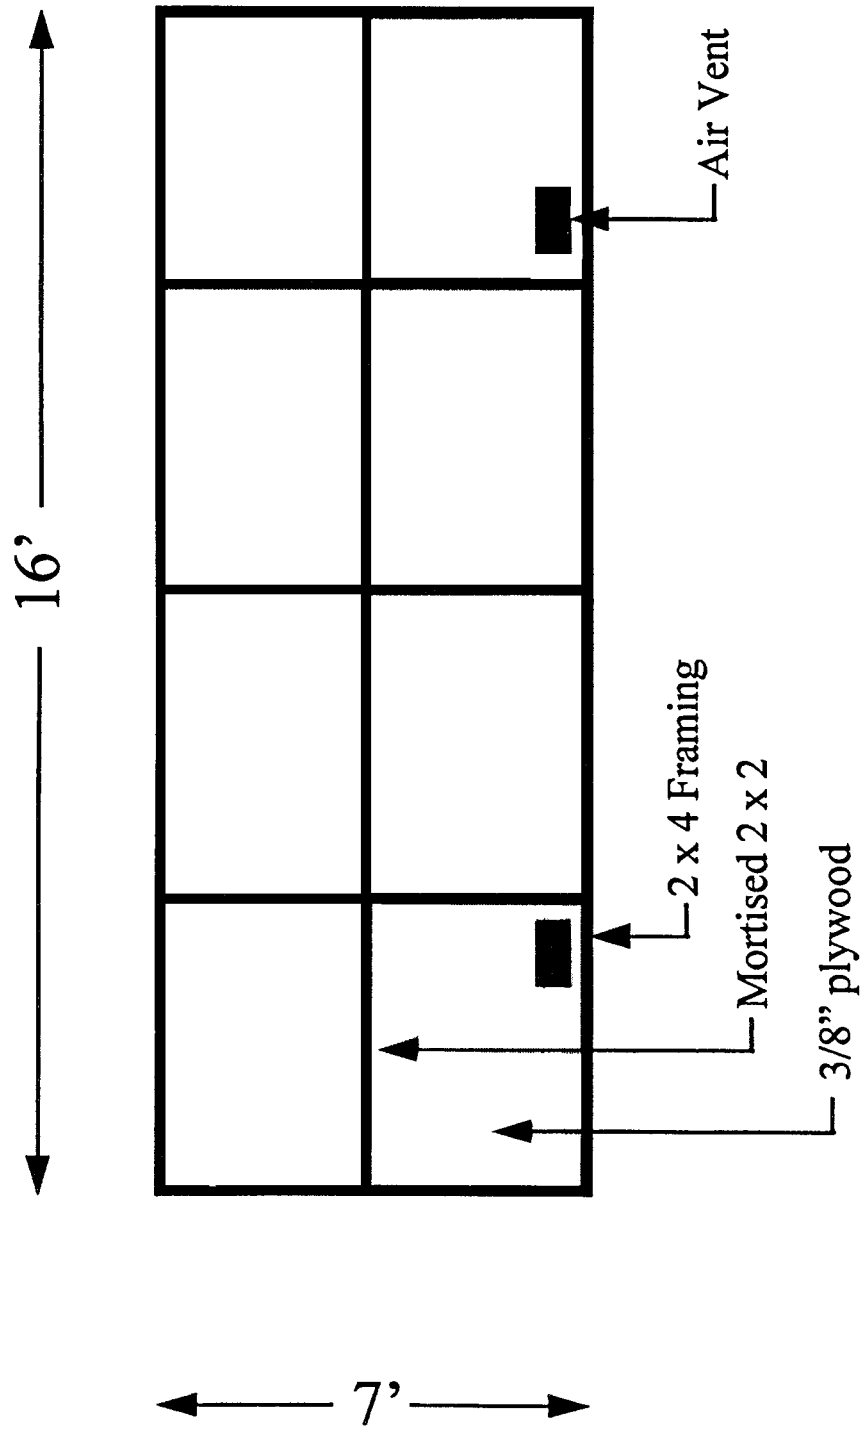
Figure 4

The garage door was a single panel, constructed of 3/8 inch plywood with 2x4 and 2x2 framing (Figure 4). This door was 16 feet wide, 7 feet high and weighed about 250 pounds. Connected to the door was a screw drive type mechanical garage door opener. The opener could be activated by a wall-mounted push button near the door leading to the entry hall (Figure 5) or either of two remote controls. The remotes were kept in the family cars.

The possibility of overhead doors closing unexpectedly should be recognized as a potential hazard to firefighters. Some overhead doors are rather heavy and use springs to assist in lifting the weight. With the spring properly tensioned, a 300-pound door can be lifted with 25 pounds of force. A heated spring can lose its tension. Without the spring properties the mechanical advantage is lost and the full weight of the door must be lifted to open it.

The presence of a garage door opener adds another dimension to the overhead door problem. If the opener remains energized, the door could open or close at any time if the remote control or push-button is activated. Newer doors should not close completely or stay down if there is an obstruction under the door. This has been a Federal Requirement since 1991 and has been a requirement for an Underwriters Laboratory listing since 1973. A charged 1-3/4 inch hoseline should be enough obstruction to cause the opener to reverse and reopen the door.

Exposure to the fireground environment of heat and water could cause abnormal activation of an opener. If the opener is activated abnormally there is no assurance that the safety features of the system will function. These features apparently did not function at the Everson Street fire.

A garage door opener can usually be disconnected from the door with the pull of the release handle. This takes the danger out of activation of the opener. The same result can be obtained by unplugging the opener so it cannot operate. This should not cause the door to close if it is in the full open position, but the door should be blocked open to ensure that it does not close later.

This incident illustrates the danger of overhead doors to fire personnel. Overhead doors, including fire doors are generally very heavy. Once closed they may be impossible to reopen under fire conditions. If entry is made through an overhead door, steps must be taken to ensure that the door will not close.

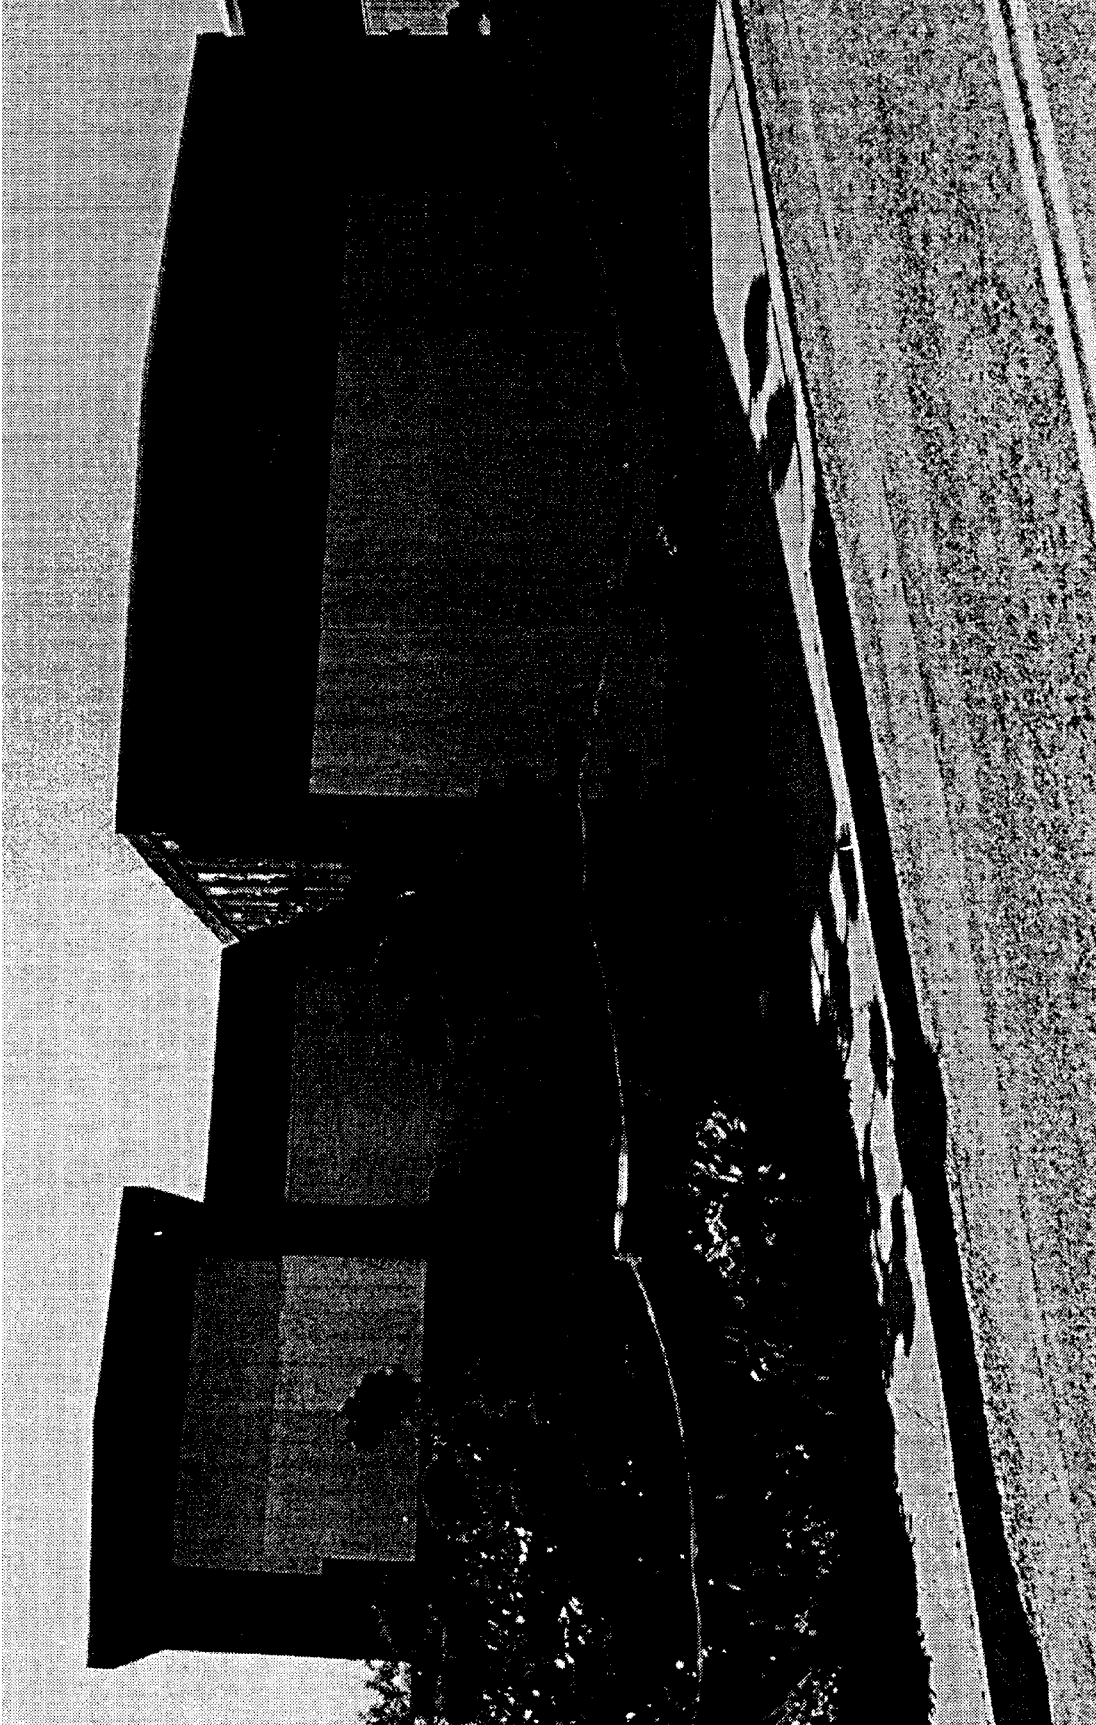
PHOTOGRAPH 1: The front of the house. The garage is to the right, the entryway door is in the center and the kitchen is to the left side of the photograph.

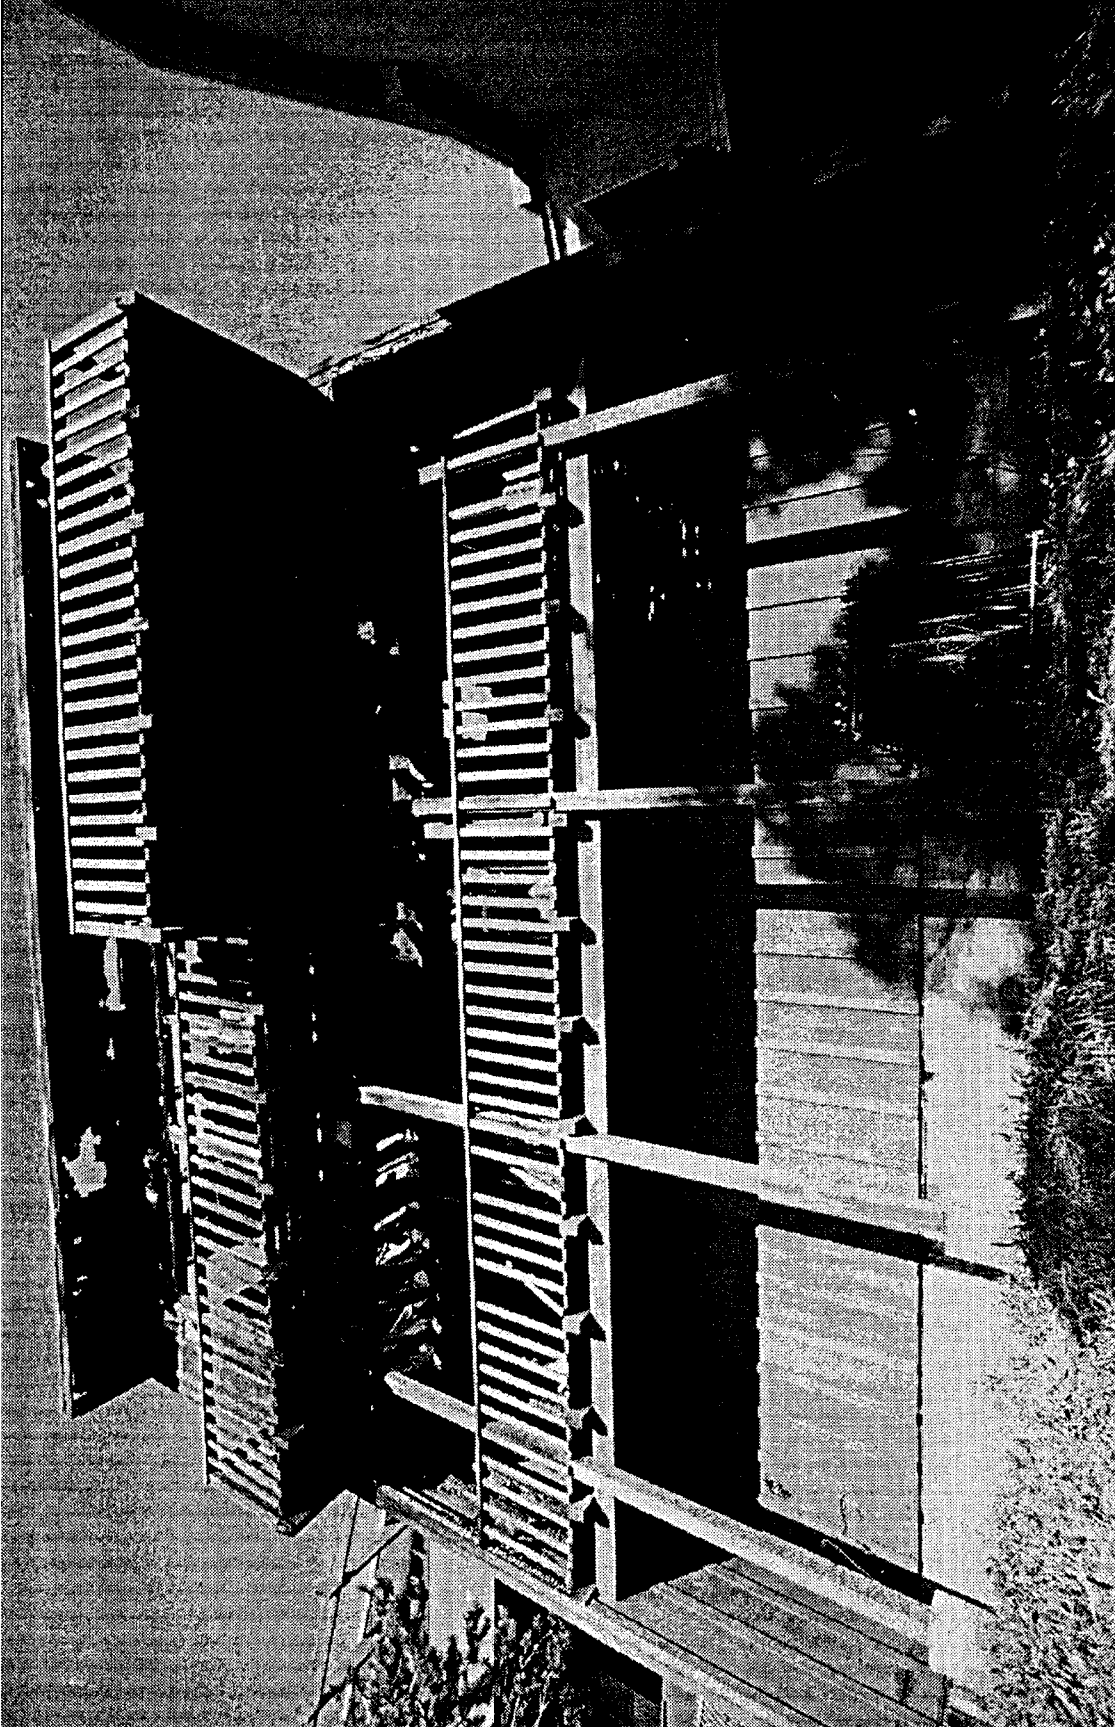
On the outside deck he found a one-foot by one-foot area burning around an outside electrical outlet. He went to the kitchen, filled a pan with water, which he used in an attempt to fight the fire. He refilled the pan twice in the downstairs bathroom, but was unsuccessful in controlling the fire.

PHOTOGRAPH 2: The rear of the house as viewed from ground level. The fire started in the wall above the lower deck to the right center of the photograph.

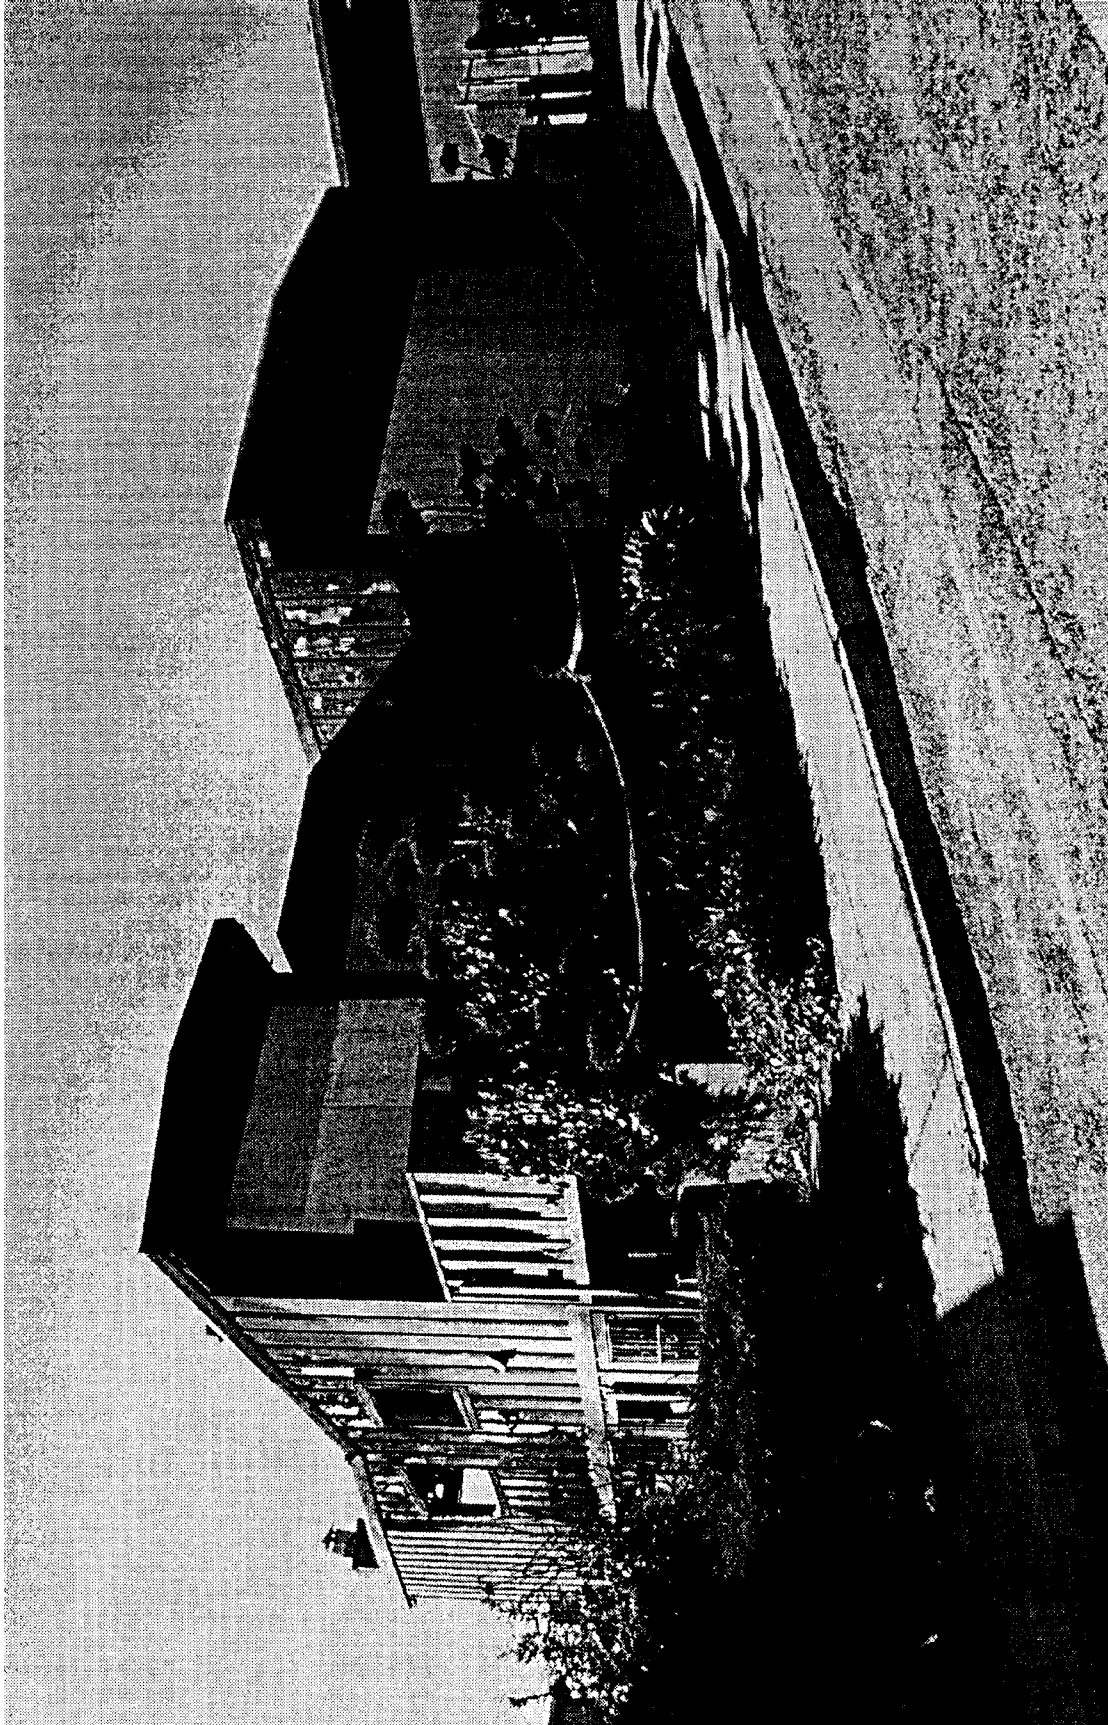
PHOTOGRAPH 3: The northeast corner of the house. Note the security gates on the lower level openings.

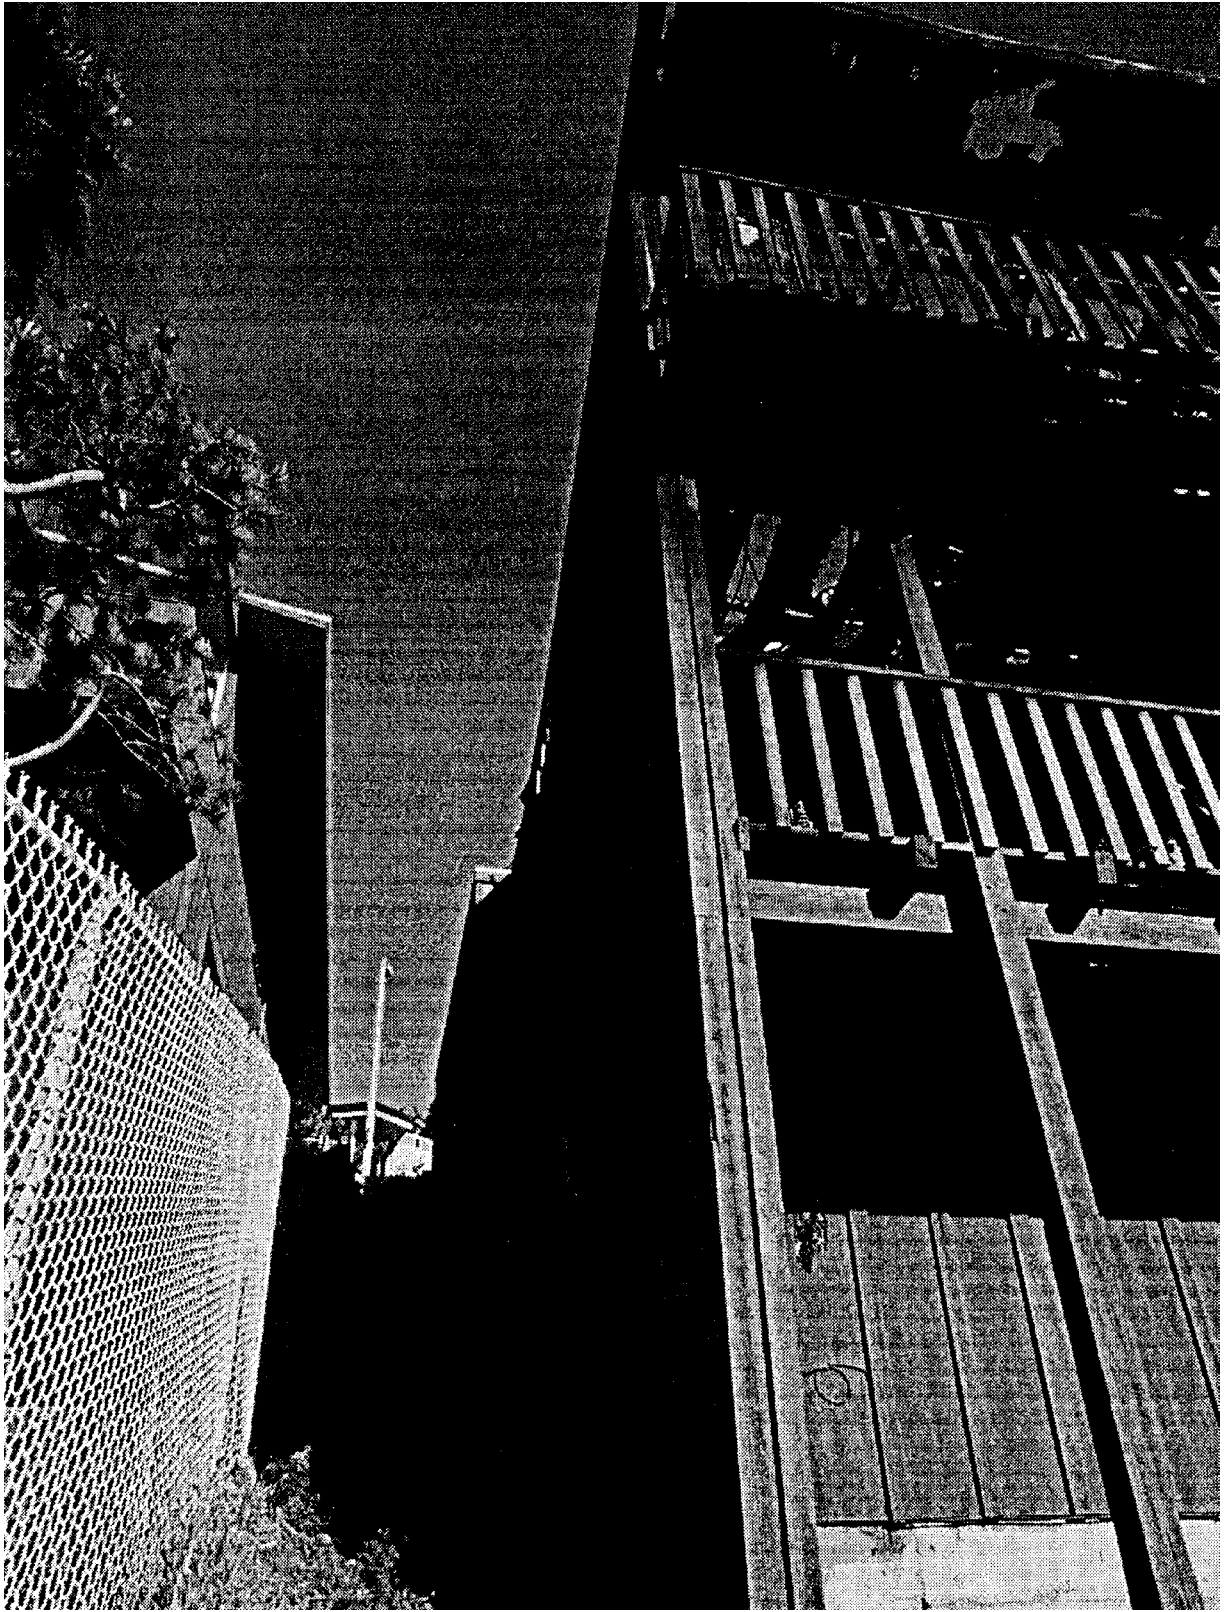
PHOTOGRAPH 4: The southwest corner of the house. Note the steepness of the building lot and the proximity of the house next door.
